Dam Removal in the USA: Effects on River Water Quality

DAM REMOVAL IN THE USA: EFFECTS ON RIVER WATER QUALITY

Michael A. Kruge

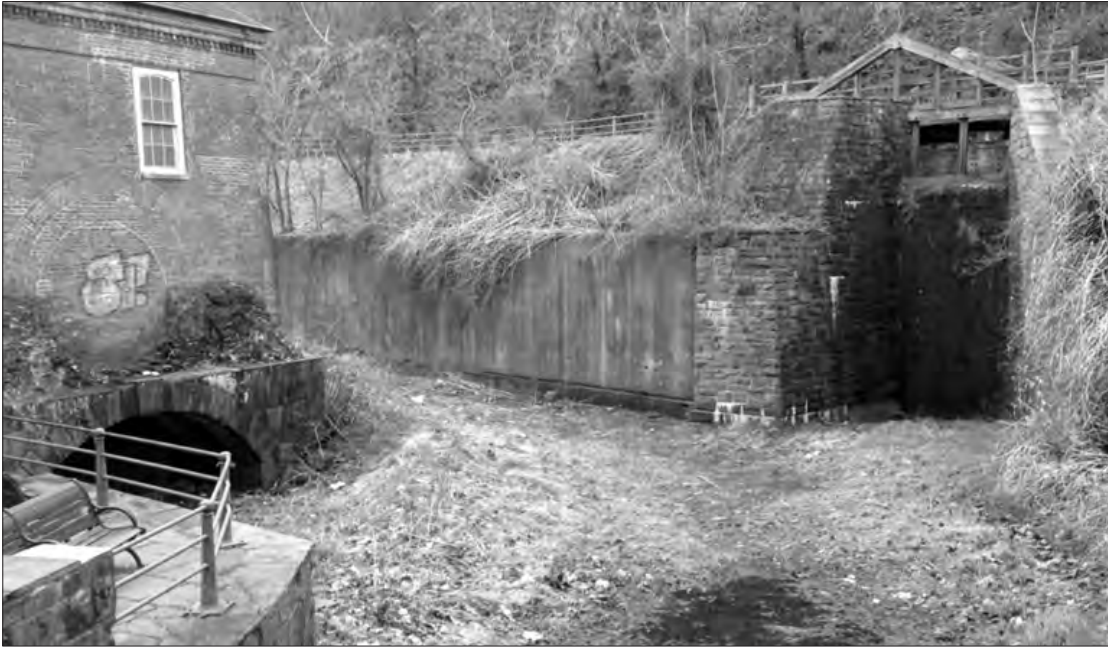
Figure 2. Remnants of the raceway system in Paterson (April, 2015). Note the sluiceway at the right which served to admit water from the upper canal at the top of the image. The circular pattern in the bricks on the wall of the industrial building on the left marks the former entrance of the rotating driveshaft. Photo: M. Kruge.

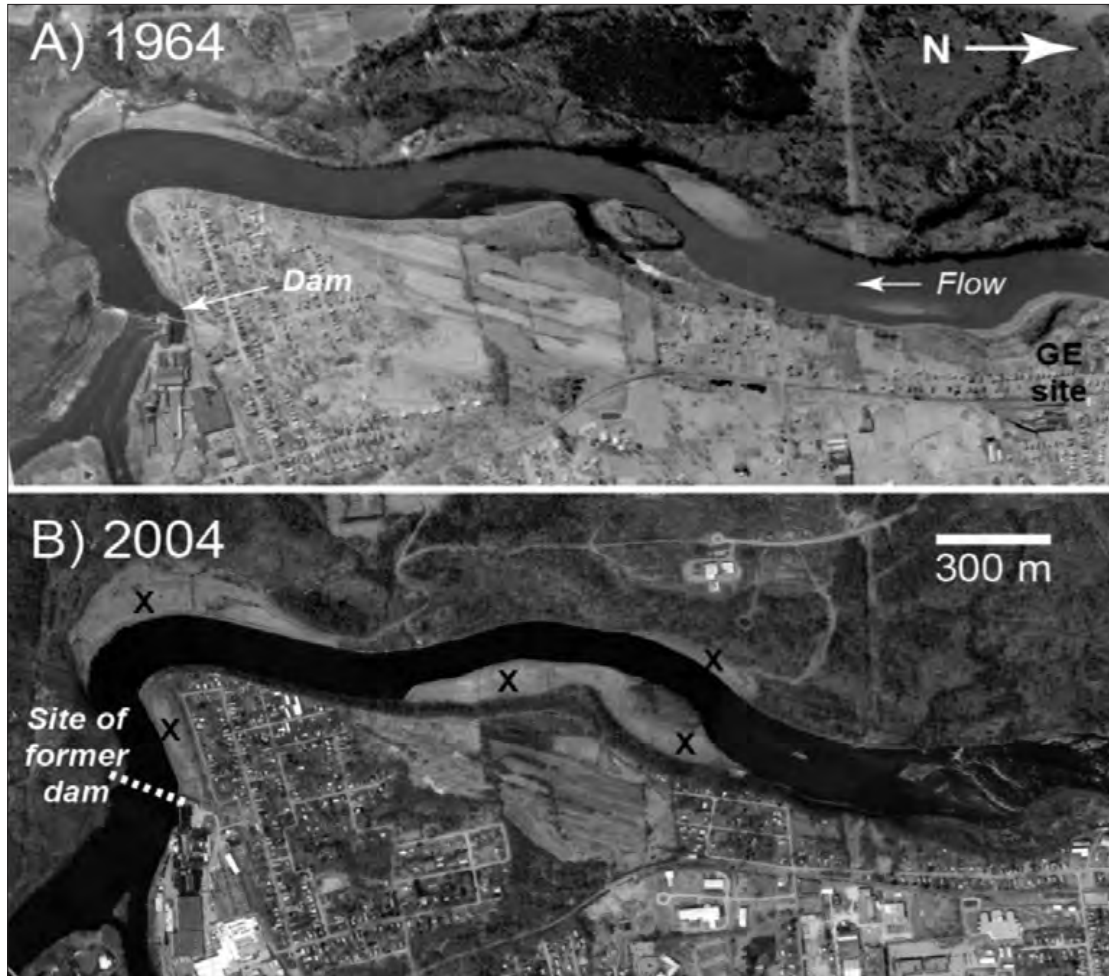
Figure 3. Aerial views of the Hudson River at Fort Edward (New York). A) Image from 1964 while the dam (at left) was in place, downstream from the General Electric capacitor factory (at right). Map imagery: United States Geological Survey. B) The same area in 2004 showing the site of the former dam. Light colored zones marked with black X's are the PCB remnant deposit sites exposed by the draining of the reservoir. Map imagery: Google Earth, New York GIS.

The contamination concerns provoked by the removal of the Fort Edward dam are twofold. Comparing Figures 3A and 3B, it is evident that draining the reservoir exposed large areas of sediment, namely the light-colored patches marked by X's in Figure 3B (USEPA, 2012). These remnant deposits have high

levels of PCB contamination, but remain a fairly localized hazard. However, PCB-contaminated sediments in the riverbed were also able to migrate downstream after the removal of the barrier in 1973, especially during intense storm events (Schneider *et al.*, 2007). In its lower reaches, the Hudson River is an estuary, such that sediments can migrate back upstream with the flood tide. After decades of PCB residence in this complex fluvial/estuarine regime, the net result is that the river is contaminated all the way down to its mouth in New York City harbor (USEPA, 2012).

The USEPA initially placed the Hudson River site on the Superfund list in 1984 (Figure 4), with the goal of capping the remnant deposits (Figure 3B) with

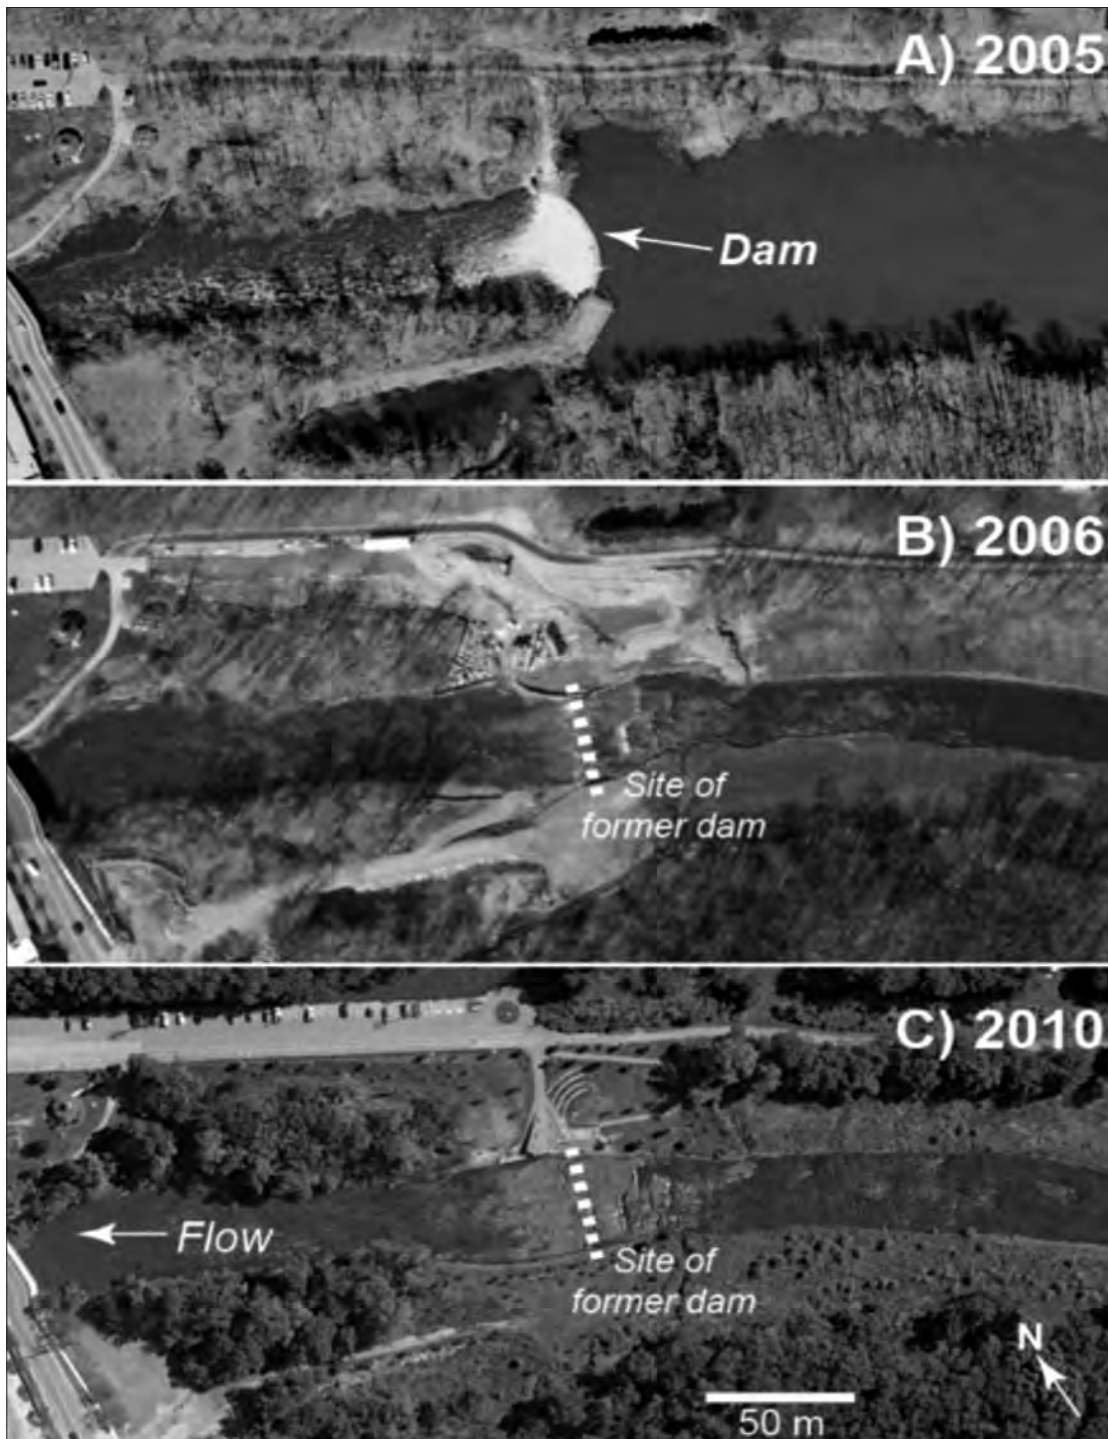
Figure 5. Sequence of aerial images of the Munroe Falls dam site, Cuyahoga River (Ohio). Map imagery: Google Earth, State of Ohio/OSIP. A) View in the year 2005 prior to the removal of the dam. B) View in 2006 shortly after dam removal. C) View in 2010 showing completed landscaping and public park.

River channel profiling revealed that erosive down-cutting was primarily localized in the deepest parts of the former reservoir, reaching the pre-dam river bed surface only one month after dam removal, while the reservoir sediments on the margins remained largely in place. Remobilized sediments were transferred down the river below the site of the former dam, significantly altering river bed morphology and sedimentology (Rumschlag and Peck, 2007). Similar observations were made in a decade-long geomorphological study of the effects of the Stronach dam removal on the Pine River in Michigan (Burroughs *et al.*, 2009). The reestablished Cuyahoga River channel occupies about 30% of the width of the reservoir above the dam site (Figures 5A, B); the reclaimed land was repurposed as a public park (Figure 5C).

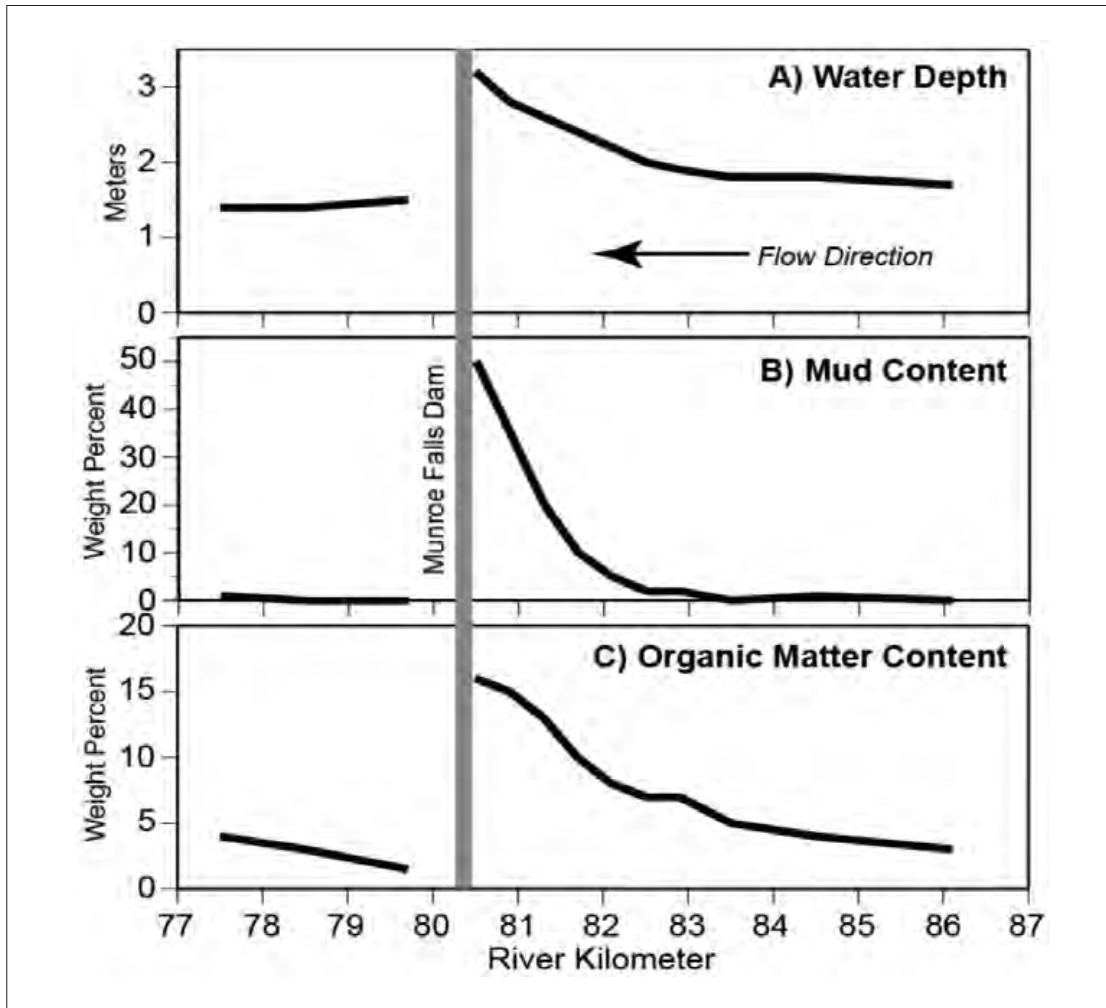
Figure 6. Conditions between river kilometers 77 and 87 prior to the removal of the Munroe Falls dam, Cuyahoga River (Ohio). Data from Peck *et al.* (2007). A) Water depth in the main channel above and below the dam. B) Proportion of mud in the sediment (grain size < 63 μm , normalized on an organic matter-free basis). C) Proportion of organic matter in the sediment, as measured by the loss-on-ignition method.

The Munroe Falls reservoir illustrated the classic effects of decades-long impoundment (Peck *et al.*, 2007). Concomitant with the increased water depth behind the dam (Figure 6A) and reduced stream flow velocity, muddy deposits extended a kilometer upstream (Figure 6B). In addition, the reservoir muds were highly enriched in organic matter, due to the relatively stagnant water conditions (Figure 6C). As mentioned previously (Section 3), this sequestered carbon is subject to alteration after the lake has been drained, potentially releasing greenhouse gases. Radiometrically-dated core samples taken in reservoir prior to dam removal provided a detailed record of the environmental history at the site. The sedimentology and trace metal contents indicated that episodic flood events had mobilized industrial contaminants from upstream sites, but resulted in levels that were unlikely to be significantly bioavailable (Peck *et al.*, 2007).

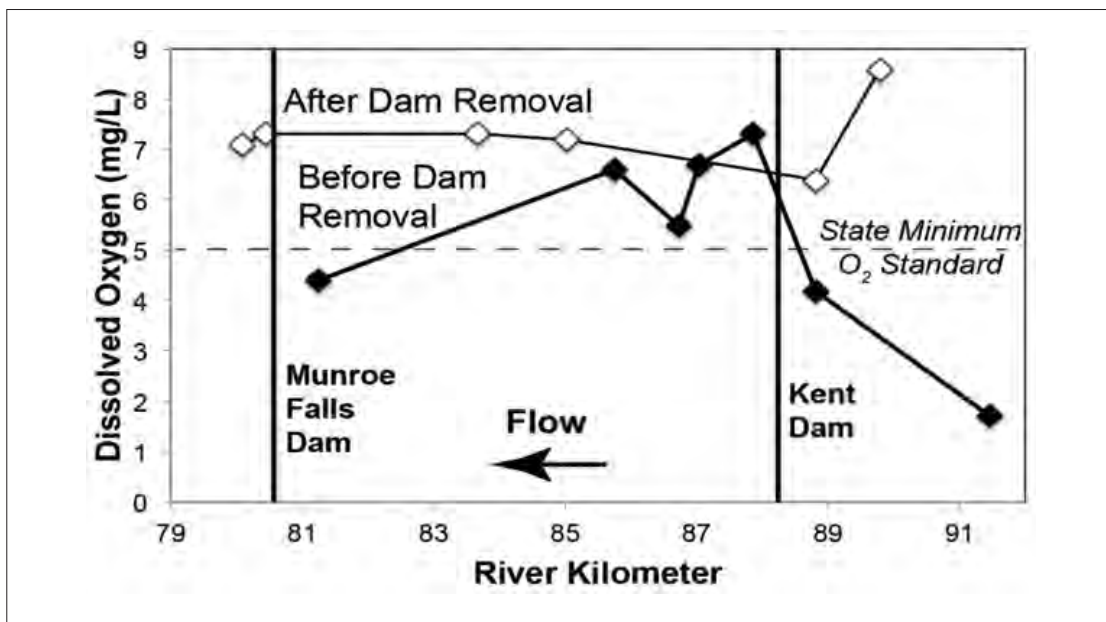
Figure 7. Mean summer (month of August) dissolved oxygen concentrations in Cuyahoga River water before and after the removal of the Munroe Falls and Kent dams. Data from Tuckerman and Zawiski (2007).

The stagnant water conditions behind the Munroe Falls dam and the companion Kent dam 8 km upstream led to seasonal hypoxia in the reservoirs, impacting aquatic life. The 19th century Kent dam was one of the oldest arched masonry dams in the United State. The desire for a free-flowing river was at odds with the need for the preservation of this historic structure. After a series of formal community meetings, governmental agencies devised a compromise plan to divert the principal streamflow around the arched dam, which was left in place as an artificial waterfall (Tuckerman and Zawiski, 2007). With the removal of the Munroe Falls dam and the bypass of the Kent dam, summer dissolved oxygen levels improved markedly, exceeding the regulatory standard (Figure 7).

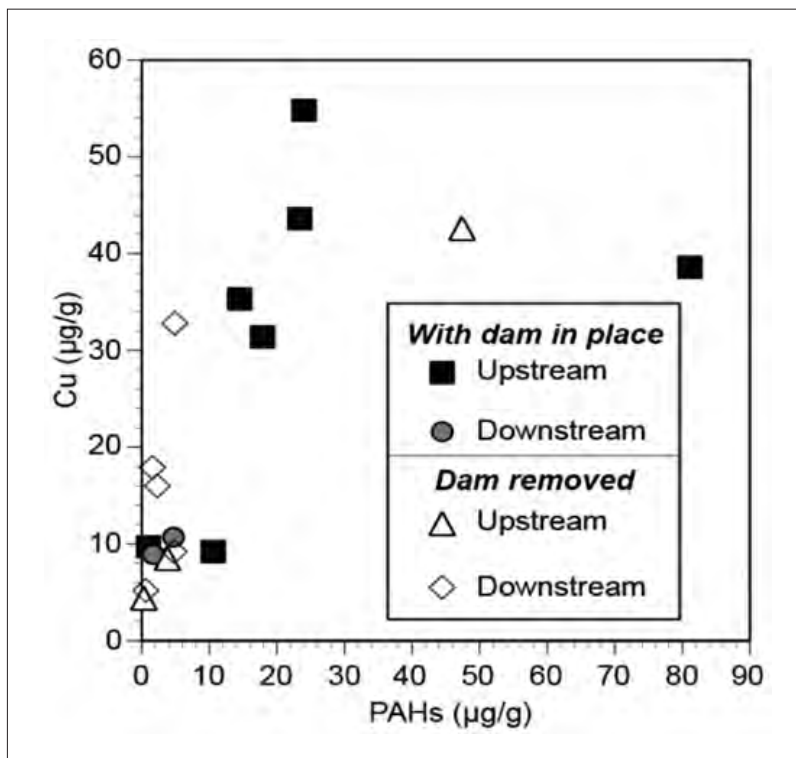
Figure 8. Concentrations of contaminants in the sediments of Manatawny Creek (Pottstown, Pennsylvania) upstream and downstream of the dam site, before and after dam removal. Copper and total polycyclic aromatic hydrocarbons (PAHs) are shown as examples of inorganic and organic contaminants, respectively. Data from Ashley *et al.* (2006).

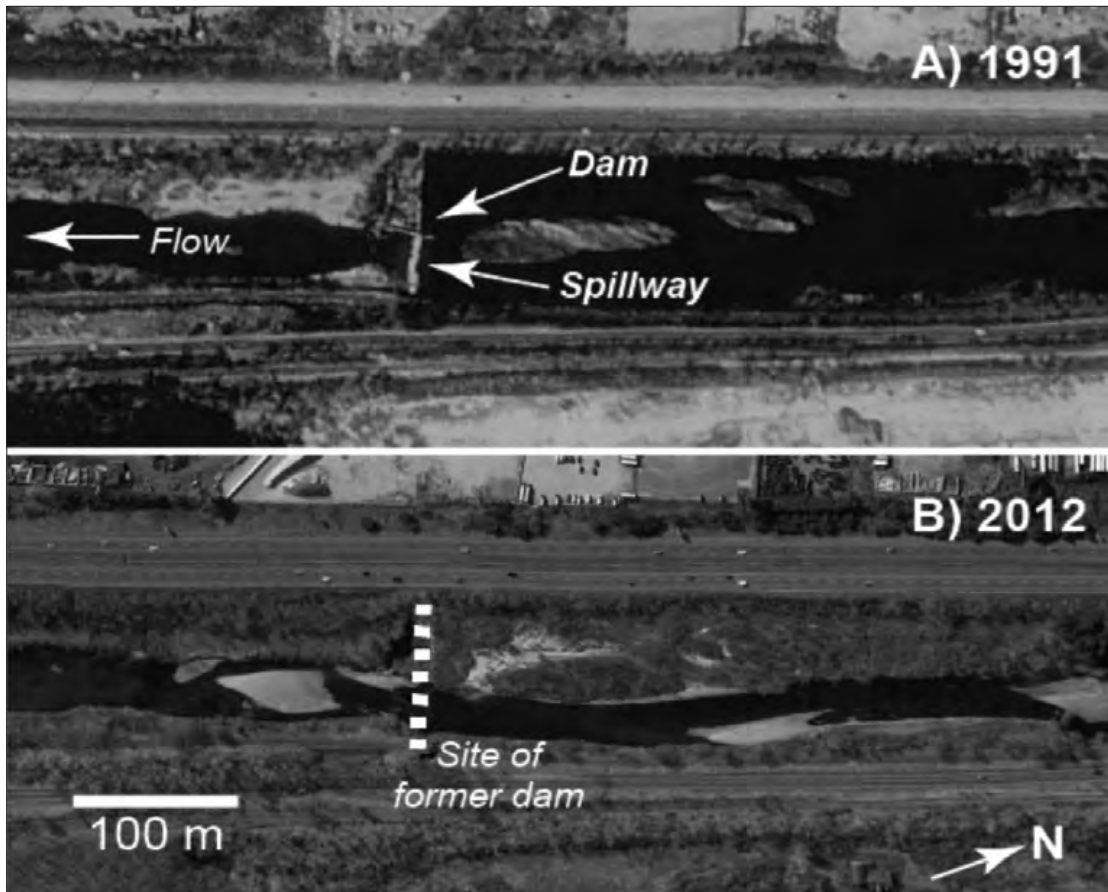
Figure 9. Sequence of aerial images of the Anaconda dam site, Naugatuck River (Waterbury, Connecticut). Map imagery: Google Earth, U.S. Geological Survey. A) View in the year 1991, with dam in place. Note the wide spillway along the eastern half of the dam. B) View in 2012, after removal of dam.

The Naugatuck River (Connecticut), a major tributary of the estuarine Housatonic River, was once known for its abundance of anadromous fish, particularly *Alosa spp.* With the advent of the Industrial Revolution, fish migration was impeded by the dams built to serve the new mills. These water-powered facilities evolved into heavy industrial complexes by the early 20th century, giving the Naugatuck its reputation as “Connecticut’s dirtiest river”. By the century’s end, the condition of the river was beginning to improve as a result of environmental regulations, closure of the factories due to global economic shifts, and public concern. Dams were removed or by-passed with hopes for ameliorating fish habitat (Howard, 1999). As one of eight dams involved in the ongoing Naugatuck River restoration efforts, the Anaconda dam (Figure 9A) was removed in 1999.

Standing 3.4 m high and 100 m long, it was deteriorating and hazardous. After extensive sediment analysis, the broad spillway on its east side was to be opened and impounded sediments removed to prevent their remobilization. Before these plans could be implemented, a strong storm breached the dam at the spillway. It had to be dismantled quickly, under an emergency decree, to prevent erosive damage to a municipal sewer main. The river soon reestablished itself, scouring a slightly sinuous channel down to the pre-dam riverbed on the east side of the former reservoir (Figure 9B), nearing an equilibrium state in only four years. Much of the reservoir sediment on the west side remains in place as a dewatered, vegetated floodplain, naturally armored over time with coarse sediment. The urgent spillway demolition precluded completion of the planned sediment testing. PAHs were detected, but in relatively low concentrations, likely due to the predominance of coarse-grained deposits. In the years since dam removal, fish populations have increased and recreational angling is now possible (Wildman and MacBroom, 2005).

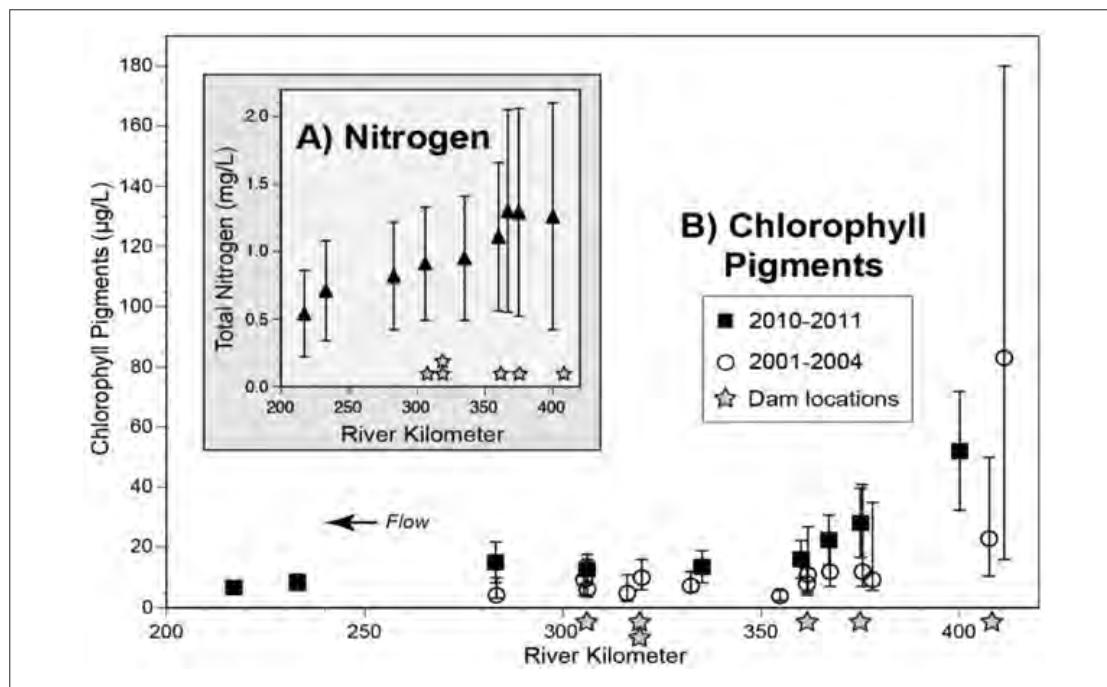
Figure 10. Water quality in the Klamath River (Oregon and California) between river kilometers 200 and 420. Stars mark dam locations: Link River (upstream), Keno, J.C. Boyle, Copco Nos. 1 & 2, and Iron Gate (downstream). A) Total nitrogen concentrations in 2010-2011 (data from Oliver *et al.* (2014)). B) Concentrations of chlorophyll pigments measured from 2001 to 2004 (data from Kann and Asarian (2006)) and in 2010-2011 (data from Oliver *et al.* (2014)).

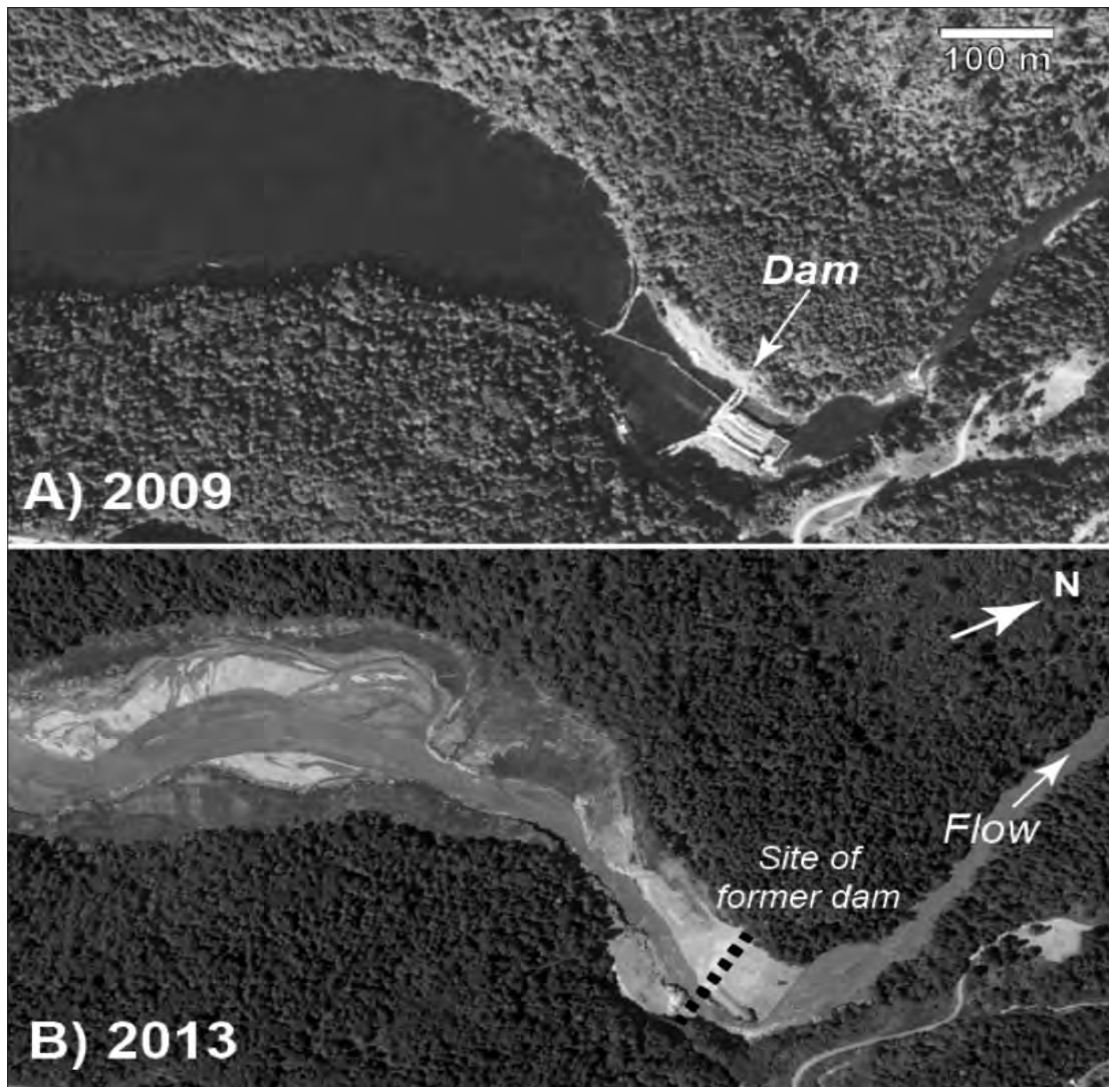
Figure 11. Sequence of aerial images of the Elwha dam site, Elwha River (Washington state). Map imagery: Google Earth, U.S. Department of Agriculture Farm Service Agency. A) View in the year 2009, with dam in place. B) View in 2013, after removal of dam.

upstream from the river's mouth at the Juan de Fuca Strait, the concrete Elwha dam was 33 m high (Figure 11A). The taller, arcuate Glines Canyon dam stood at 64 m, constructed 14 km farther upstream in 1927. Privately built for electricity generation with a combined capacity of 28 MW, the dams offered little flood control or water supply benefit (Randle *et al.*, 2015; Warrick *et al.*, 2015). The dams lacked fish ladders and effectively blocked anadromous fish runs. The U.S. Congress approved the purchase and demolition of the dams in 1992, recognizing that most of the river's watershed (as well as the Glines Canyon dam itself) was located in Olympic National Park. Due to persistent controversy, the actual removal was delayed for another two decades (East *et al.*, 2015; Nijhuis, 2014; Randle *et al.*, 2015).

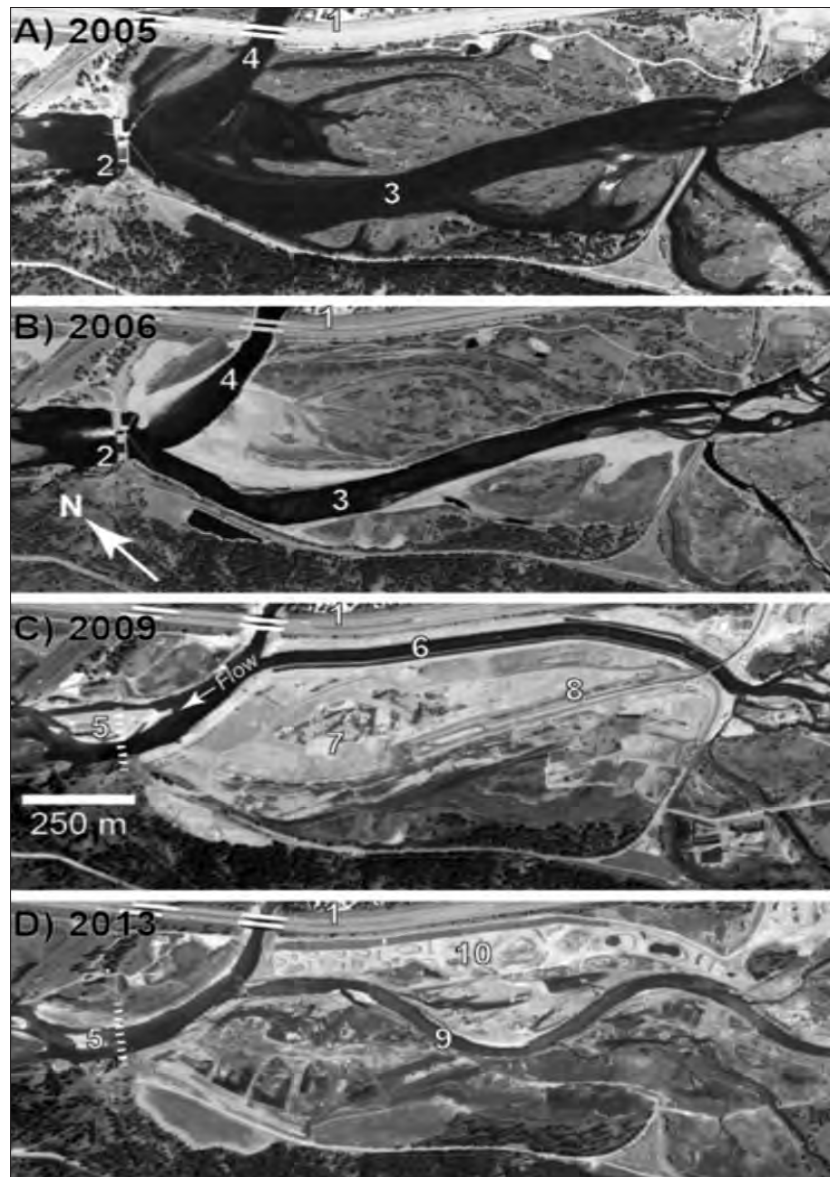
Figure 12. Sequence of aerial images of the Milltown dam site, confluence of the Clark Fork and Blackfoot Rivers (Montana). Map imagery: Google Earth, U.S. Department of Agriculture Farm Service Agency. A) View in the year 2005, with dam in place. B) In 2006 after the gradual draining of the reservoir. C) In 2009 after removal of dam and creation of a diversion channel to permit removal of contaminated reservoir sediment. D) In 2013 showing the restored, natural-appearing Clark River channel after completion of contaminated sediment removal. Key to indicated features: 1) municipality of Milltown, 2) Milltown dam, 3) reservoir behind dam (Clark Fork River), 4) reservoir behind dam (Blackfoot River), 5) former dam site, 6) temporary Clark River channel during floodplain sediment removal, 7) sediment removal activities in Clark River floodplain, 8) temporary railroad for sediment removal, 9) restored “natural” Clark River channel, 10) landscaping for the new state park.
