Shoreline evolution, Chesapeake Bay shoreline, City of Virginia Beach, Virginia

Shoreline Evolution Chesapeake Bay Shoreline City of Virginia Beach, Virginia

Shoreline Studies Program ¹
Department of Physical Sciences and
Wetlands Program ²
Center for Coastal Resources Management

Virginia Institute of Marine Science College of William & Mary Gloucester Point, Virginia

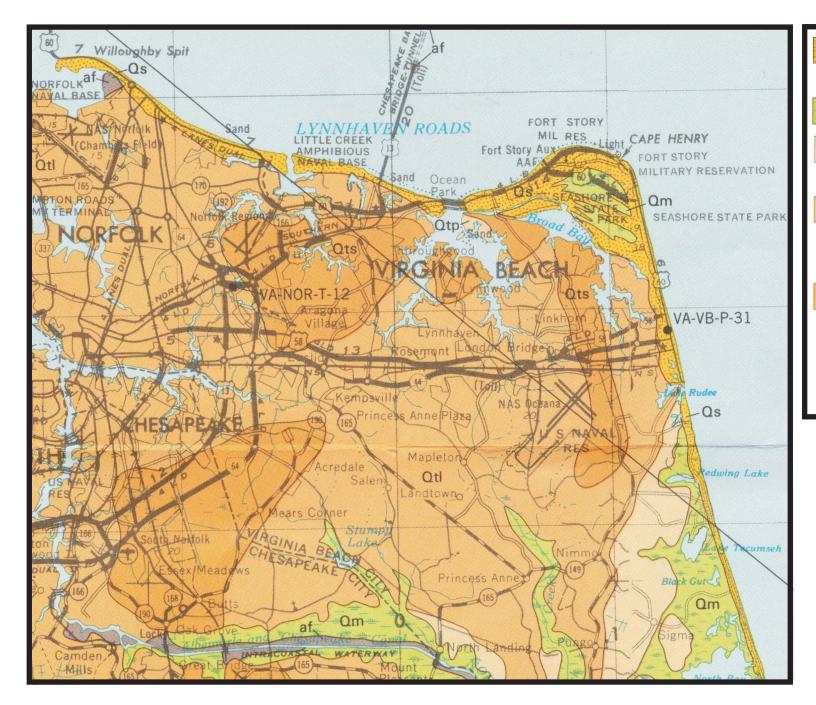
Figure 3. Geologic map of the City of Virginia Beach (from Mixon *et al.*, 1989).

The coastal geomorphology of the City is a function of the underlying geology and the hydrodynamic forces operating across the land/water interface, the shoreline. The Chesapeake Bay coast of Virginia Beach is exclusively Holocene beach sands which overlie earlier Holocene sands, mud, and clays (Figure 3). The Atlantic Ocean has come and gone numerous times on the Virginia coastal plain over the past million years. The effect has been to rework older deposits into beach and lagoonal deposits at time of the transgressions.

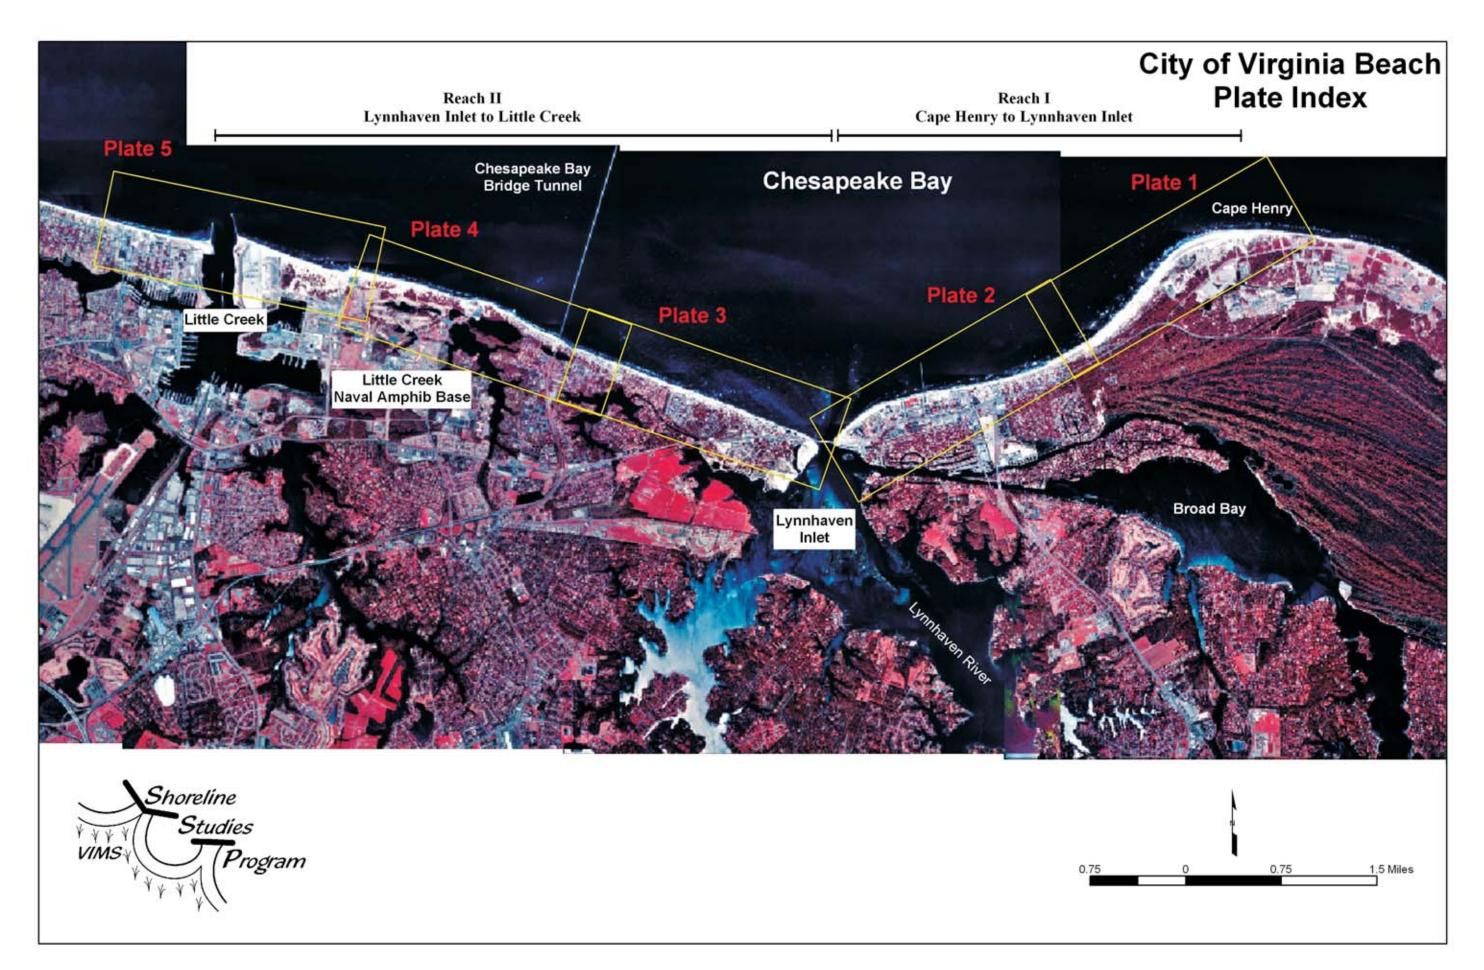
Figure 4. Index of shoreline plates.

Two main shore reaches occur along the Bay shore of Virginia Beach. These reaches are divided into five plates for discussion and are presented in Figure 4. Reach I extends from Cape Henry to Lynnhaven Inlet and Reach II from Lynnhaven Inlet to the entrance of Little Creek Inlet. The littoral system is sand rich from transport into the Bay. Net longshore transport is to the west.

For each Plate shown on Figure 4 (Page 5), Appendix A contains orthorectified aerial photography flown in 1937, 1960, 1970, 1976, 1980, 1994, and 2002. Also shown are the digitized shorelines, identified dune sites, and an arbitrarily created baseline. Another copy of the recent photo depicts the relationship of historical shorelines to the present. Finally, a plot shows only the relative locations of the shorelines while another one depicts the rate of shore change between dates. A summary of the average Plate rate of change in ft/yr as well as the standard deviation for each rate is also shown.

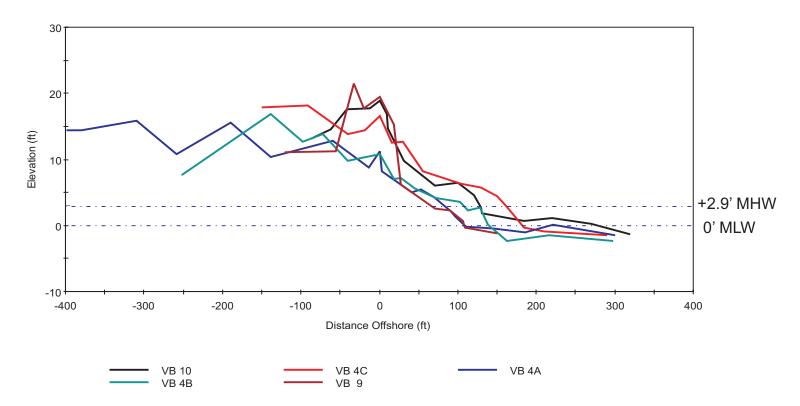
Figure 5. Variability of dune and beach profiles in the City of Virginia Beach.

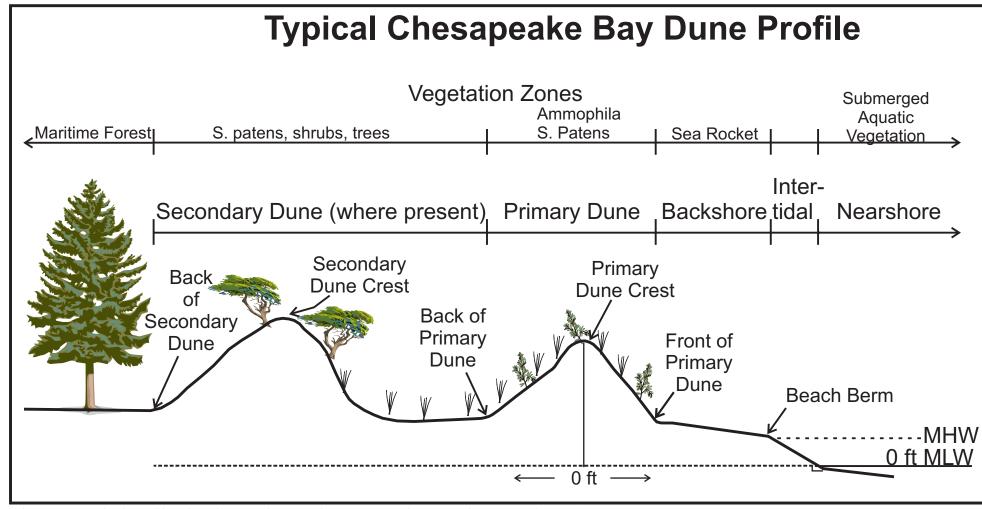
Figure 6. Typical profile of a Chesapeake Bay dune system (from Hardaway et al., 2001).

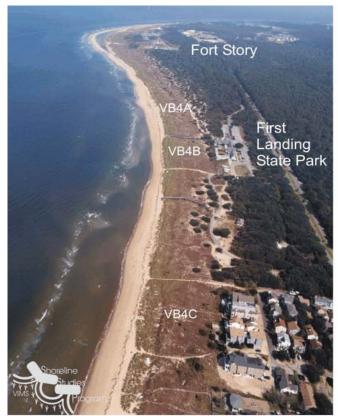
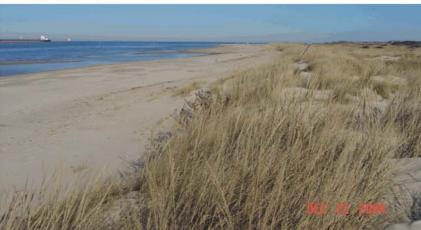
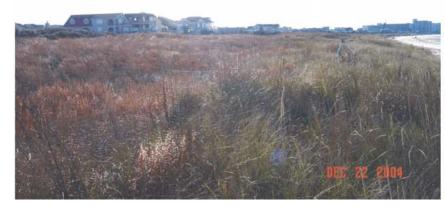
Looking east toward the mouth of the Bay on 24 October 2004.

At dune site VB4B looking west toward dune site VB4C on 22 Dec 2004.

Figure 7. Photos of the Virginia Beach shoreline showing dune sites VB4A, VB4B and VB4C.

Shoreline advances at and west of Cape Henry are historically significant. One factor that may have played a role has been ongoing beach nourishment project at the Virginia Beach resort area several miles down the coast from Cape Henry. This area has had beach fill and sand bypassing operations in effect to one degree or another since the mid-1950s whereby several million cubic yards of sand have been placed in the littoral system whose net transport is to the north toward and around Cape Henry. The effect along the coast of Reach I is an ongoing advance of the coast resulting in the primary dune becoming the secondary dune and subsequently the tertiary dune over time. The dune sites VB4A and VB4B at First Landing State Park exhibit this trend as they are natural dunes with little or no development (Figure 7).

The dune system west of First Landing State Park, VB4C, has been extensively developed, but the primary dune feature was not significantly impacted. It is only the area further west where condominiums were built on the primary dune that the dune is severely impacted. Many shoreline condos were bulkheaded as the beach narrowed and the dune disappeared thereby losing the natural protection the dune offered. This section of coast between station 5,000 and 9,000 was historically slightly erosional but as one proceeds further west toward Lynnhaven Inlet, an accretionary trend evolves and the condos there enjoy a wide beach and stable dune (*i.e.* VB6).

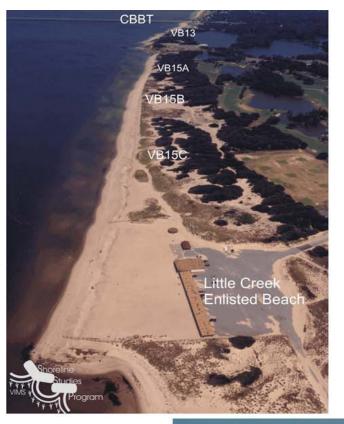
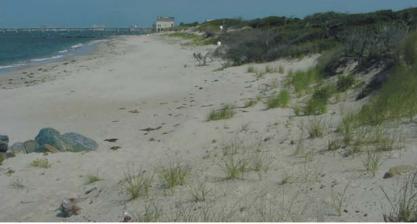
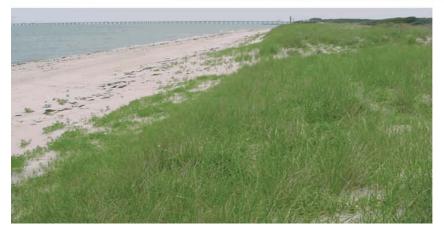
Looking east toward the Chesapeake Bay Bridge Tunnel on 12 June 2002.

At dune site VB13 looking east toward the CBBT on 19 June 2002.

At dune site VB15B looking east toward dune site VB15A and the CBBT on19 June 2002.

Figure 8. Photos of the Virginia Beach shoreline showing dune sites VB13, VB15A, VB15B and VB15C.

The shoreline at dune site VB13 (Figure 8) has migrated east and west between the rubble groin on the Little Creek NAB boundary and the groins and breakwaters at the Officer's Club Beach (Station 4,000). This trend is likely to continue. The beach/dune along VB15 has 3 morphologic subreaches, A, B and C. VB15A is erosional as the shoreline migrates landward, partially in response to the shore structures installed at the Officer's Club beach over the past 20 years. The combination of groins, breakwaters and large revetments have created a headland feature that is now working in combination with the large rubble groin at the Enlisted Beach to create a long curvilinear embayed coast. VB15B is a transitional area (Figure 8), and VB15C has accreted to its maximum extent and is now relatively stable. VB15A will continue to recede toward equilibrium which could take 20 years or more unless the Navy intervenes with additional structures.

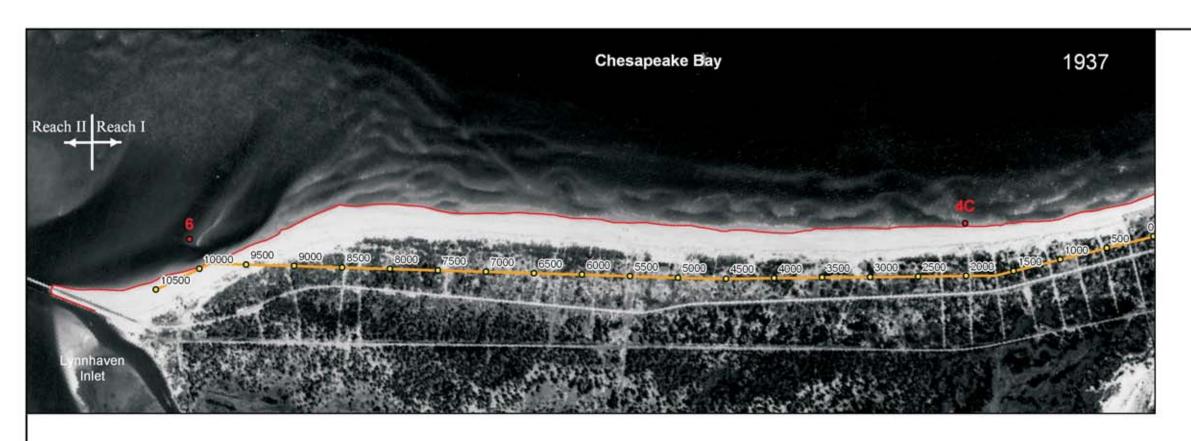
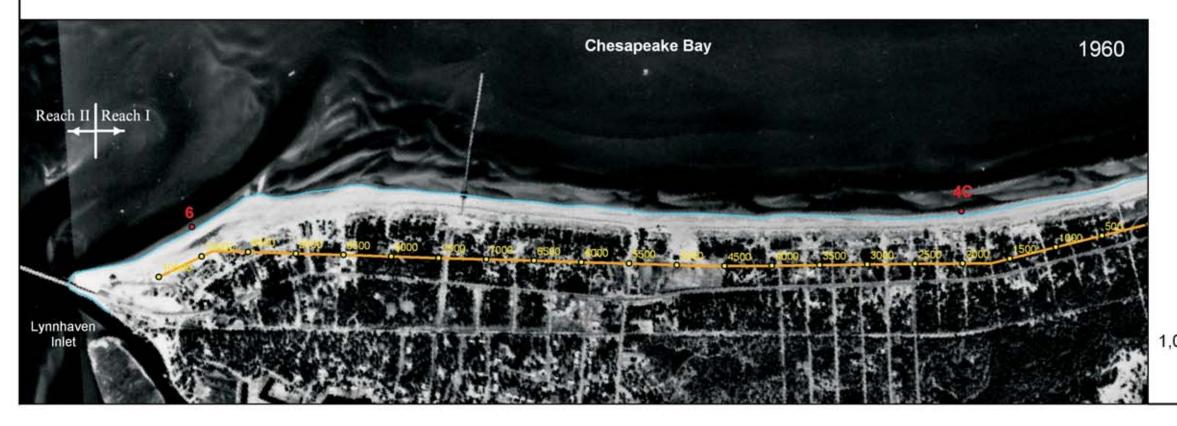
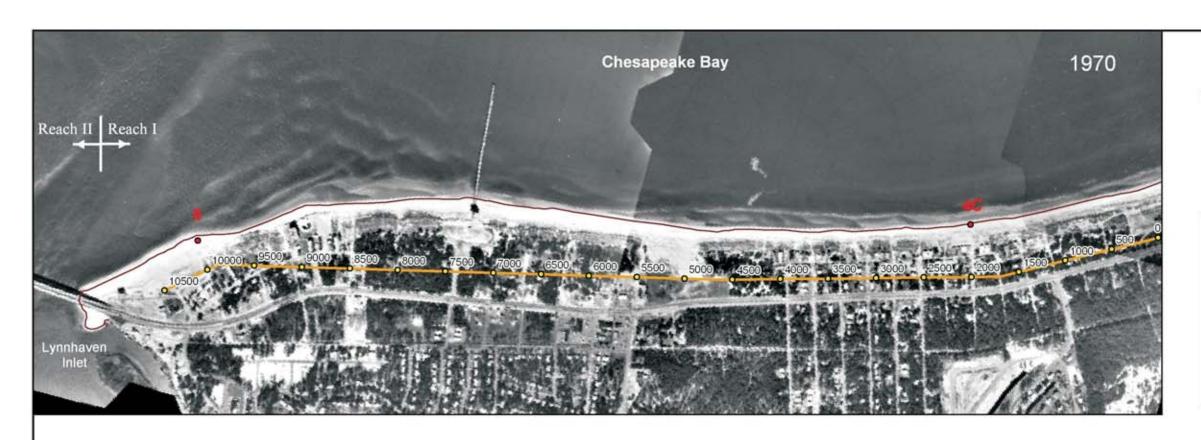
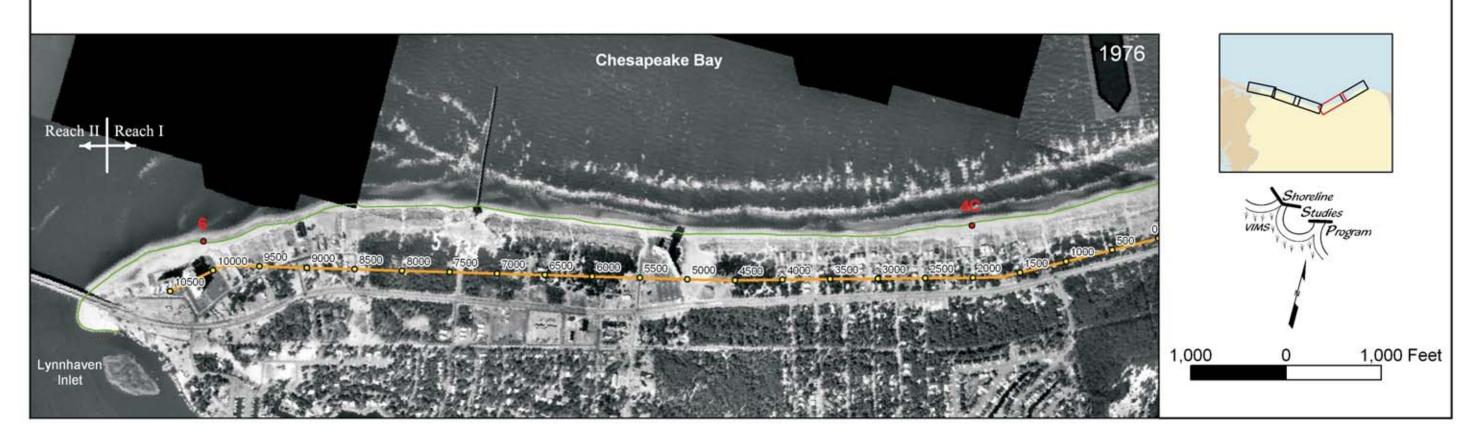
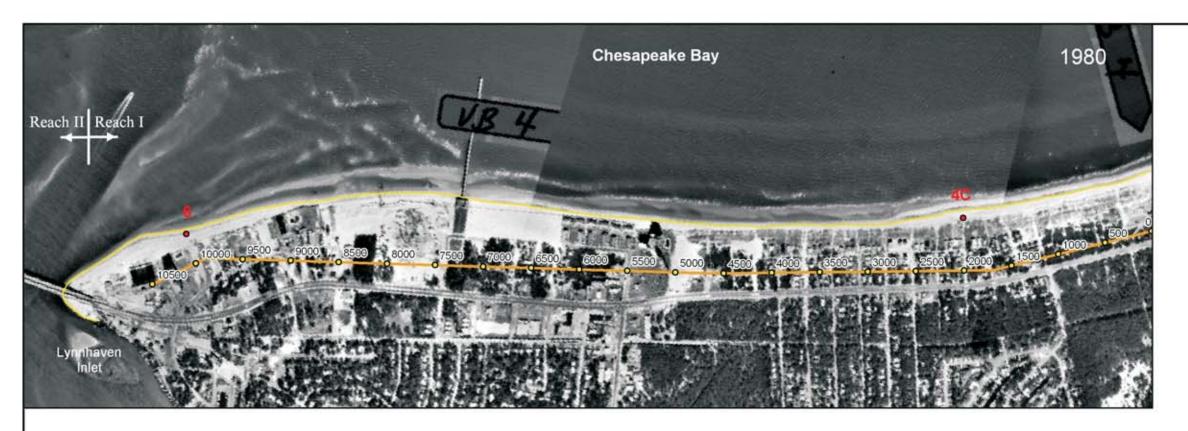
Morphological Reach I Cape Henry to Lynnhaven Inlet

The Plate 2 coast continues the net accretionary trend from stations 0 to about 2,000, then the shoreline trends become very stable with minor advances and retreats to about station 8,500 where shoreline advance becomes the dominant trend. Dune site VB4C is the westward extension from Plate 1 and stops at about Station 5,500. At that station condominiums begin to occupy the coast, and the primary dune has been developed. This development continues to about Station 9,000 where the primary dune begins again and continues around to the entrance of Lynnhaven Inlet as VB6.

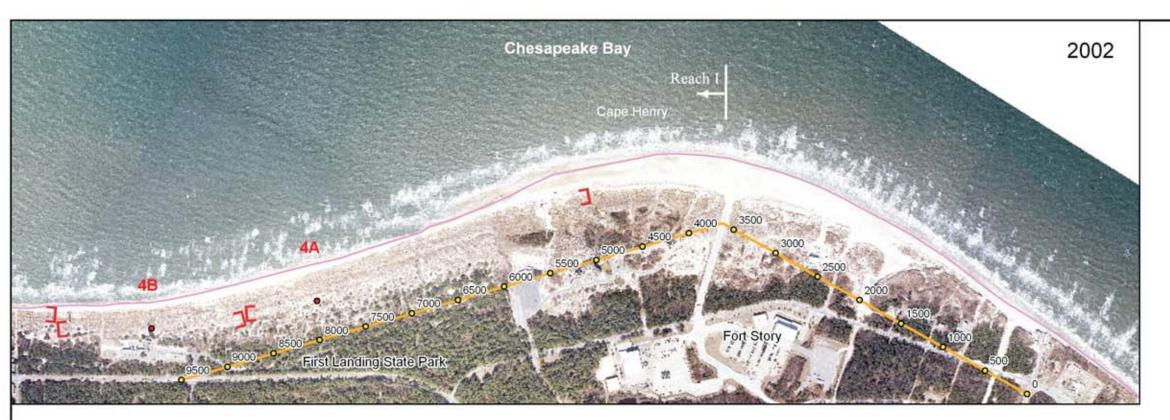
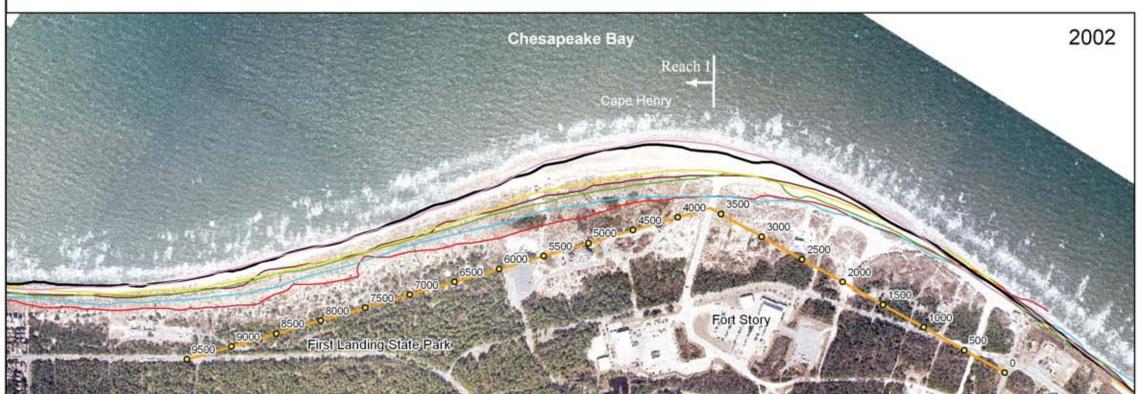
Plate 1

Morphological Reach I Cape Henry to Lynnhaven Inlet

Reach I includes Plates 1 and 2 along with the dune sites denoted as VB4A, VB4B, VB4C and VB6. VB4 is a continuous dune feature with VB4A and VB4B representing subreaches along First Landing State Park's extensive natural dune field (Plate 1). This subreach has experienced significant net (1937-2002) accretion since 1937 causing the primary dune to advance bayward leaving behind a series of "secondary" dunes, particularly between Stations 3,500 and 9,500.

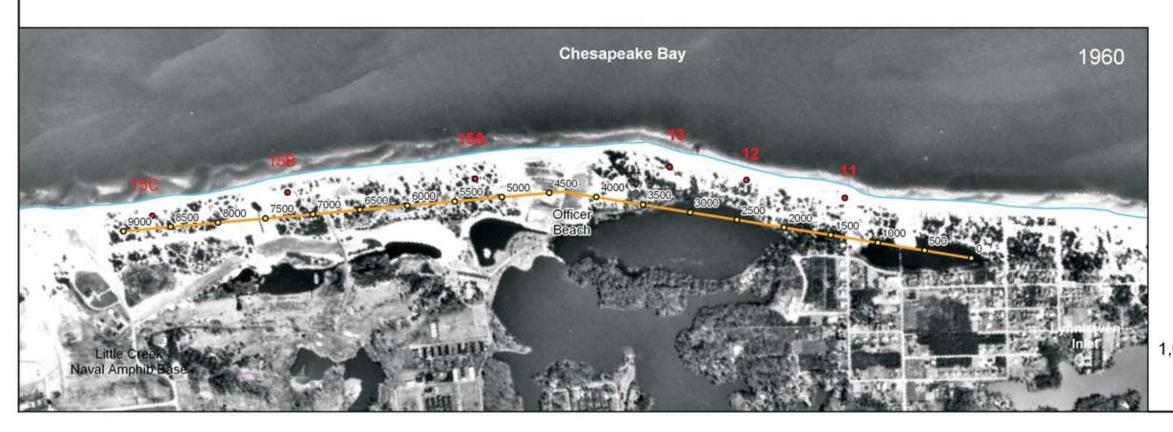
Morphological Reach II Lynnhaven Inlet to Little Creek

Plate 4 includes dune sites VB11, VB12, VB13, VB15A, VB15B and part of VB15C. The shoreline trend of this plate has been erosional between 1960 and 1976 except for a small area between stations 6,500 and 7,500 where a slight advanced occurred. Dune site VB11 is separated from VB12 by a single bulkheaded lot. The same exists for the boundaries between VB12 and VB13. VB13 and VB15 are part of the Little Creek Naval Amphibious Base (NAB). VB15 is actually a continuous beach/dune feature with three slightly different shore morphologies. It is bounded on the east by a stone revetment and on the west by the Enlisted Beach parking lot. The area from station 3,500 to 5,000 has been impacted by groins, breakwaters and revetments

since 1994. The shore was erosional between 1994 and 2002 from stations 5,000 to about station 9,000. Beyond station 9,000, the shore had been accretionary since 1970 because the littoral transport was interrupted when a large groin was installed sometime between 1970 and 1976 and beach nourishment was placed along the shore. Large rubble groins were installed in the early 1970s at stations approximately stations 3,000, 4,000, 4,500 and 9,800. Shore offsets on the west side and advances on the east side indicate net alongshore sand movement to the west.
