Tension-tension Fatigue Behavior of Nextel™ 720/Alumina-mullite Ceramic Composite at 1200°C in Air and in Steam

THESIS

Sarah A. Witzgall, 1st Lt, USAF

AIR FORCE INSTITUTE OF TECHNOLOGY

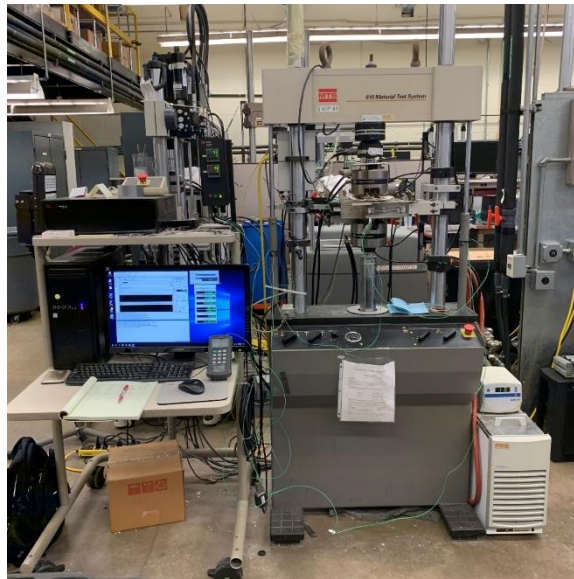
The mechanical testing equipment used was an 810 Material Test System (MTS), a servo-hydraulic testing machine fitted with MTS water-cooled hydraulic wedge grips. The machine, shown in Figure 3, has a load cell of 5-kip capacity. In all tests, the grip pressure was set to 8 MPa. During testing, the grips were cooled to 15°C using a Neslab RTE 7 chiller. An MTS FlexTest 40 digital controller and MTS Multipurpose Testware (MPT) software were used to program test routines and collect test data.

Figure 3. Test Station with 5-kip MTS and accompanying equipment

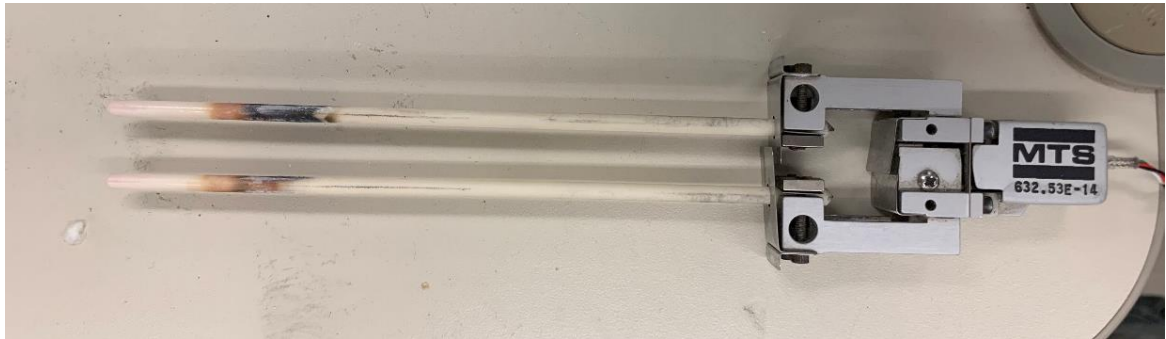
To measure strain, a high-temperature extensometer from MTS (Model 632.53E-14) with a gauge section of 12.5 mm was used. The data from the extensometer is displayed in the MTS software. Due to the nature of the material, the specimens were not marked with extensometer indentations; preferably, the extensometer was just placed against the material. The extensometer is shown in Figure 5.

Figure 5. MTS Extensometer

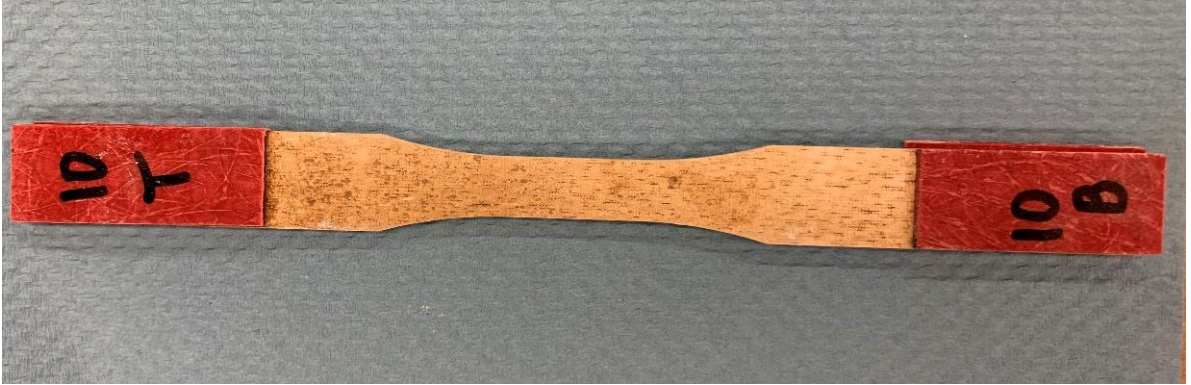
Figure 8. Specimen equipped with tabs and ready for testing

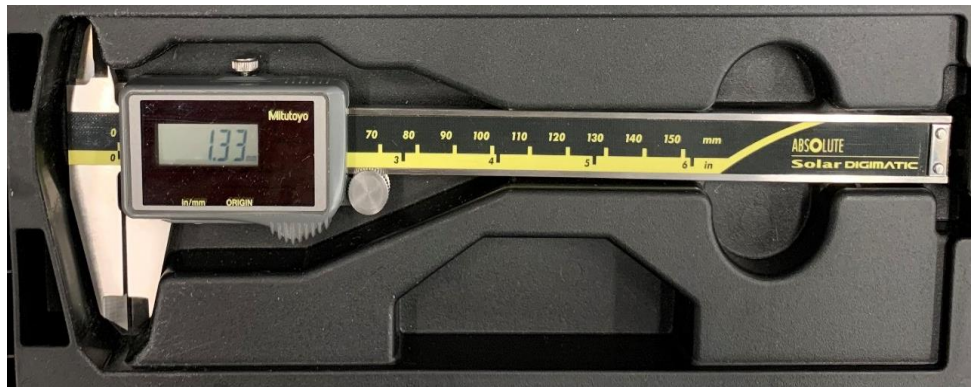
The width and thickness of each specimen gauge section were measured using a Mitutoyo Corporation digital micrometer (shown in Figure 9) at least three times. The average of these values was recorded for each specimen. These values are essential for determining the specimen's cross-sectional area, which is used in engineering stress calculations.

Figure 9. Mitutoyo Corporation Digital Micrometer

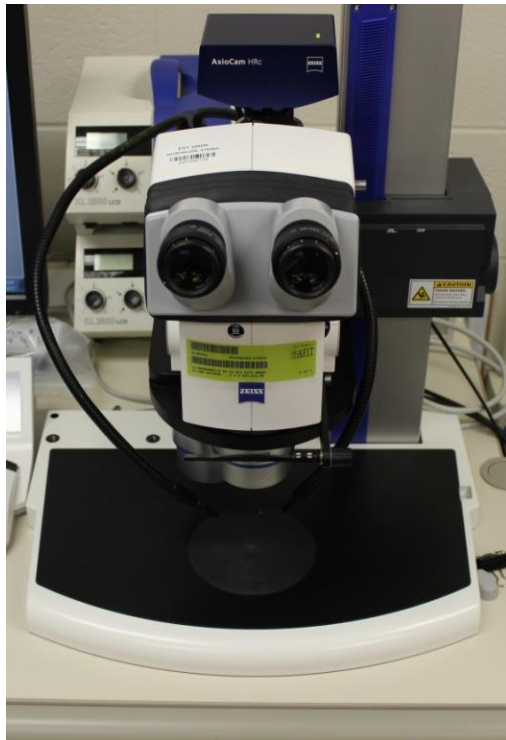
Figure 15. Zeiss Discovery V12 optical microscope equipped with an AxioCam HRc digital camera

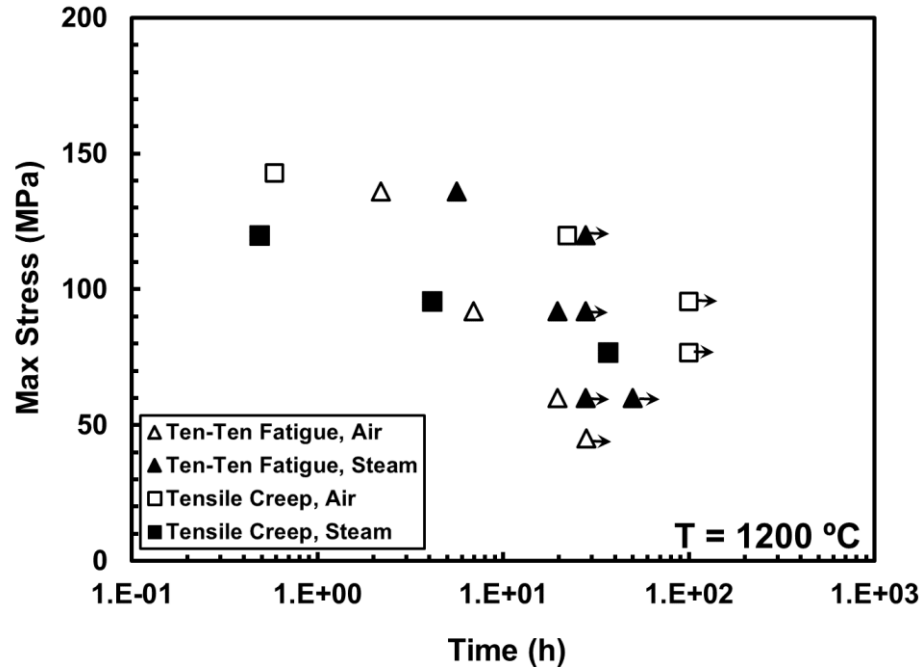
Figure 17. Stress vs. time to failure for N720/AM at 1200°C in laboratory air and steam obtained in tension-tension fatigue and in tensile creep. The arrows indicate that failure of the specimen did not occur when the test was terminated. Creep-rupture data from Genelin [22]. All data are adjusted for $V_f = 0.385$.

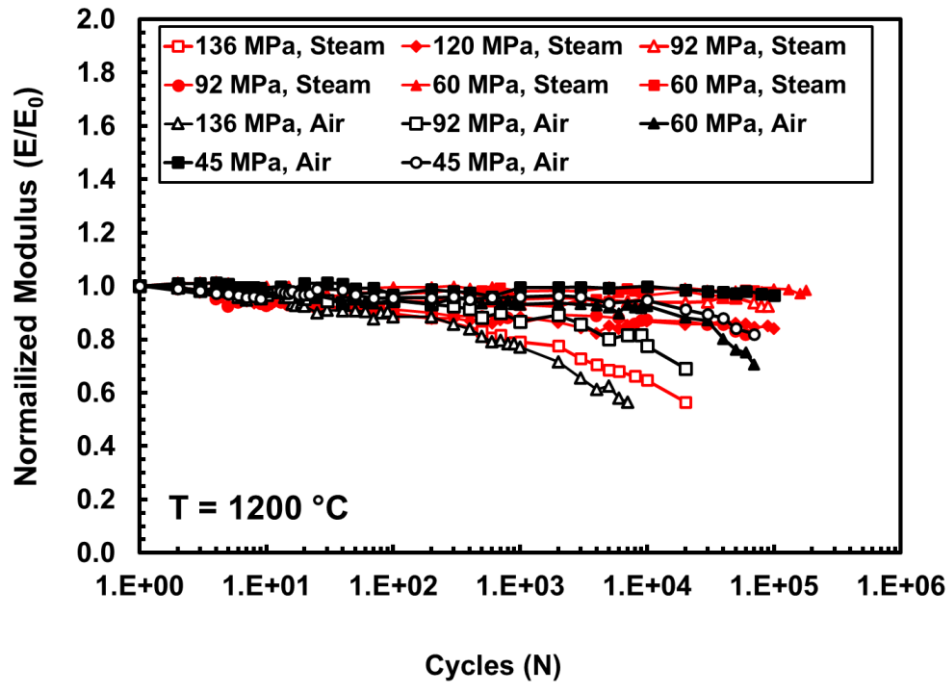
Figure 18. Normalized modulus vs. cycles for N720/AM at 1200°C in air and steam

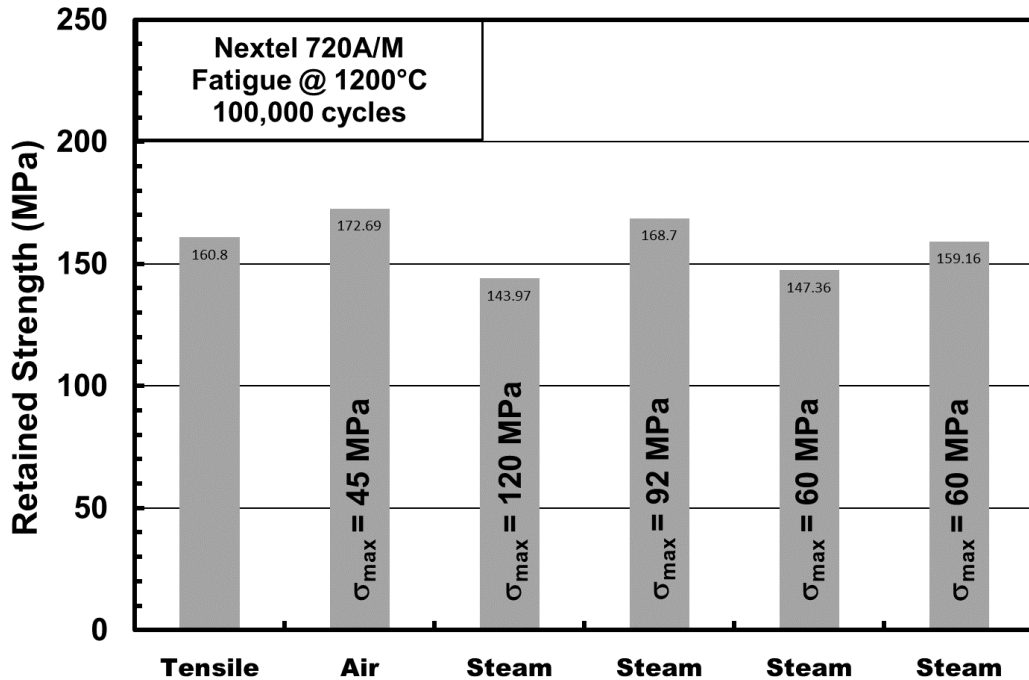
Figure 22. Retained tensile strength of N720/AM specimens subjected to prior fatigue in air and steam at 1200°C

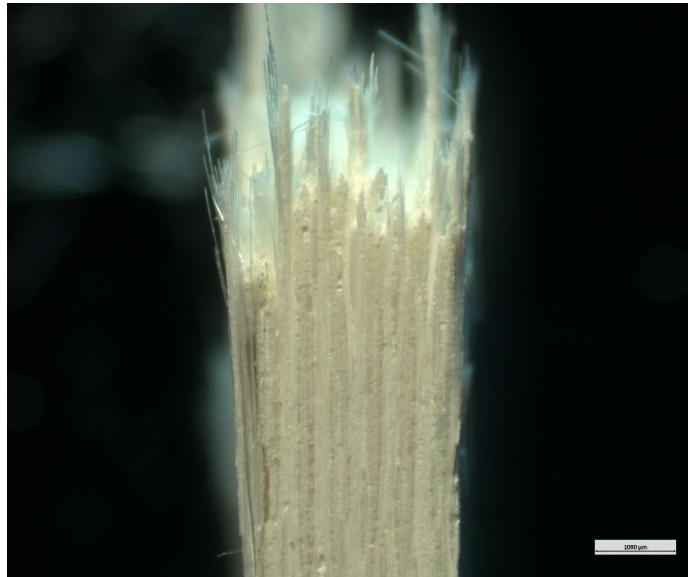
Figure 79. Optical micrograph of the fracture surface of N720/AM specimen tested in tension-tension fatigue at 1200°C in steam. $\sigma_{\max} = 60$ MPa, $N_f > 100000$.
