Air Force Institute of Technology

**AFIT Scholar**

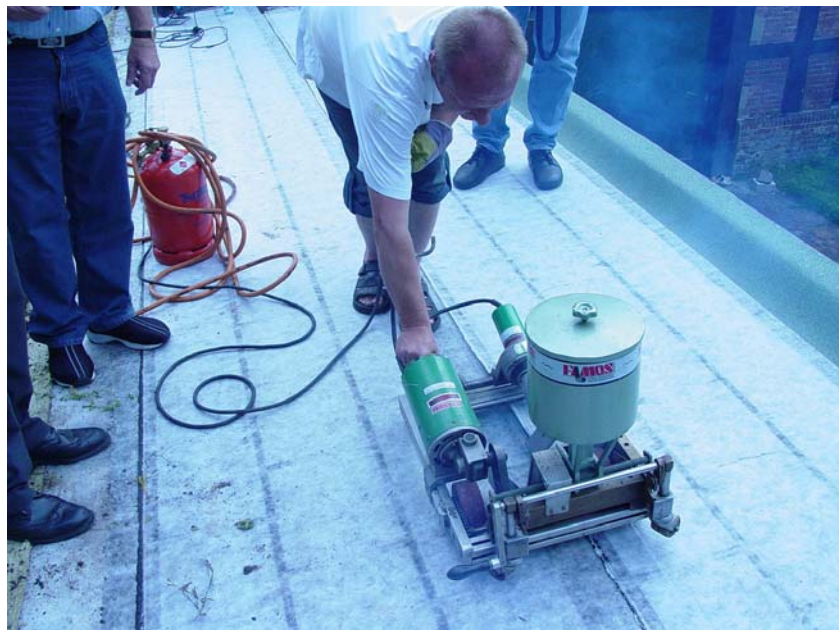
Figure 2.5 Famogreen Ret. This water proofing membrane has inherent root protection and uses gel crystals to provide water retention capabilities.

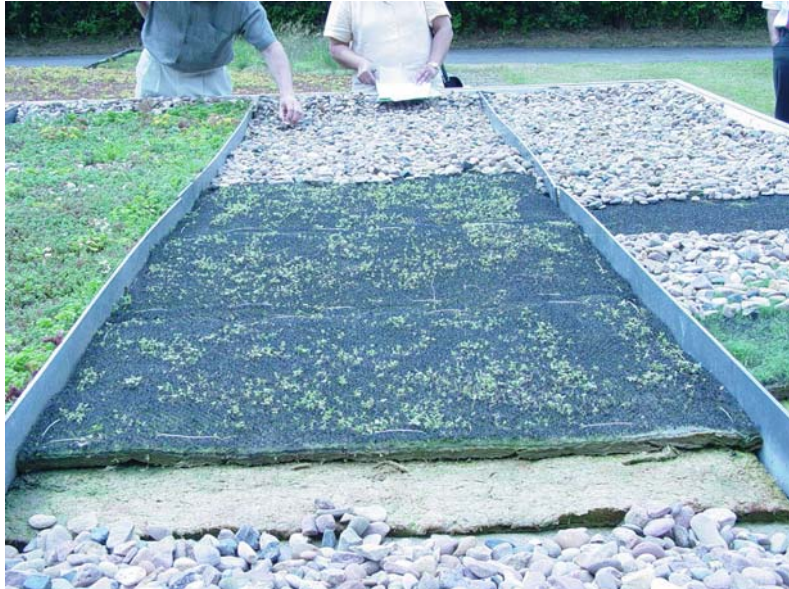
Figure 2.6 Soil-less plants. Xeroflor's seed-impregnated mats. Plastic mesh covers seed impregnated mats; pebbles cover others; pre-grown mats grow without soil as well.

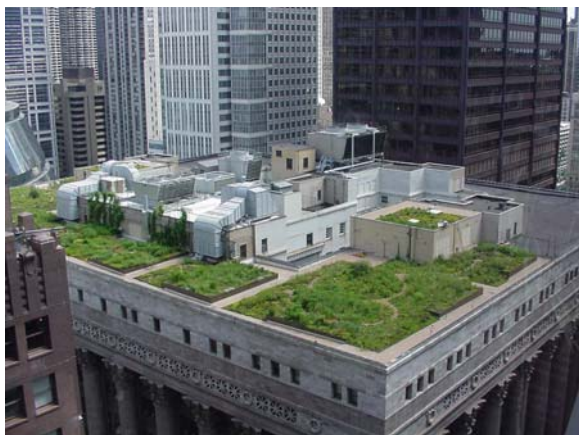
Figure 4.2 Chicago City Hall Green Roof. Note the black roof on the county's portion of the building in the back right.

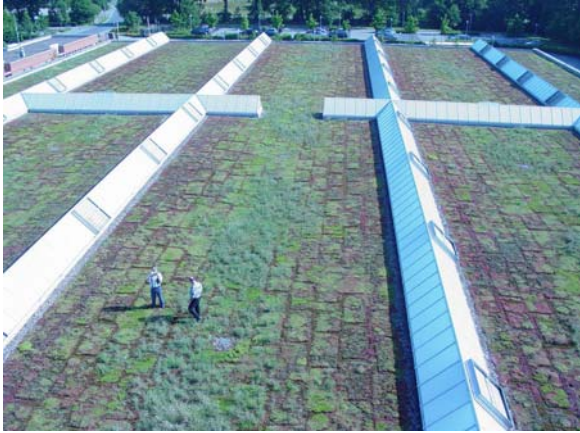
Figure 4.9 Oldenburg Bus Station. Atypical roof. Vegetated mats made with coconut fibers that later shrunk leaving gaps between the mats. Gaps filled in with mosses.

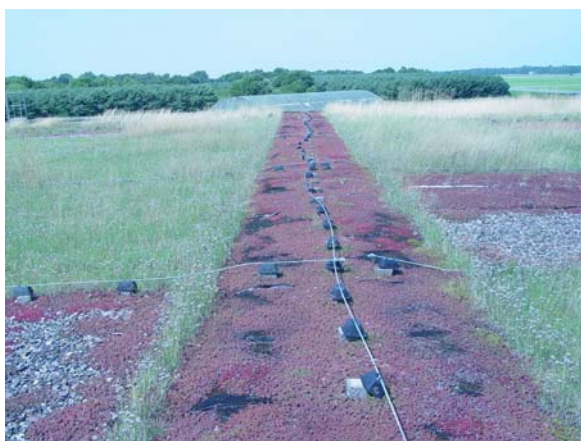
Figure 4.19 Building 3. The Building 3 roof has varying conditions such as exposed gravel, no soil, and multiple soil depths.

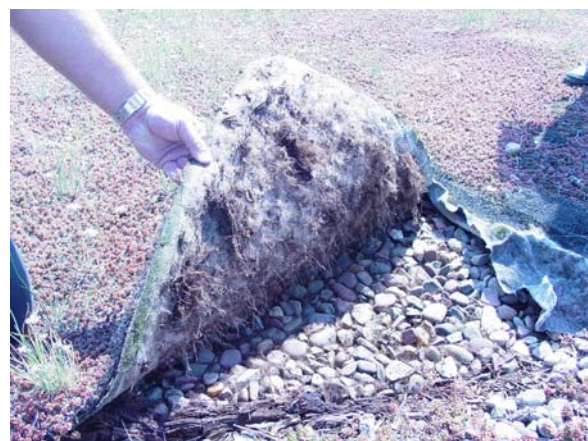
Figure 4.20 Building 3. Only sedums remain on the portions of the roof with only gravel and no soil.

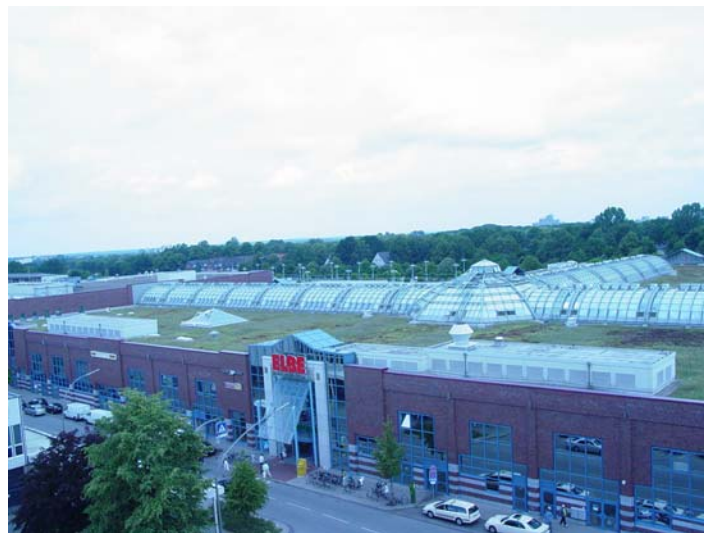
Figure 4.26 Elbe Center Department Store. The cooling benefits of the roof and the ventilation from the open skylights eliminates the need for air conditioning.

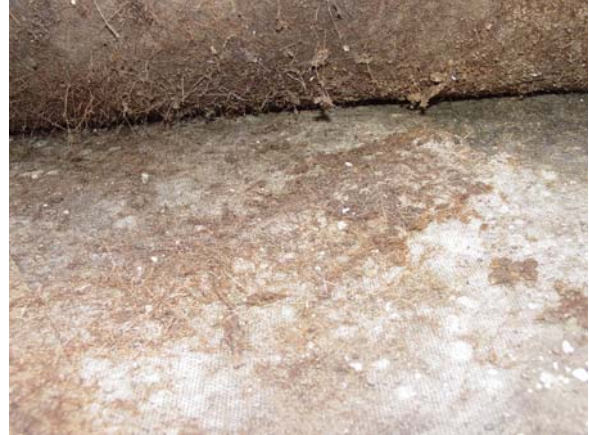
Figure 4.28 WIRO GmbH Roof. Slender sedum roots can be seen on the bottom of the vegetated mats and broken off on the Famogreen Ret membrane underneath the mats. Roots grow through the white fabric to reach the water retaining gel crystals below.

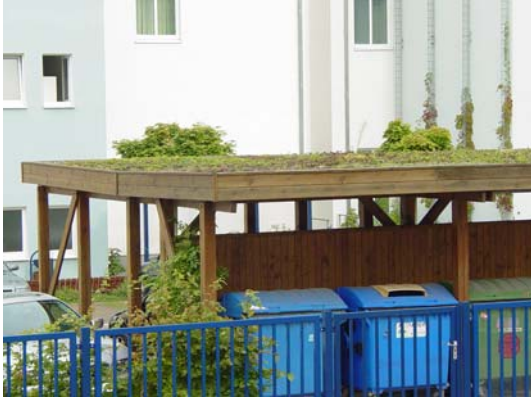
Figure 4.29 Green Roof Shed. Green roofs are installed on refuse sheds in Rostock, Germany to retain rainwater and reduce the “rain tax” Germans pay for storm water runoff. This roof is located a short distance from the WIRO roof.

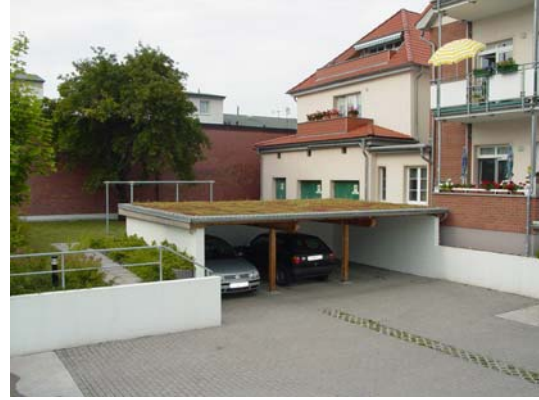
Figure 4.30 Green Roof Carport. Green roof over a carport – reducing storm water runoff.
