Monotonic, Creep-Rupture, and Fatigue Behavior of Carbon Fiber Reinforced Silicon Carbide (C/SiC) at an Elevated Temperature

THESIS

AIR FORCE INSTITUTE OF TECHNOLOGY

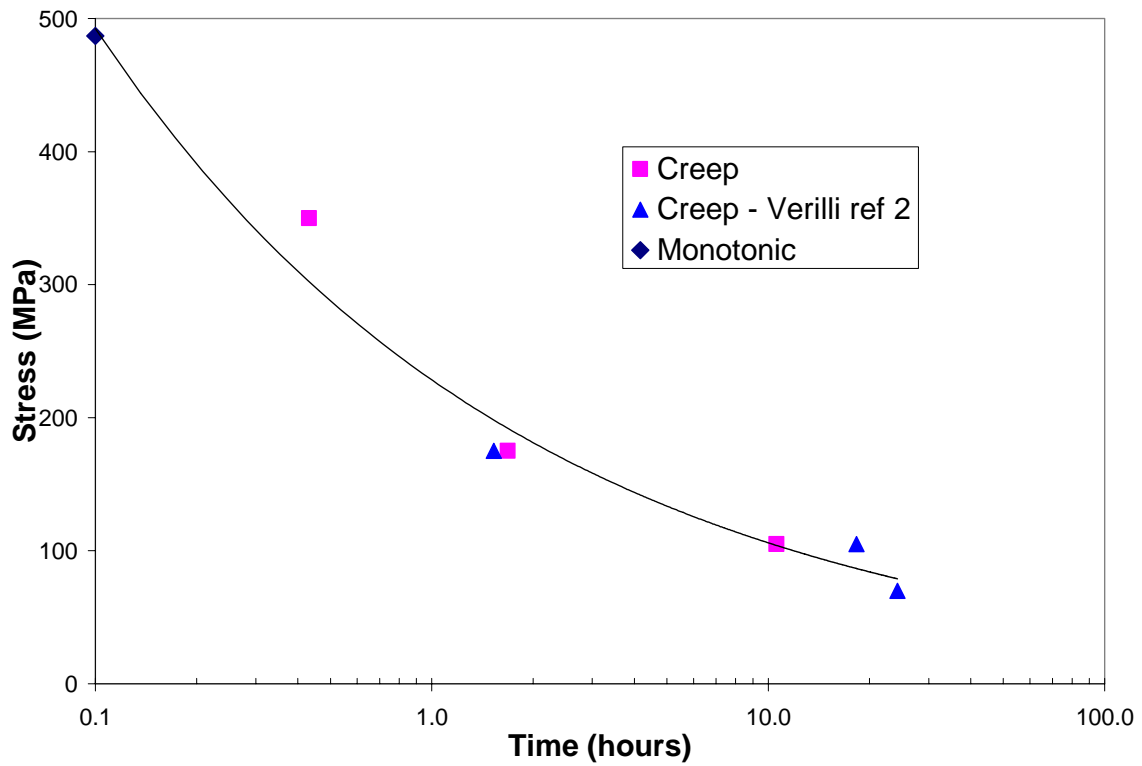
Figure 4-2. Maximum Stress vs. Time to Failure of Creep-Rupture Tests

Figure 4-3. Maximum Stress vs. Time to Failure of Creep-Rupture Tests (log scale)

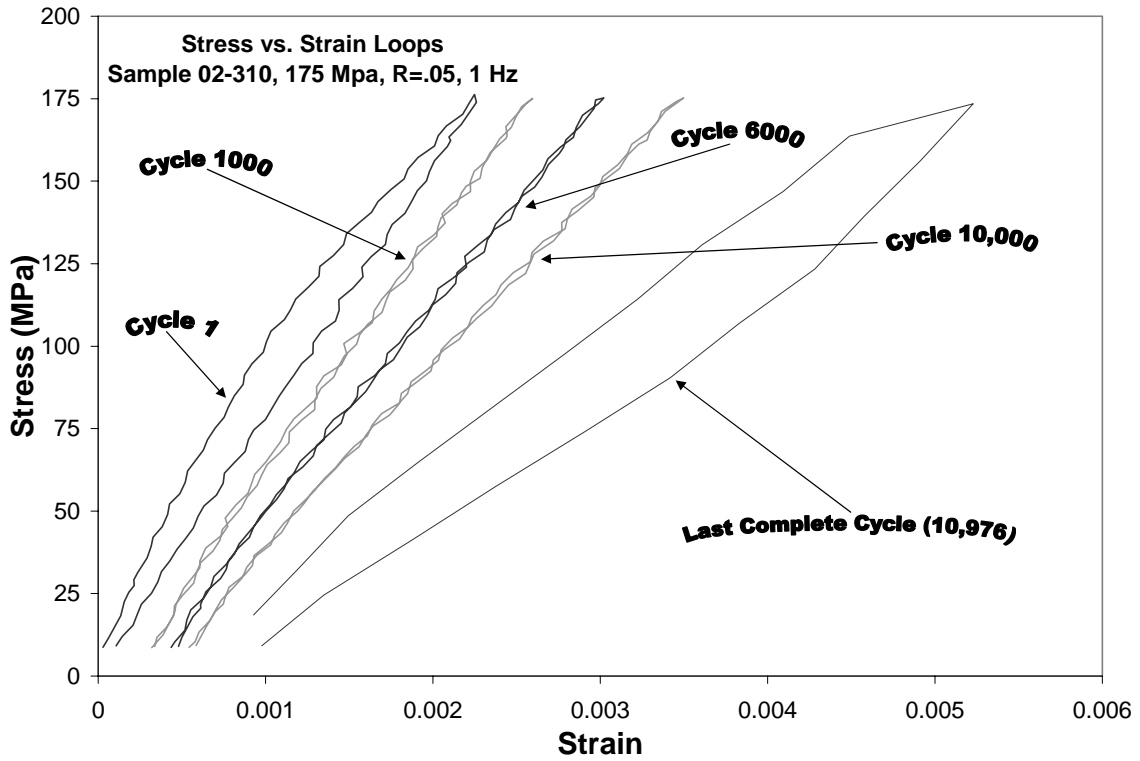
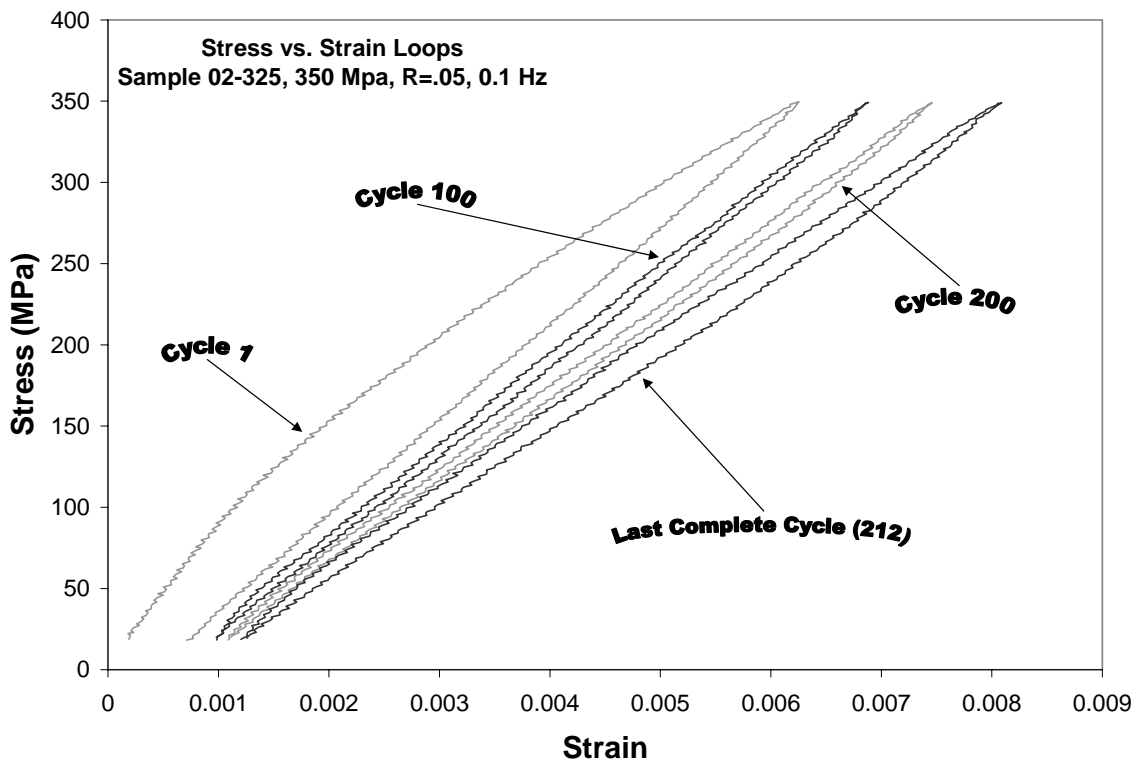
of the fatigue loading. Dramatic changes in the first few cycles occur because the C/SiC composite begins to experience fiber debonding and an increase in matrix cracks. The changes in the stress-strain loops during the last few cycles occur because the composite is beginning to show signs of failure.

Figure 4-9. Stress-Strain Loop (0.1 Hz, 105 MPa)

Figure 4-10. Stress-Strain Loop (1 Hz, 175 MPa)

Figure 4-11. Stress-Strain Loop (0.1 Hz, 350 MPa)

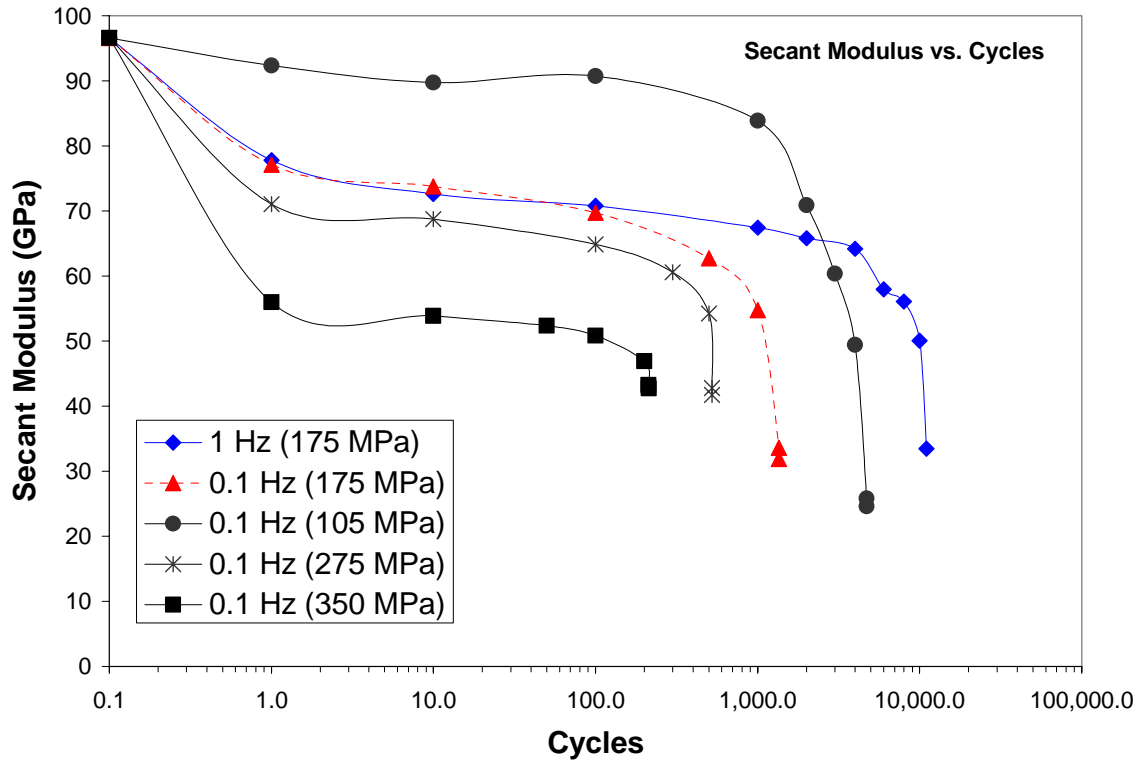
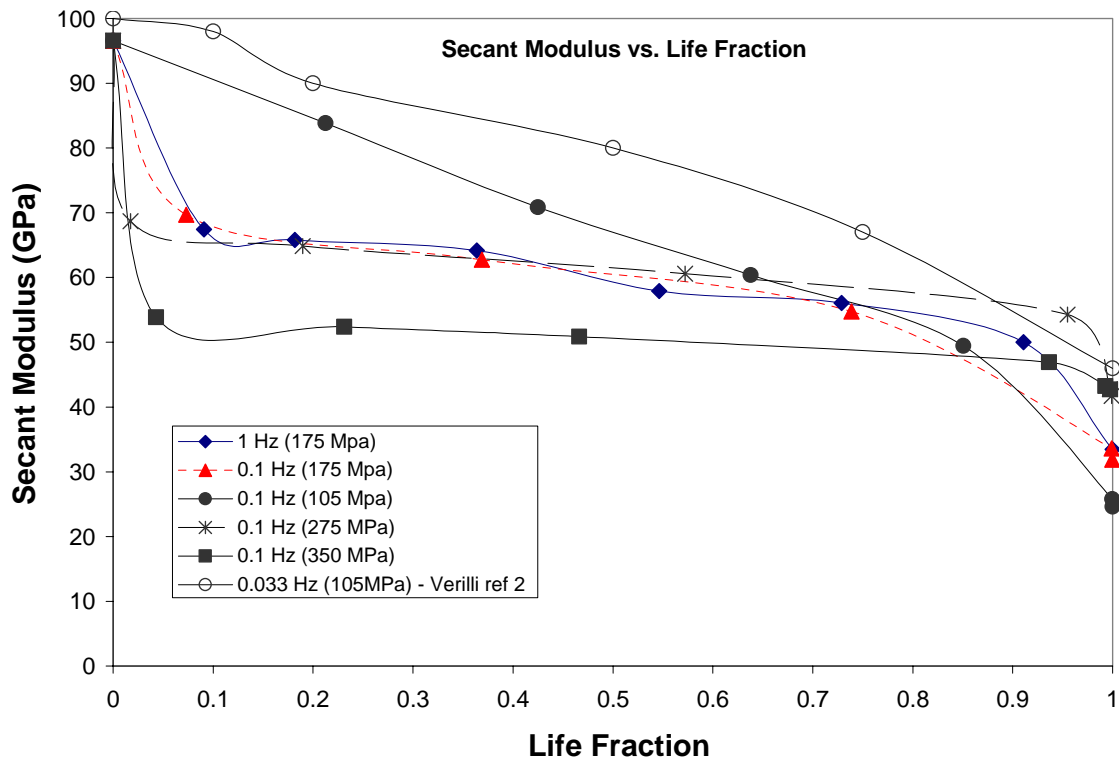
begins to drop rapidly. The high stressed fatigue samples (275 MPa and 350 MPa) maintain their original stiffness because oxidation does not occur to a great extent within these samples. Thus, modulus degradation is less in the high stressed fatigue samples and more in the low stressed fatigue samples.

Figure 4-14. Secant Modulus vs. Cycles at 550°C

Figure 4-15. Secant Modulus vs. Time at 550°C

Figure 4-16. Secant Modulus vs. Life Fraction at 550°C

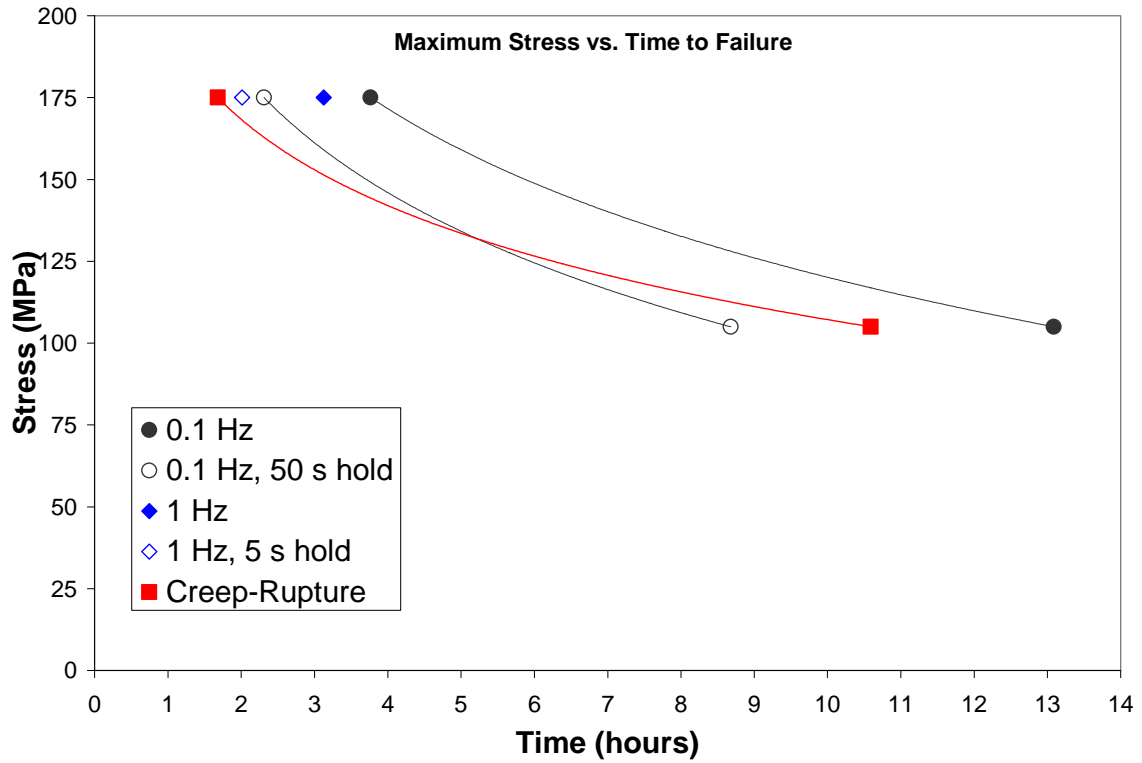
A straightforward way to compare the combination, creep-rupture, and fatigue data in Table 4-3 is to display a plot of maximum stress versus time to failure. The plot of this data is given in Figure 4-17(a) for the given tests. A bar graph also displays the same data in Figure 4-17(b).

Figure 4-17(a). Maximum Stress vs. Time to Failure of the Tests in Table 4.3

Figure 4-17(b). Bar Graph Displaying Time to Failure of the Tests in Table 4.3

with time. The 0.1 Hz (105 MPa) combination sample and the 0.1 Hz (105 MPa) sample last longer as seen from Figure 4-17. Therefore, they degrade more than the higher stressed samples.

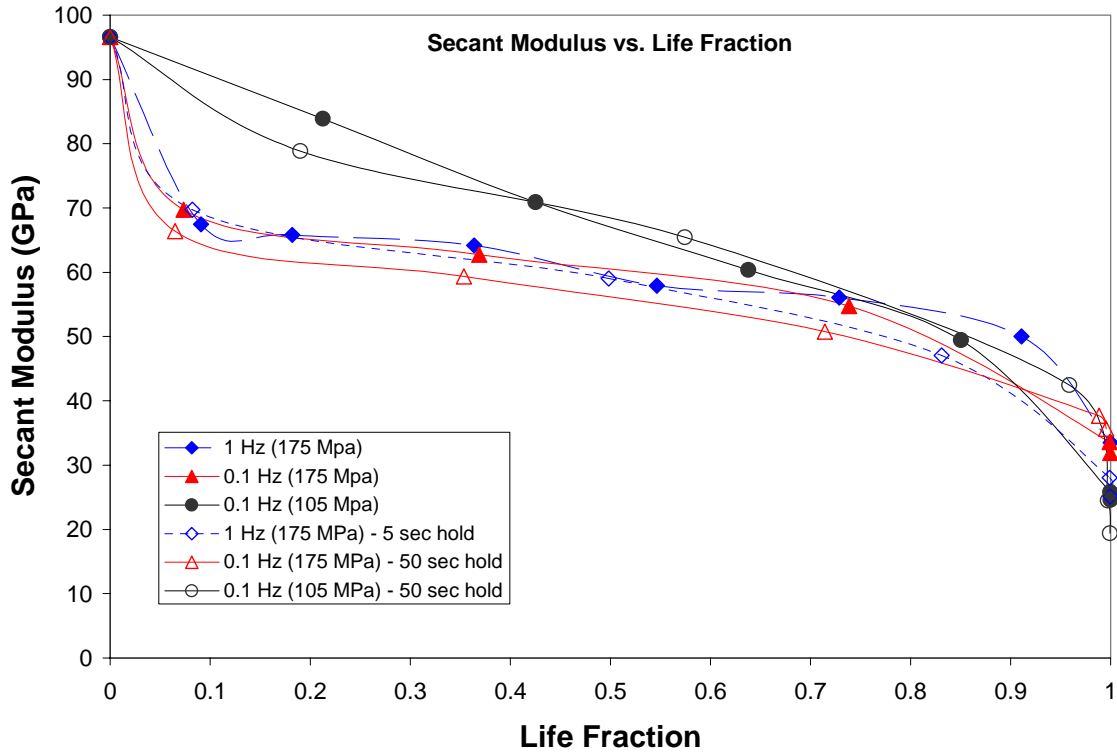
Figure 4-19. Secant Modulus vs. Life Fraction – Combination Tests
