Report on
HYDRAULIC MODEL TESTS
FOR
RIHAND DAM

Civil Engineering Section
Colorado Agricultural Experiment Station
Fort Collins, Colorado

International Engineering Company, Inc.
74 New Montgomery Street
San Francisco, California

April, 1950

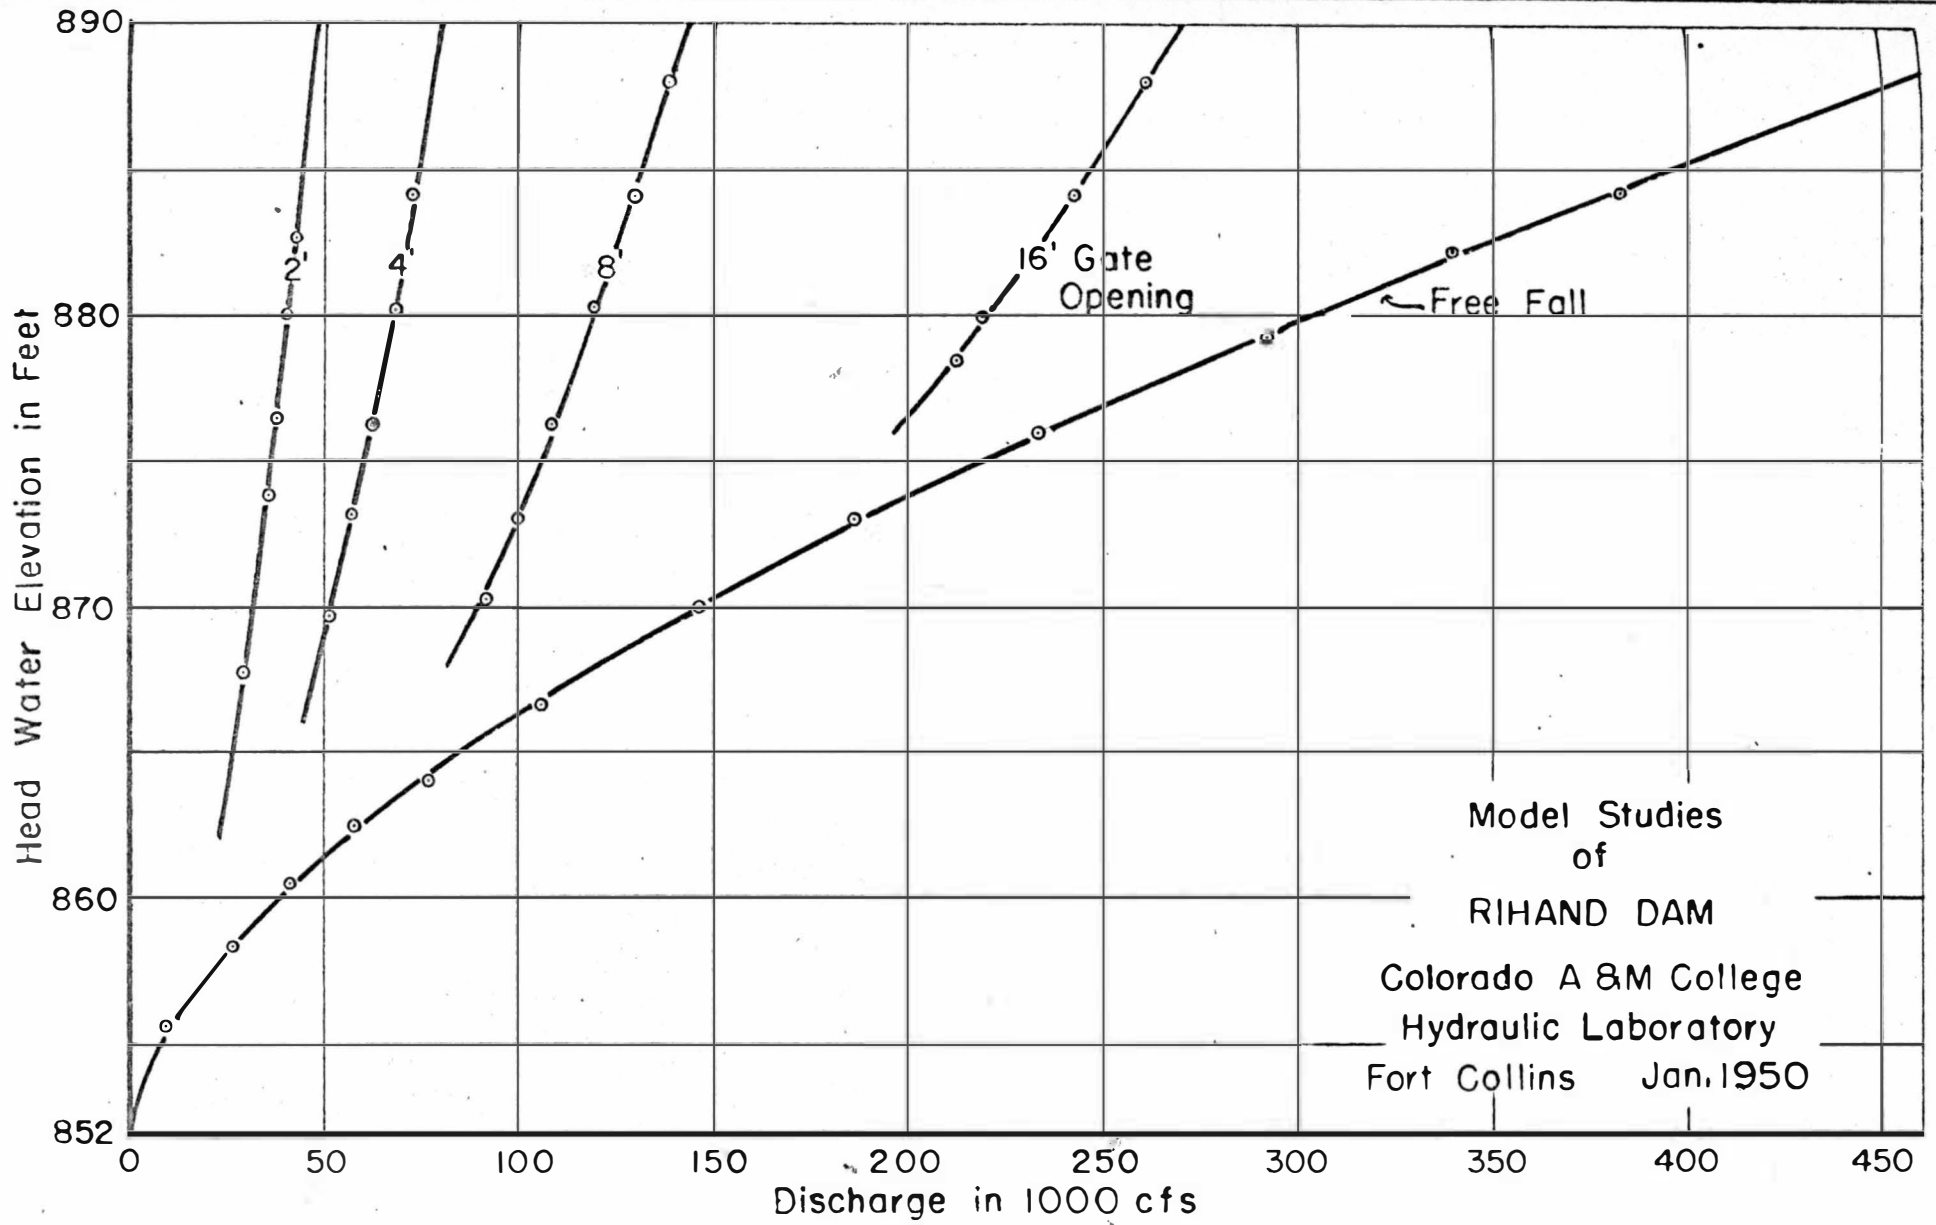
Variation of Discharge with Head Overfall Spillway.

Spillway Capacity: The capacity of the overfall spillway was determined for a range of headwater from Elevation 852.0 (top of crest) to Elevation 888.0. Free discharges over the crest and discharges through partially raised gates were measured. The gates were opened uniformly at all times. With reservoir at Elevation 880.0 and tainter gates fully raised, the spillway capacity was found to be 304,000 cfs. With reservoir at maximum flood stage, Elevation 888.0, the discharge was found to be 454,000 cfs.

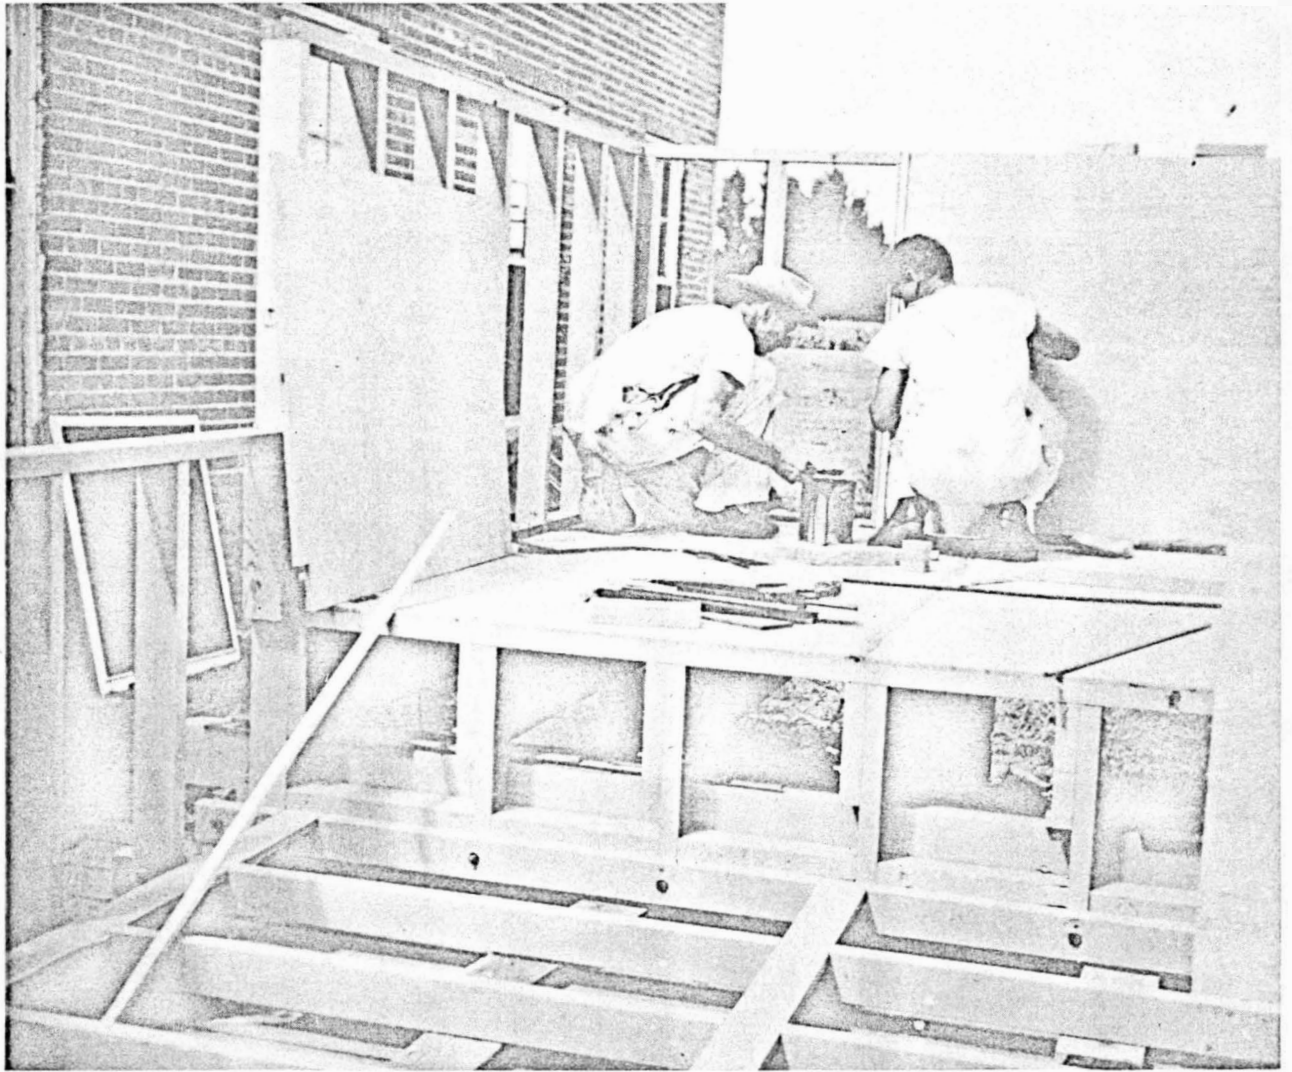
PLATE 1
Construction Details - Head Box and Tail Box
Plywood Wall Panels being Placed
1:72 Complete Model

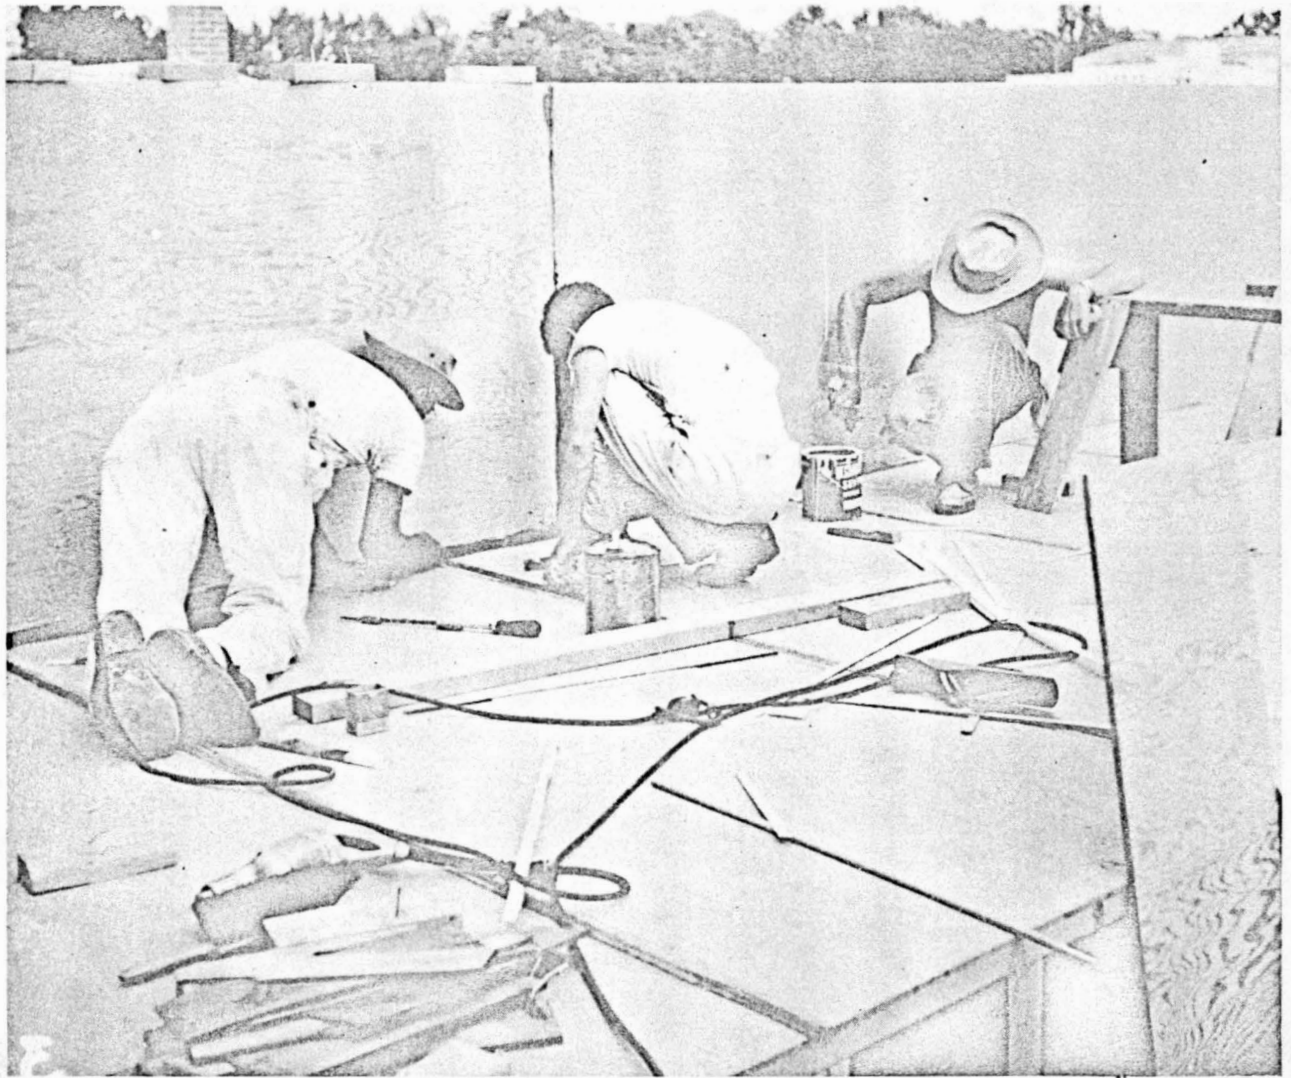
PLATE 3
Construction Details - Head Box
Joint Construction with Waterproof Rubber Seal

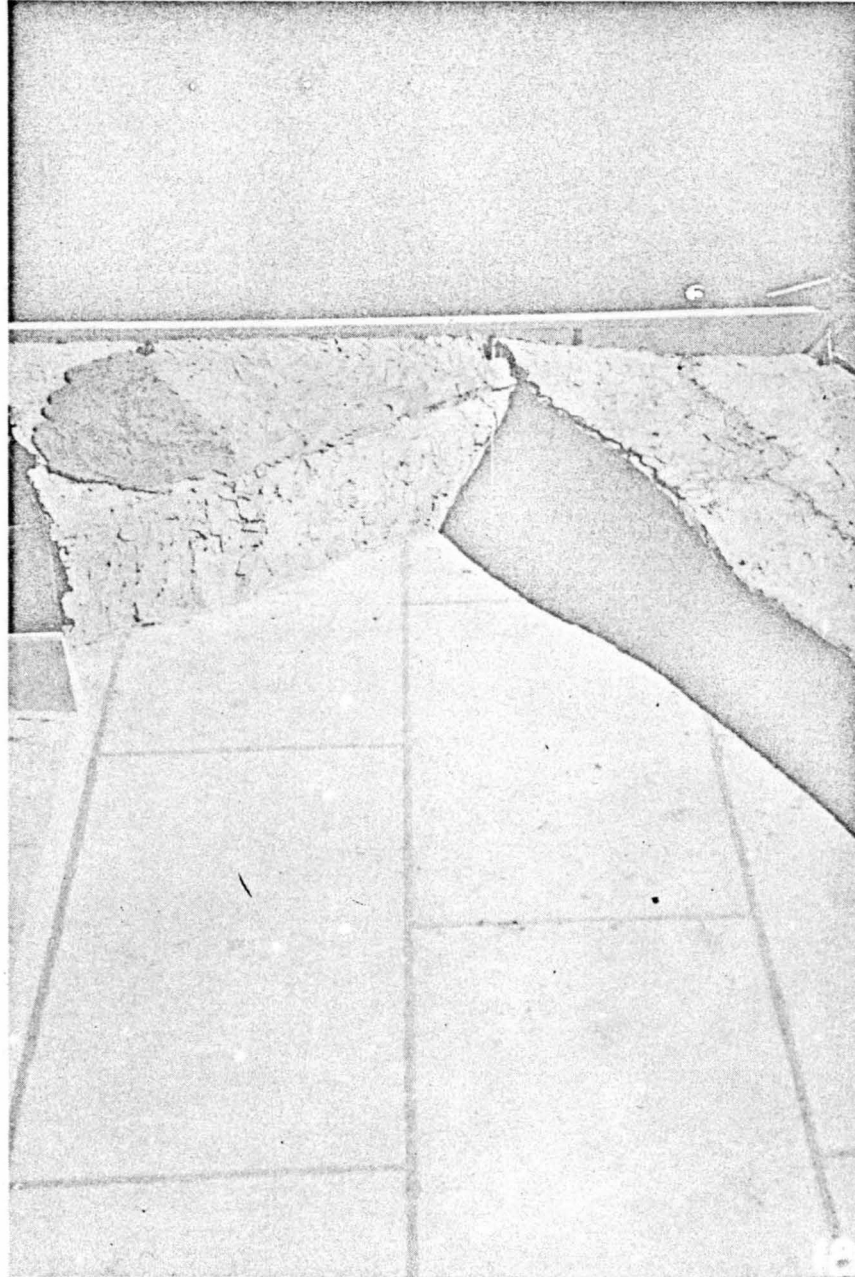
PLATE 12
Construction Details - Tail Box
Topography Templet Framing
Scratch Coat and Finish Coat Application

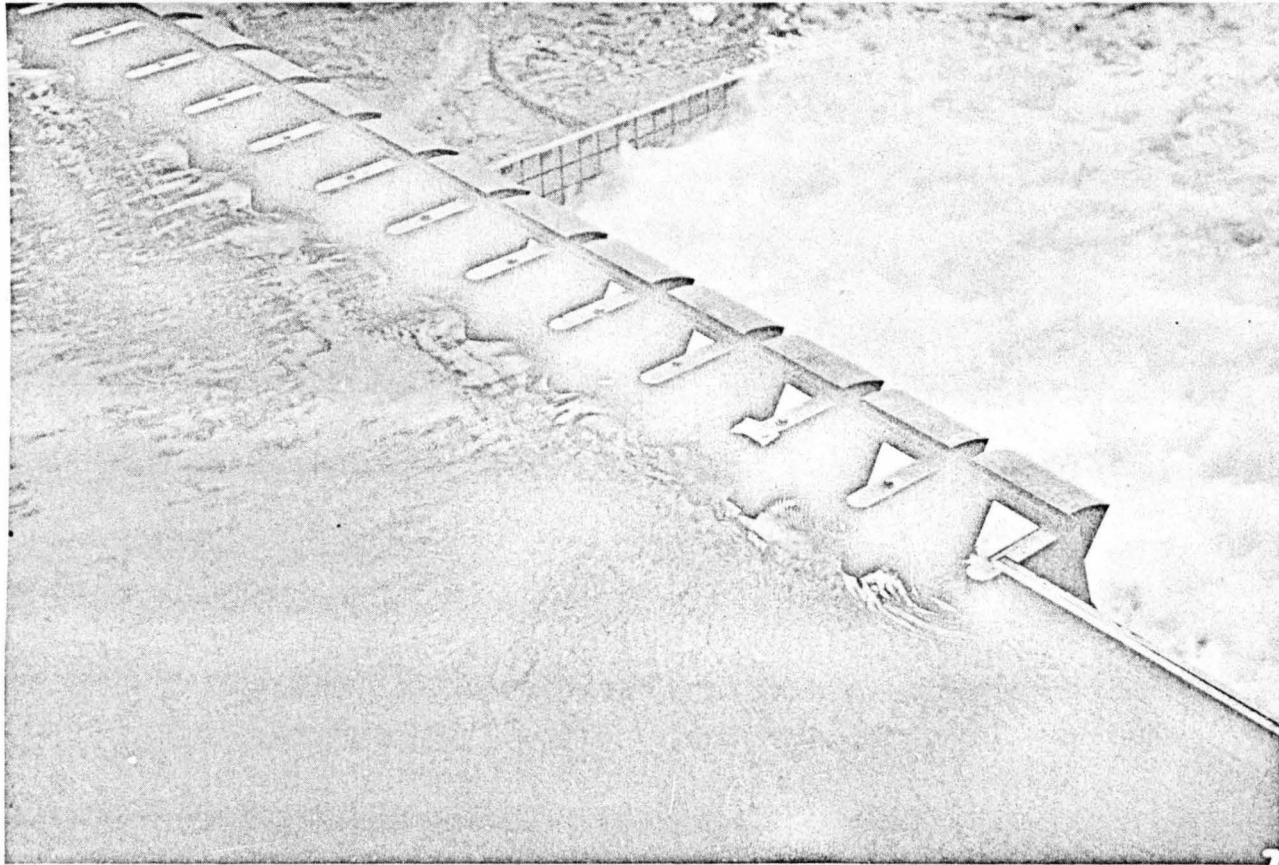
PLATE 16
Flow Patterns - Overfall Spillway
Approach and Drawdown at Piers - Side View
HW Elev 888.1 - $Q = 455,000$ cfs, Spillway Flow Only

For low and medium discharges the flow condition near the spillway piers was satisfactory. However, as the flow was increased, the drawdown at the piers increased until, at a discharge of about 450,000 cfs, the surface became very irregular. A depression was formed around the pier noses as shown on Plates 15 and 16. Except at the end piers, this was of no particular concern. Since the piers project 7-1/2 feet upstream from the face of the adjoining non-overflow section, there was considerable flow of water around end piers into the spillway. Thus, much of the flow entering the end bays was forced to turn on a very small radius and accelerate at the same time. The result was a contraction in the flow and a considerable depression of the water surface around the end piers as shown on Fig. 12. Although the reduction in overall capacity caused by the depressed water surface was minor, there

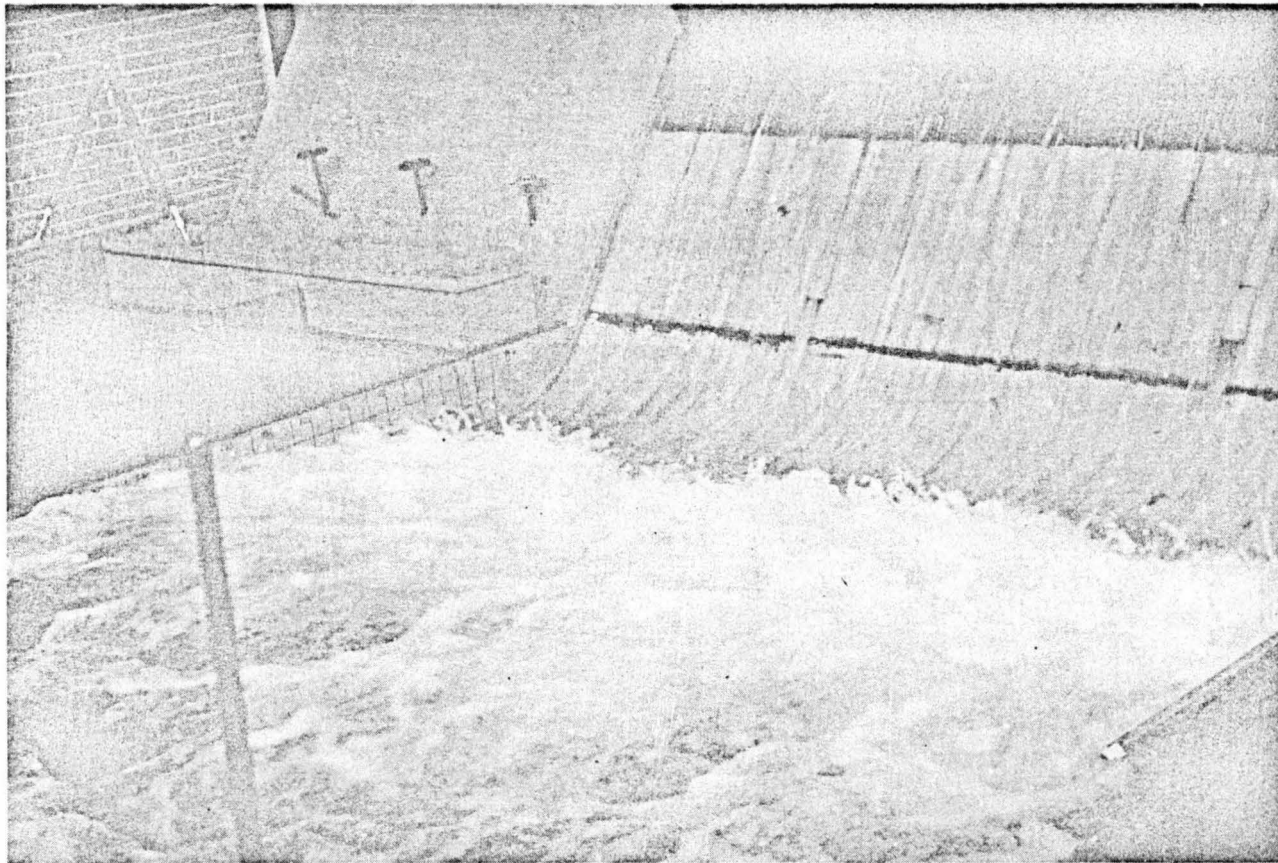
PLATE 18
Flow Patterns - Overfall Spillway
HW Elev 888.1, $Q = 455,000$ cfs, Spillway Flow Only

Certain water-surface profiles were recorded as shown on Fig. 17 and 18. Flow patterns and water-surface profiles in the stilling basin were photographed and are shown on Plates 17 to 27 inclusive. An inspection of the profiles in the stilling basin shows that for 477,000 cfs, the maximum discharge used in the tests, and with tailwater at Elevation 679.7 (about 1.3 ft below normal), the training walls were overtopped by wave action, (See Plate 17). The inflow, however, was so slight that it had no measurable effect on the efficiency of the stilling basin. When the tailwater was raised to Elevation 689.7, about 8.7 feet above normal level for this discharge, there was a head of 10.7 feet over the top of the walls. Even this amount of inflow at the sides of the basin was found to reduce the efficiency of the basin but little. Since maximum floods are rare, it seems reasonable to assume that the height of the training walls could be somewhat reduced without detrimental effects.

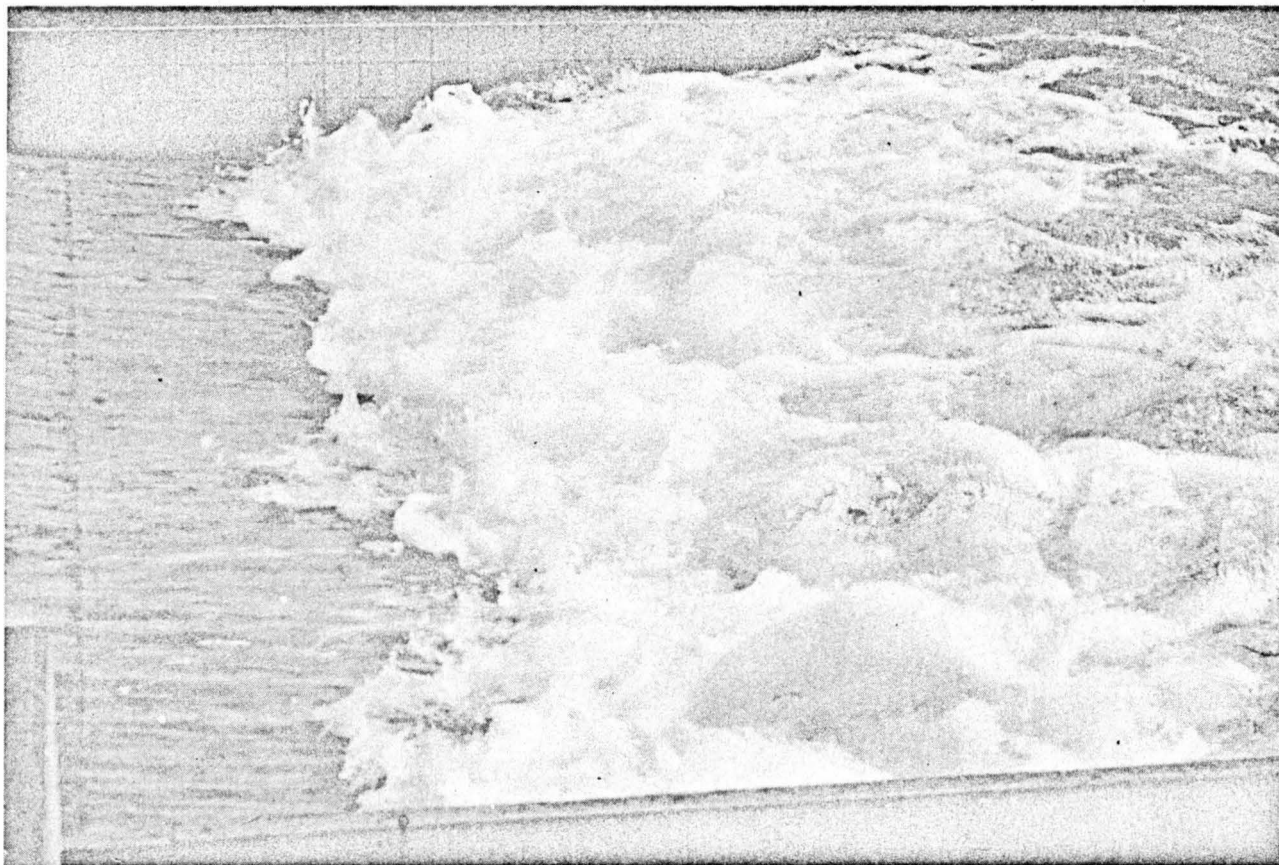
PLATE 20
Water Surface Profiles - Stilling Basin
Tail Water 11.1 Feet Below Normal
HW Elev 880.1, TW Elev 661.5, $Q = 334,500$ cfs

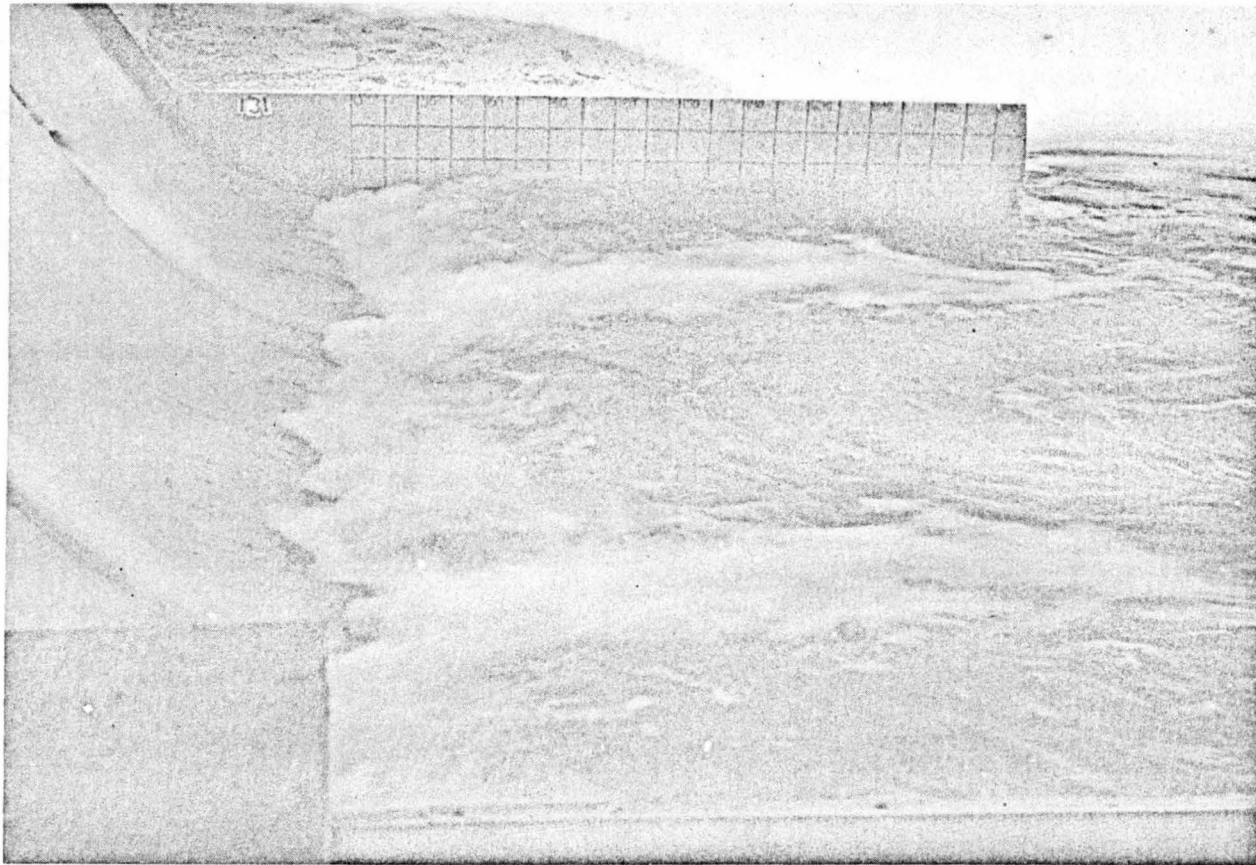
PLATE 23
Flow Patterns - Stilling Basin
Effect of Sluice Operation on Stilling Basin Performance
HW Elev 880.5, TW Elev 664, $Q = 69,500$ cfs

For total discharges of 69,500 cfs and less (See Plate 23) the effect of sluice operation was manifested by increased disturbances in the stilling pool flow pattern. The water surface profile became irregular and the force of the concentrated sluice jets caused two indentations at the toe of the jump. This resulted in some instability of the hydraulic jump.

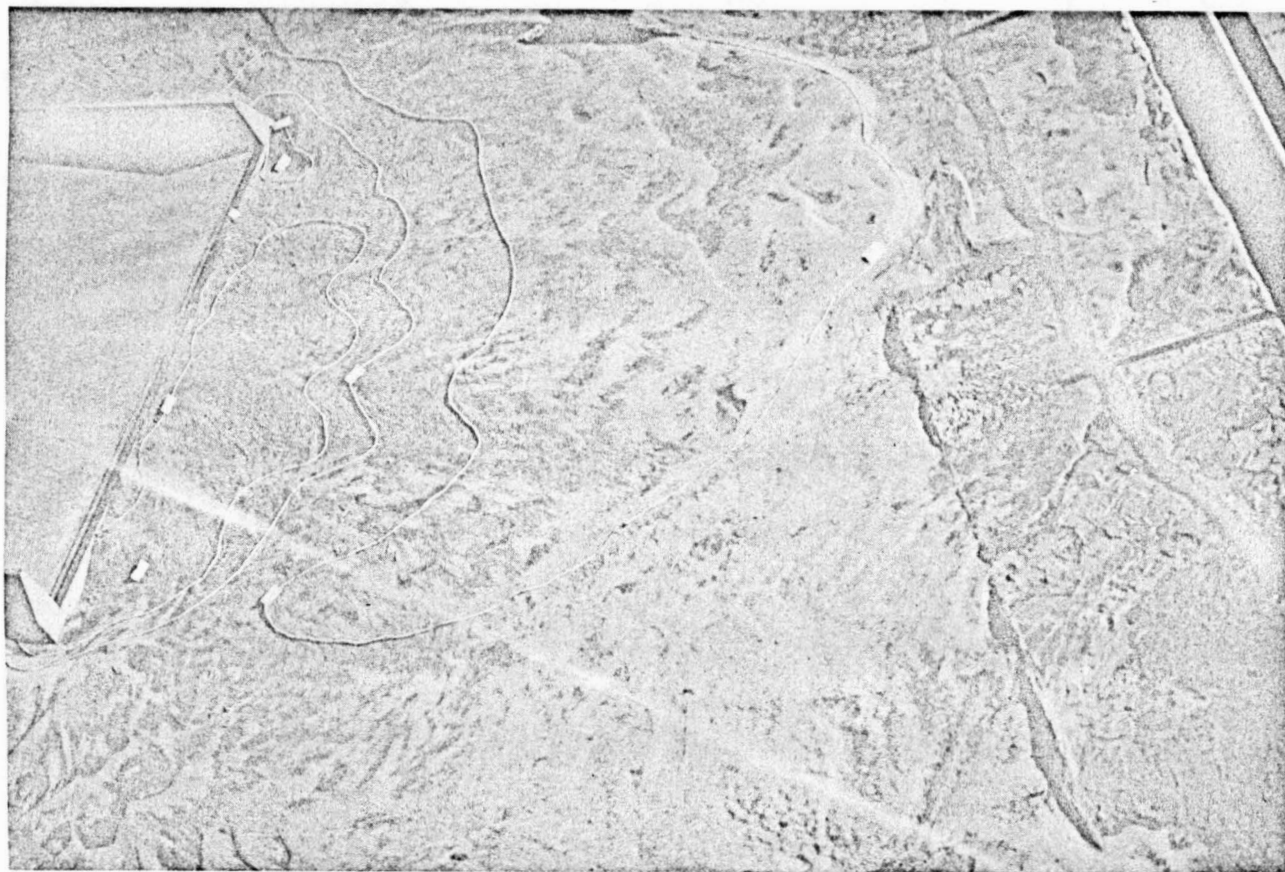
PLATE 28
Erosion Tests - River Channel
Bed Movement Downstream from Stilling Basin
Side View
HW Elev 887.6, TW Elev 679.7, Q = 477,000 cfs

Erosion at the end of the apron was moderate regardless of the discharge or tailwater condition tested. Even for a discharge of 477,000 cfs, there was no undermining of the apron or training walls. Erosion tests are summarized in Table III.

The deepest erosion occurred at the end of each spillway training wall and was the result of a subsurface eddy. Flow leaving the end sill was directed upward, inducing a cross current moving inward under the main flow. At the right wall, the river bank was sufficiently far removed to permit this eddy to develop fully. On the left side, due to the proximity of the bank, only a weak current was observed.

Generally, as may be seen from Table III, extent of erosion decreased with a decrease in discharge. With a flow of 477,000 cfs, the maximum depth of erosion occurred at the right training wall and was 32 feet below the top of the end sill (See Plates 28, 29, and 30). As stated before, due to the smaller eddy developed at the left training wall, the erosion was considerably less than at the right wall. Two additional areas of erosion developed in the channel immediately downstream from the sill and were caused by the two jets of flow from the sluices (See Plate 29). These twin scour channels were approximately 300 feet long, 100 feet wide and 15 feet below the top of the end sill at their deepest points.

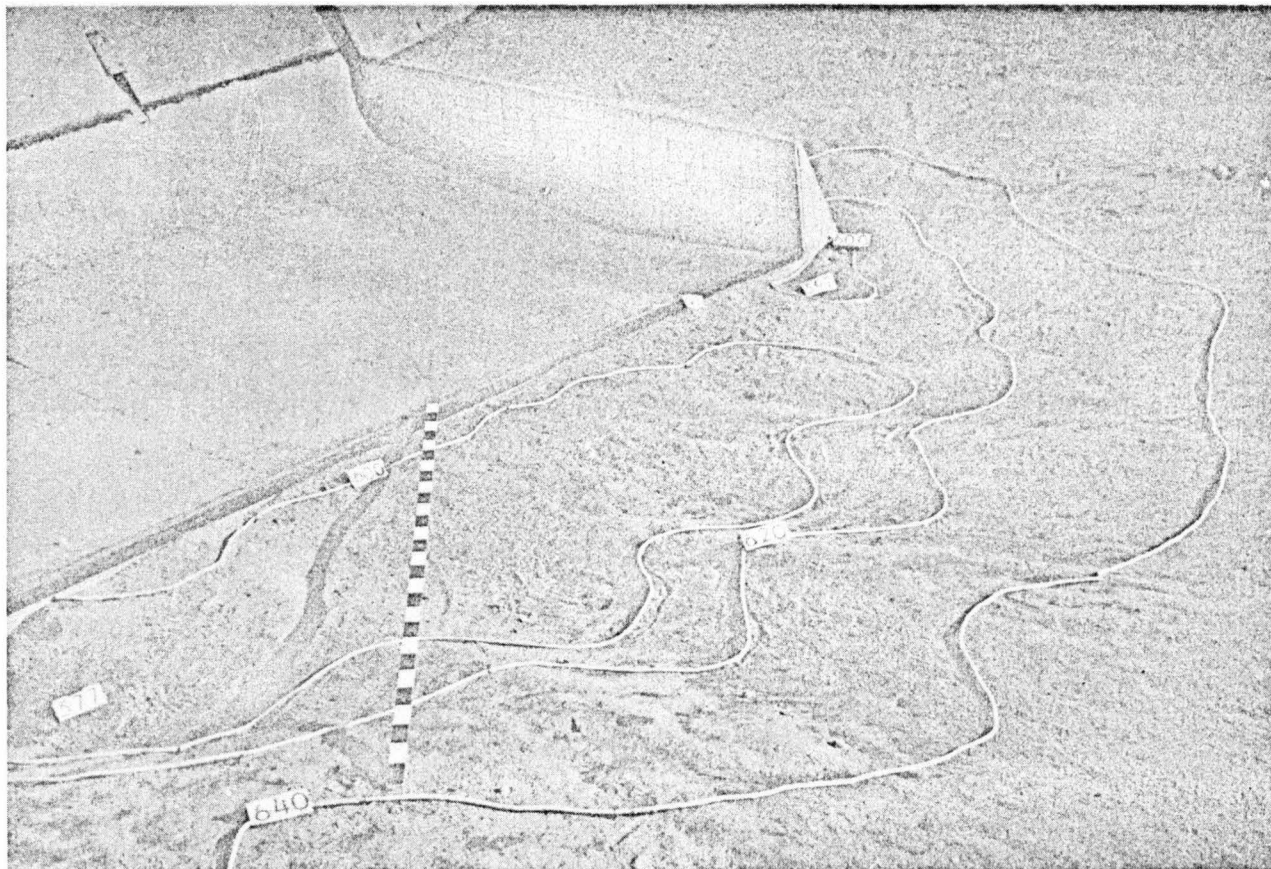
PLATE 29
Erosion Tests - River Channel
Bed Movement Downstream from Stilling Basin
Side View
HW Elev 887.6, TW Elev 679.7, $Q = 477,000$ cfs

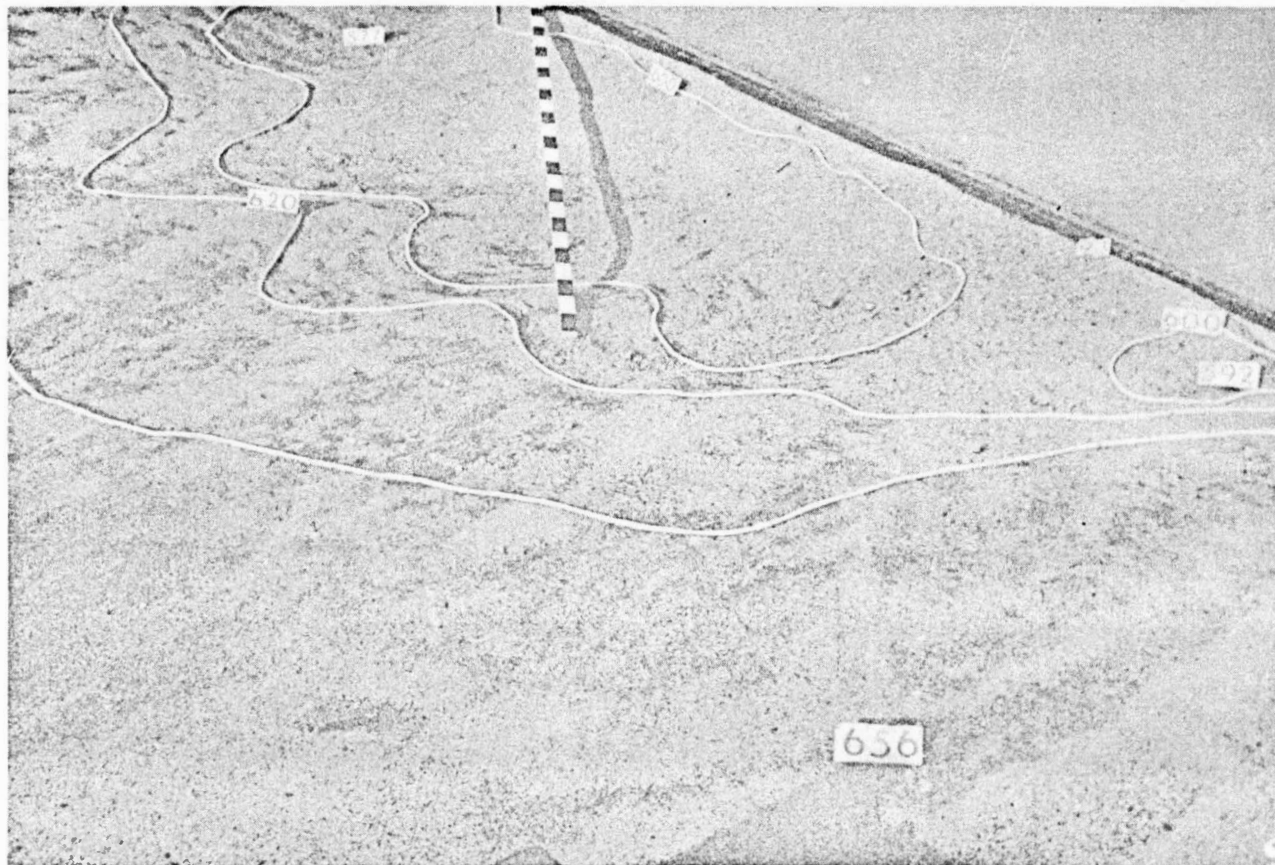
PLATE 30
Erosion Tests - River Channel
Bed Movement Downstream from Stilling Basin
Oblique View from Left Side
HW Elev 887.6, TW Elev 679.7, $Q = 477,000$ cfs

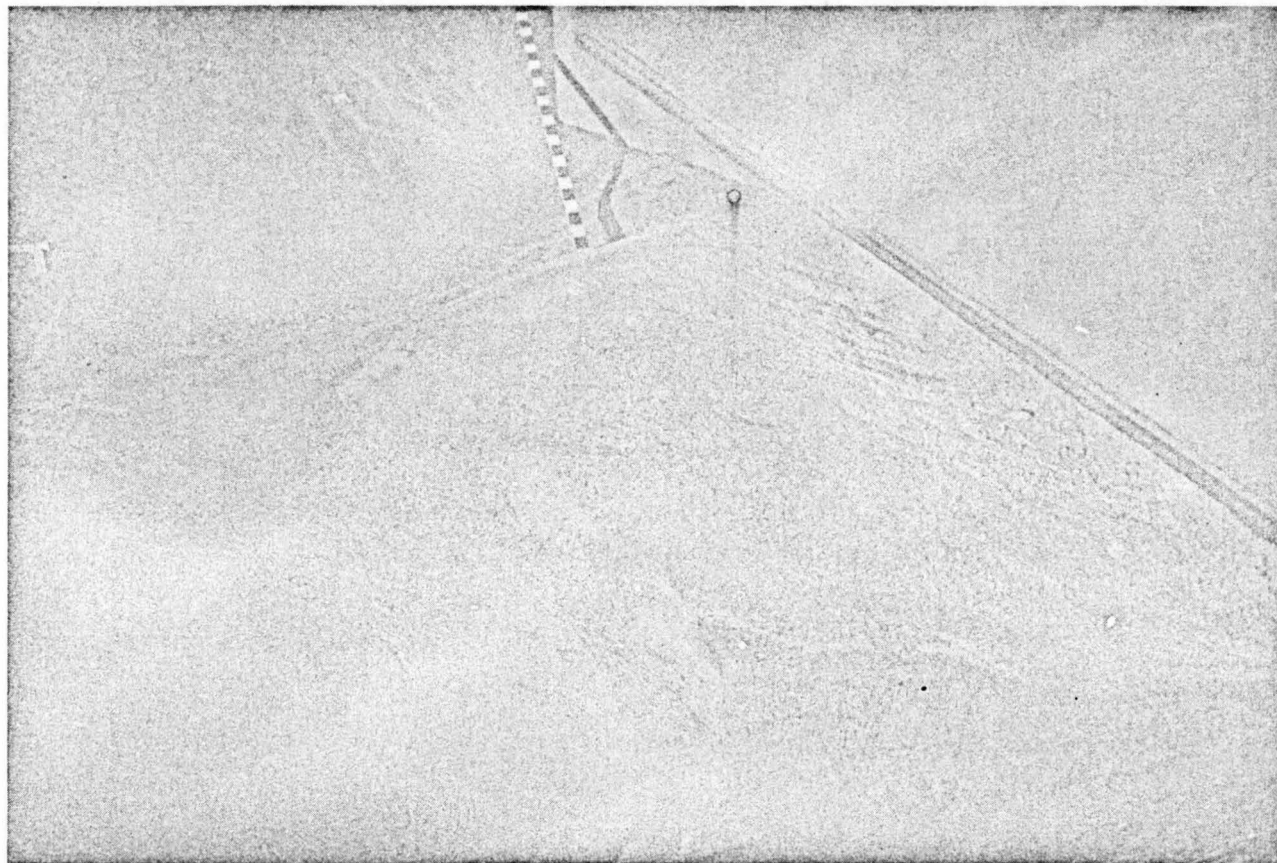
PLATE 33
Erosion Tests - River Channel
Bed Movement Downstream from Stilling Basin
View from Left Side
Gate Operation Schedule - Two Left Gates Closed
HW. Elev 888, TW Elev 685.5, $Q = 390,000$ cfs,
Spillway Flow Only
