FIELD MANUFACTURE AND APPLICATION OF REINFORCED PLASTIC CANAL AND PIPE LININGS

GERALD WESTESEN¹

LEROY PAYNE²

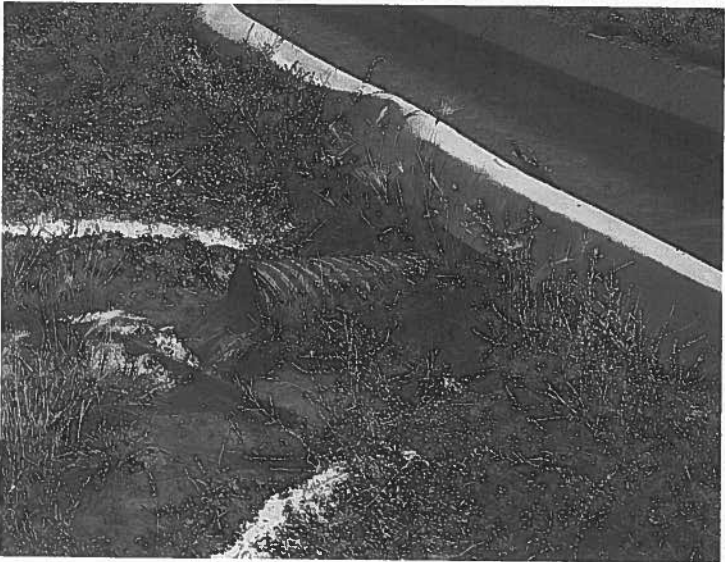
Fig. 1 Plastic lining of a concrete ditch

The second site involved a concrete lined ditch having a bottom width of 25 cm, a top width of 2.4 m, and 1:1 side slopes. A section of the ditch after lining including a metal turnout is shown in Figure 1. The concrete in this ditch had been badly damaged by cracking and corrosion. In some places short sections of concrete were completely missing. The only preparation for lining was shoveling out some sediment

deposits on the ditch bottom. A 400 m section of this ditch was lined with a semi-rigid material. The lining was done in a snow storm and was done quickly with the machine moving continuously and parallel to the ditch. The lining has survived one Montana winter and the ditch is being used for irrigation. In areas where the concrete lining had completely fallen away the plastic used had the strength and rigidity to

build a new ditch bank for short distances. Using this process for lining deteriorating concrete linings appears to have great potential.

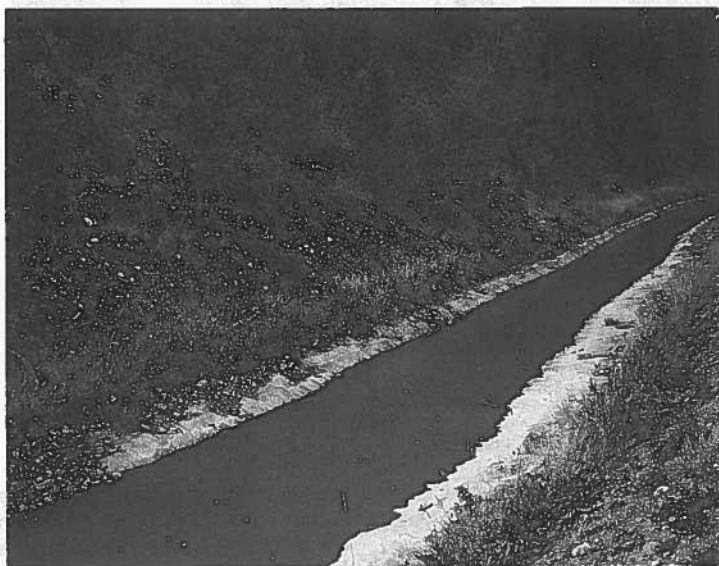
Fig. 2 Plastic lining of a rock/earth canal

The third site lined shown in Figure 2 was on an existing section of canal which traversed a shale hillside about 10 m above a farmer's field. Through this section more than 50% of the flow was lost to seepage. The farmer's field was in effect a swamp with a loss of productivity and a threatened law suit. Attempts had been made for years to make this 10 m wide, 450 m long section watertight. The canal was 150 km from any concrete ready mix plant and the job was too small to justify bringing a plant to the site. Thus concrete was economically precluded. Bentonite had been tried unsuccessfully and simply washed through the rock. Sheet stock plastic would have been

punctured on the sharp rocks, and soil for covering the sheet stock was not available.

The farmers in the area, with some technical assistance, roughly shaped the canal cross section. Using this process the leaky section was lined in a two hour period. The lining was applied in

overlapping straps perpendicular to the canal. The necessary raw material was transported to the site in a small truck. The lining is functioning, leaks and seepage have been eliminated, and the farmer is happy.
