THESIS

INVESTIGATING POTENTIAL GROUNDWATER OUTFLOWS:
COTTONWOOD SUB-BASIN, JOSHUA TREE NATIONAL PARK, CALIFORNIA, USA

Colorado State University

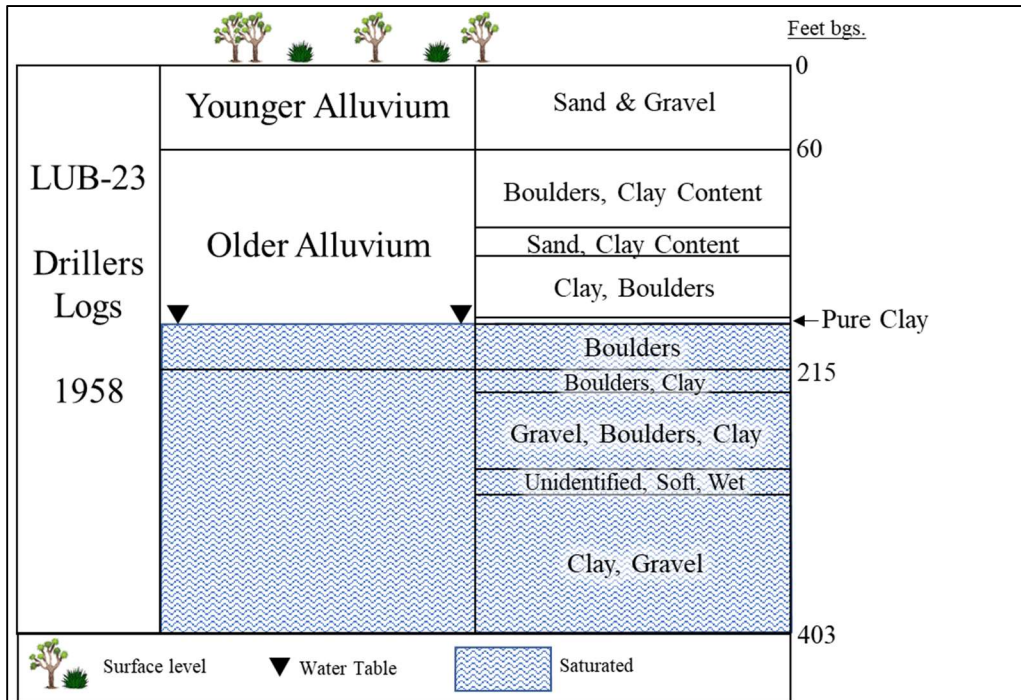
Figure 2-3. Estimated stratigraphy illustration interpreted from driller's logs of LUB-23, refer to Table 2-1 for complete description and depths.

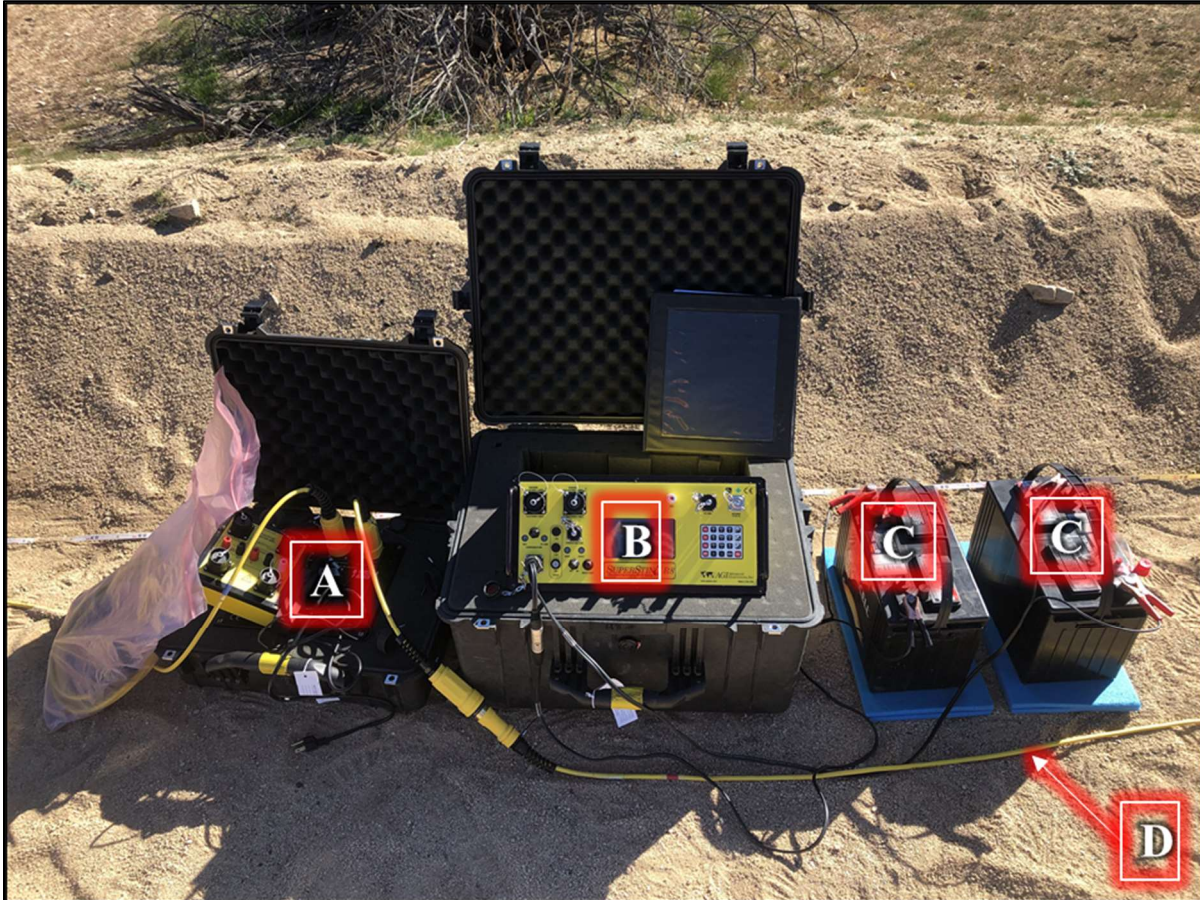
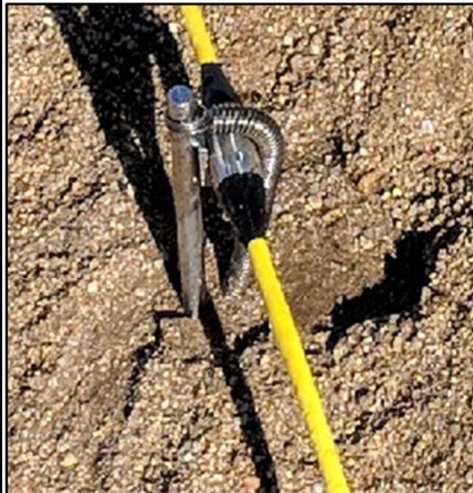
Figure 3-1. AGI Supersting™ Equipment. Layout to include associated peripherals.

Figure 3-1a. Equipment Layout. (A) ERT Switch Box, (B) ERT Supersting™ R8, (C) 2x Deep Cycle Marine Batteries, (D) 4x ERT Electrode (10m spacing) Land Cables.

Figure 3-1b. An electrode connected to the electrode land cable.

Figure 3-1c. An electrode being saturated with a salt water solution.

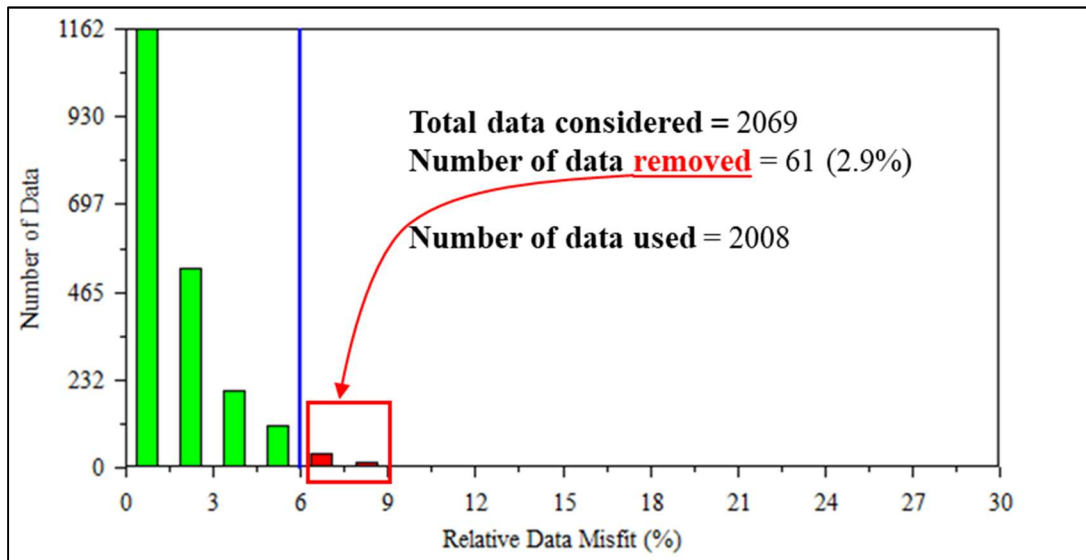
Figure 4-2. Survey A: Data Misfit Histogram.

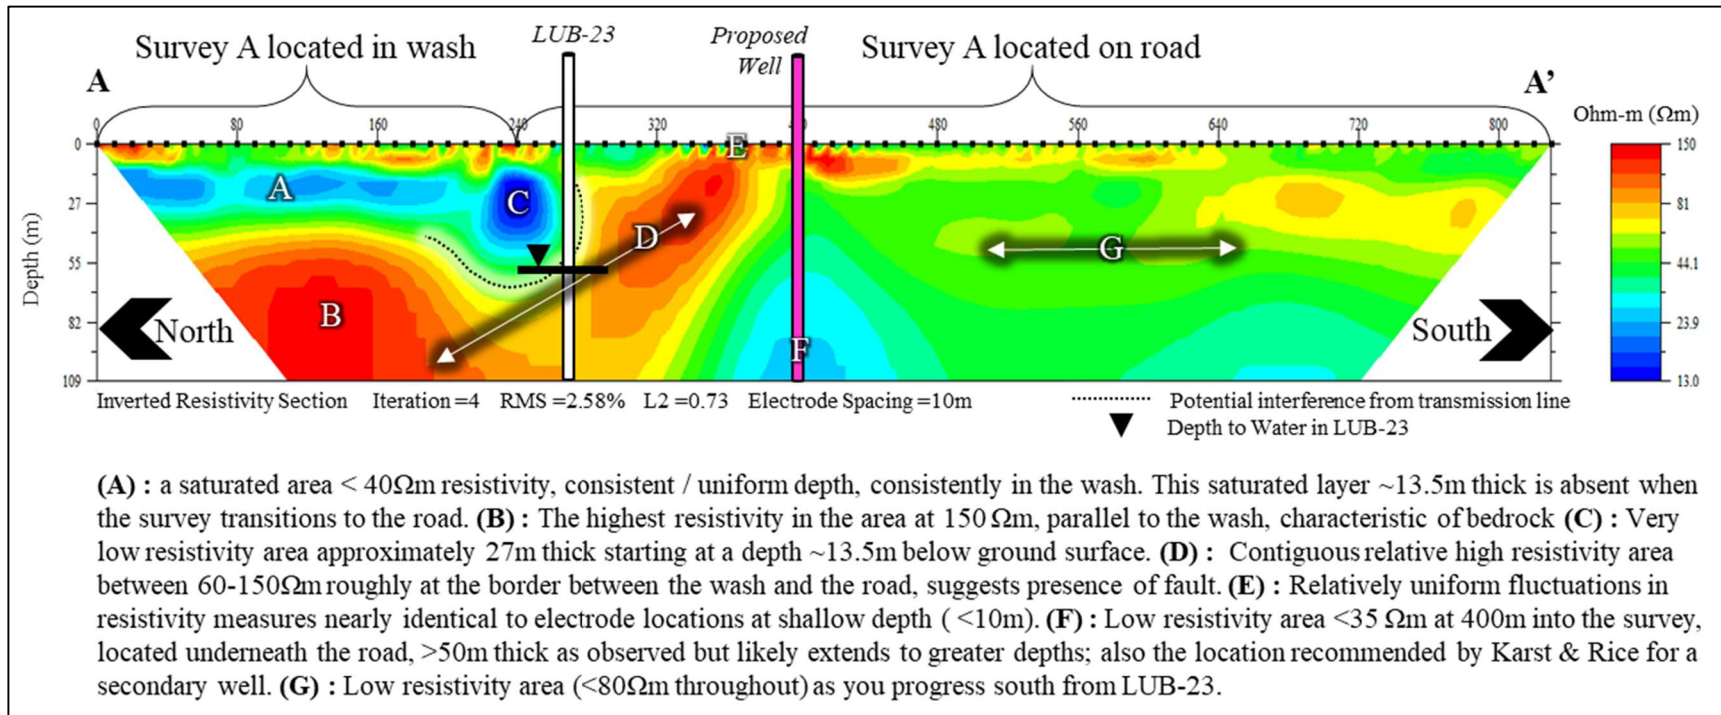
Figure 4-5. Survey A: Interpreted Resistivity Inversion Results

Refer to Figure 4-5 to visualize the following interpretations of data. Location A of Survey A is a wet or saturated layer directly beneath the wash and averages a resistivity measurement of approximately $40\Omega\text{m}$. This layer begins at approximately $\sim 13.5\text{m}$ bgs and averages $\sim 13.5\text{m}$ thick. This layer is likely the result of infiltration from overland flow on 13 October 2018 (6 weeks prior to data collection) which was an event of 60mm ($2.34''$) of precipitation, nearly 33% of all the precipitation that fell in the area in 2018. The existence of this layer is directly correlated (and parallel) to the wash as it ceases to exist when measurements are taken outside of the wash. This could be a result of a more permeable subsurface and the infiltrating waters are able to travel deeper into the subsurface, or more likely, that overland flow is contained within the washes of the area limiting the likelihood for the concentration of subsurface waters outside of the washes. A study in the very arid Gidron Wadi area of Israel observed similar low resistivity areas that were interpreted as perched subsurface water that underlie ephemeral streams (Winters, et al., 2015). With similar climate and aridity to this study area this finding supports the interpretation of this low resistivity layer being a non-persistent underflow. The arid Smoke Tree Wash could be characterized as similar in nature to ephemeral streams substantiating the interpretation of this low resistivity area as saturated.

Location B has the highest relative resistivity in the area ($150\Omega\text{m}$). The previously described saturated layer seems to be perched above it. However, it cannot be determined whether the saturated thickness would continue to infiltrate further into this higher resistivity area with this data collection alone. This increase in resistivity could indicate an area of lower permeability or a change in sediment type. The resistivity contour indicates a change to this

Location F (on road), suggests a low resistivity zone ($34\Omega\text{m}$ and less) starts at 370m into the survey and begins at a depth of 60m (196ft) bgs extending to at least 109m (357ft) bgs. It is likely that this is the saturated zone of the basin and the saturated thickness extends to bedrock depth and is connected to the adjacent saturated area at similar depth at 670m from survey start. This saturated area at 400m from the survey start point is the same location where Karst & Rice (2018) recommended a second site for a well to be placed as an alternate or secondary well

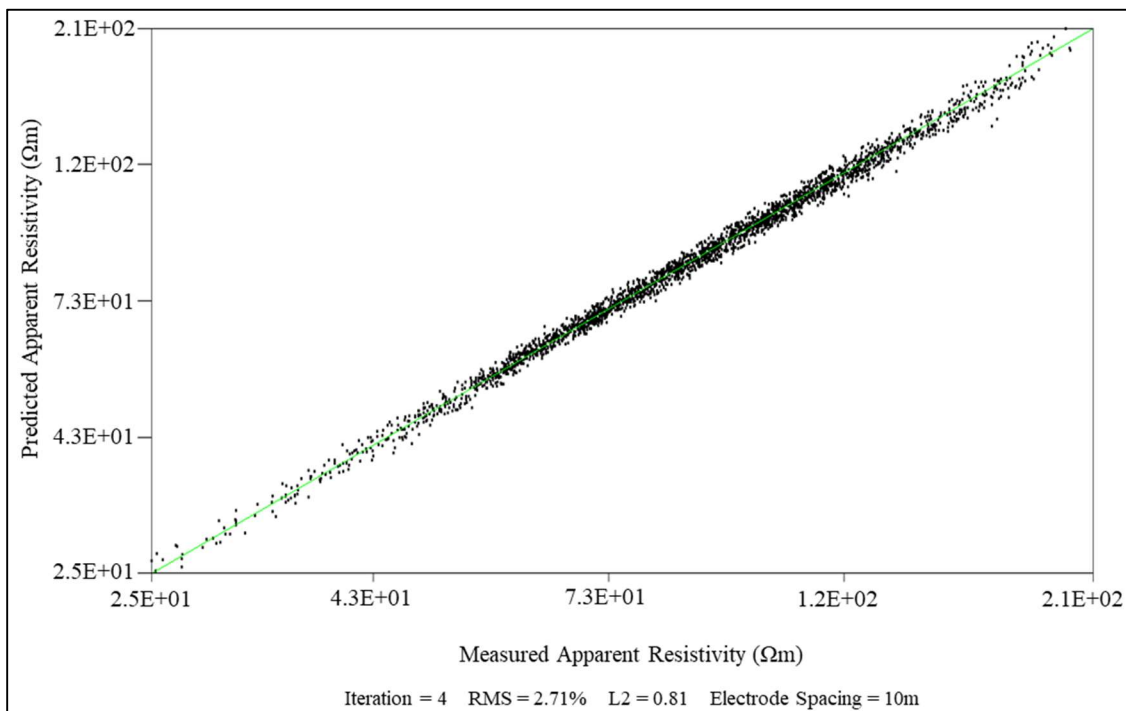
Figure 4-7. Survey B: Data Misfit Cross-Plot. Measured vs. Predicted Resistivity Values.

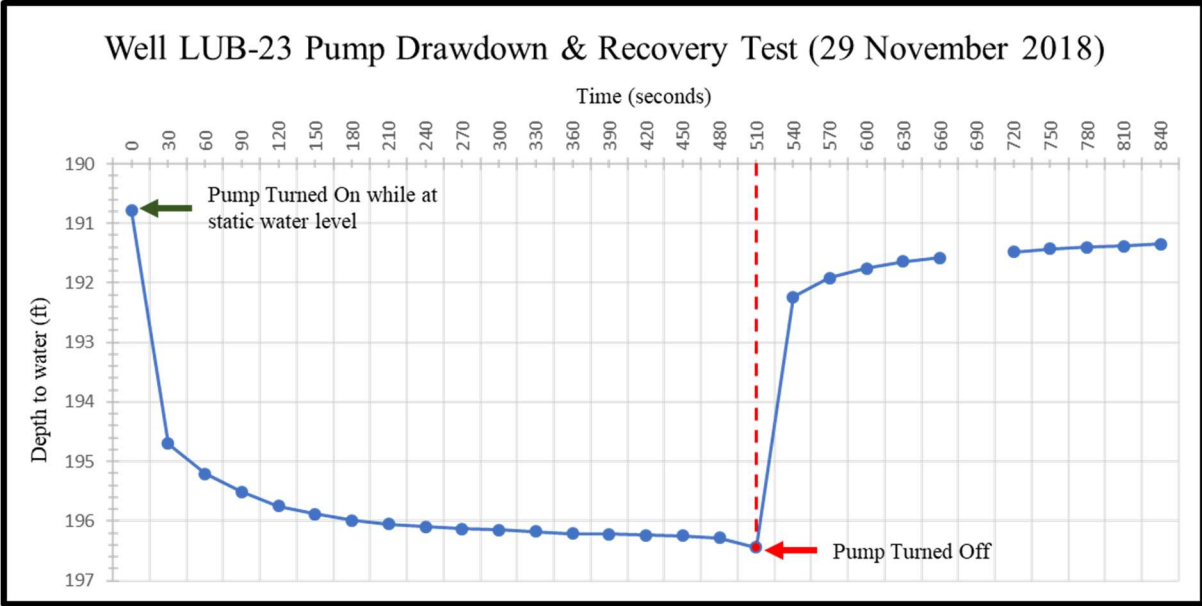
Figure 4-10. LUB-23 Pump Drawdown & Recovery Test. Cottonwood sub-basin, Joshua Tree National Park (29NOV18).

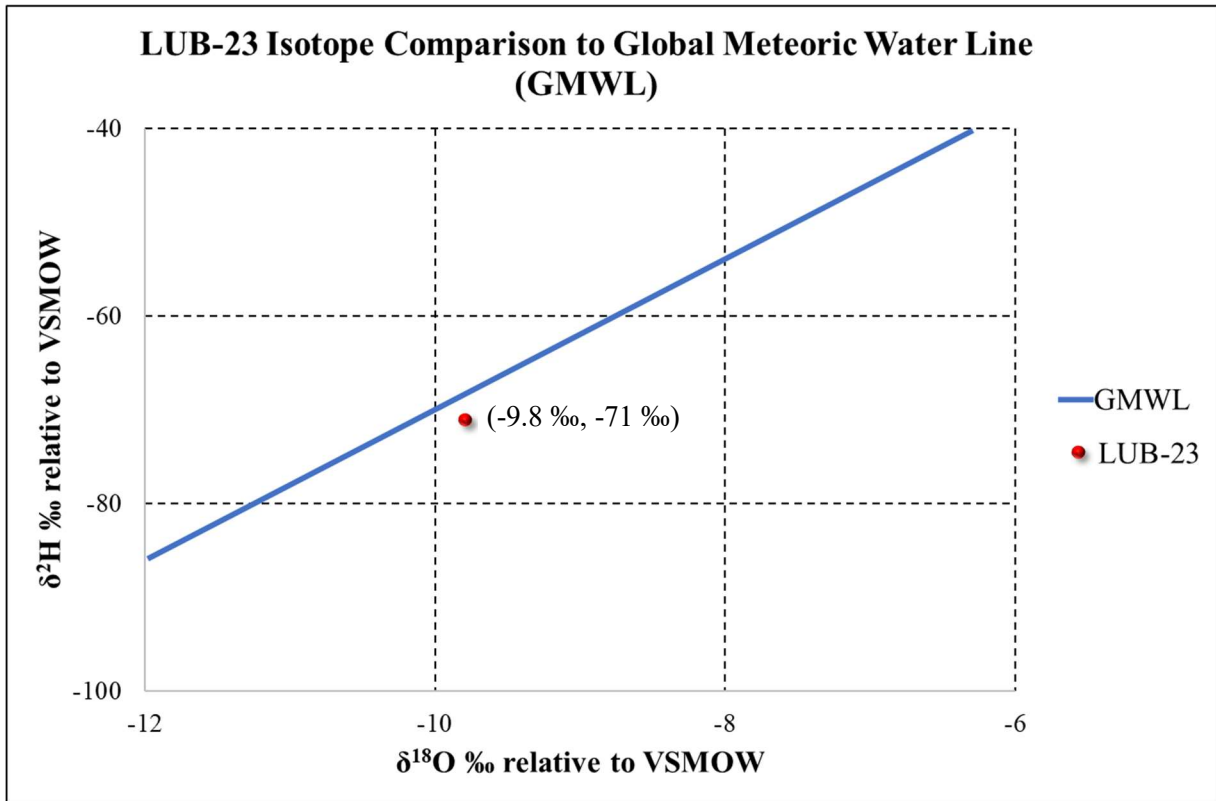
Figure 5-1. Global Meteoric Water Line (GMWL) comparison to LUB-23 measured stable isotopes of deuterium (^2H) and ^{18}O . GMWL source credit: Clark & Fritz, 1997.

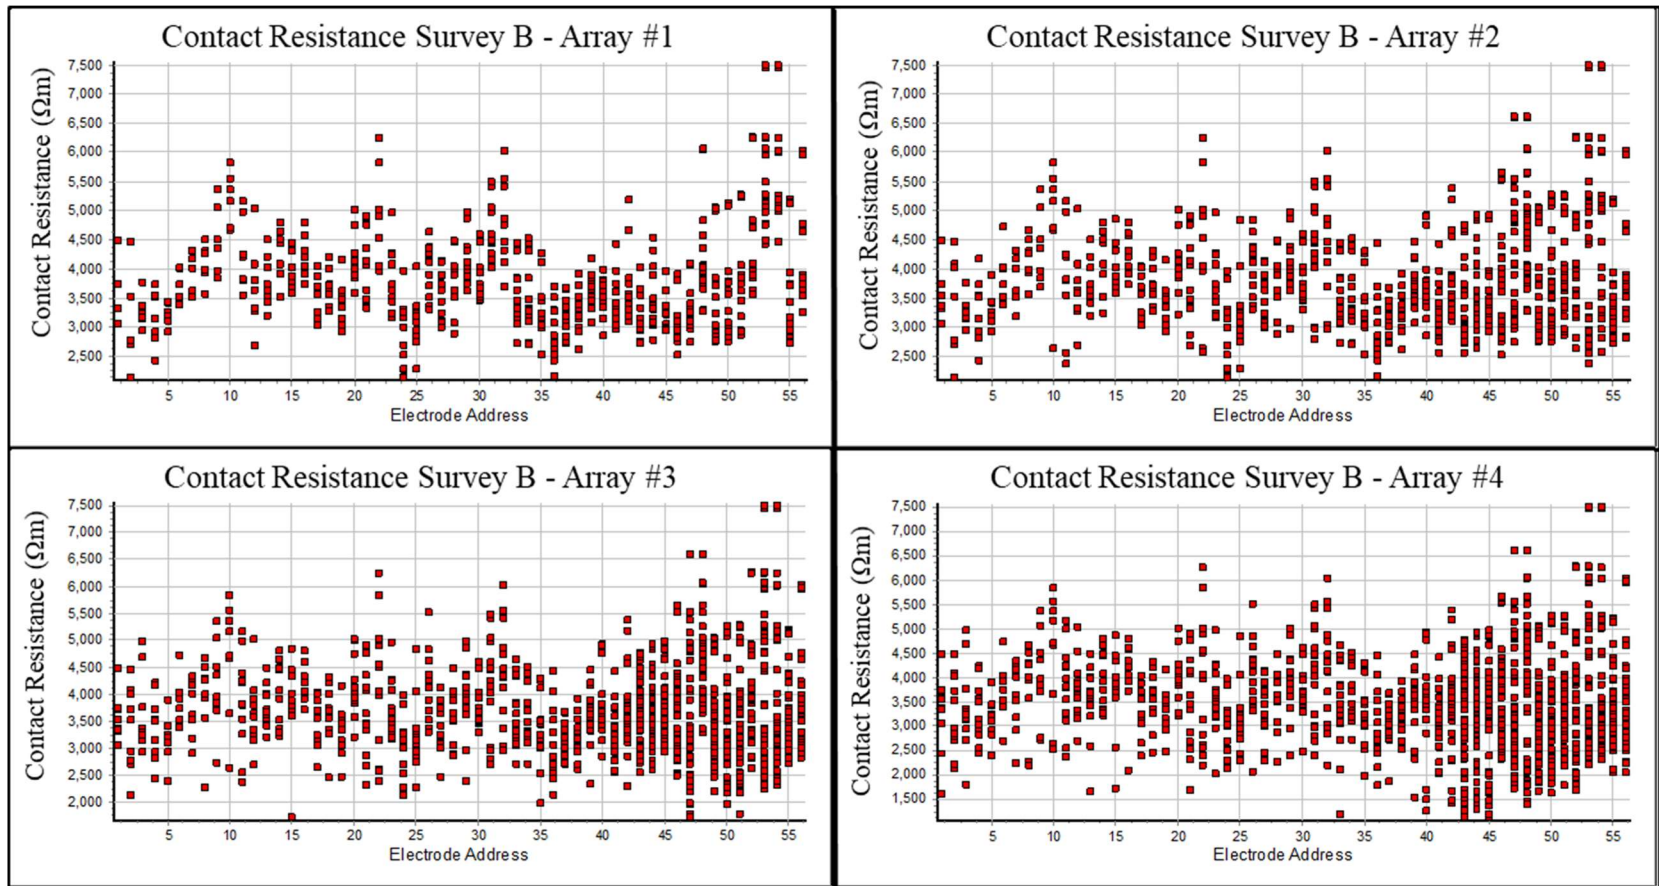
Figure 7-2. Contact resistance for each electrode for each array run for Survey B.

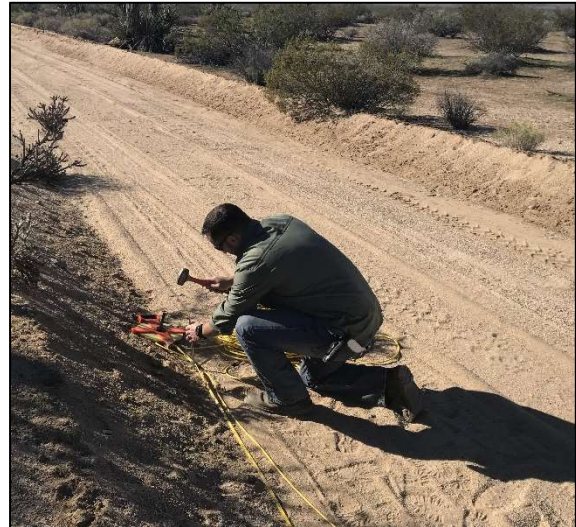
Figure 9-2. John Boyle installing an electrode into the ground for Survey A, along the road. 11/26/18.

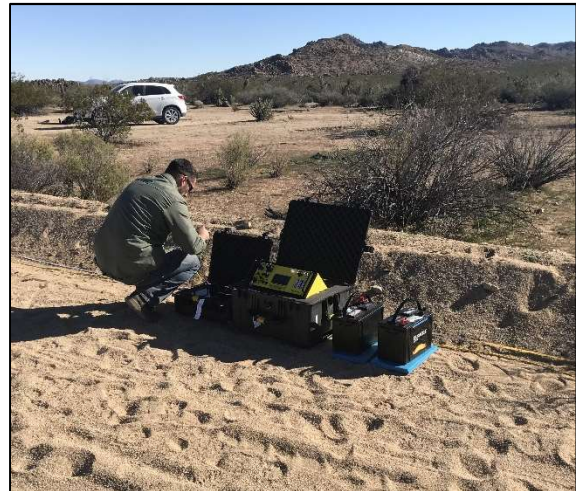
Figure 9-4. John Boyle setting up the AGI Supersting™ at the center point of Array 1 of Survey A along the road. 11/26/18.

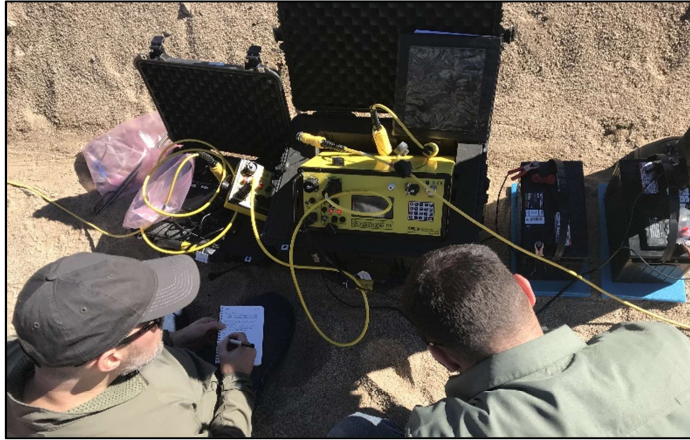
Figure 9-5. Steven Rice (left) and John Boyle (right) recording contact resistance measurements for Survey A. 11/26/18.

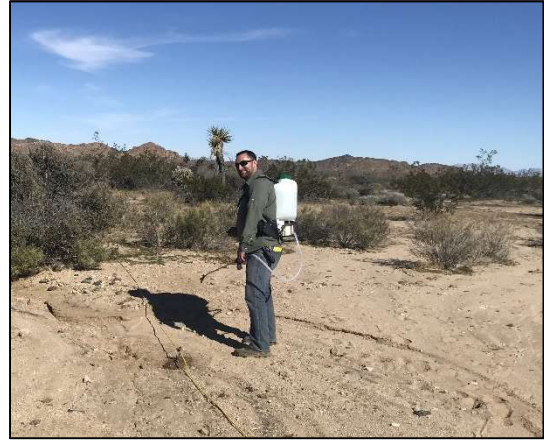
Figure 9-6. John Boyle utilizing the 5-Gallon backpack sprayer with salt-water solution to saturate electrodes in order to improve contact resistance. 11/26/18.

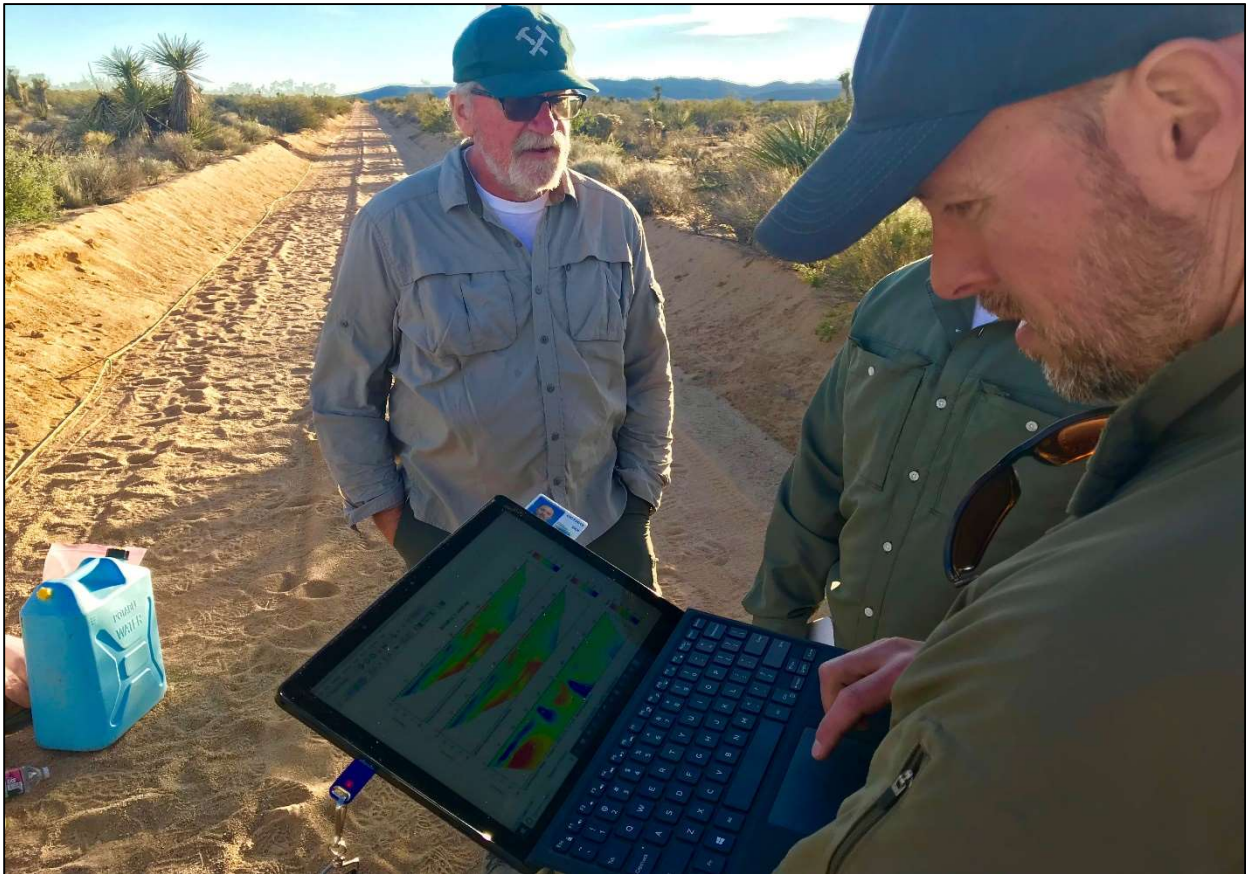
Figure 9-7. Dr. William Sanford (top center), John Boyle (top right), and Steven Rice (right) reviewing initial inversion resistivity for Array 1, Survey A. 11/26/18.

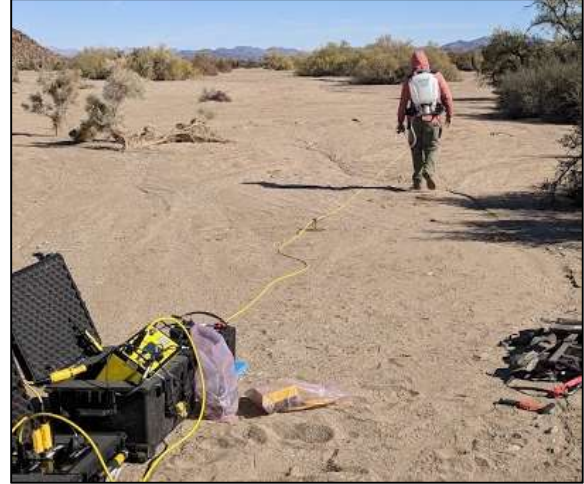
Figure 9-9. Tyler Gilkerson using the 5-gallon backpack sprayer to saturate the electrodes to help improve contact resistance for Survey B.

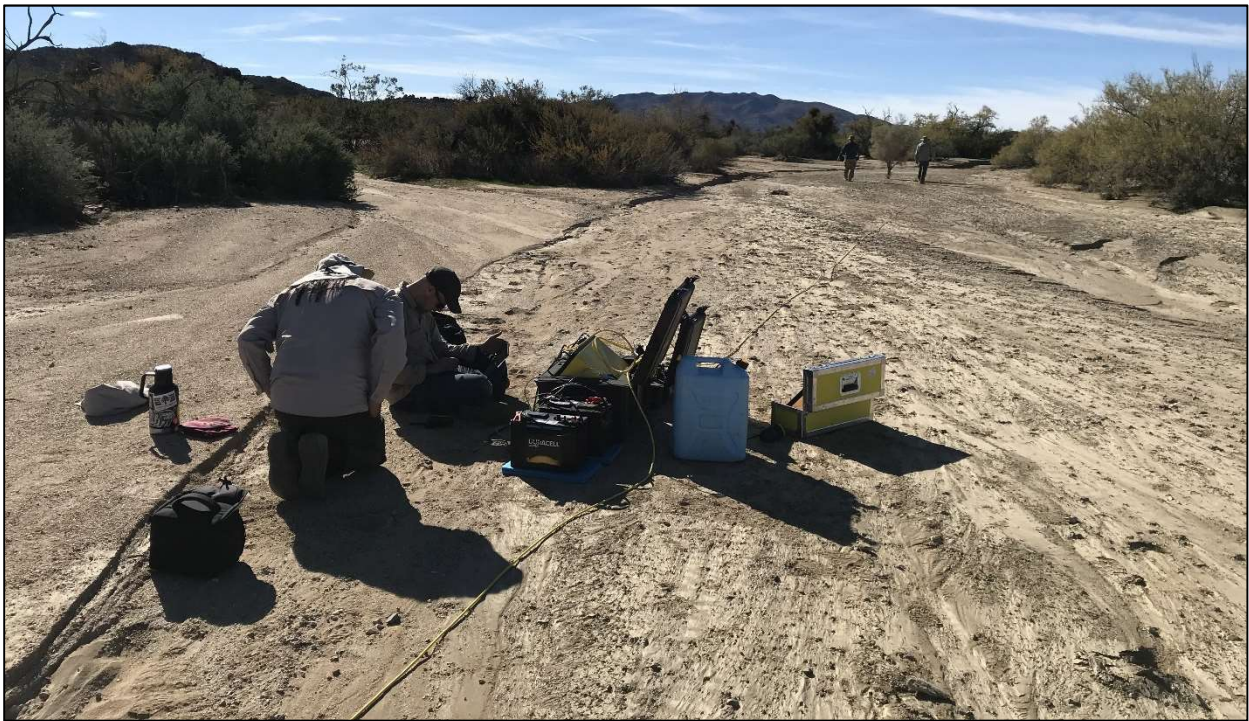
Figure 9-10. John Boyle (background left), Dr. William Sanford (background right), Steven Rice (center) and Luke Sabala (JOTR Science Div) (left), inspect lines and run initial contact resistance tests for Survey B. 11/27/18.

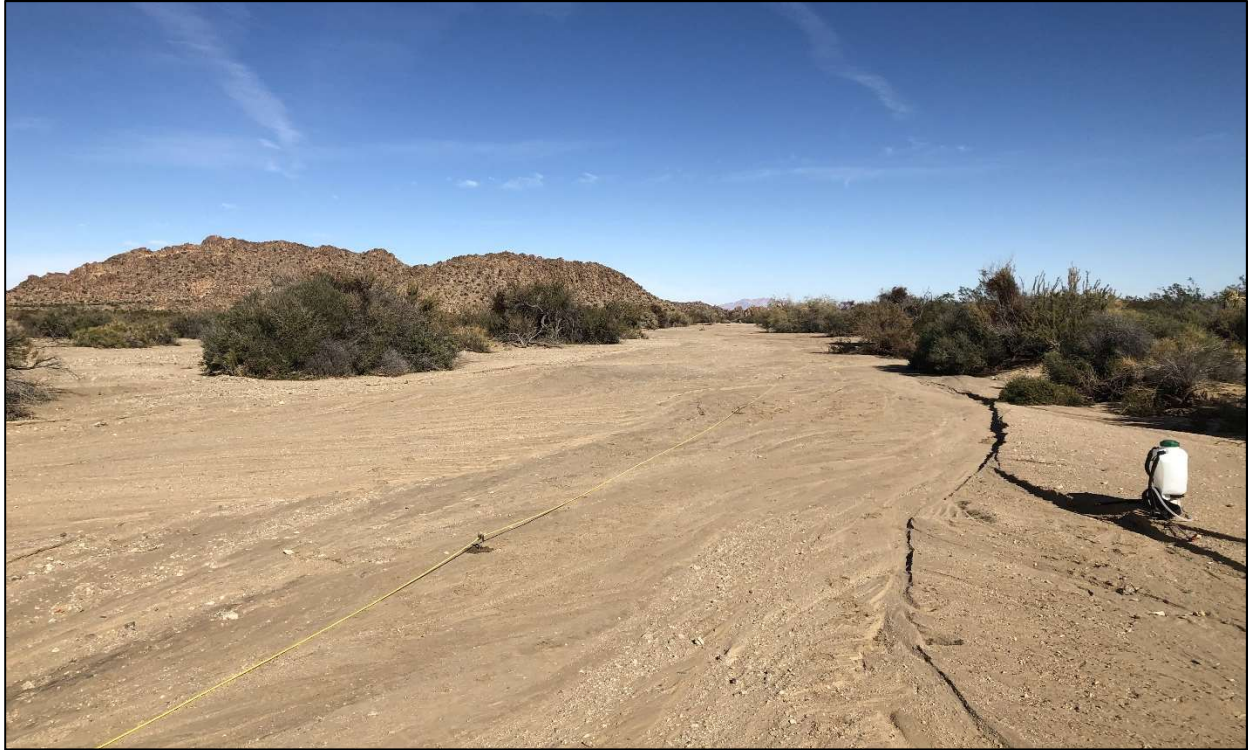
Figure 9-11. A length of Survey B in the wash after applying the salt water solution to the electrodes in order to improve contact resistance. 11/27/18.

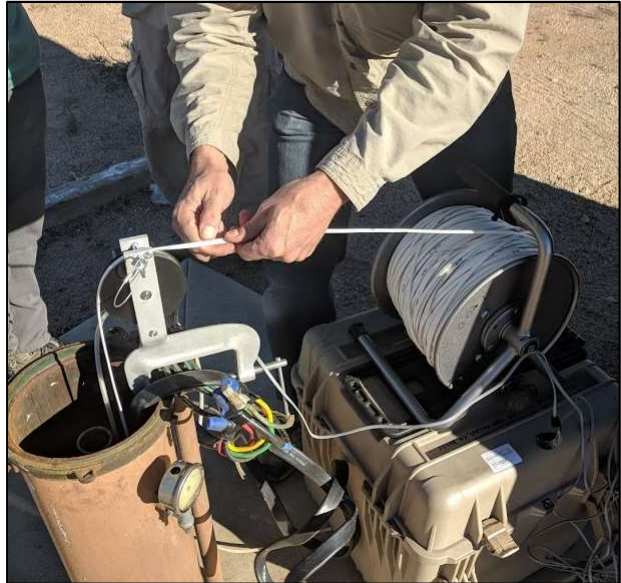
Figure 9-14. Steven Rice and Allison Dunkel lowering the digital camera into LUB-23. 11/28/18.

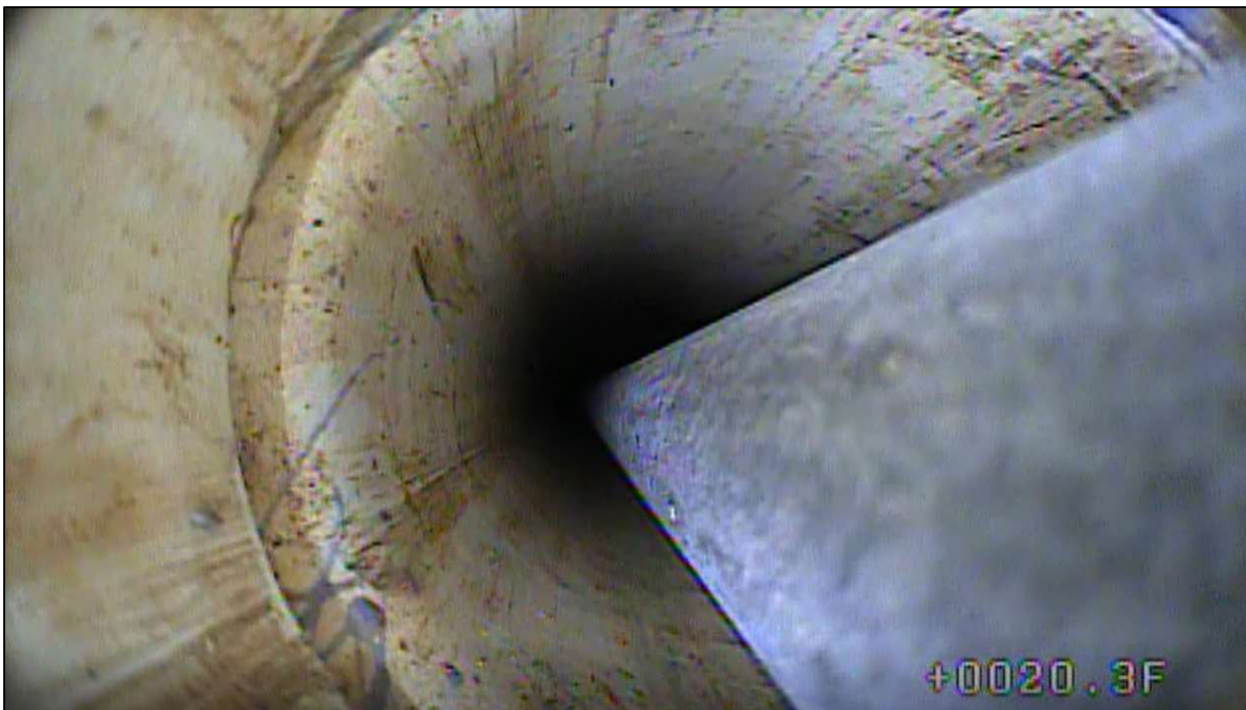
Figure 9-15. Camera screenshot inside LUB-23 at a spool length of 20.3 ft, and 17.9 ft below ground surface (the well entry point is 2.4 ft above ground surface). 11/28/18.

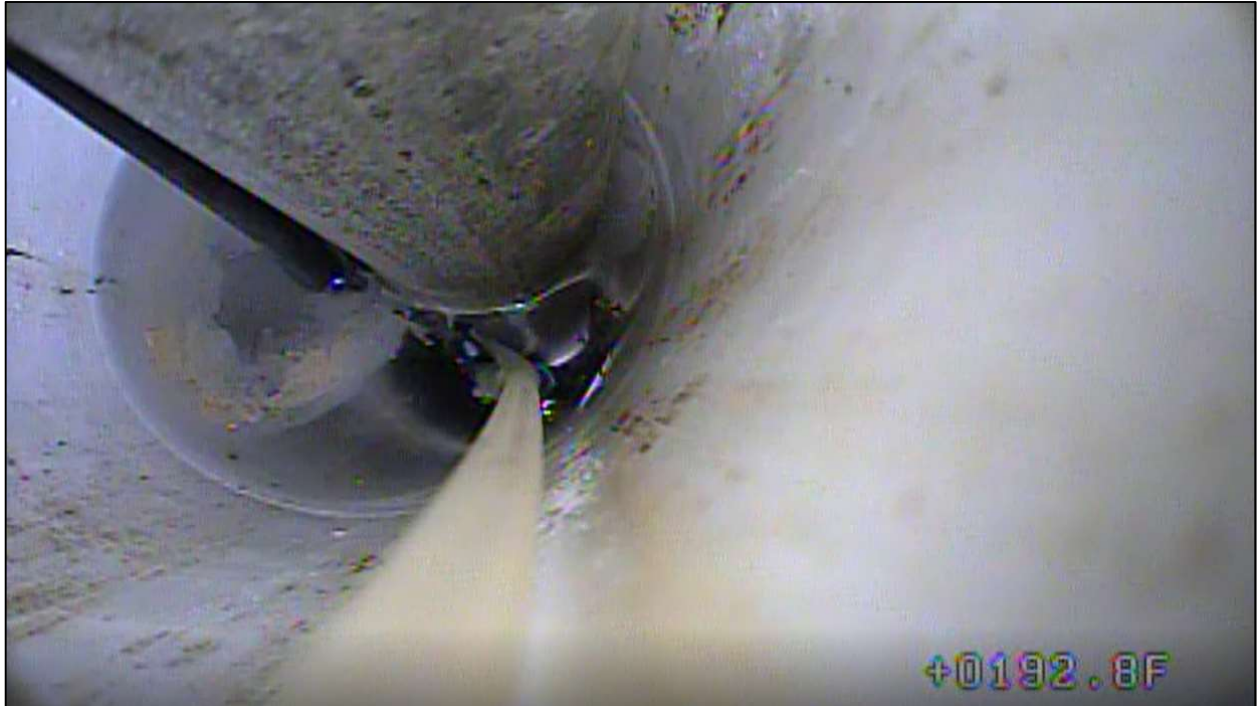
Figure 9-16. Camera screenshot inside LUB-23 at a spool length of 192.8 ft. Notice the water level just below the camera. The precise reading at that water level is 193.18 ft from spool or 190.78 ft bgs.

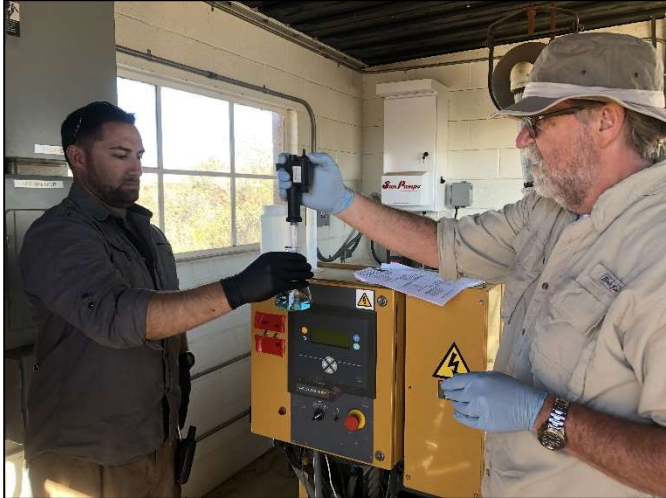
Figure 9-19. John Boyle (left) and Dr. William Sanford (right) using Hach Method 8203 to determine alkalinity of LUB-23 well water. 11/28/18.

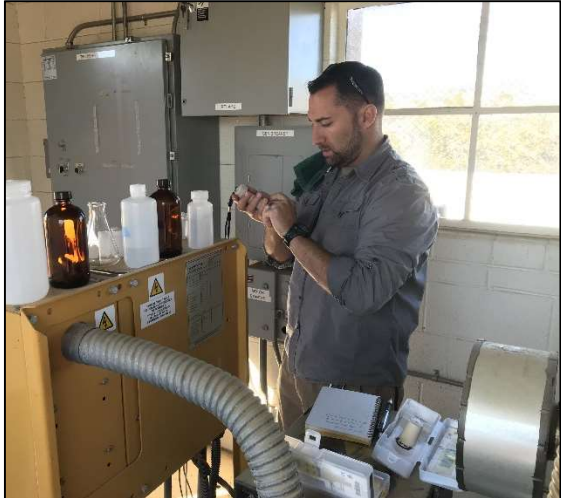
Figure 9-20. John Boyle using the Oakton multi-parameter PC Testr-35 to measure pH, conductance, water temperature, and dissolved oxygen of LUB-23 well water. 11/28/18.

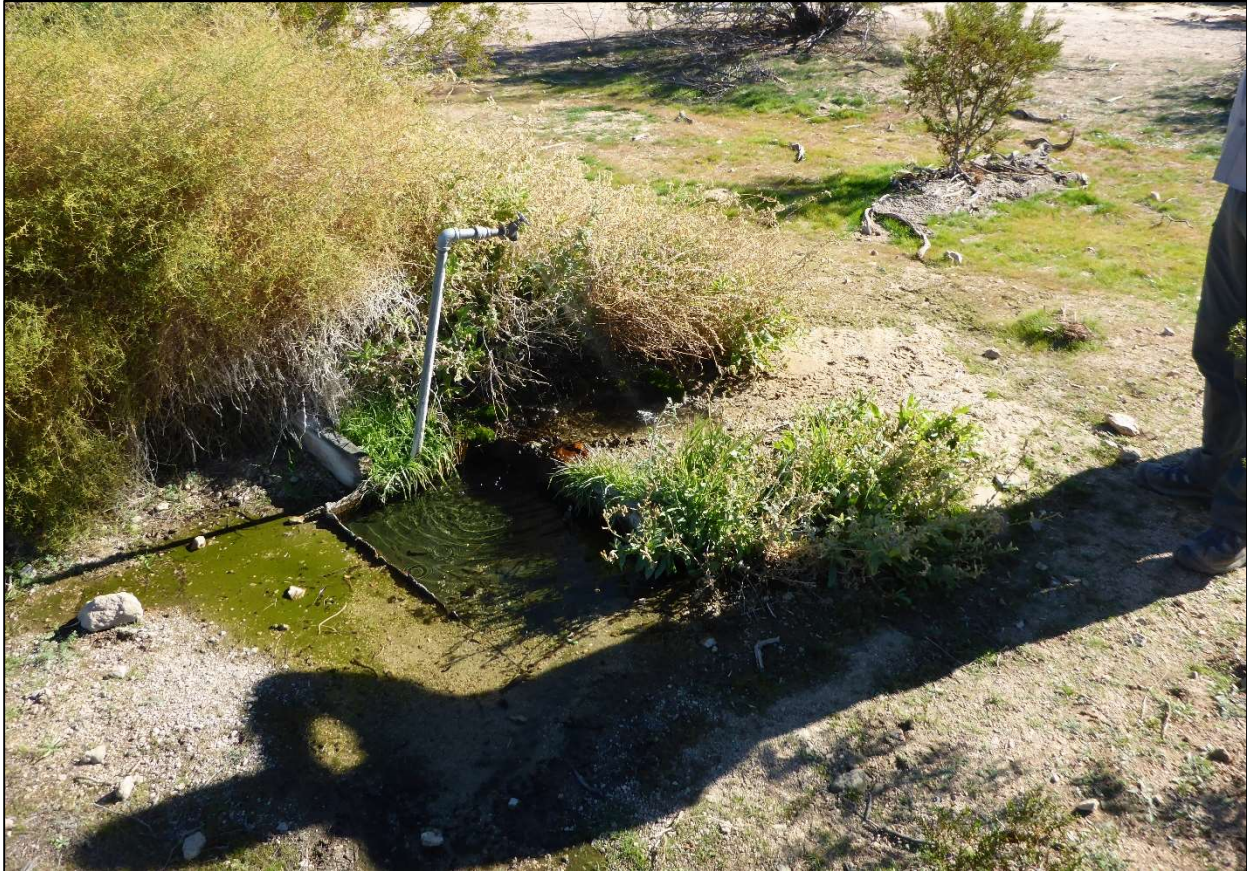
Figure 9-21. The leaking spigot near the generator house, a continual small pool of water is present year-round.

Another observation includes a leaking spigot at approximately 262m from the start point of the survey (Figure 4-1) connected directly to LUB-23. It has been consistently leaking since, what is assumed to be, 1958. A consistent pool approximately 1m² persists year-round, to the point it has created its own small ecosystem. It does not appear to have influenced ERT data nor can we see resistivity evidence to this point but 262m is also at the area of uncertainty from the assumed transmission line.
