Published by Elsevier Science Ltd. All rights reserved
12th European Conference on Earthquake Engineering
Paper Reference 726 (quote when citing this paper)

SEISMIC BEHAVIOUR OF R.C. BEAM-COLUMN JOINTS DESIGNED FOR GRAVITY LOADS

S. Pampanin, G.M. Calvi and M. Moratti

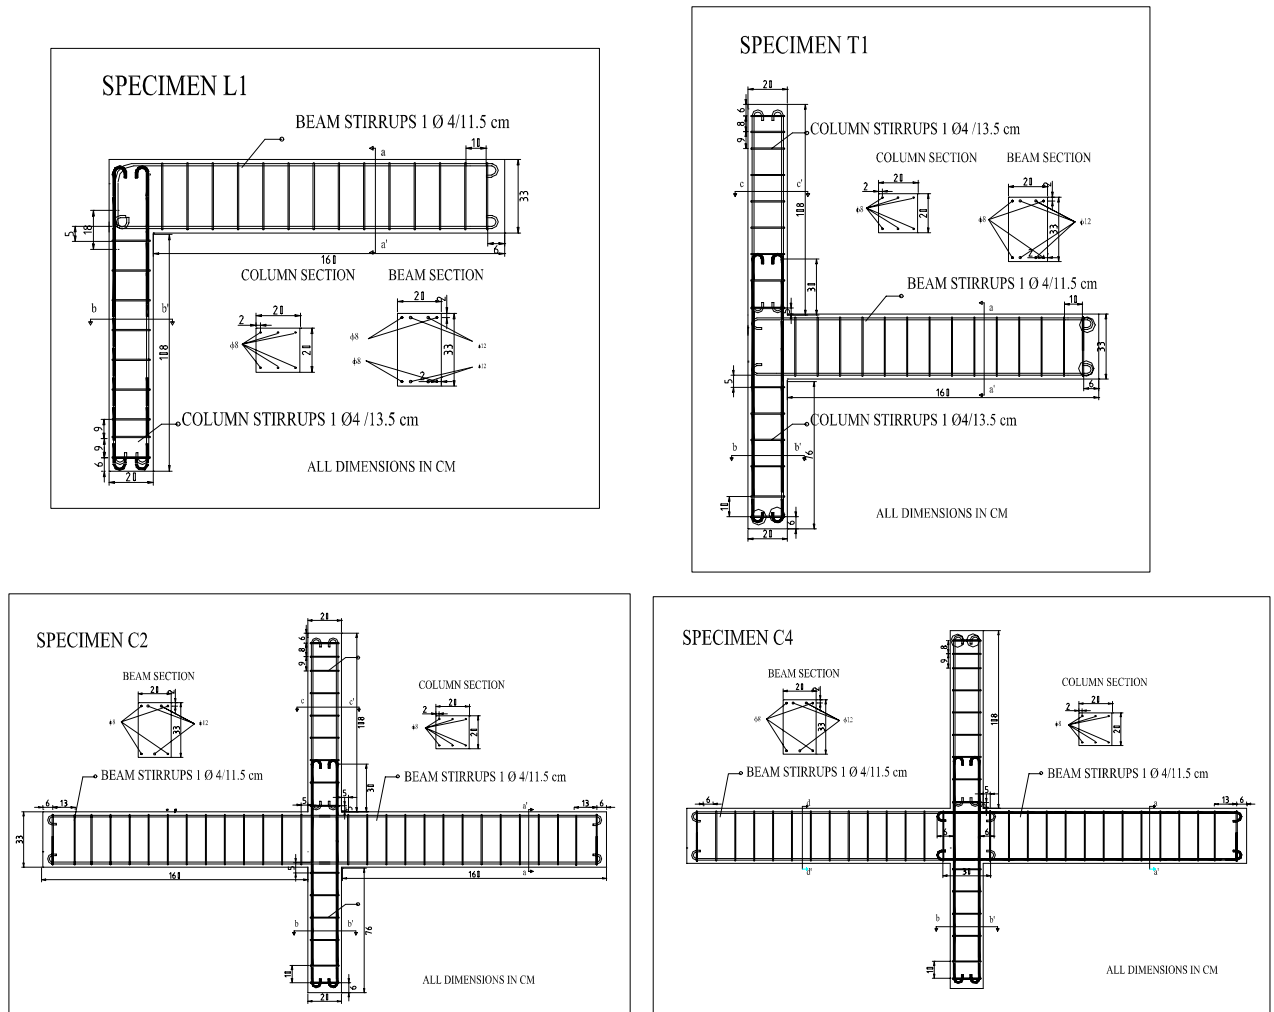
Figure 1 –Beam-column subassemblies specimens

Within the knee and tee typology (Fig. 1 top), the beam longitudinal reinforcement was varied between the two specimens. In the interior specimens (Fig. 1 bottom), two different

anchorage solutions for the beam longitudinal reinforcement through the joint region were adopted: continuous reinforcement (specimen C2) or lapped splices with hook-end anchorage outside the joint region (specimen C4).

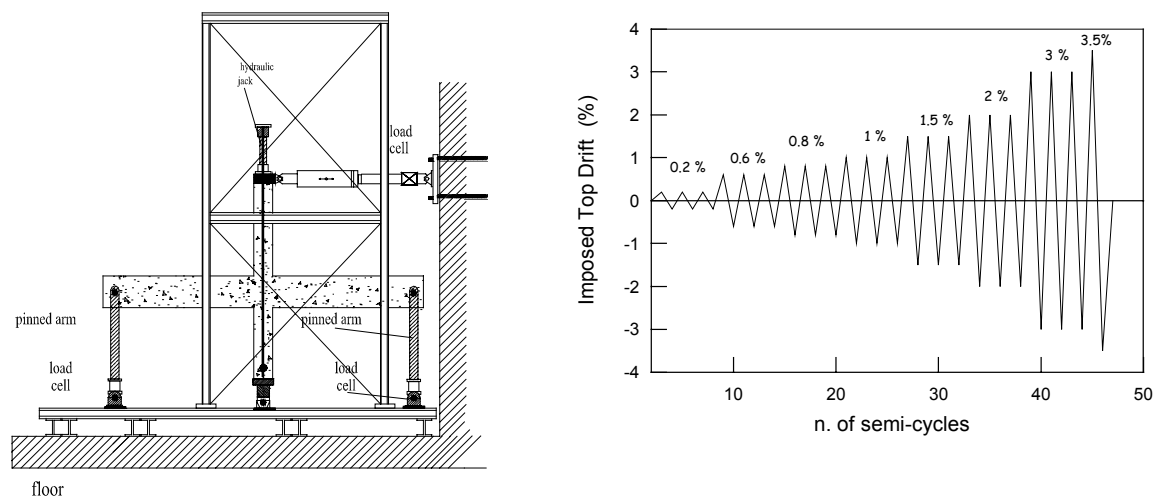
Figure 2 – Test set-up and loading-history

Figure 2 illustrate the set-up for the different specimens and the applied loading history. Beam and column elements were extended between contraflexure points (assumed to be at midspan of the beams and at midheight of the columns) where pins are introduced. Simple supports at the beam ends were obtained connecting pin-end steel members to the floor. A series of three cycles at increasing level of interstorey drift was applied through the horizontal hydraulic actuator (100 kN, 250 mm stroke). In order to better reproduce the actual state of stress of beam-column joints during an actual cyclic push-pull test on a frame system, the column axial load was varied during the experiments as a function of the lateral load, alternatively to what typically done in experimental tests on beam-column subassemblies presented in literature. The axial-load vs. lateral-force relationships for exterior and interior joints were evaluated with preliminary pushover analyses on the three storey-three bays R.C. frame system of the co-ordinated research program (Pampanin *et al.* [2]).

Significant variations of the axial load up to 40-50% (increase and decrease) with respect to the value due to gravity load only were observed. During the tests on the beam-column specimens, a simplified bi-linear relationship between axial and lateral load was adopted. According to the adopted sign convention, positive drift and positive lateral force correspond to a decrease in the axial load. The constant values of axial force due to the gravity loads were 100 kN and 120 kN for the exterior tee-joints and interior cruciform-joints respectively. The axial load was applied by means of a vertical hydraulic jack, acting on a steel plate connected to the column base plate by vertical external post-tensioned bars.

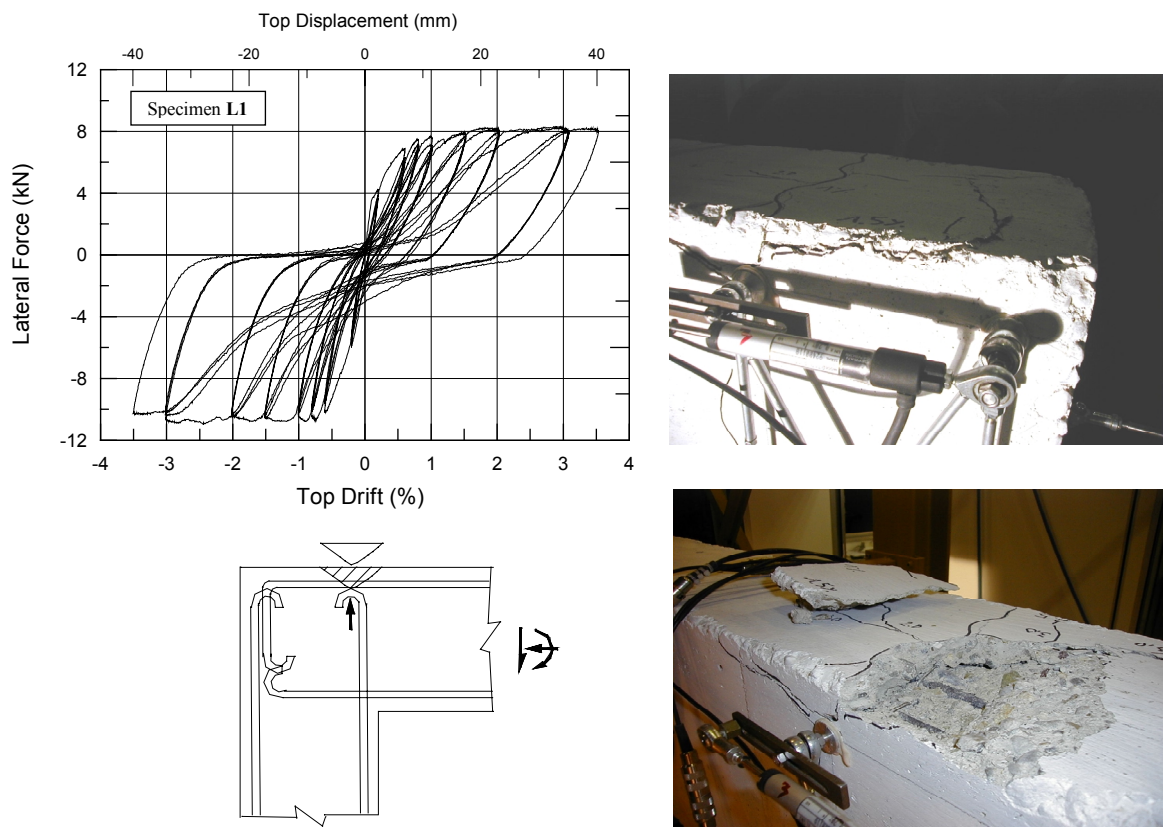
Figure 3 –Exterior knee joint (specimen L1): hysteretic behaviour and damage mechanism

The behaviour of the two knee specimens, characterized by different reinforcement, was governed by flexural damage concentration at the column interface. High level of drift (up to 3.5%) was reached without significant reduction in strength: this high ductility capacity was provided by the low level of axial load and longitudinal reinforcement ratio as well as by the column bar slip, as evident from the marked “pinching” in the experimental hysteretic behaviour (Fig. 3). At high level of drift a particular local damage mechanisms developed at the top of the joint region, while the cracks at the column interface kept increasing in width. Due to slippage of the column reinforcement and stress concentration at the end-hook, crushing and spalling of the concrete occurred at the top face of the joint (Fig.3).

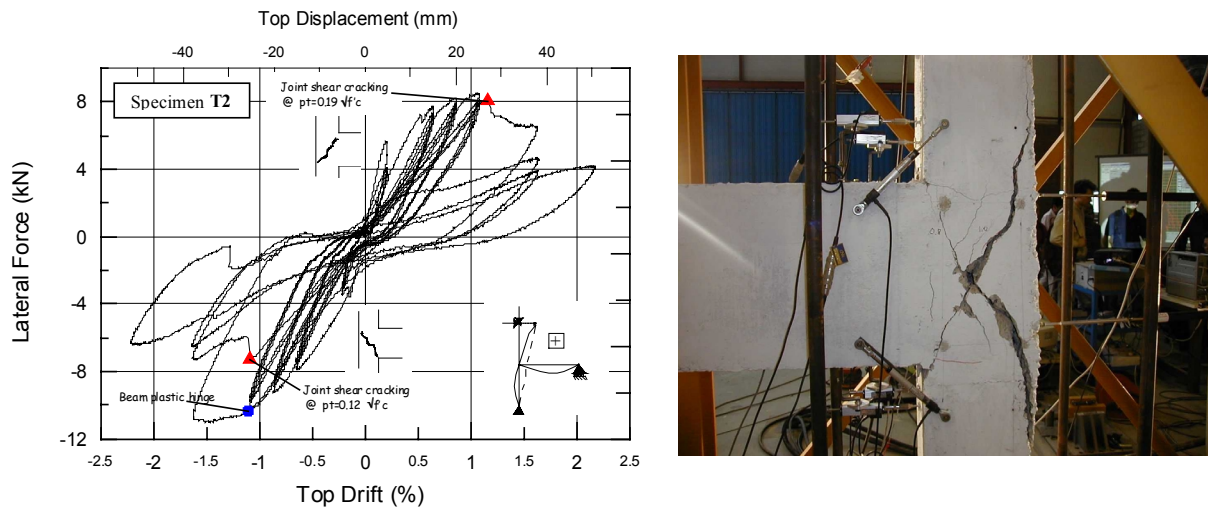
Figure 4- Hysteretic rule and observed damage mechanism in exterior tee-joint

The exterior tee-joint specimens showed an analogous particular brittle hybrid failure mechanism: joint shear damage combined with slippage of longitudinal beam bars within the joint region with concentrated compressive force at the end-hook anchorage. As a result, a concrete “wedge” tended to spall off, leading to brittle local failure and loss of bearing-load

capacity (Fig. 4). The observed mechanism presents interesting peculiarities when compared to damage mechanisms typically expected for exterior tee-joint (Fig. 5), depending on the anchorage details adopted: beam bars bent away from the joint or into the joint region. Recent experimental investigations presented by Hakuto et al. [6] on existing joints with substandard reinforcing details, typical of pre-1970s designed moment resisting frames in New Zealand, confirmed the inefficiency of alternative shear transfer mechanism in the joint region, after shear cracking, when beam bars are bent out from the joint. The former anchorage details can not provide an effective node point for the development of the diagonal compression strut mechanism unless a significant amount of transverse column hoops is used immediately above the joint core. Deformed reinforcement bars were adopted during the test.

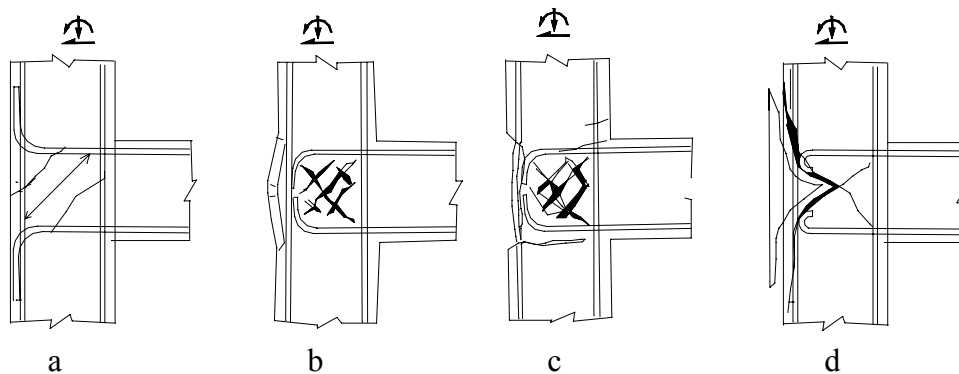
Figure 5- Alternative damage mechanisms for exterior tee-joints :

- a) beam bars bent away from joint region;
- b), c) beam bars bent in joint region;
- d) end-hook anchorage: “concrete wedge” mechanism

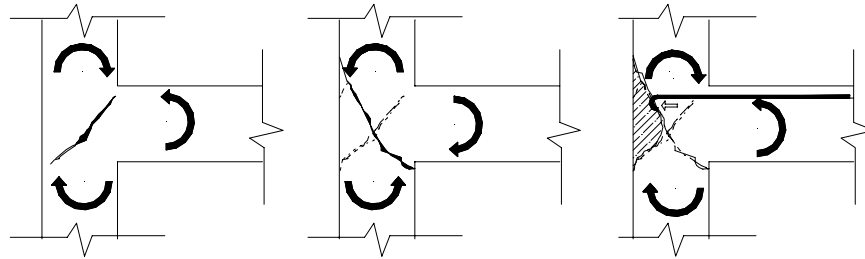
Figure 6 –Development of “concrete wedge” mechanism

Similar qualitative damage mechanism were observed in the tests carried out at the University of Pavia. However, the use of smooth bars in combination with end hook-anchorage played a significant role in modifying the sources of the observed hybrid mechanism. As shown in Fig. 6, due to bond deterioration and beam bar slip at early stages,

an additional localized concentrated force at the compressed bar edge acted, after first joint diagonal cracking, in combination with the inefficient strut mechanism, leading to the expulsion of the aforementioned concrete “wedge”.

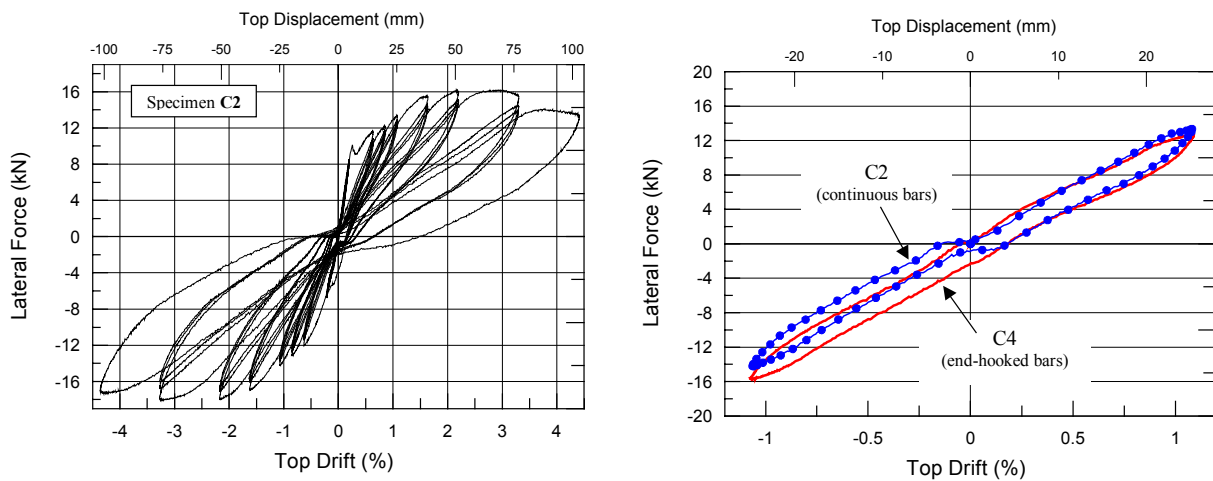
Figure 7 –Interior joints: hysteretic behaviour and comparison of anchorage solutions

The interior joint specimens showed significant resource of plastic deformation (Fig. 7), even without specific ductile structural details. According to preliminary capacity design considerations shear joint cracking and column hinging were predicted to be relatively close events. The concentration of flexural damage in the column at early stages, thus, acted as a structural fuse for the joint panel zone, which did not suffer any cracking. The anchorage solutions with lapped splices and end hooks (specimen C4).confirmed a superior efficiency as clearly shown in Figure 7. However, a marked pinching was observed in both cases, due to slip of the column longitudinal reinforcement bars. Discussion on the critical implications from beam bar or column bar slip phenomena in interior beam-column subassemblies has been recently proposed by Hakuto et al. [7] and Calvi et al. [3], respectively.

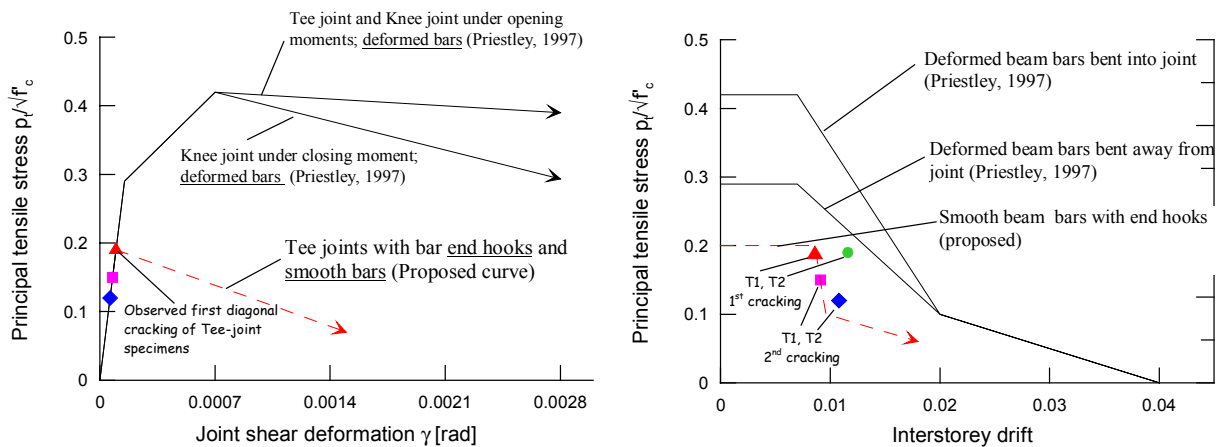
Figure 8 –Strength degradation curve for exterior joints

Typical strength degradation models available in literature (Fig. 8) and based on research on poorly designed joints (Kurose [11]; Hakuto et al.[6]; Priestley [4]) recognises the inherent vulnerability of exterior joints without transverse reinforcements in the joint region. Recent comprehensive tentative degradation models, suggested by Priestley [4] according to a displacement based assessment procedure, for exterior and corner joint in terms of principal tensile stress p_t as a function of subassemblage drift level or joint shear deformation are illustrated in Figure 8 and compared with the experimental evidences. It is important to underline that literature models refer to experimental investigations on specimens with deformed reinforcement bars.

At a local level (joint panel zone), the elastic stiffness is correctly predicted, while cracking and high damage limit states are overestimated both in terms of stress and deformation values. Drift limits at a subassembly level for the first cracking are slightly underestimated, as a consequence of higher deformability of the tested specimen due to the use of smooth bars. The limited number of specimens tested does not allow to formulate a reliable alternative degrading curve. However, an approximate qualitative trend of a degrading curve for tee-joint specimen without shear reinforcement in the joint region and with inadequate anchorage details of the beam bars, can be proposed as illustrated in Figure 8 and described as follows:

- $p_t = 0.2\sqrt{f'_c}$ should be considered an upper limit for first diagonal cracking, with significant reduction for second cracking as a consequence of reverse cyclic deterioration (not necessarily associated with ductility demand of adjacent elements);
- the associated reduced joint shear deformation at cracking can be determined following the elastic curve proposed in literature;
- significant and sudden strength reduction might occur after the cracking point without any additional source for hardening behaviour.
