# The role of deep-seated landsliding in the geomorphic evolution of the Esk Valley, Hawke's Bay: An innovative approach to hazard evaluation

Master of Science in Engineering Geology

University of Canterbury

2003

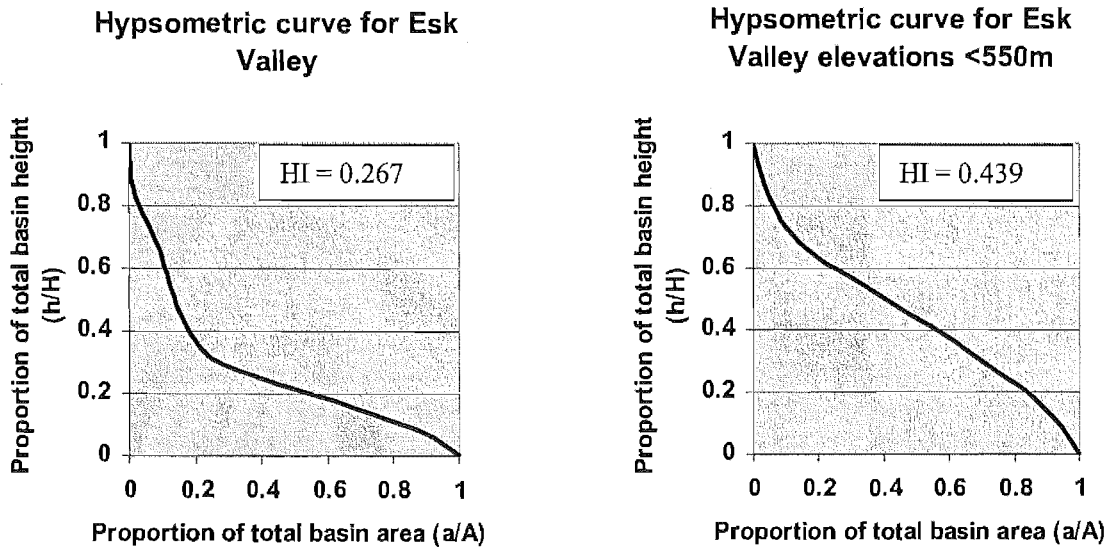
Figure 2.5 Hypsometric curves for the whole Esk Valley (left), and with Maungaharuru Range removed (right).

The hypsometric curve is a useful means of summarising basin morphology and comparing degrees of basin maturation irrespective of basin scale. It indicates the total proportion of basin area above a proportion of total elevation (Keller and Pinter, 1996). The hypsometric curve for the Esk Valley is given in Figure 2.5.

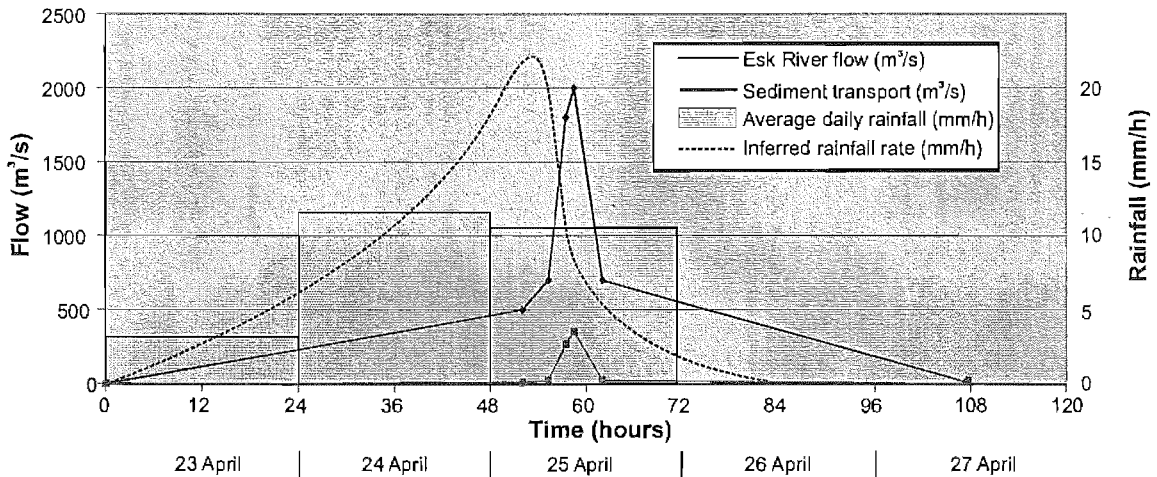
**Figure 2.9 Inferred hydrograph for April 1938 Esk Valley Flood**

While the Esk River was not the only river to flood during this storm, the discharge of the Esk Valley was the highest per unit area of any in Hawke's Bay (Grant, 1939). A hydrograph based on rainfall records in Grant (1939) and eye witness accounts in Cowie (1957) is given below in Figure 2.9.

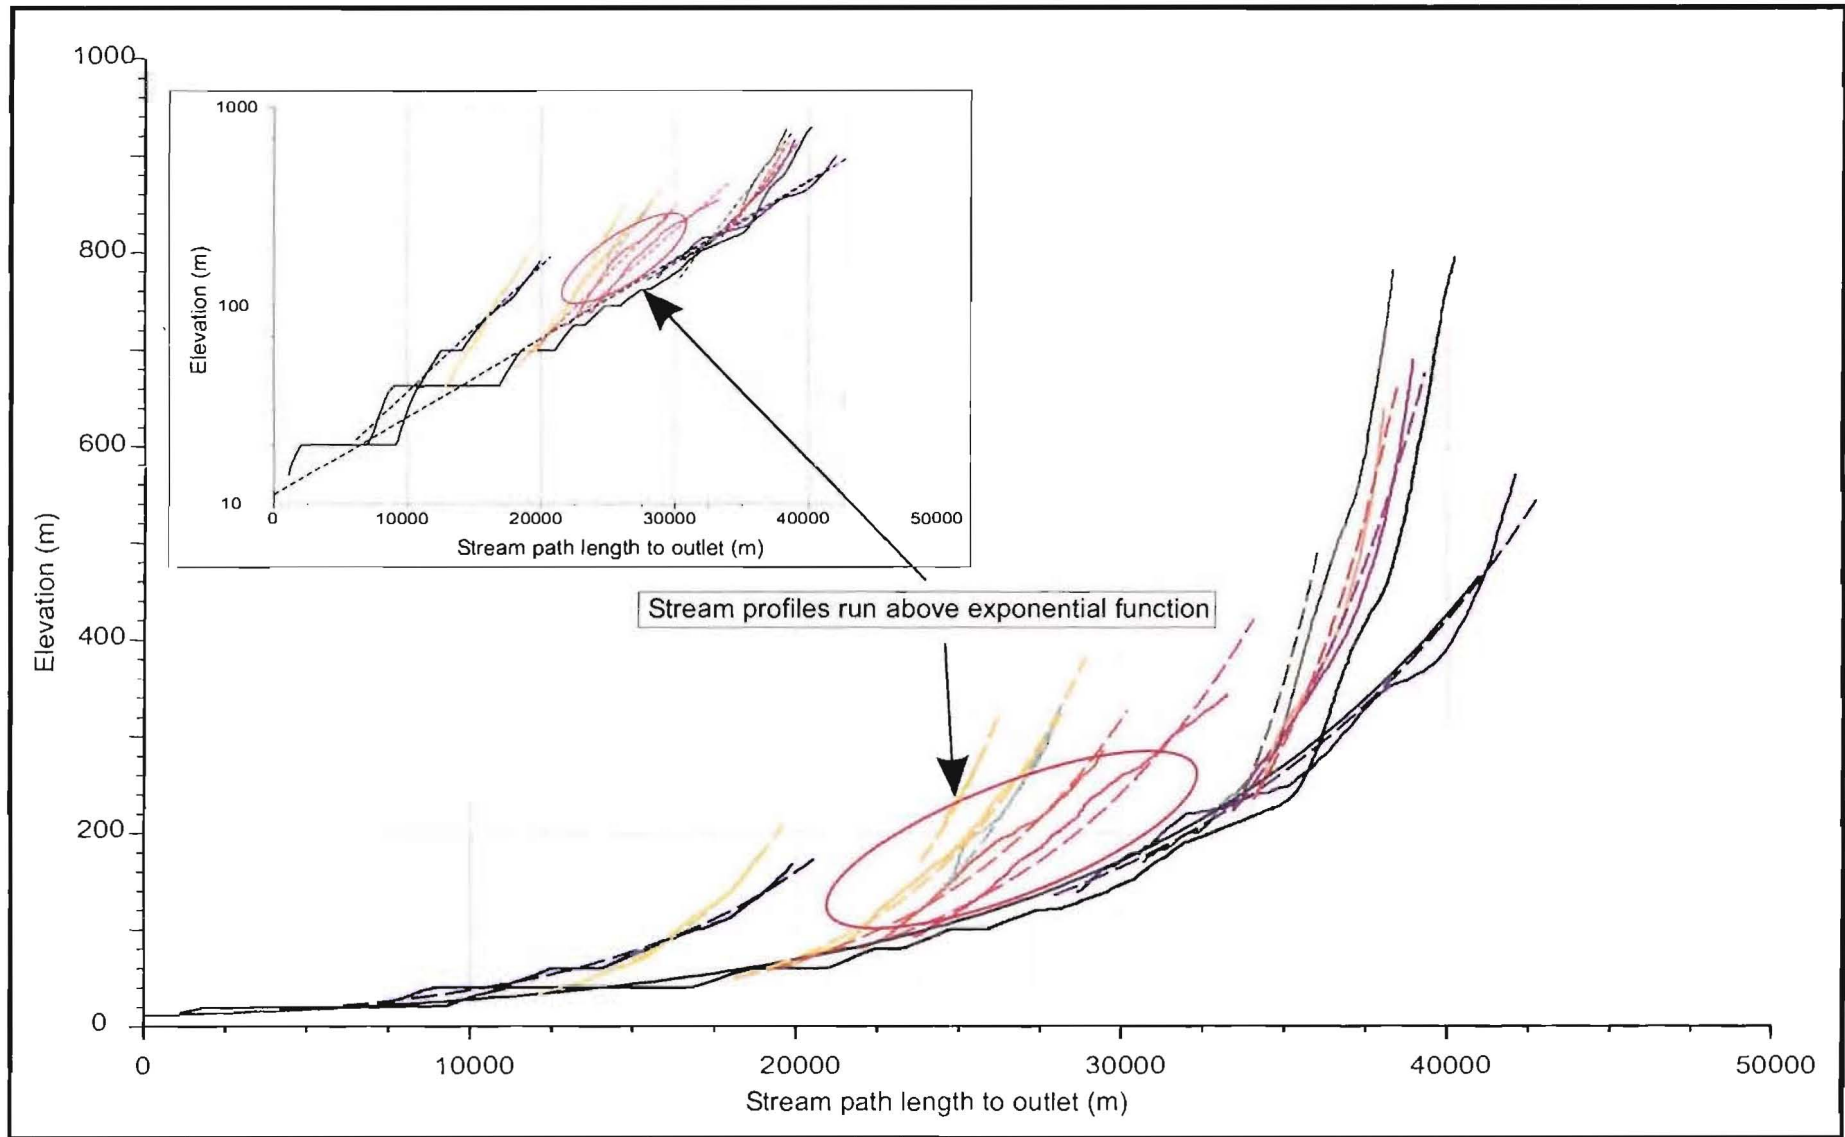
This region denotes Matahorua Formation, this contains prominent conglomerate beds (dashed lines). These are likely to require an increase in stream power in order for the streams to incise through them and may therefore cause the channels to alter grade. Areas where it can be identified the streams have incised through conglomerates since the onset of the most recent period of incision are indicated with coloured arrows. An illustration of the relationship of these arrows to the streams is given

**Figure 3.2 Long profiles and location map for Esk Valley rivers**  
 Profiles are based on interpolated 20m contour data. Note coarse data, particularly in lower gradient reaches. Exponential profiles (dashed lines) are automatically fitted to river profiles. Inset shows semi-log plot of profiles illustrating strong correlation to exponential curves, and increased grade in upper reaches. Deviation of the stream channels above these profiles is high lighted in both the profile curves and map. Possible conglomerate control is illustrated in the location map, and catchments controlling stream power are also displayed. The Maungaharuru Range is in the top left of the map.

Individual streams were digitised and plotted on a composite graph of long profile length vs. elevation (see Figure 3.2). This plot is used in preference to that of Whipple and Tucker (2002) primarily because of the simplicity of the data acquisition compared to inherent difficulties involved in calculating drainage area variation along the stream profiles. The linear nature of most of the catchments in some ways negates the need to plot drainage area, as with the narrow valleys investigated by Morris and Williams (1997), path length effectively becomes a proxy for drainage area. The increased stream power related to the orographic effect of the Maungaharuru Range as discussed in (Chapter 2) would also be severely underestimated by a simple area-power correlation. Exponential curves of the form in Equation 3.2 were automatically fitted to the profile curves (Figure 3.2). Fit statistics are given in Appendix F.

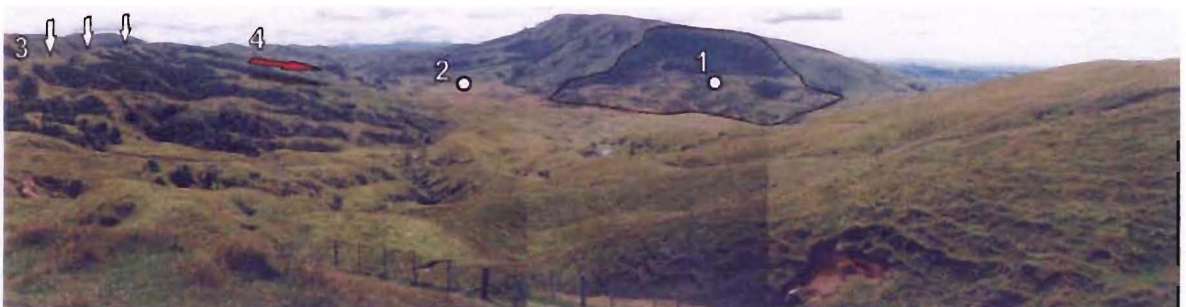
**Figure 4.9 View looking north into the basin on top of the Maungaharuru Range**

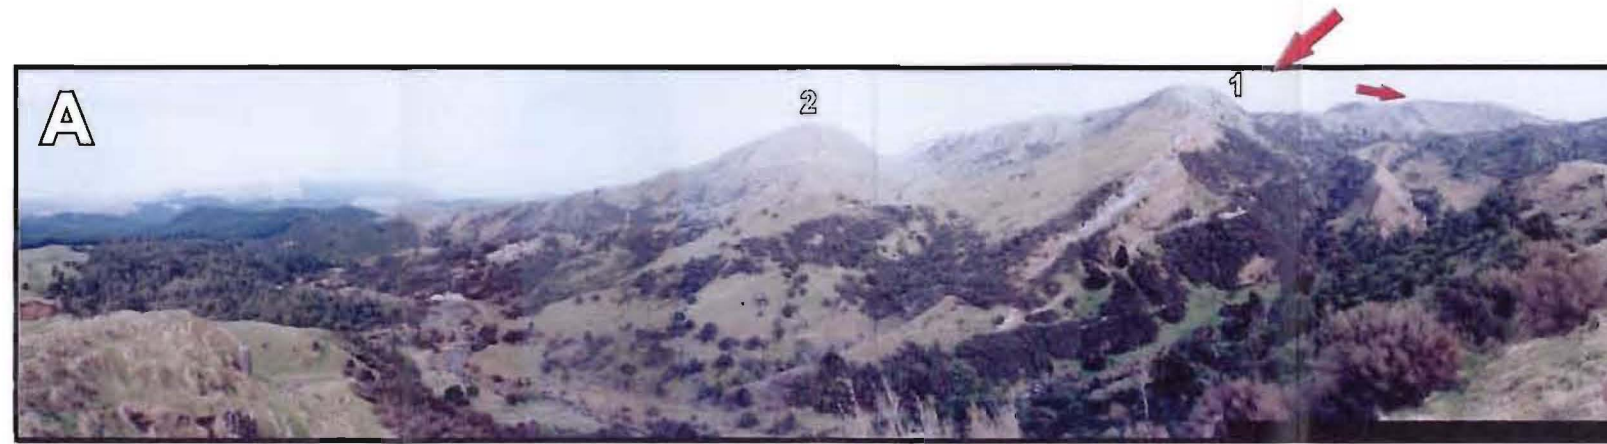
**Figure 4.11 Schematic of Maungaharuru Range Gravity Collapse**

**C** Shaded relief map based on 1:50 000 DEM. Section lines and photograph location are indicated. NZMG co-ordinates.

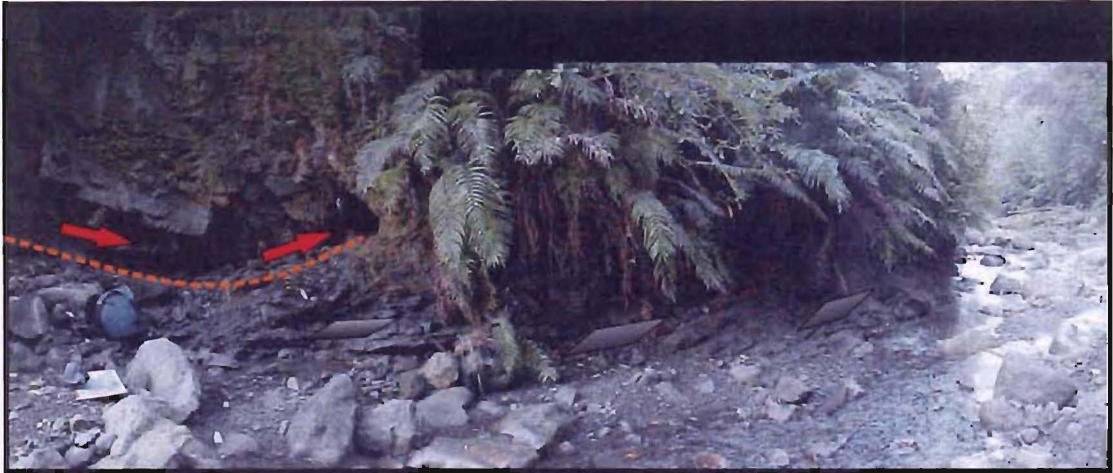
**Figure 4.17 Outcrop of Trelinnoe Slide failure surface in Kaiwaka Stream**

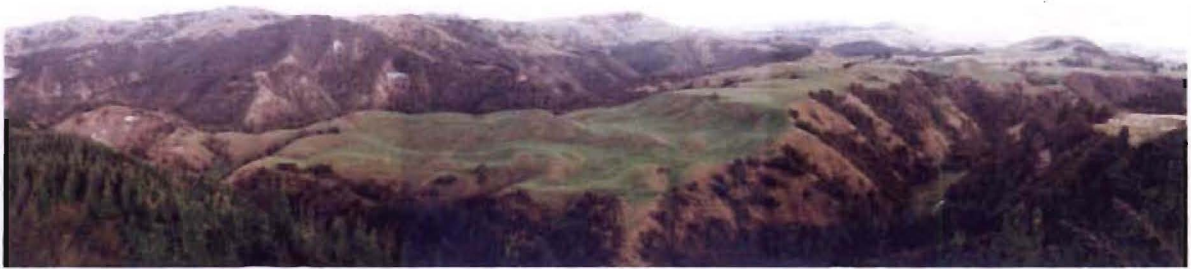
**Figure 4.18 Kaiwaka Landslide from Island Farm**

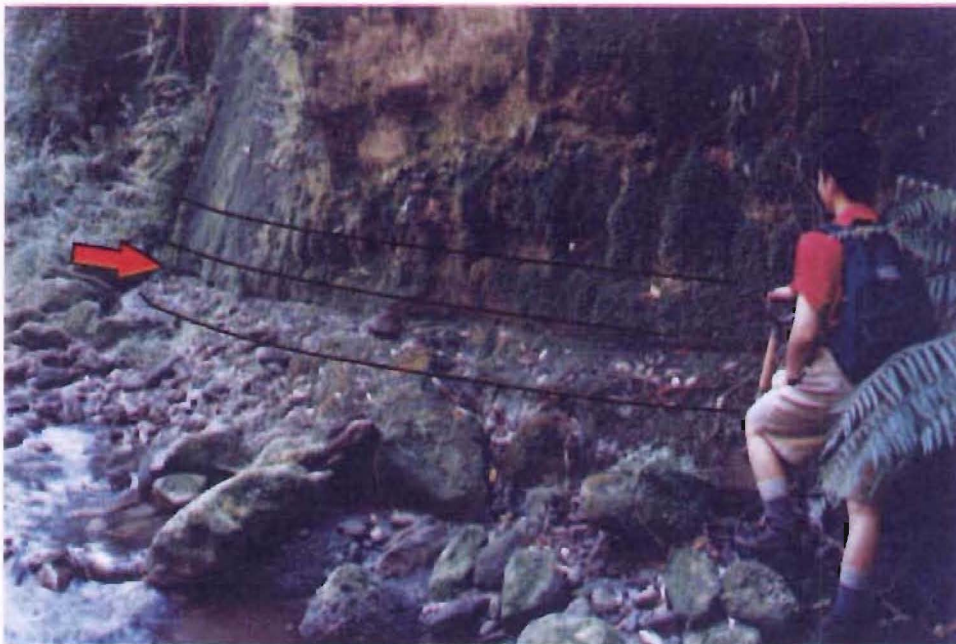
**Figure 4.24 Flexural shear defect sub-parallel to bedding**

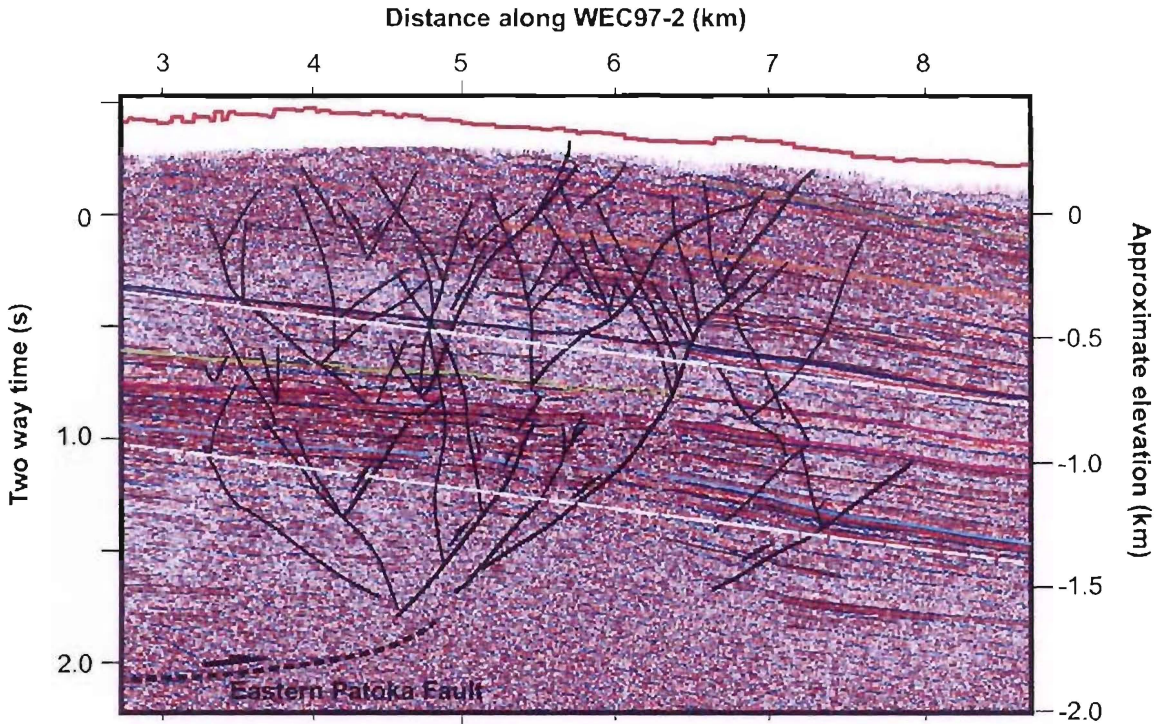
**Figure 5.2 Detail of WEC97-2 showing broad anticlinal structure, and diffuse fault zone above the Eastern Patoka Fault**

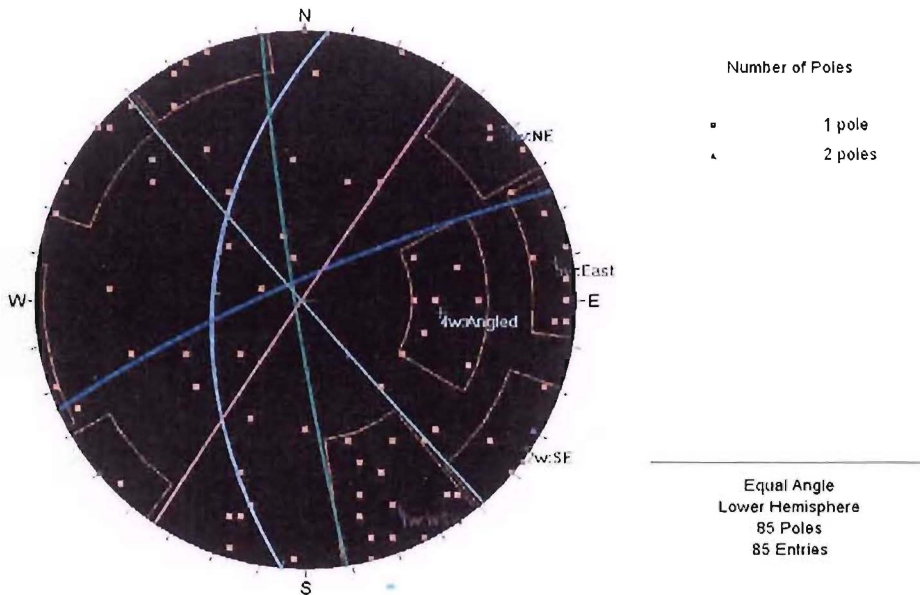
Figure H.3 Stereographic plot of defect poles

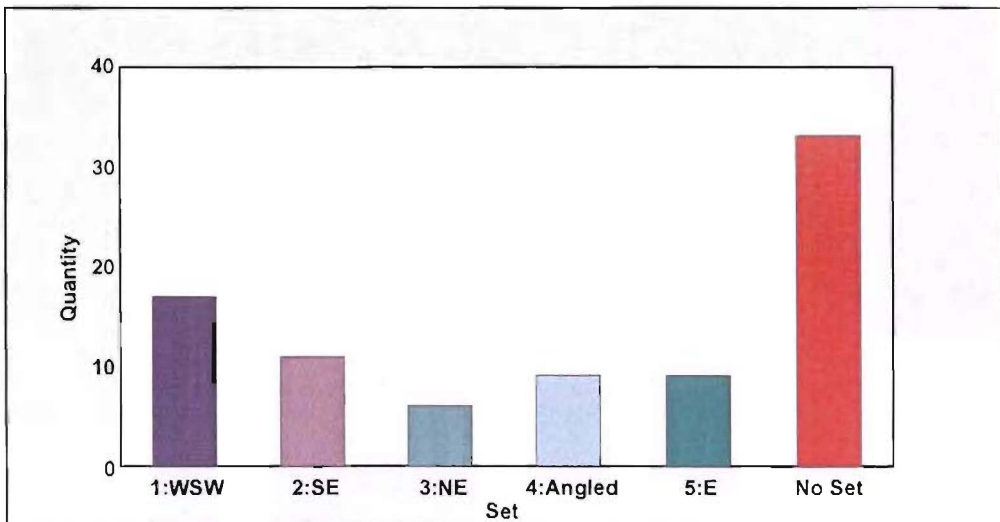
Figure H.4 Relative weightings of defect sets
