BIBLIOGRAPHIC REFERENCE

Sword-Daniels, V.; Wardman, J.; Stewart, C.; Wilson, T.; Johnston, D. and Rossetto, T. 2011. Infrastructure impacts, management and adaptations to eruptions at Volcán Tungurahua, Ecuador, 1999-2010, *GNS Science Report 2011/24*. 73 p.

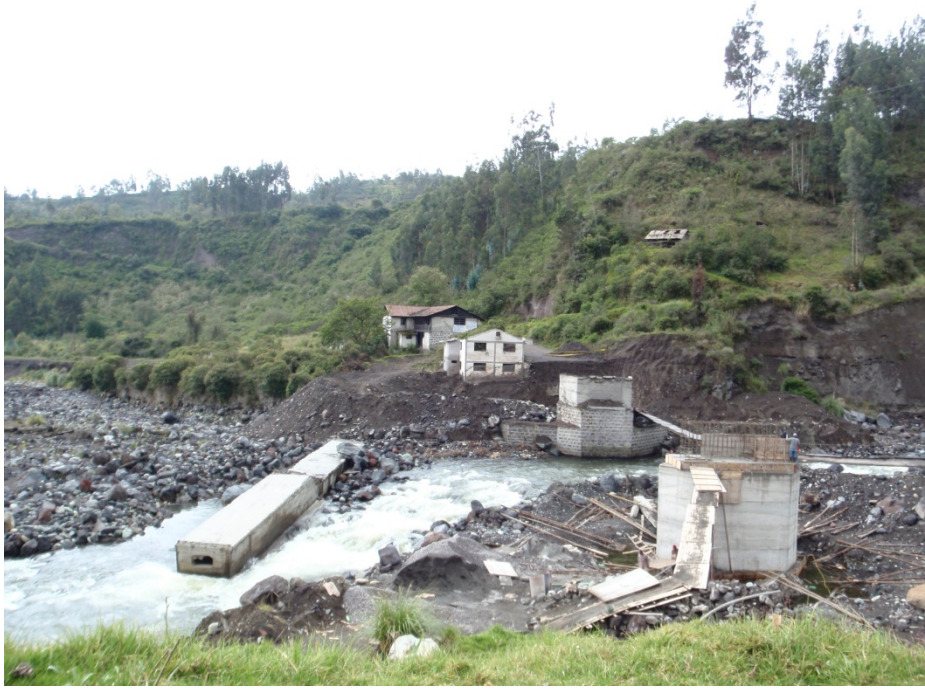
Figure 1 Bridge on Rio Palitahua washed out by lahar from Volcán Tungurahua, near settlement of Penipe, on direct route between Riobamba and Baños.

Riobamba's economy is heavily dependent on agricultural produce from surrounding rural areas. In recent years, direct road access from Riobamba to Baños has been heavily restricted following extensive lahar damage (Figure 1).

Several villages are dependent on this travel route for transporting goods and services elsewhere in the region. Plans to repair this road are indefinite.

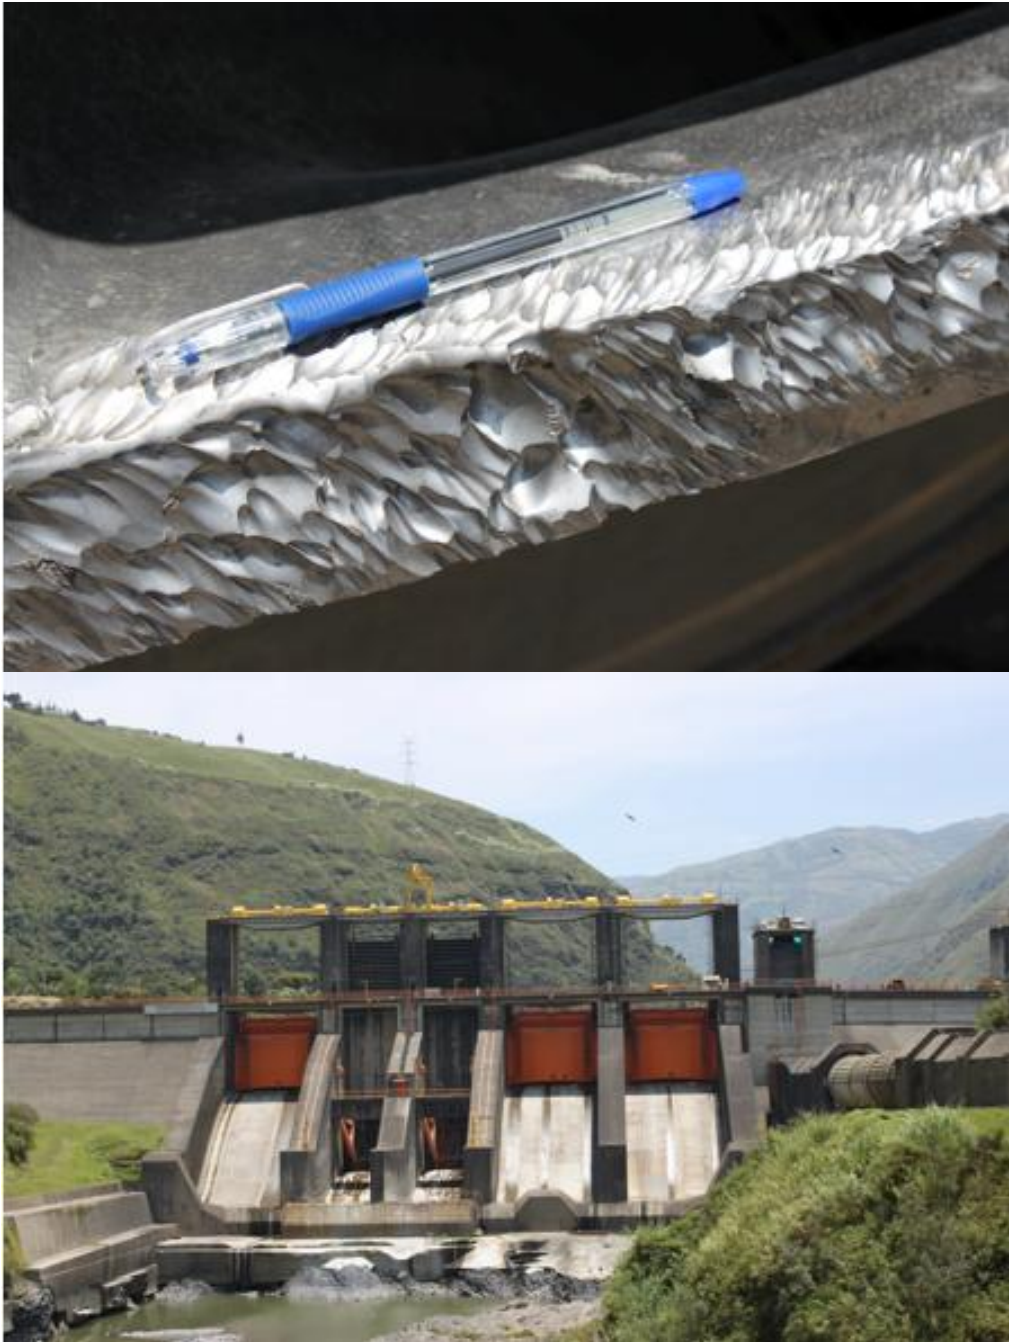
Figure 12 Above: a severely pitted turbine that has been removed from service. Below: the Agoyan Dam and its orange floodgates.

The lahar hazard from Tungurahua is more threatening to the Agoyan hydroelectric project than direct ashfall (an Agoyan Dam Operator). Intake mechanisms such as wicket gates, turbine covers and blades are particularly at risk of abrasion from ash-laden water. Severe pitting of the metallic components (Figure 12) has accelerated their degradation; Agoyan has had to replace four turbines in the last 21 years.

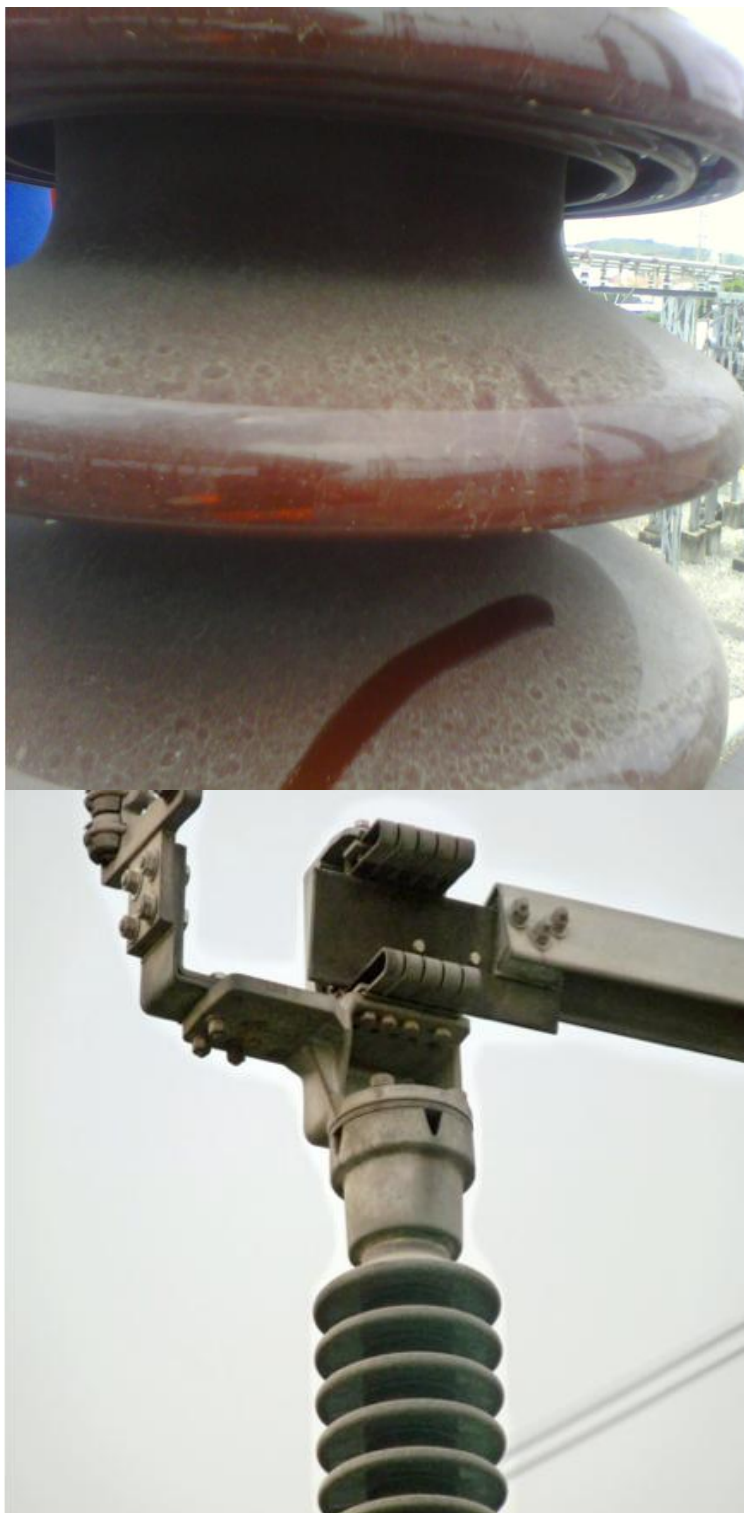
Figure 13 Above: 138 kV transformer bushing coated in 1-2 mm of fine-grained ash at a Guayaquil substation. Below: a contaminated disconnect switch. (Photos Courtesy of Transelectric, Ecuador).

Immediately following this ashfall, crews were dispatched to survey substations. Substations identified as most affected were cleaned to prevent ash-induced failure of high voltage equipment.

The Guayaquil substation (Pasquales) is of critical importance to the continuity of the power supply to the city, and it required the most attention from line maintenance and cleaning crews. During the cleaning process, all personnel were required to wear a mask and goggles. To avoid interruption to supply, the substation remained energised while insulated batons (rated for 230 kV) were fitted with brush heads and rags as the cleaning crew manually cleaned the surfaces of all substation equipment except for transformers (e.g. switches, bus bars, conductors, etc.). 'OMYA' brand ceramic cleaning detergents were used to aid in the primary cleaning stage (applied by rag or brush) before high-pressure power washers were brought in to thoroughly rinse away any remaining ash. To avoid permanent damage to the power transformers, each of the three transformer banks at the Pasquales substation had to be taken offline individually while these sections of the yard were cleaned. Only eight hours of total de-energized time was allowed by CELEC EP for this procedure. The substation was re-energized once drying of substation equipment (following high pressure washing) was complete. While remobilization of the ash was an inconvenience to substation workers for about a month following the initial ashfall, no further cleaning of equipment was required.

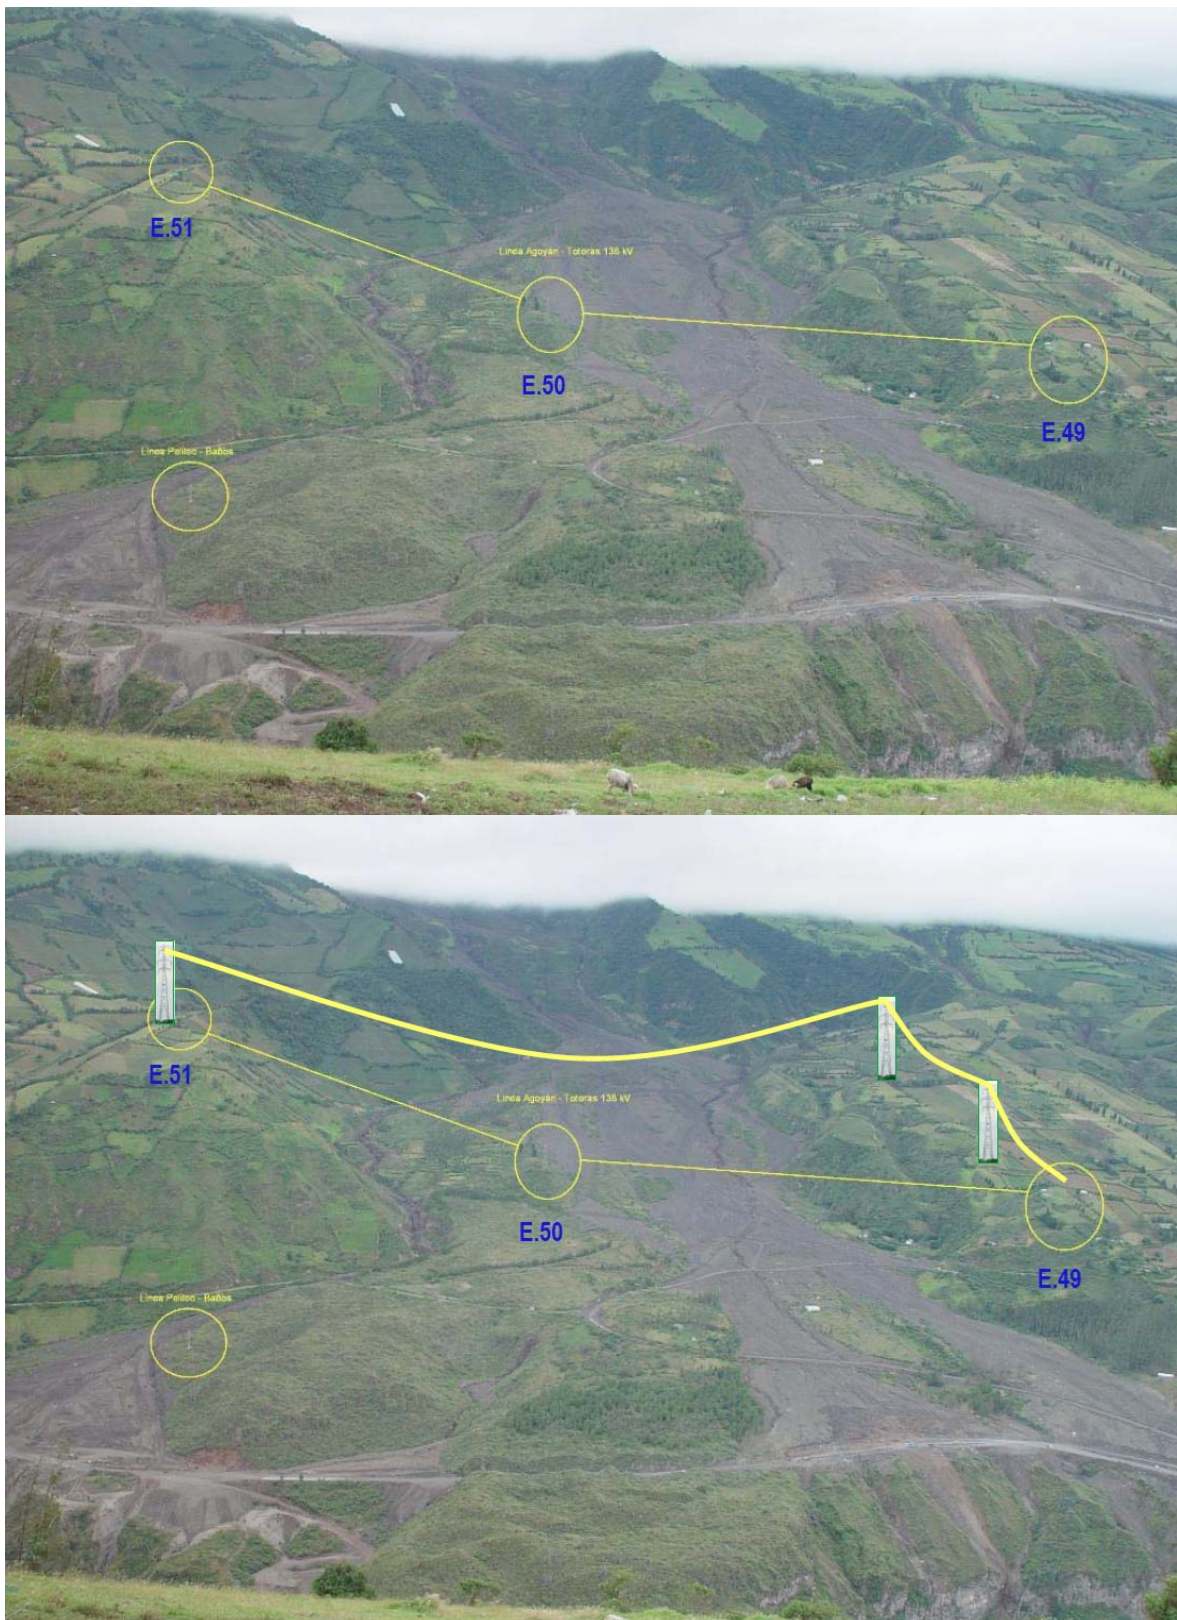
Figure 14 Above: 138 kV transmission tower (E50) situated in a 2006 lahar path. Below: Proposed re-design of the 138 kV transmission circuit showing relocation of towers and conductors (lines) to avoid lahars (Photo's courtesy of Transelectric, Ecuador).

Transmission equipment located on the northern flank of the volcano has had to be re-routed due to lahar hazards (Transelectric officials). Lahars in 2006 came within metres of a 138 kV transmission tower, initiating a plan by CELEC EP to relocate the tower to avoid future lahar-induced interruption to the high voltage supply around the volcano (Figure 14).

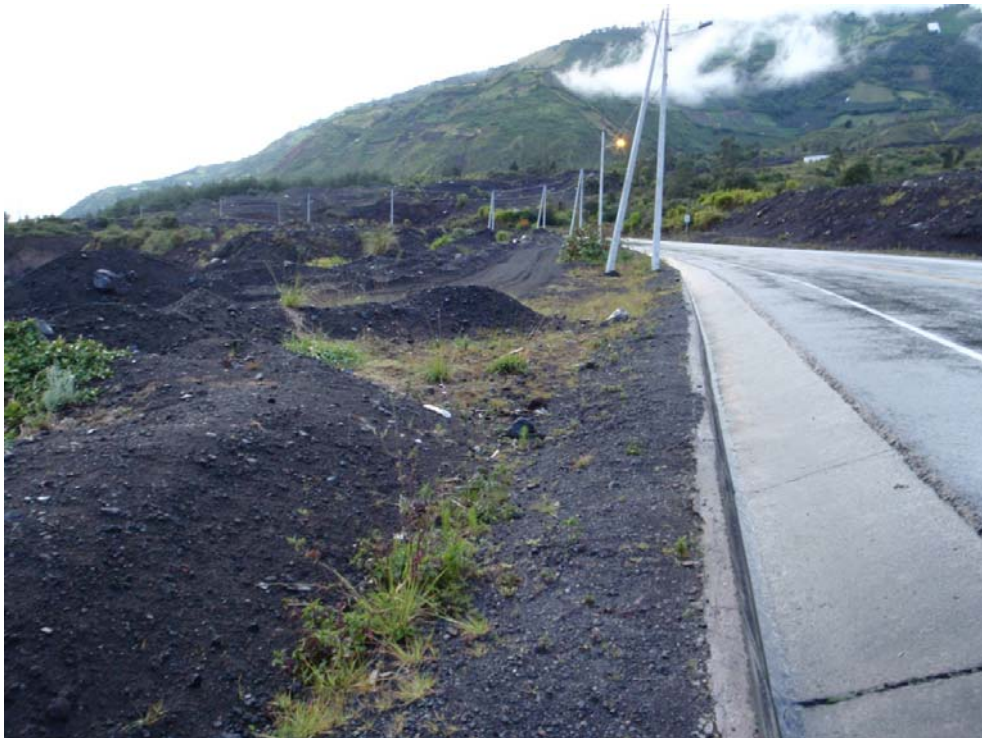
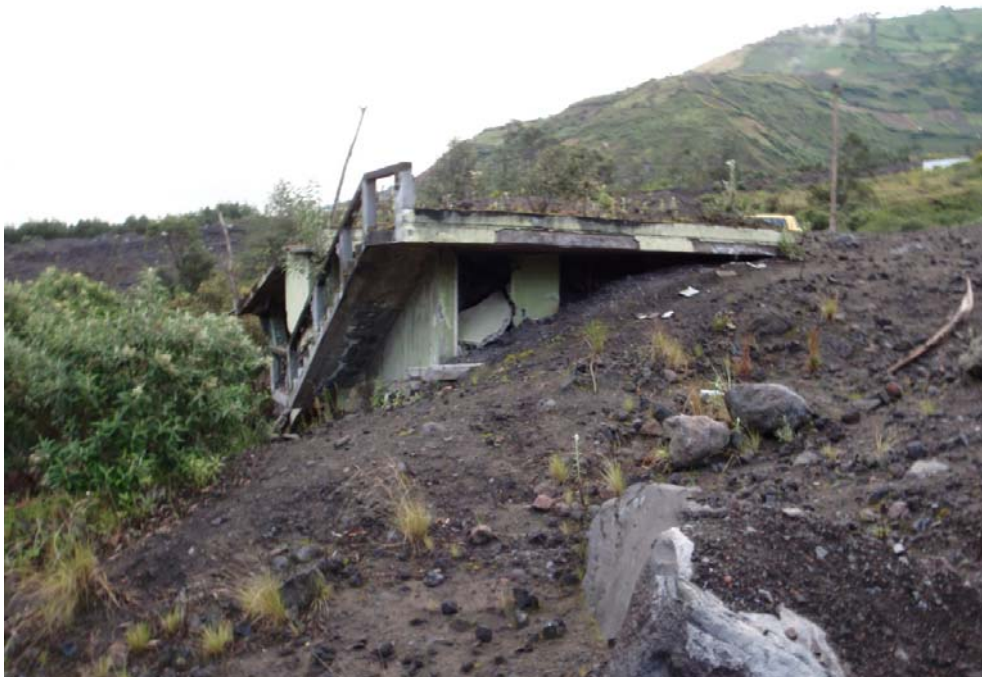
Figure 15 Area of lahar damage in Juive Chico, west of Baños (GPS 16). Upper photo: new section of road replacing lahar-damaged section. Lower photo: in same area, house buried by lahar deposits.

In general, ashfalls from eruptions of Volcán Tungurahua since 1999 have caused few problems for road transport networks. However, frequent lahars from Tungurahua have caused road and bridge washouts, particularly during the rainy season (February to September). During these months, heavy rains fall on the Ecuadorian highlands. These can entrain unconsolidated volcanic material deposited on the upper slopes of the mountain which can form lahars. Roads traversing the base of the mountain are particularly vulnerable. The road from Penipe to Baños was cut at the time of fieldwork as a result of mudflows. Another vulnerable location is the area called Juive Chico, immediately west of Baños. Major lahars in 2006 buried houses, covered the road and washed out a bridge (Figure 15).

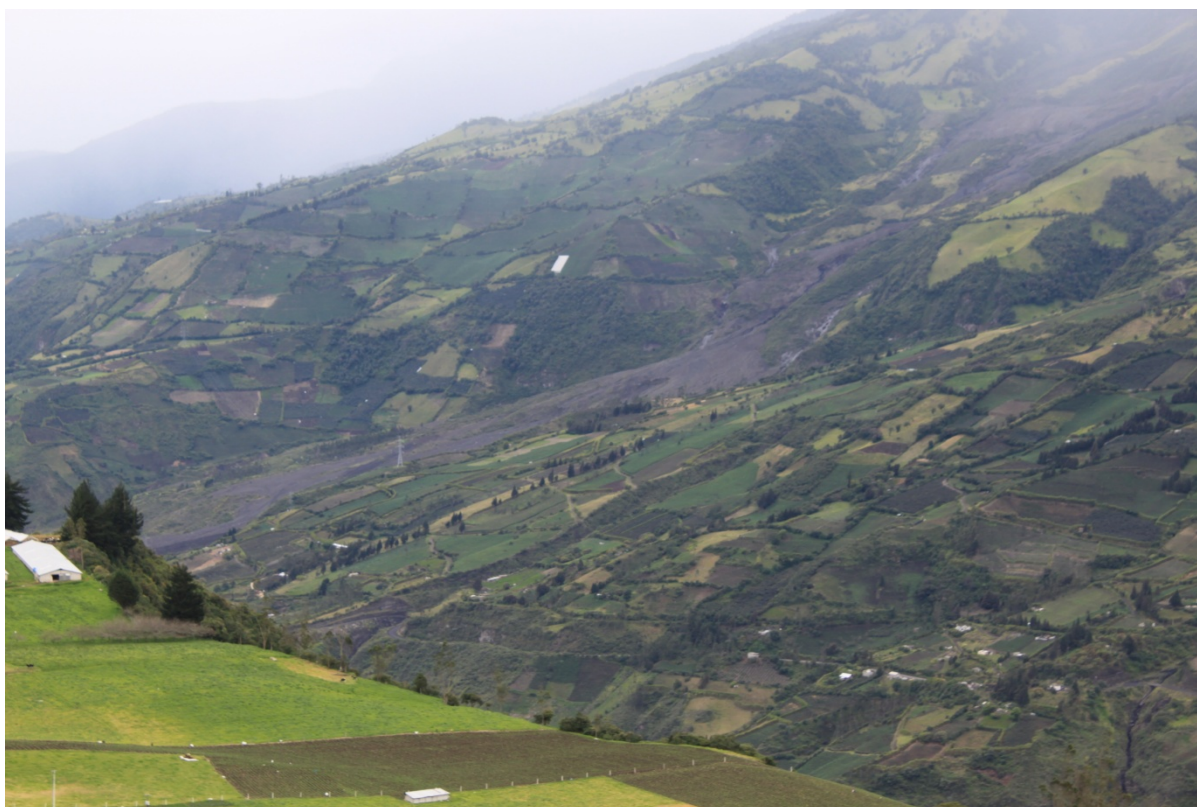
Figure 16 Intensive land use on lower slopes of Volcán Tungurahua (photo taken from near Cotaló).

Volcán Tungurahua is surrounded by high-density agricultural land (Figure 16). Locally-grown crops include maize, beans, potatoes and onions (these four constitute approximately 80% of the crops in the Tungurahua region), as well as citrus fruit, avocados, bananas, flowers, and sugar cane. Livestock activities include dairying and intensive chicken farms (Leonard et al., 2005). Most farms are smallholdings (80-90% of farms in the region are estimated to be less than 10 ha).

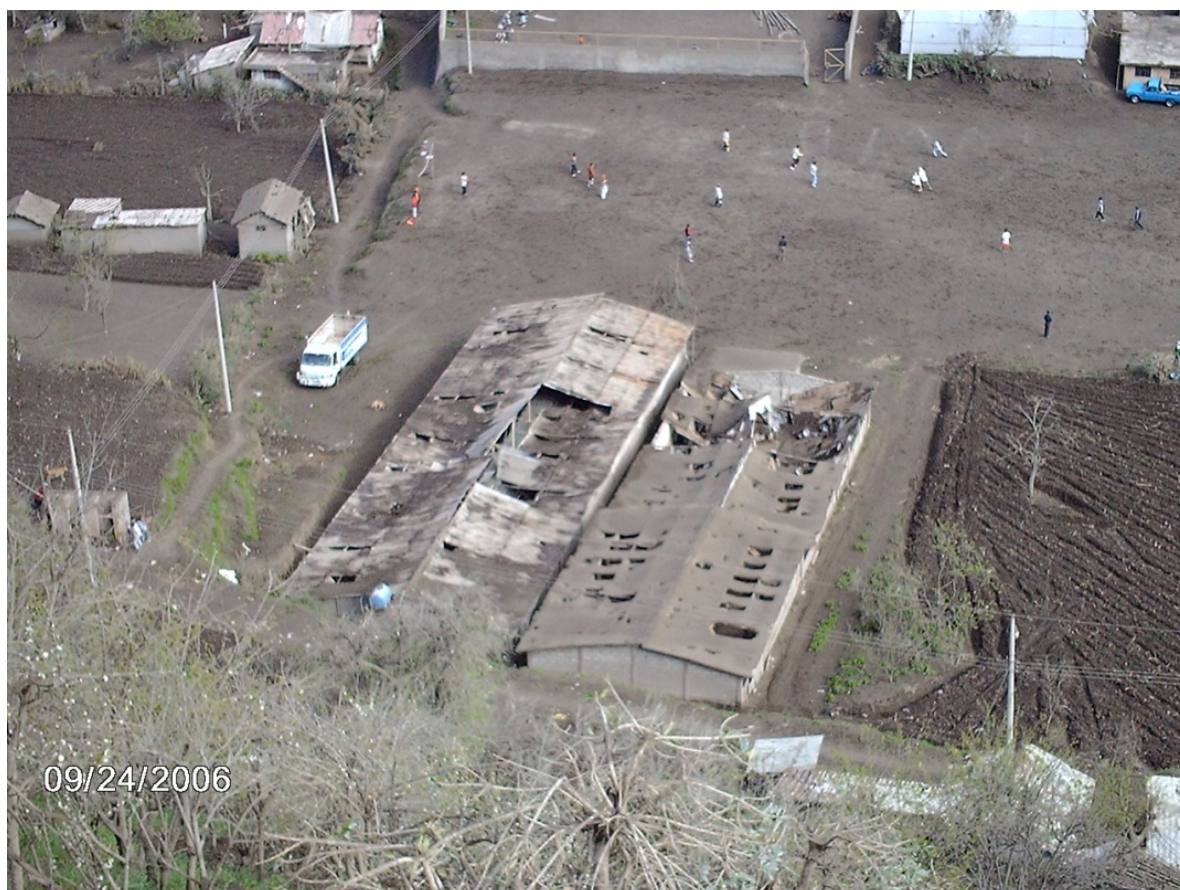
Figure 19 Ballistic block damage to shed roof, Cotaló, 2006 (photo courtesy of Carlos Fernando Perez).

Local people estimated that 20-40 cm of ash was deposited in Cotaló during the 2006 eruptions. Incandescent blocks also fell on the village, and caused major damage to roofs, and building collapses (Figure 19 and Figure 20). A local farmer estimated that 50% of roofs in the town were damaged and needed to be replaced. She also mentioned that the ashfall caused some corrosion damage to roofs.

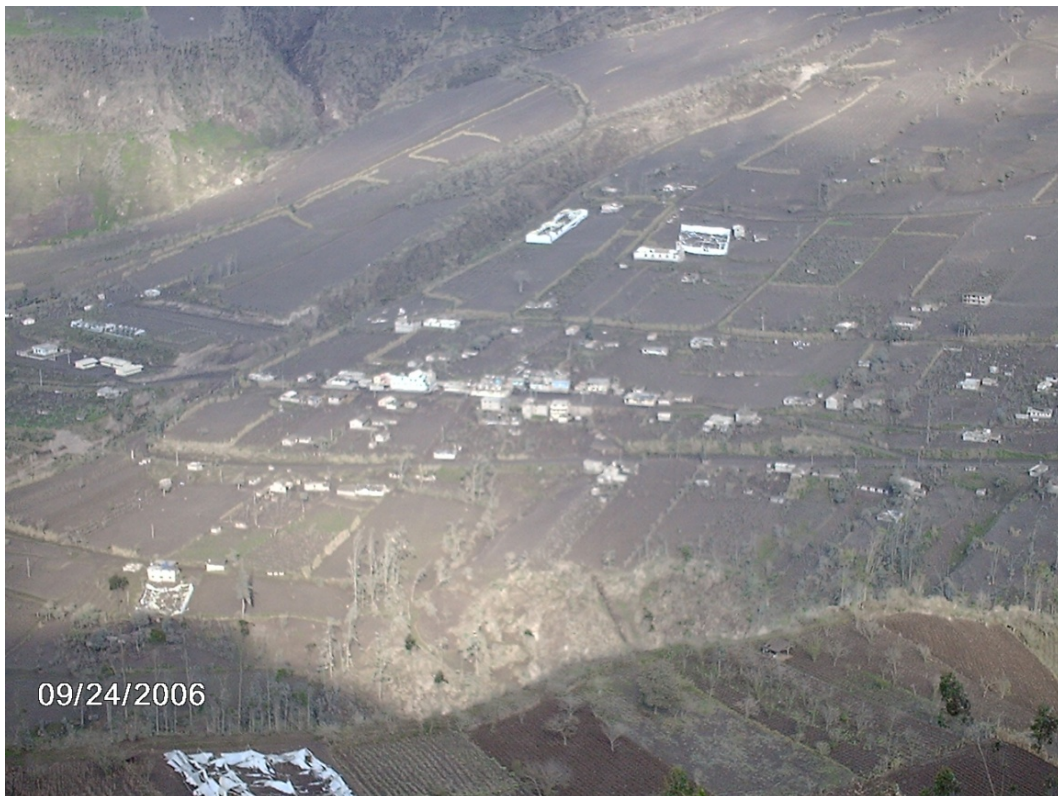
Figure 20 Ashfall on ground, Cotaló, 2006 (photo courtesy of Carlos Fernando Perez).

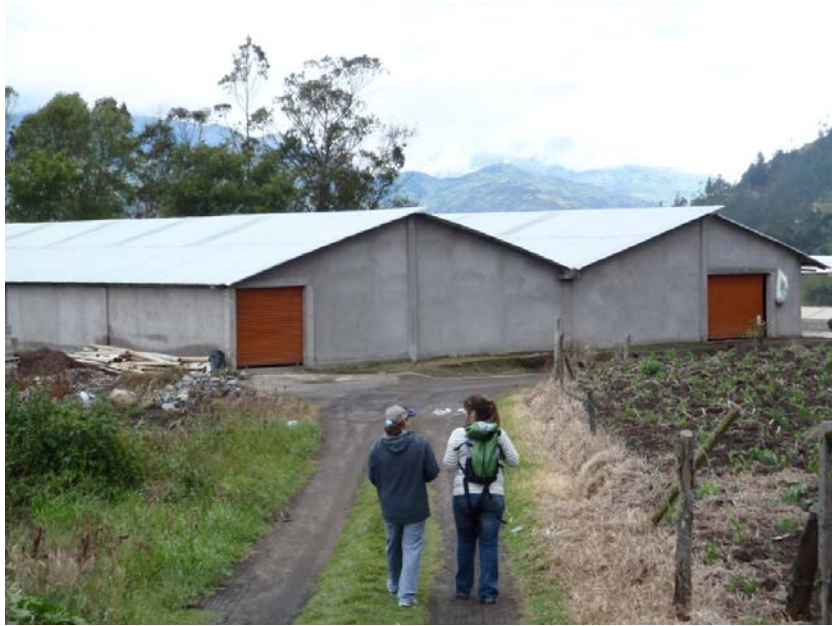
Figure 21 New sheds (rebuilt after 2006 eruption) housing chicken farm, Cotaló.

This farmer suffered a 60% loss in income for the year following the eruption. This was mostly due to the costs of repairing the buildings, and the disruptions caused by having to clean all the debris out of the sheds. They had to survive on their savings, but were 'back on their feet' by 2008. There were no loans available from the government to help rebuild.

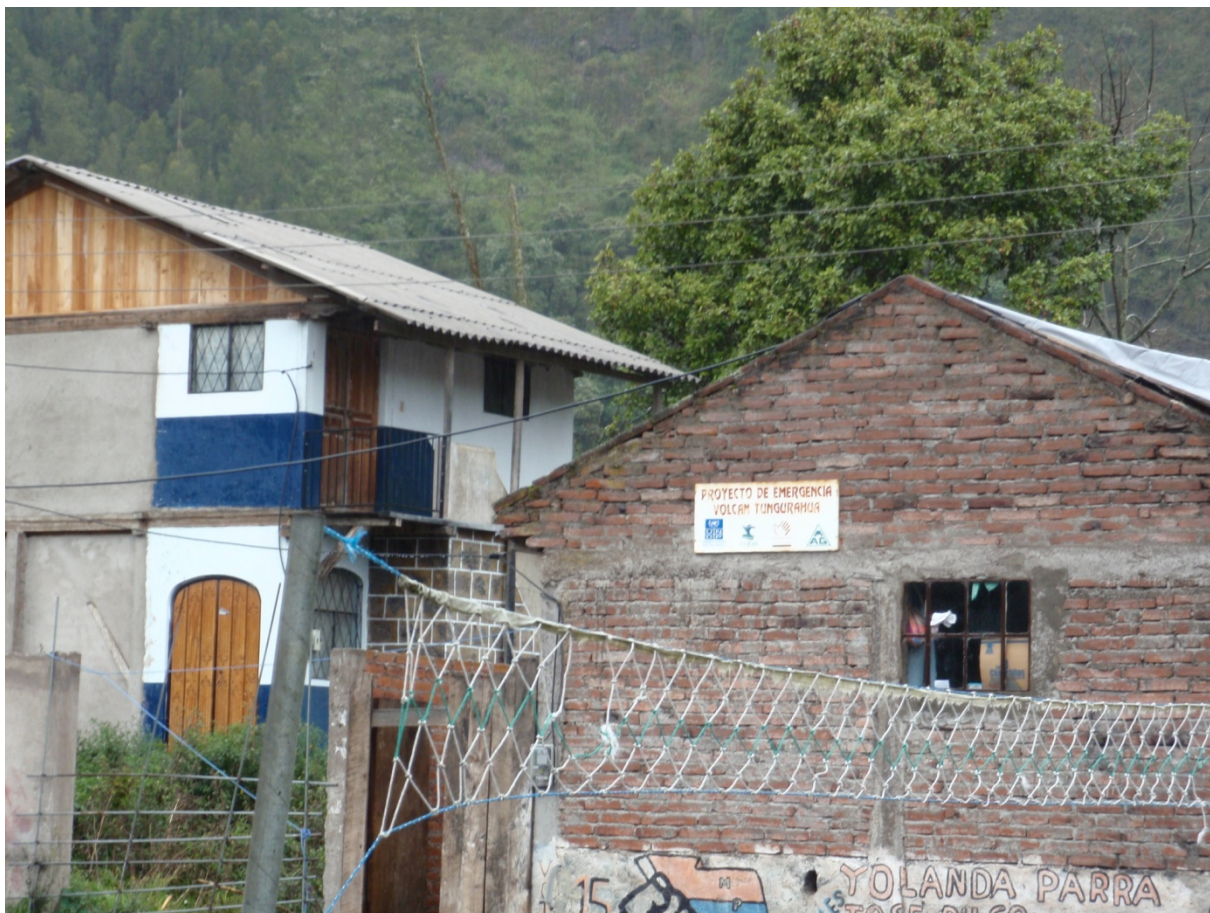
Figure 23 Emergency shelter near Penipe, Tungurahua area.

Since the reactivation of Volcán Tungurahua in 1999, emergency shelters have been set-up in safer areas, close to the communities at risk. The shelters provide food, a place to sleep, and are visited by medical professionals to provide basic medical care, medicines and psychological support. A photograph of a shelter near Penipe is shown in Figure 23.

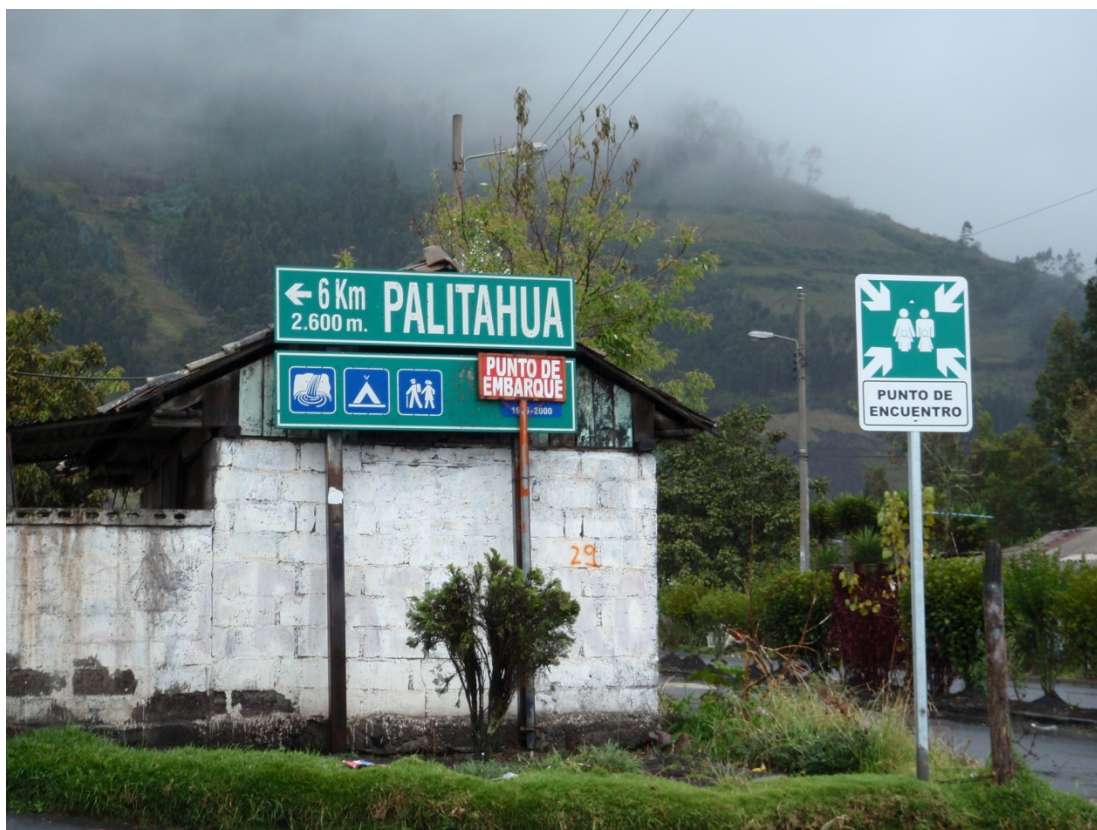
Figure 24 Emergency muster point signage in Penipe.

The National Secretariat has organized signs and evacuation routes to inform local populations where the nearest shelters are located in emergencies (see Figure 24 and Figure 25).

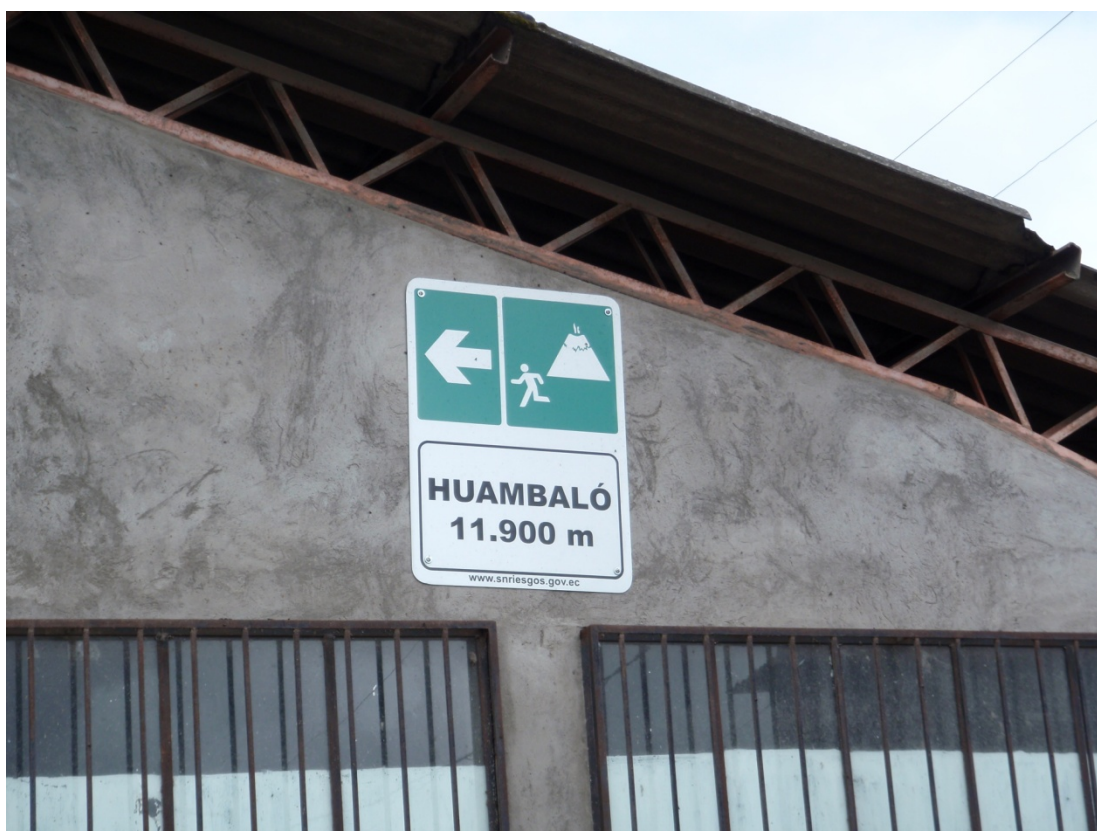
Figure 25 Evacuation route signage in Cotaló.

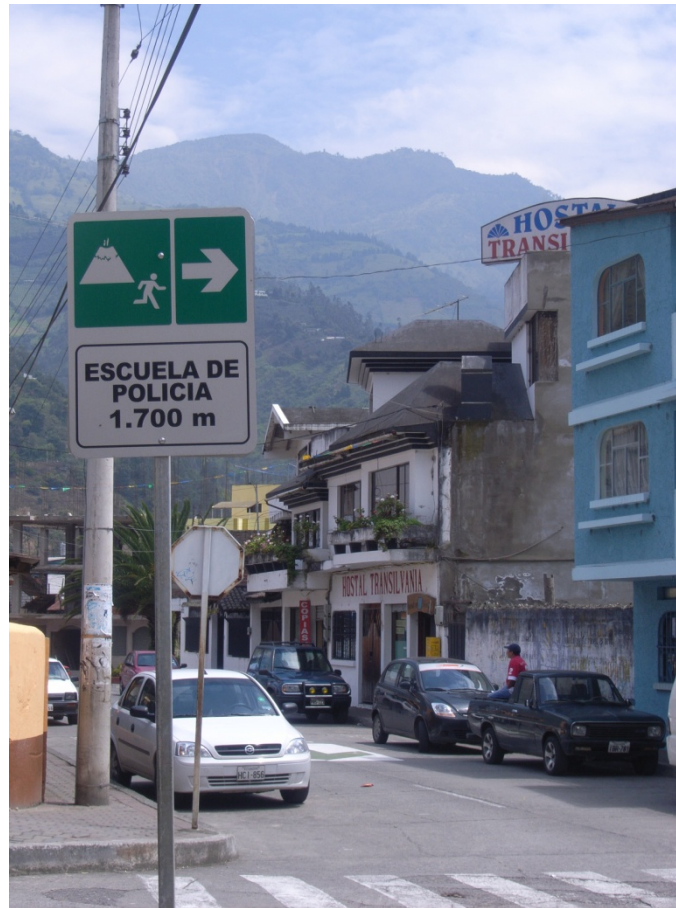
Figure 26 Signs marking the routes to emergency shelters, taken in Baños (September 2010).

In general the evacuation routes are clearly marked with signs and road markings throughout the city, although many shelters are some distance from the town at more than 2 km away. A photograph taken in Baños of the routes to emergency shelters is shown in Figure 26. Drills are also carried out in the town to ensure that people are practiced in emergencies.

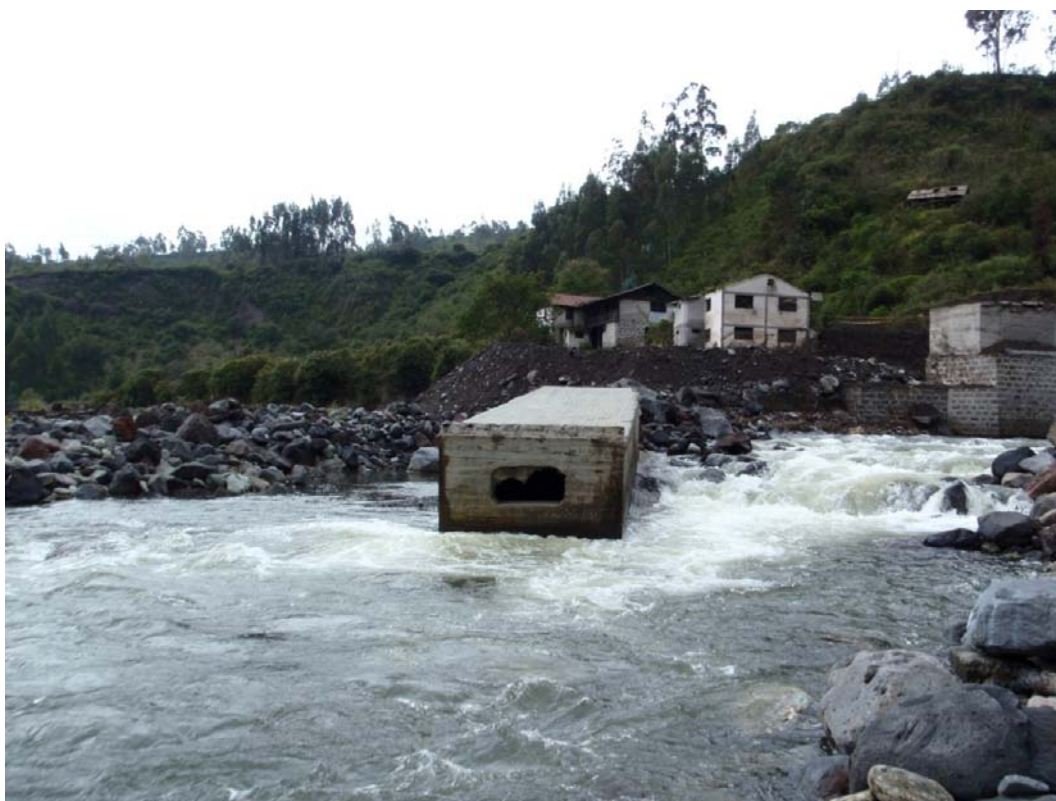
Figure A1 Rio Palitahu (GPS 2)

GPS	Location	Description	Date sampled	Temperature	pH	Conductivity	Turbidity
				°C		μS/cm	NTU
2	1° 31' 11.0" S 78° 29' 27.4 " W	Rio Palitahu a	15/9/2010	12.1	7	109.5	4.3
15	1° 24' 21.6" S 78° 25' 58.7 " W	Rio Vascún	16/9/2010	17.4	7.5	884	24.6
19	1° 24' 3.7" S 78° 24' 1.14 " W	Rio Chama na	17/9/2010	15.7	6.4	57.9	3.6
20	1° 23' 44.5" S 78° 23' 57 " W	Rio Ulba	17/9/2010	14.5	6.8	154	6.6

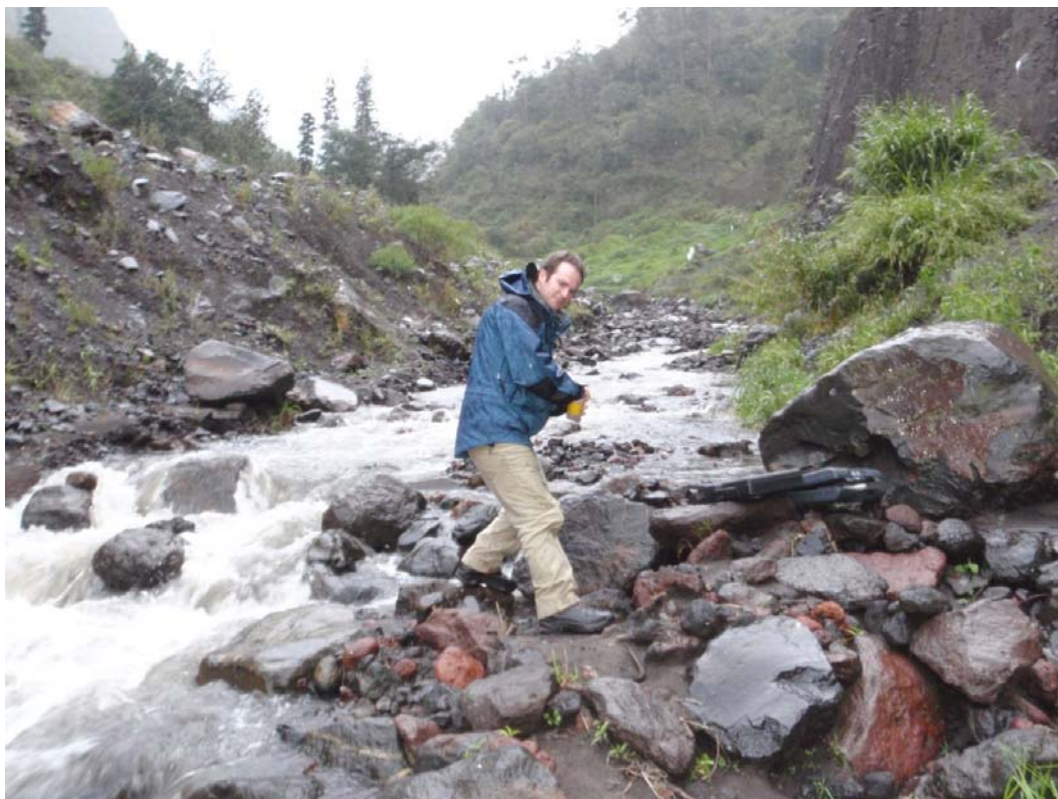
Figure A2 Rio Vascún (GPS 15)

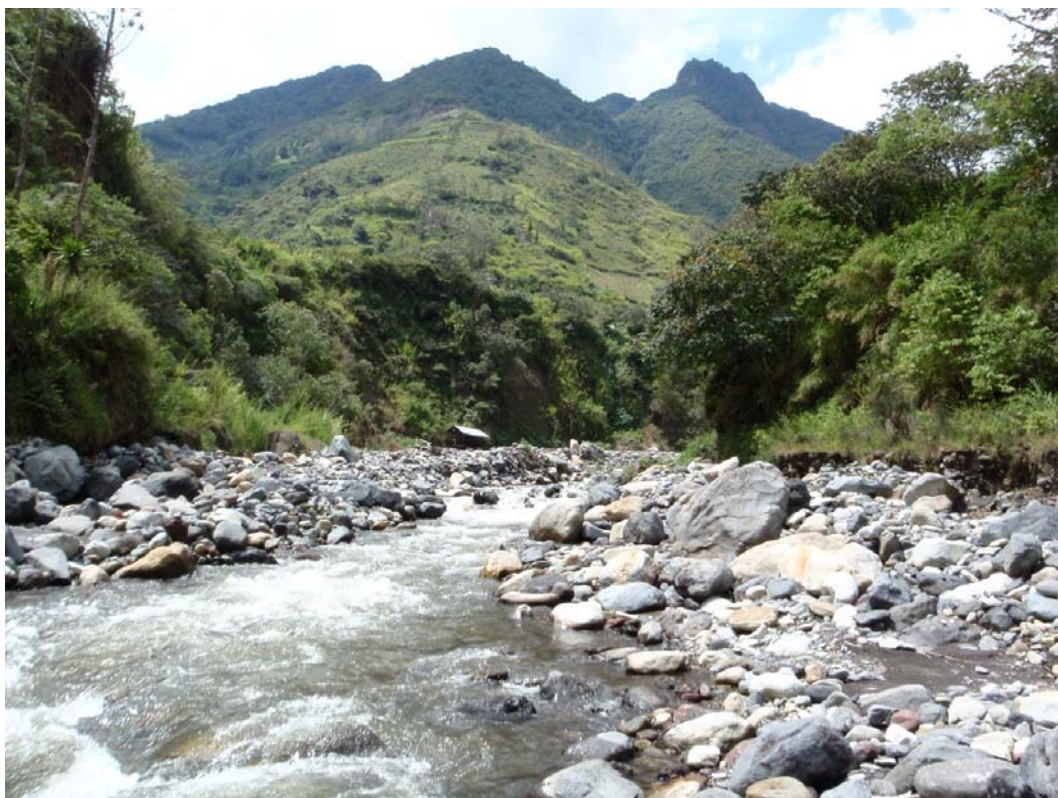
Figure A3 Rio Chamana (GPS 19)
