The Impact of the 22nd February 2011 Earthquake on Christchurch Hospital

2012
NZSEE
Conference

3 PHYSICAL AND FUNCTIONAL IMPACT OF THE CHRISTCHURCH HOSPITAL

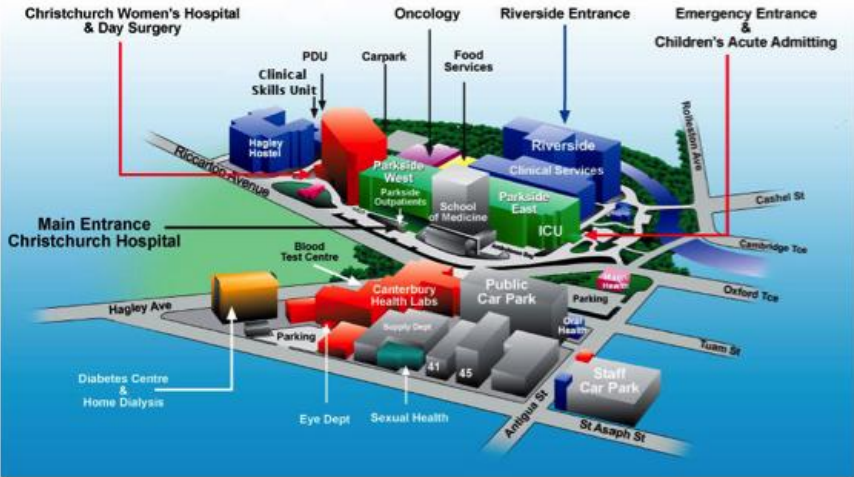
Figure 1. Layout of Christchurch Hospital

Christchurch Hospital is the largest hospital in the Canterbury Region and the centre of the region's healthcare system. Christchurch Hospital operates the only Emergency Department (ED) and Intensive Care Unit (ICU) in Canterbury and performs the majority of elective surgeries. The hospital serves the geographically largest health district (CDHB) in New Zealand, which includes a population of 560,000. The inpatient wards provide services to over 35,600 inpatients each year, of which approximately two-thirds are admitted acutely; a further 13,000 people are day patients. There are 16,000 theatre visits each year and over 197,000 outpatient attendances, excluding those for radiology

and laboratory services. The hospital operated 600-650 beds before the earthquake (Table 2), including 15 ICU beds, 18 high-dependency beds, and 9 step-down beds. Before the earthquake, the hospital typically operated at around 98% occupancy with a 48% admission rate from the ED to other wards. The hospital complex, shown in Figure 1, is made up of several buildings constructed during different time periods using concrete-shear-wall or reinforced-masonry construction. The buildings on the hospital campus include the Parkside Building (built in late 80s to early 90s), the Riverside Building (built in the 1970s), the Nurses Hostel (built in 1931, vacant prior to earthquake for scheduled demolition), the Diabetes Centre (built in late 1950s and early 1960s), and the Christchurch Women’s Hospital (built in 2005). The Christchurch Women’s Hospital (CWH) is the only base isolated structure on the South Island. The clinical buildings are bordered by the Avon River and Riccarton Avenue and are adjacent to Christchurch’s CBD.

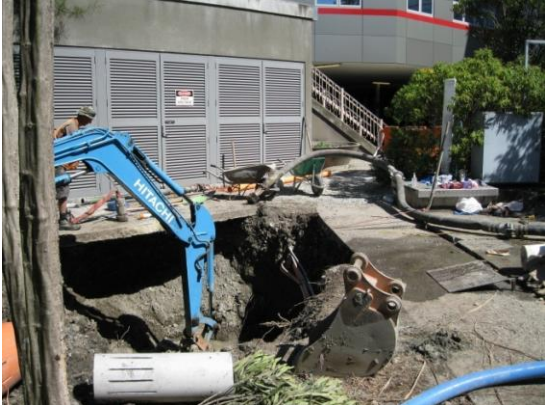
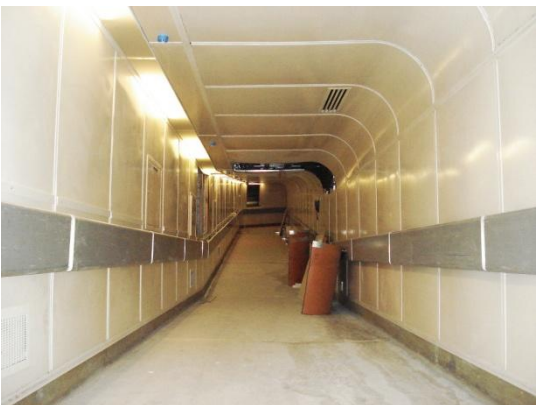
Geotechnical failures caused widespread damage to the hospital campus. For example, liquefaction caused flooding in the basements of all the buildings, including the Women’s Hospital. The Parkside and Riverside buildings suffered the worst flooding. All the retaining walls between the river and the hospital failed, and the lateral spreading near the river caused severe damage to sewage lines (Figure 1a). Additionally, the tunnel that connects clinical facilities and non-clinical facilities across Riccarton Avenue was knee-deep in water after the earthquake.

There were no catastrophic structural failures (i.e., local or global collapses) to any of clinical or non-clinical buildings of Christchurch Hospital that were operating at the time of the 22nd February earthquake. However, severe structural damage did cause some forced closures. For example, the underground tunnel carrying lifelines running below Riccarton Avenue was still unusable at the time of interviews (Figure 1b).

Figure 1. Observed damage throughout hospital campus: a) liquefaction-induced damage to the main sewer line, and (b) damage to Riccarton underground tunnel (photo credit, Alan Bavis).

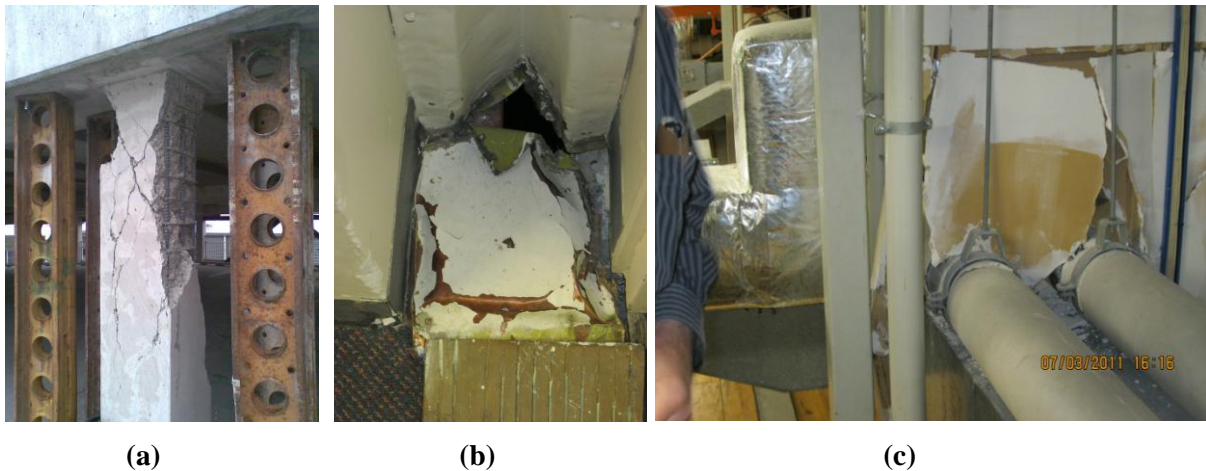
damage to the connection of the roof to the walls. The hospital's parking structure did experience extensive structural damage, including spalled concrete of its beams and columns and cracking of its steel bracing. The cost to repair the parking structure's damage is estimated to be NZ\$2 million. Figure 2a shows damage to concrete columns on the ground floor of the parking structure.

There was also widespread evidence of minor to moderate structural damage in several other buildings, including the Riverside Building, some non-clinical buildings, and the hospital's boiler stack. The Riverside Building, for example, suffered shear wall cracking, where some of these cracks went all the way through the wall. All clinical buildings suffered roof damage. Also several buildings experienced damage across separation joint and firewalls. Figures 2b and 2c show examples of damage found on the Christchurch Hospital campus, including damage to at a separation joint in the Riverside Building and damage to a firewall in the CWH, respectively.

Figure 2. Observed structural damage in non-clinical and clinical buildings: a) spalled concrete in ground-floor column of a parking structure, b) separation joint damage in Riverside Building, and c) damage to firewalls in the CWH (photo credit, Alan Bavis).

In AS/NZ 1170.0 (SNZ 2004), critical facilities like hospital buildings are categorised with importance Level 4. The code provisions require that the buildings remain operational, particularly under 500 year serviceability limit state, SLS2, earthquakes (Uma and Beattie 2010). Christchurch Hospital buildings were designed and built as predominantly rectangular buildings with no L- or T- shaped structures, no abrupt discontinuities along the height of the buildings, and no large overhangs. The lack of these building features, along with the presence of separation joints in most buildings, and the base isolation of the CWH likely mitigated structural damage. Additionally, several older buildings on campus had been seismically upgraded before the earthquake. Those with retrofits only suffered cosmetic damage.
