SLOPE FAILURE IN LOESS
A
DETAILED INVESTIGATION
ALLANDALE, BANKS PENINSULA

A
Thesis
submitted in partial fulfillment
of the requirements for the Degree
of
Master of Science in Engineering Geology
in the
University of Canterbury
by
Stefan Goldwater

University of Canterbury
1990

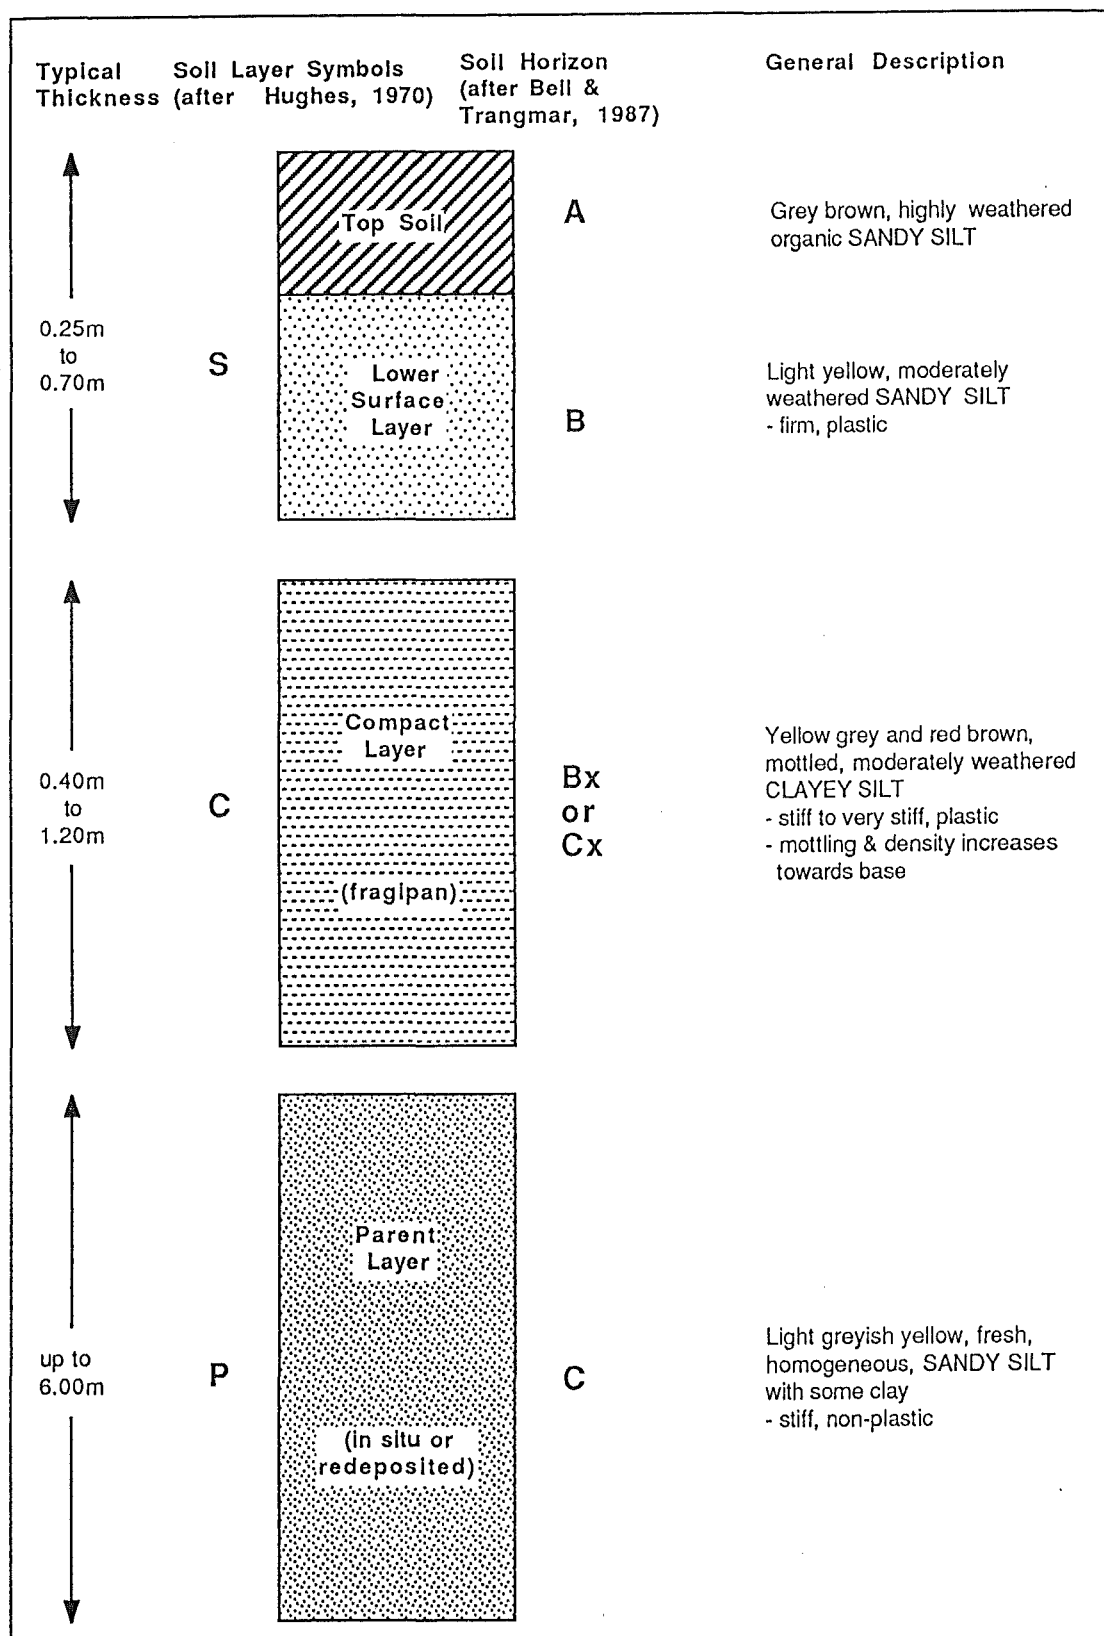
The surface (S) layer consists of top soil that grades into a moderately weathered sandy silt. Underlying the surface layer is the compact (C) layer, generally plastic, mottled clayey silt (relatively higher clay content than S and P layer loess). The compact layer typically exhibits vertical joints with associated gamma-ray and mottling zones (Griffiths, 1973). Selby (1976) calls the compact layer the fragipan, and suggests that it originates from seasonal drying, which causes cracking of the subsoil and subsequent infilling by loose material. The following wet season causes the loess to swell and compact the soil. Underlying the compact layer is the parent (P) material which, in contrast to the overlying layers, is a non-plastic homogeneous silt.

Figure 2.7 Pedogenic Layering that Develops in Banks Peninsula Loess

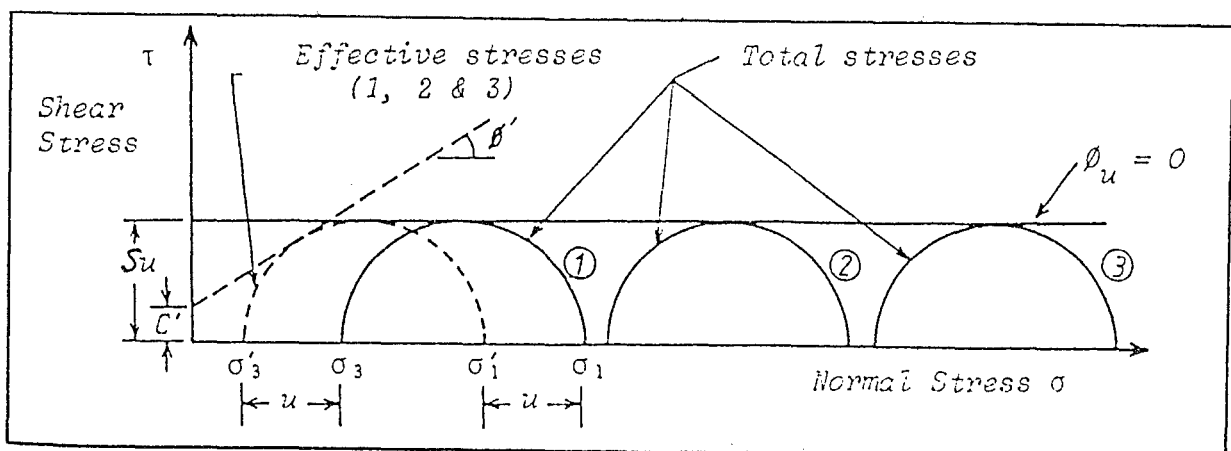
Figure 2.11 Mohr Stress Circles for Undrained Tests on Saturated Cohesive Soil (after Miller, 1982)

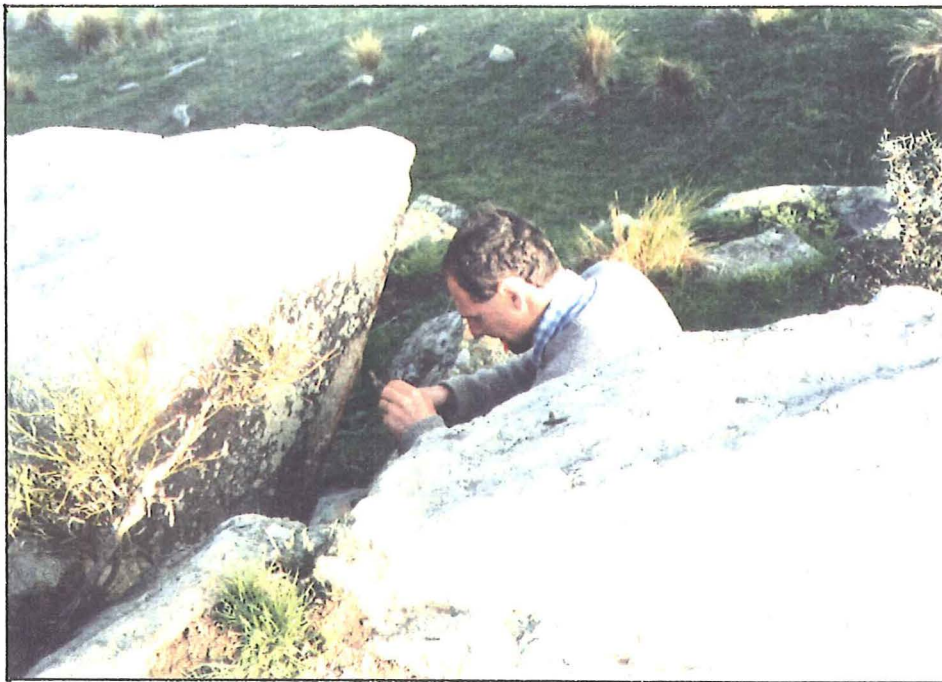
Figure 3.3 Columnar Jointed Rhyolite- Outcropping at Crest of Hillslope

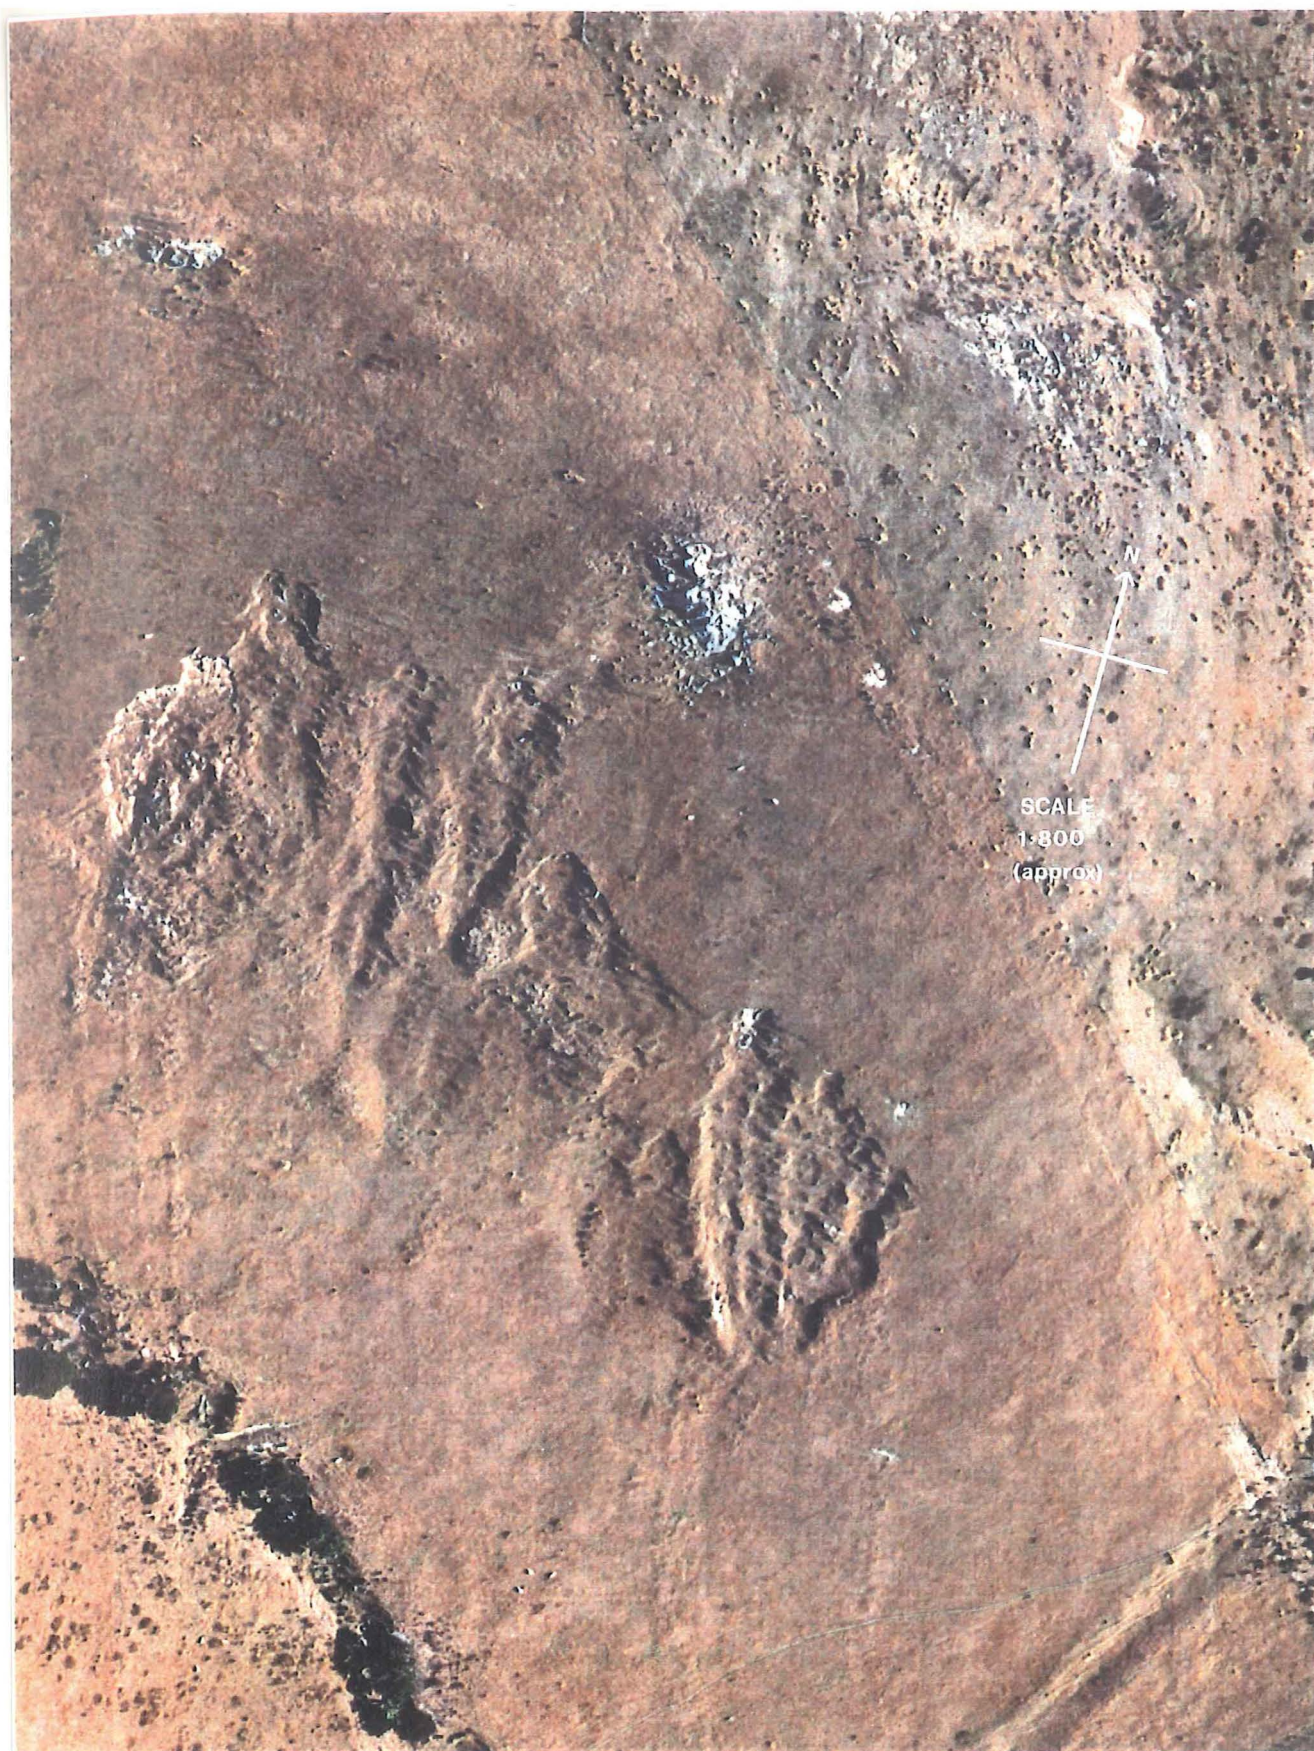
Figure 3.5 Vertical Aerial Photograph of Southeast Facing Slope Failure Complex

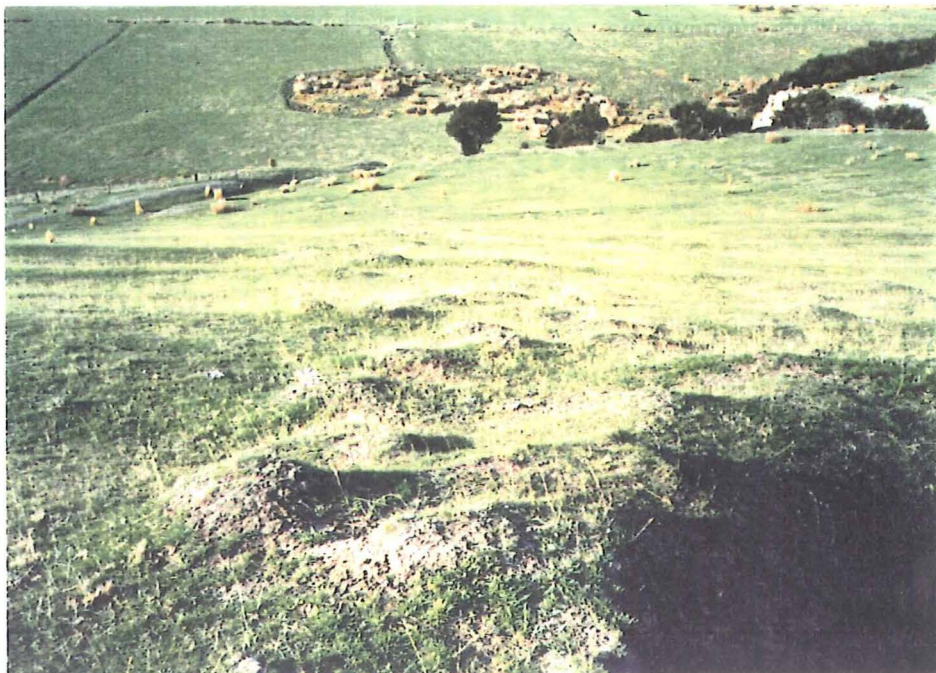
Figures 3.6 and 3.7 show the effects of erosion on the flow deposits that have come to rest on the hillslope. The smooth hummocky appearance of the older eastern-most flow deposits (figure 3.6), contrast considerably with the angular appearance of the younger western most flow deposits. The erosional action of water through time is the most probable cause of this. Figure 3.12 shows the smoothed slope features and the incised drainage channels within the failure complex resulting from the erosional action of surface runoff water.

Figure 3.6 Slope Deposit Trailing from Flanks of Failed Ground- photograph taken from the downslope portion of the eastern flank of the investigated failed ground complex.

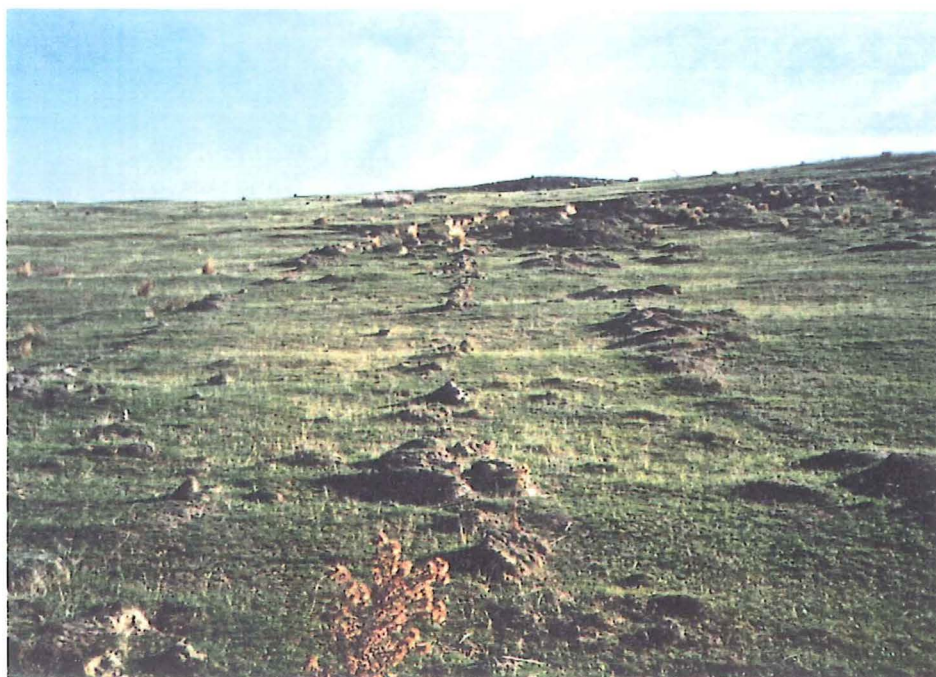
Figure 3.7 Slope Deposits below Western Portion of Failed Ground Complex- looking upslope towards western extreme of failed ground complex.

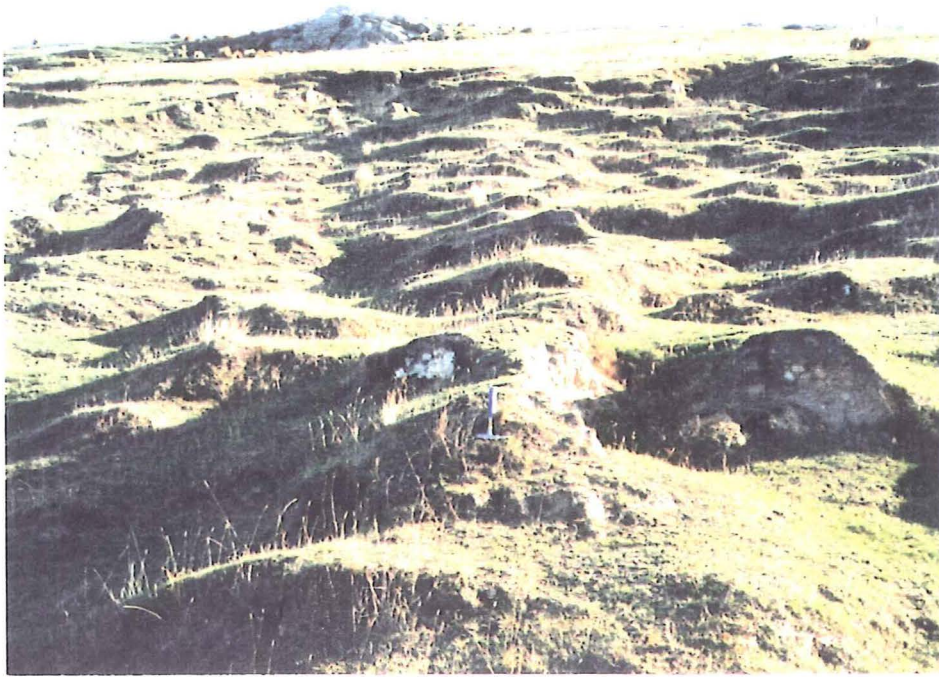
Figure 3.9 Terracette like Slump Features within Investigated Failed Ground- looking upslope.

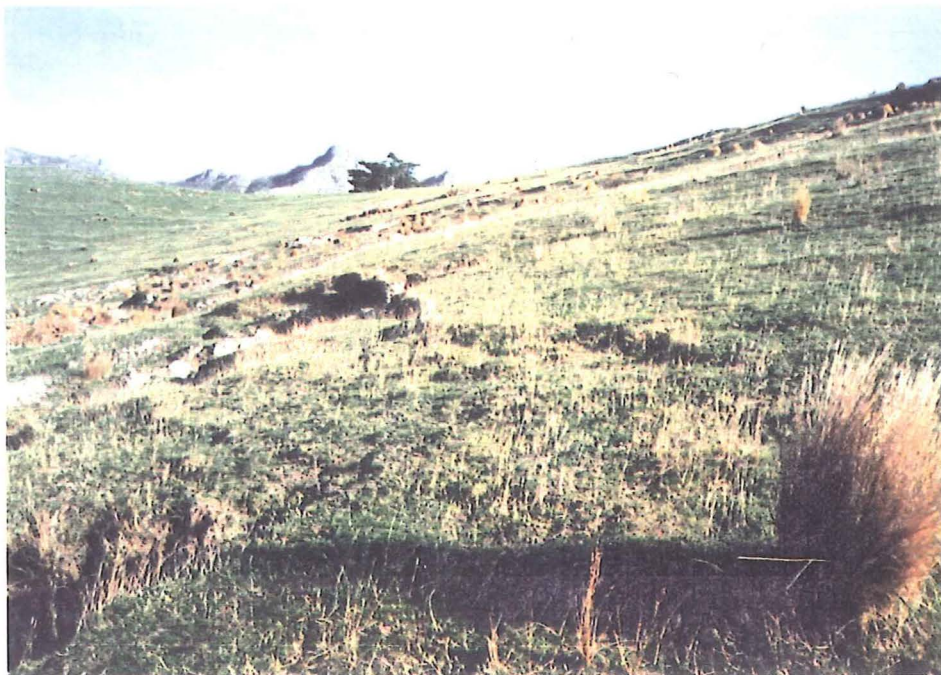
Figure 3.10 Slump Block- upper western corner of investigated failed ground. Note soil creep features in top left hand corner of photograph.

Raised ground (above the normal hillslope surface) on the left and right flanks (figure 3.24) of the failed ground complex was investigated by digging pit 4. Figure 3.10 shows some 0.25m of loess overlying the original top soil. Of particular interest are flame structures involving the original (bioturbation zone present) top-soil and the overlying soil deposit. This suggests the soil overlying the original top-soil was fluidised at the time of deposition (flow deposit). The flow deposit is more consistent with C layer loess than with lower S layer loess described in pit 1, suggesting a slope movement of larger proportions than a "turfmatslide", and involving fluidised flow of C layer loess.

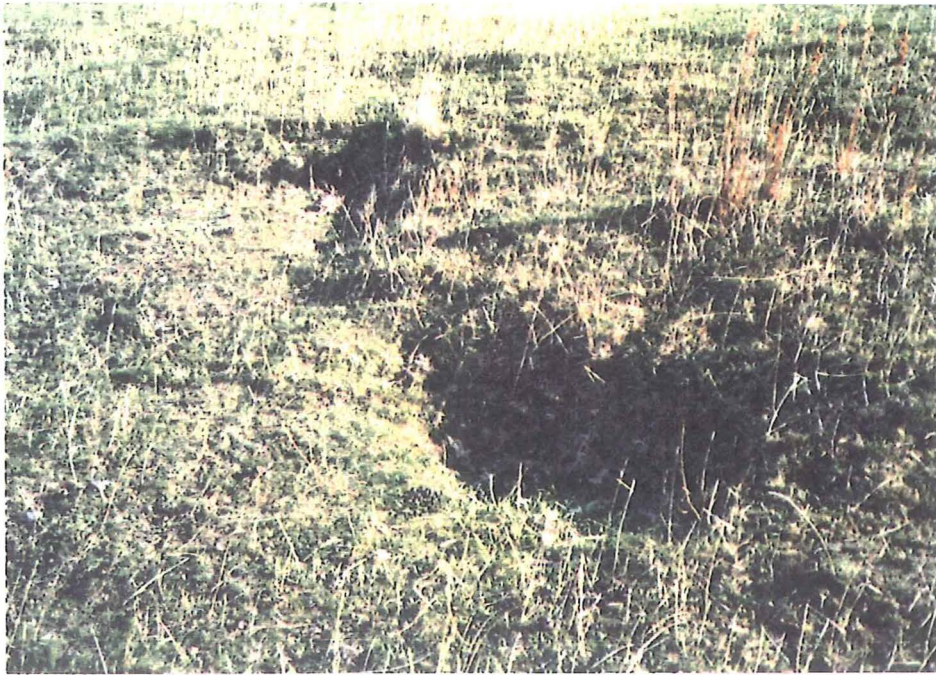
Figure 3.11 Slump Block with Associated Head Scarp- upper eastern part of investigated failed ground. Note: Pit 1 was dug across this slump feature.

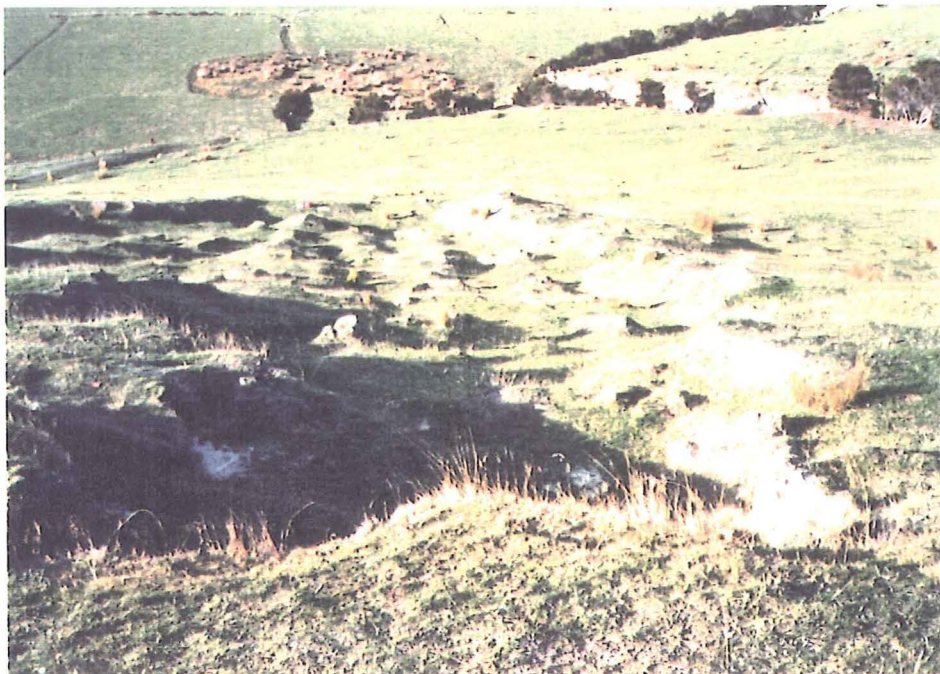
Figure 3.12 Drainage Channels in Investigated Failed Ground Complex. Note smoothing of slope features, resulting from the erosional action of surface runoff water.

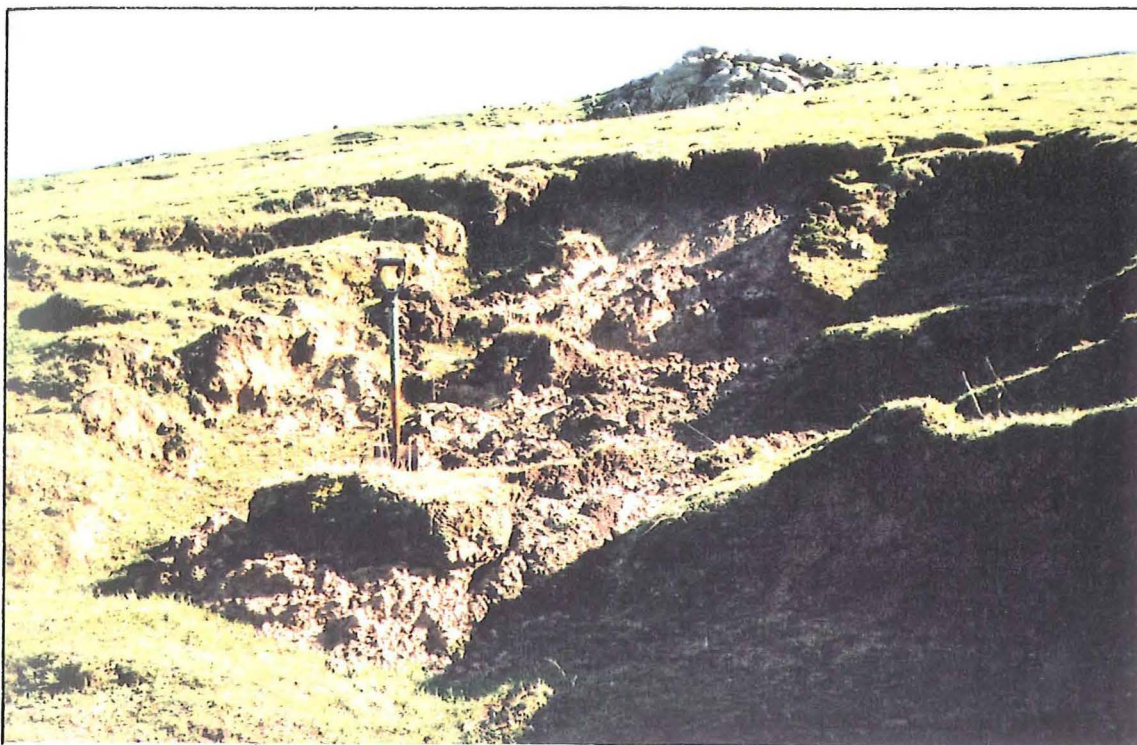
Figure 3.21 Turfmat Slide that occurred on the 14/9/89

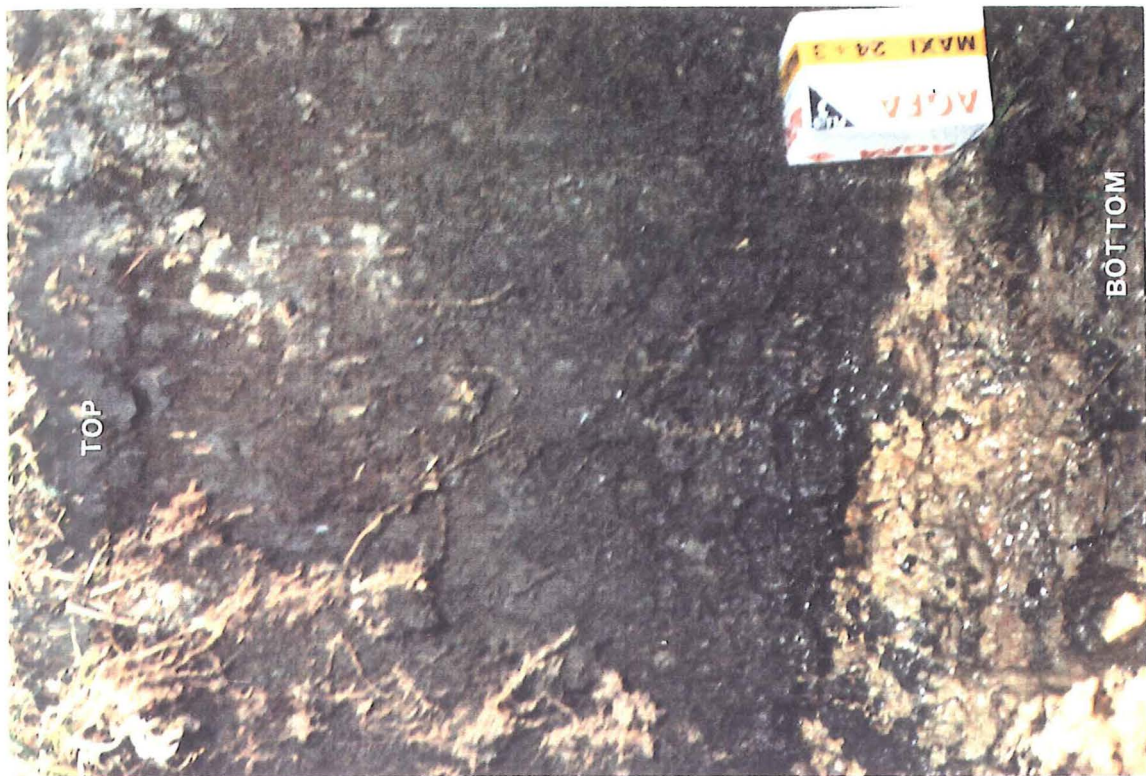
Figure 3.23 Section through Coherent Block of Failed Soil

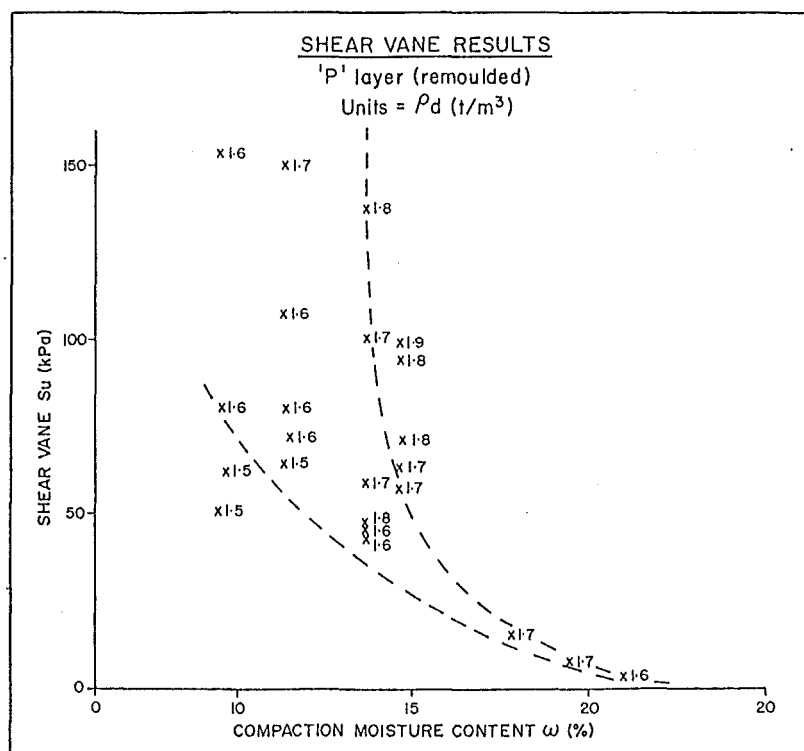
Figure 4.18 Results of Shear Vane Testing- remoulded P layer

Specimens for vane shear testing were obtained by compacting remoulded loessial C and P layers by the same method and at the same dry densities and moisture contents as for unconfined compression testing, described in section 4.3.2. Specimens were tested with the shear vane while the protor mould was clamped in place during shear vane rotation.

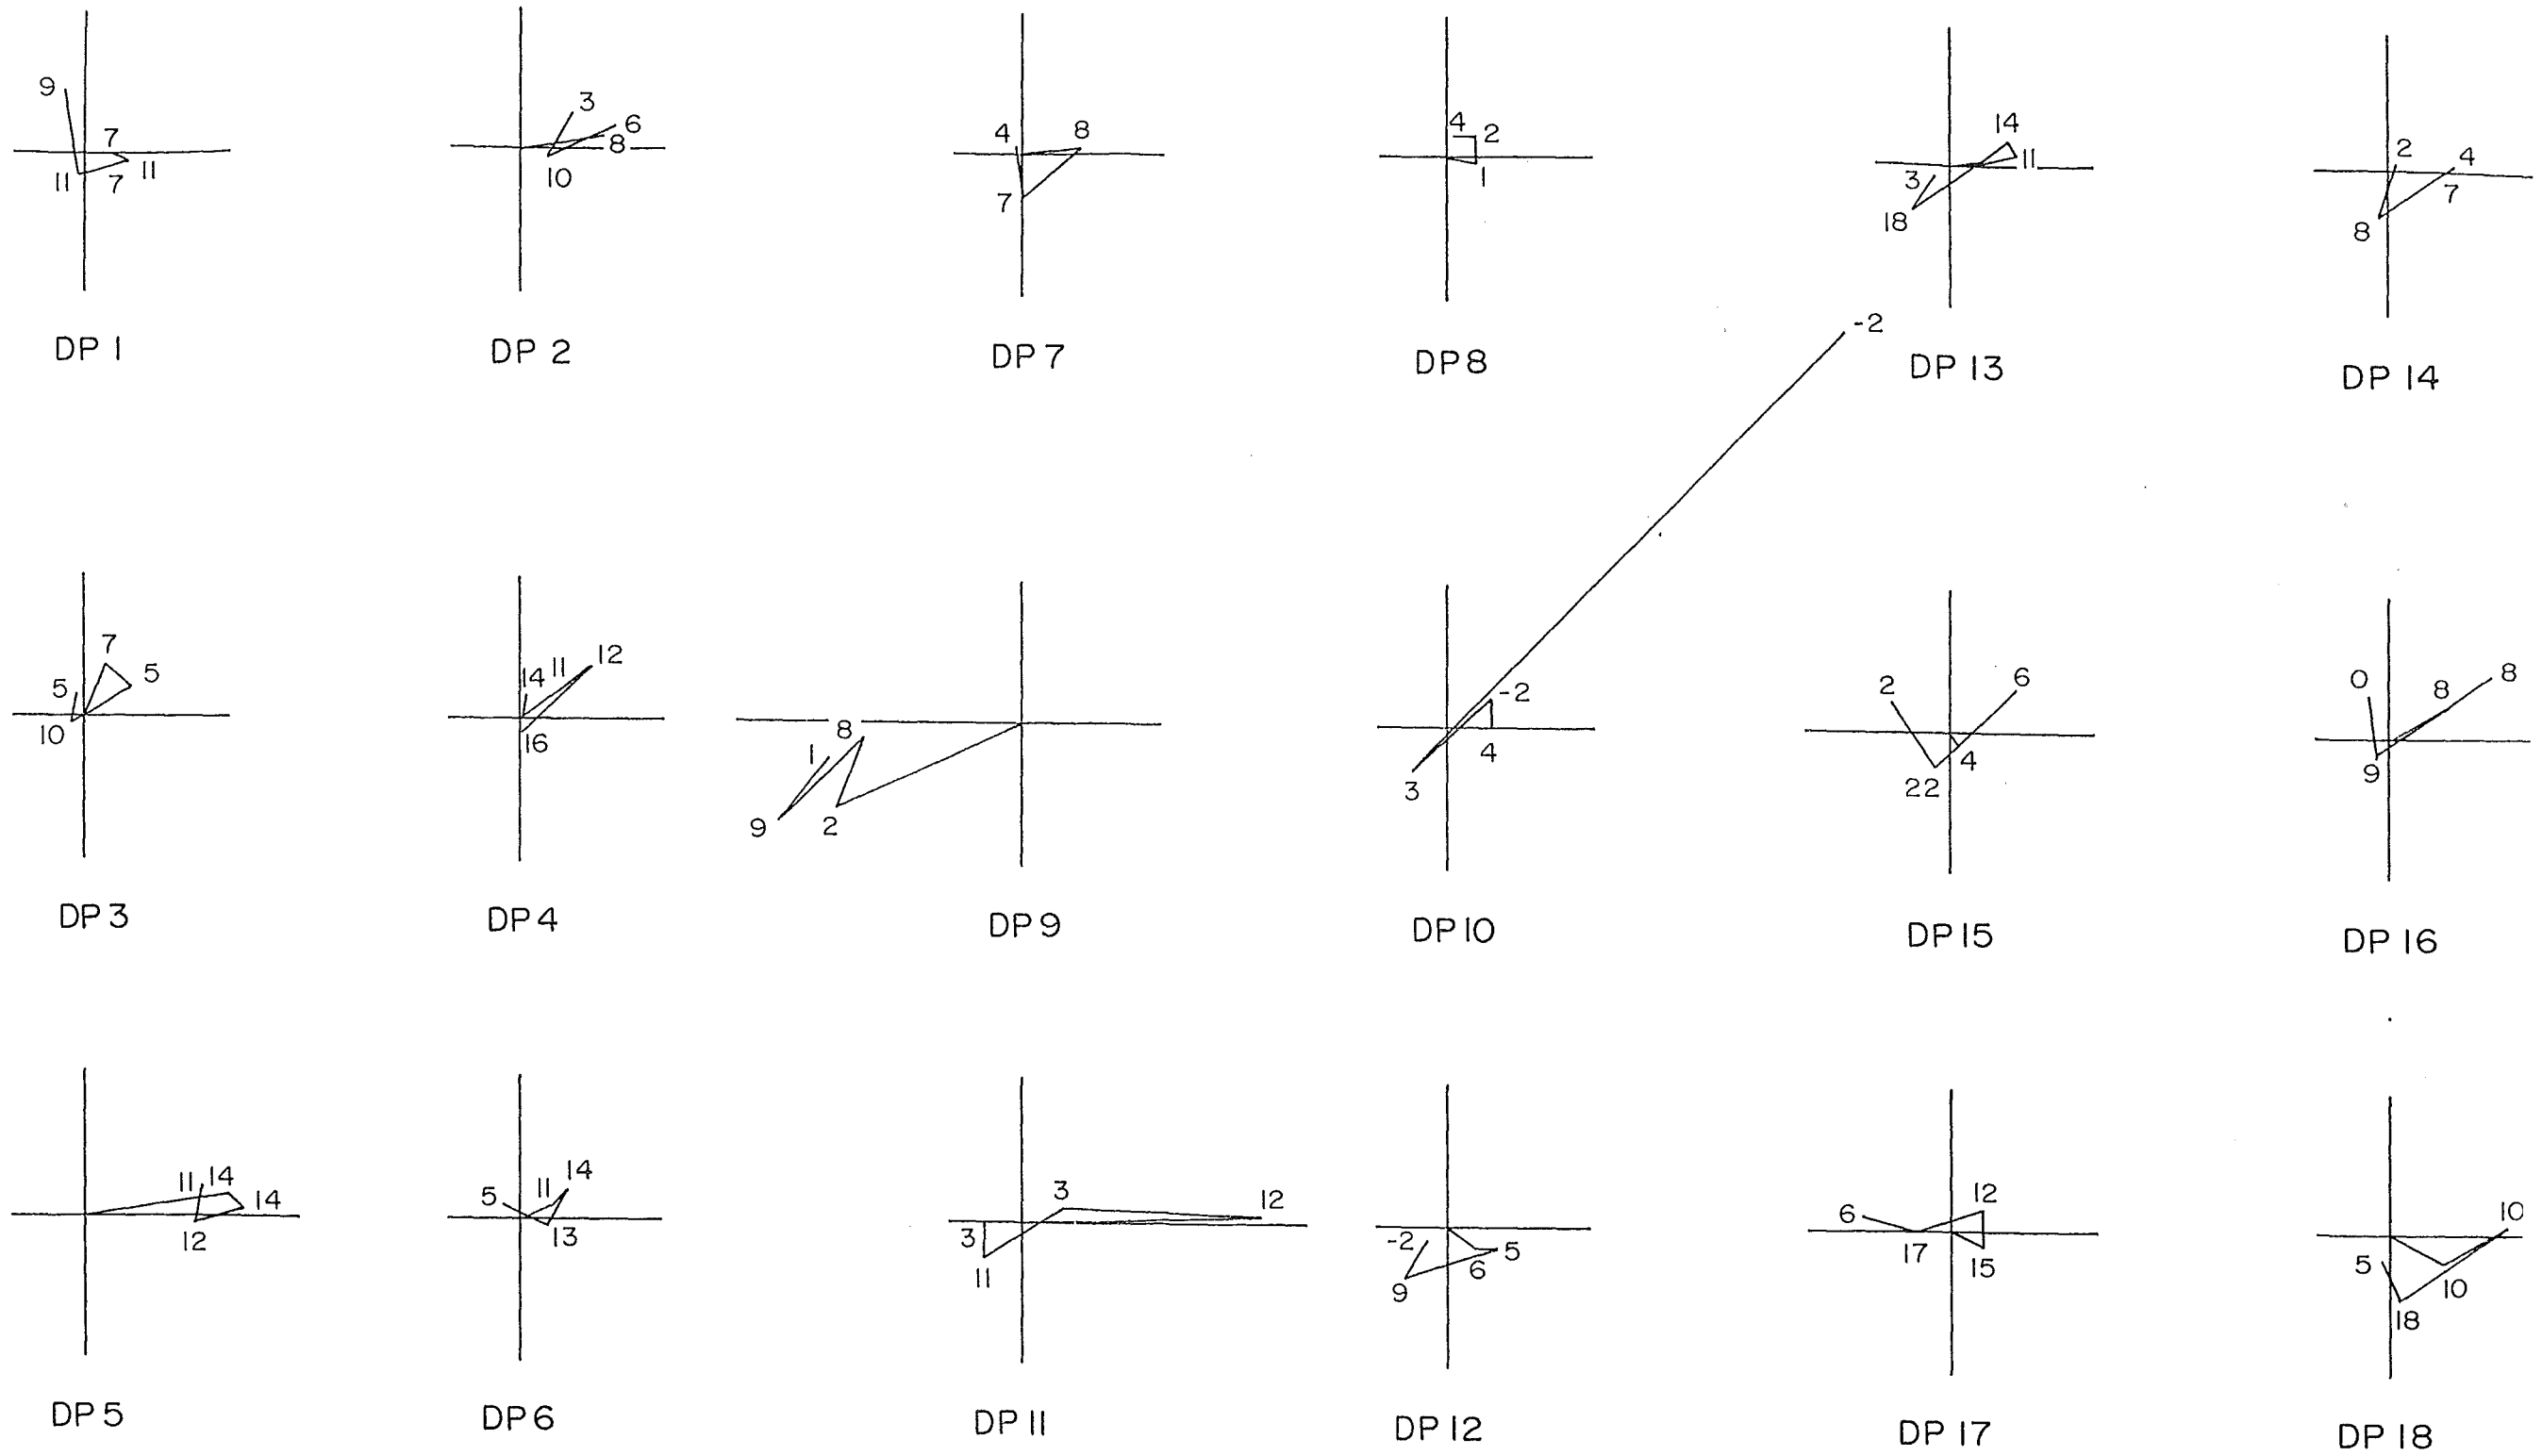
Figure A 1-6: Reduced Displacement Survey Data
