THE BEHAVIOUR OF REINFORCED CONCRETE

BEAM-COLUMN JOINTS UNDER

CYCLIC LOADING.

A thesis submitted for the degree of  
Master of Engineering in Civil Engineering  
in the University of Canterbury,  
Christchurch, New Zealand.

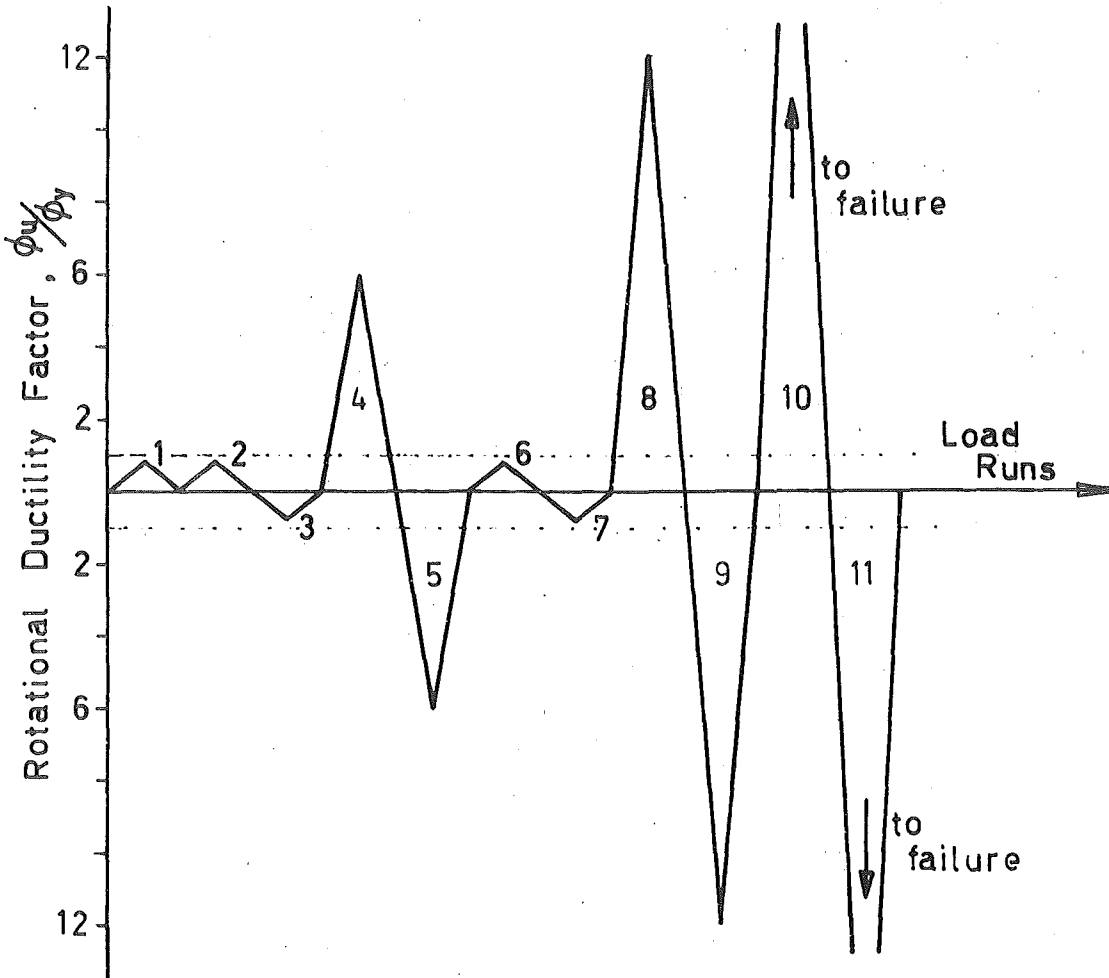
**FIG. 3.2 LOADING SEQUENCE**

The load sequence applied was adjusted slightly depending on the performance of the individual specimens. However the sequence took the general form as shown in Fig. 3.2. The initial runs 1,2, and 3 were to establish the stiffness of the structure in its uncracked and cracked states. Runs 4 and 5 subjected the specimen to deformations which would be expected during a major earthquake, which were followed by two elastic runs to determine the stiffness and general performance after the earthquake. The remaining cycles were to demonstrate the response and ductility of the structure during a second major earthquake.

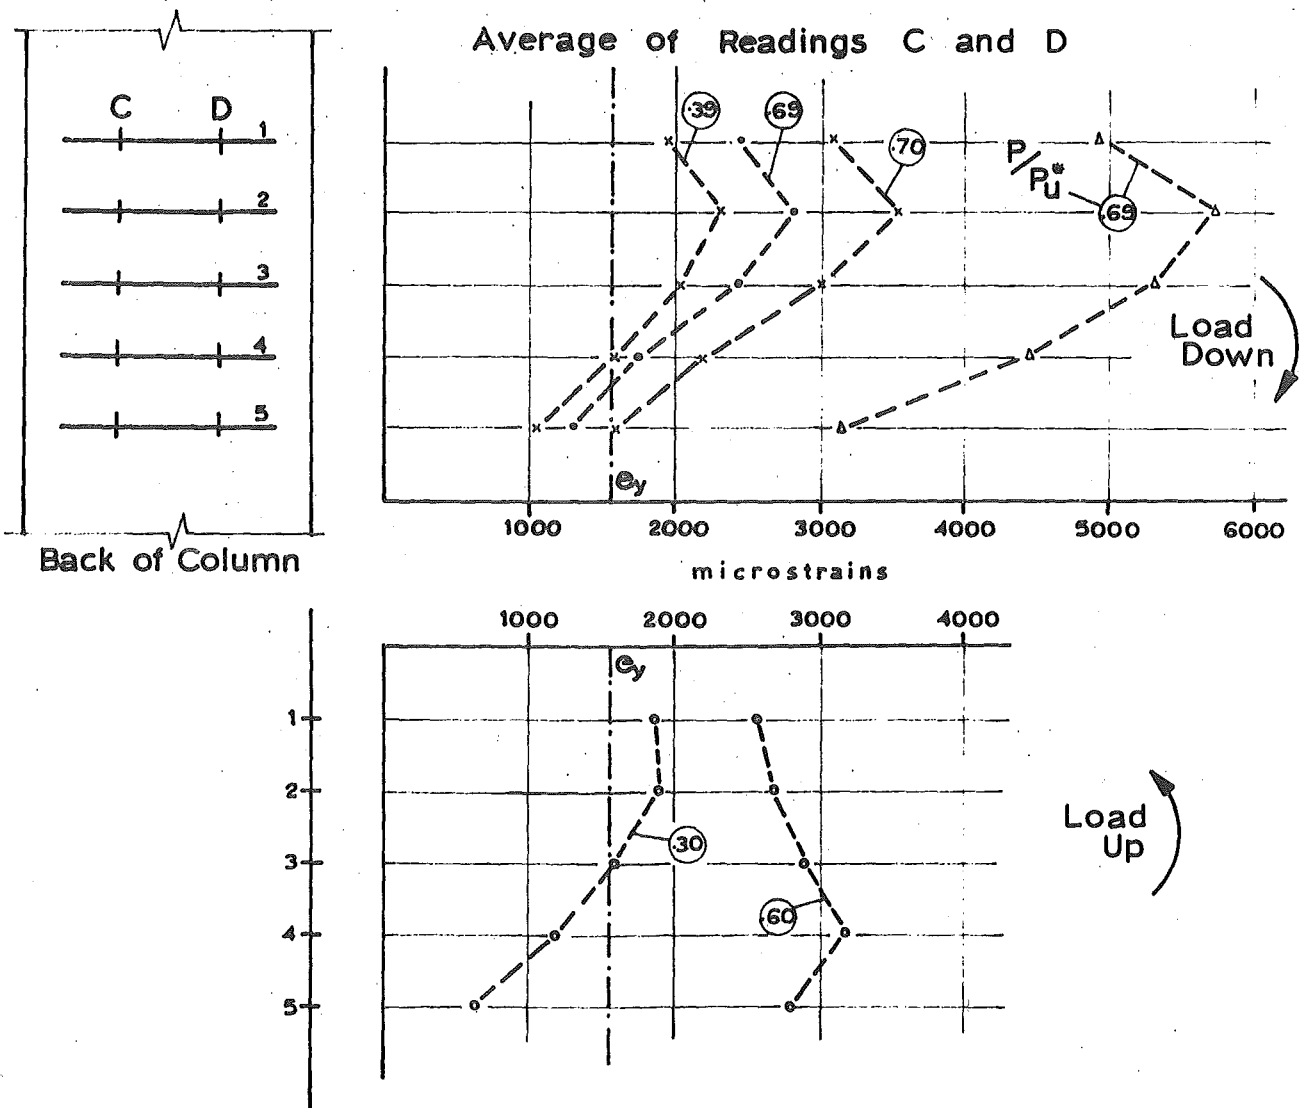
FIG. 4.6 (a) THE DISTRIBUTION OF JOINT TIE STRAINS AT BACK OF COLUMN IN UNIT 1

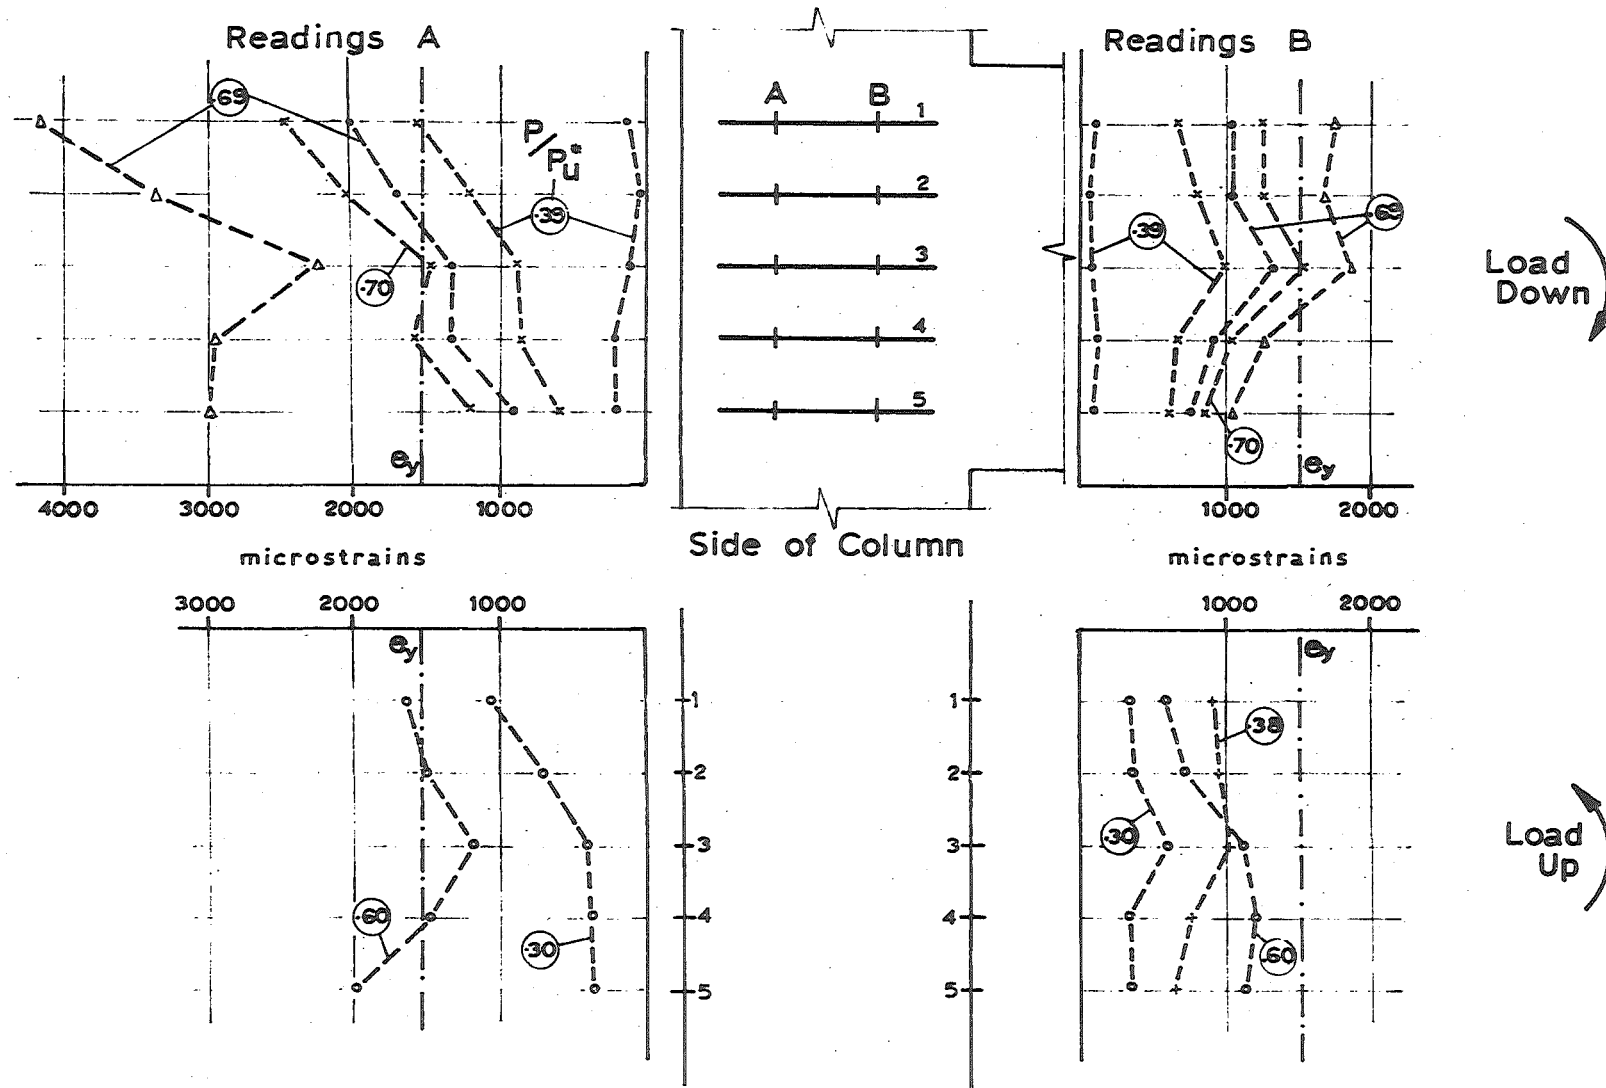
FIG. 4.6 (b) THE DISTRIBUTION OF JOINT TIE STRAINS AT SIDE OF COLUMN IN UNIT 1

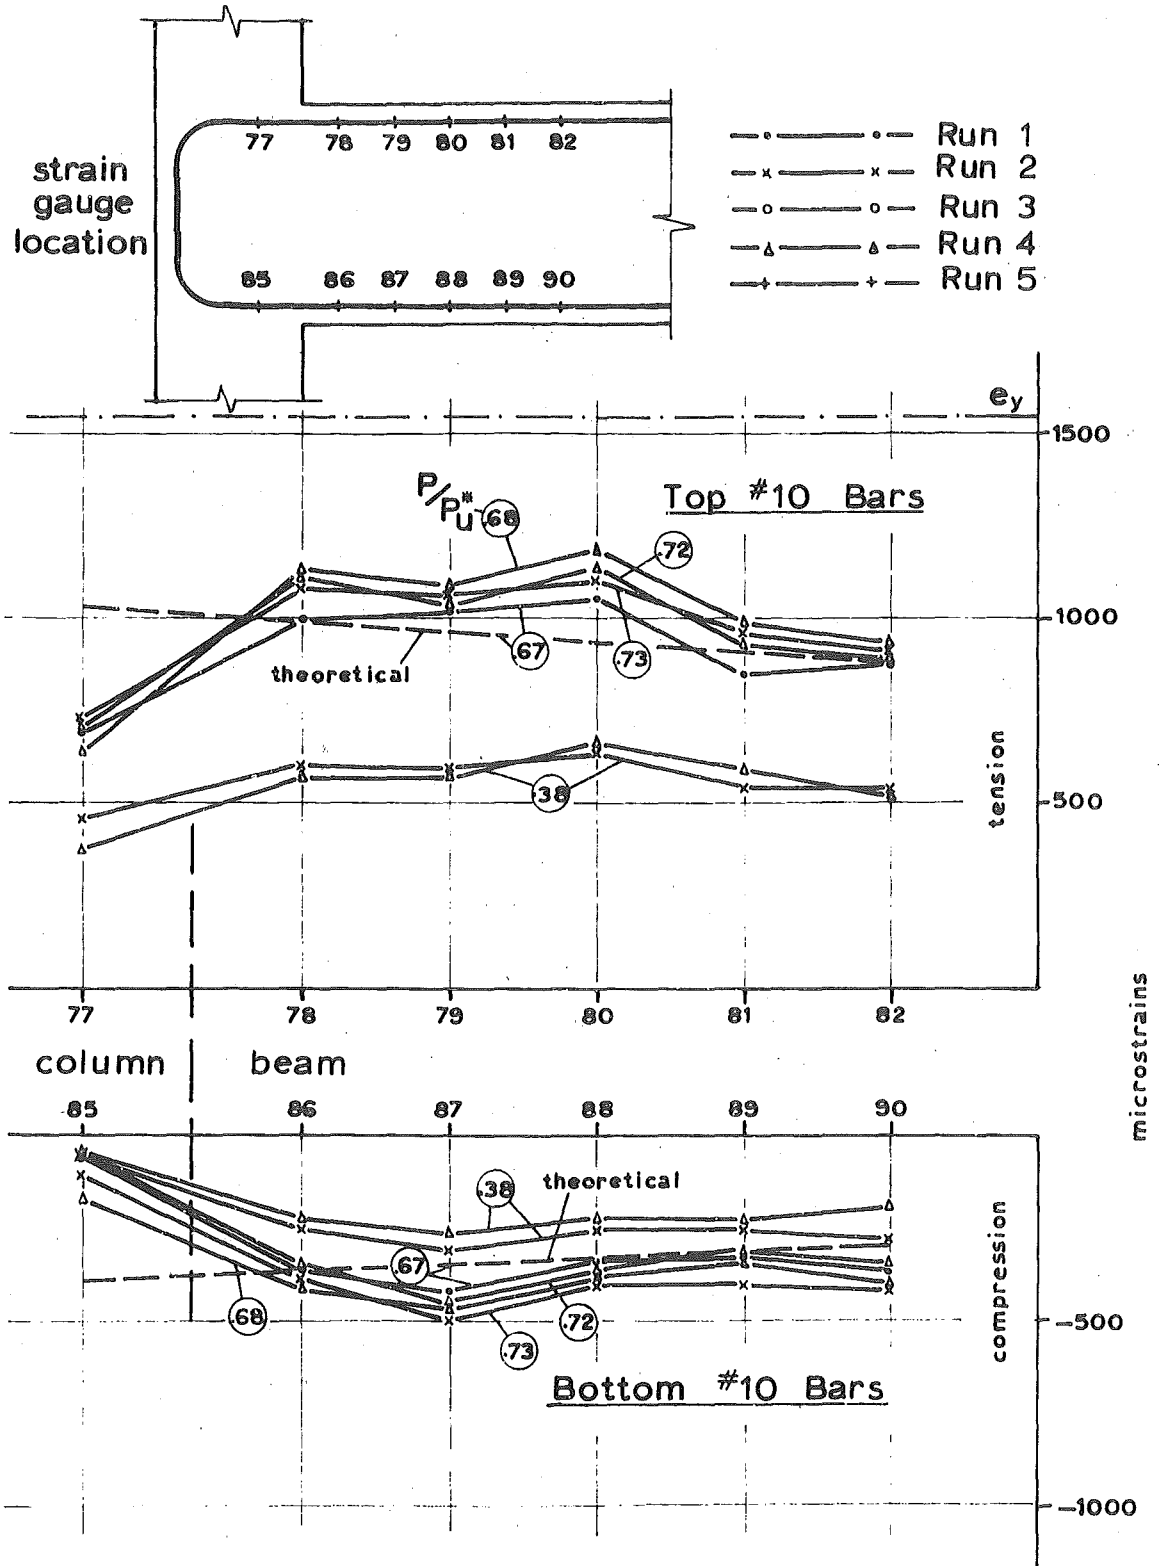
FIG. 5.6(a) THE DISTRIBUTION OF STEEL STRAINS IN BEAM FLEXURAL BARS IN UNIT 2 [FOR DOWNWARD LOAD RUNS].

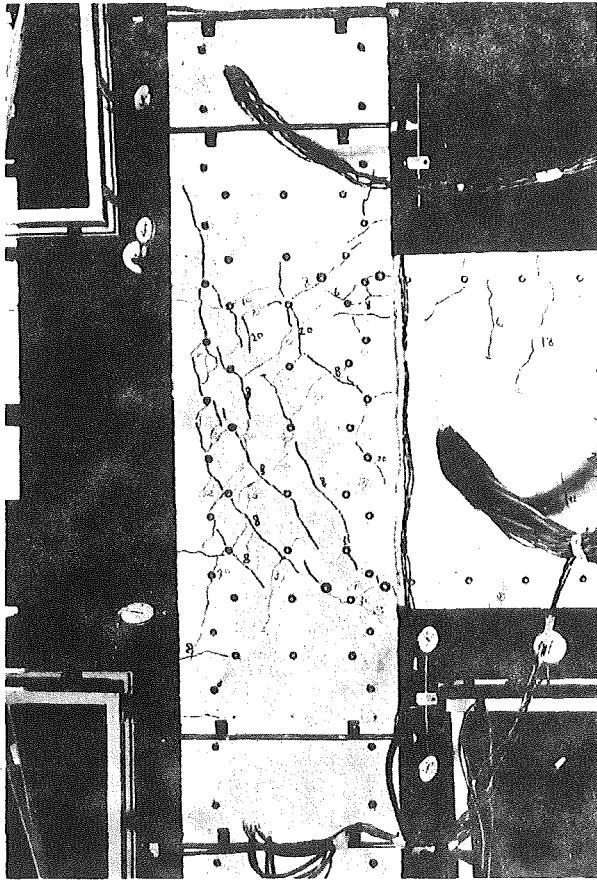
FIG. 6.2 UNIT 3 ON LOAD RUN 3

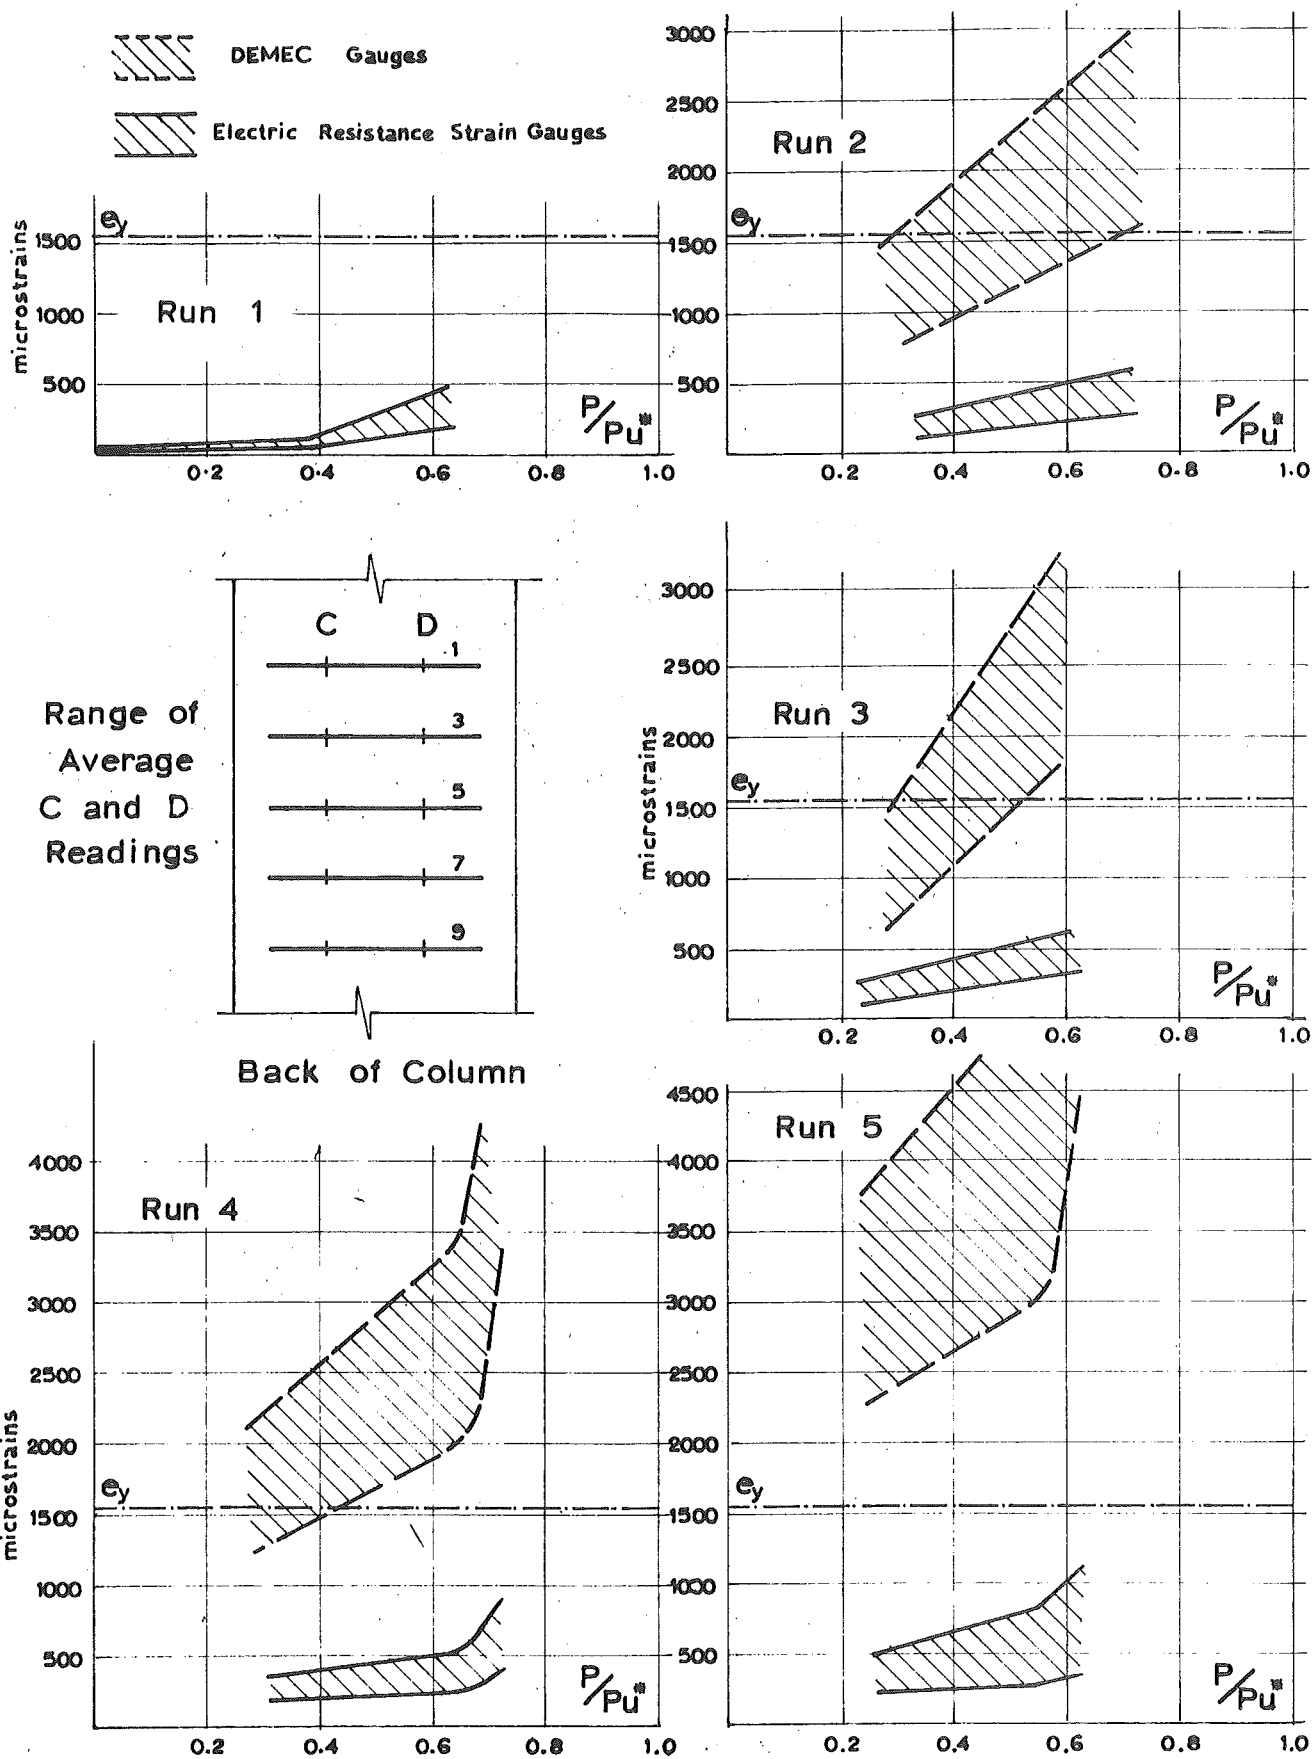
**FIG. 6.10(a)** THE LOAD-STRAIN RELATIONSHIP FOR JOINT TIES IN UNIT 3 AT BACK OF COLUMN

The load strain relationships for gauges on all four sides of the ties are shown in Figs. 6.10 (a), 6.10 (b), 6.10 (c) and 6.10 (d). These show how the stress is developed during each run and the full effect of the ties is not imposed until the latter part of each run. The effect that bowing of the ties has on the DEMEC readings is shown by not only resulting in higher readings but also a greater variation. The relationship shown in Fig. 6.10 (d) shows how the bursting effect of the column is present even at the inside of the column where the restraining effect of the beam would
