Gap and Opportunity Analysis of Hydrological Monitoring in the Ziway-Shala Sub-basin, Ethiopia

Tabea Donauer, Alemseged Tamiru Haile, Demelash Wondimagegnehu Goshime,
Tobias Siegfried and Silvan Ragetti

IWMI Working Paper 192

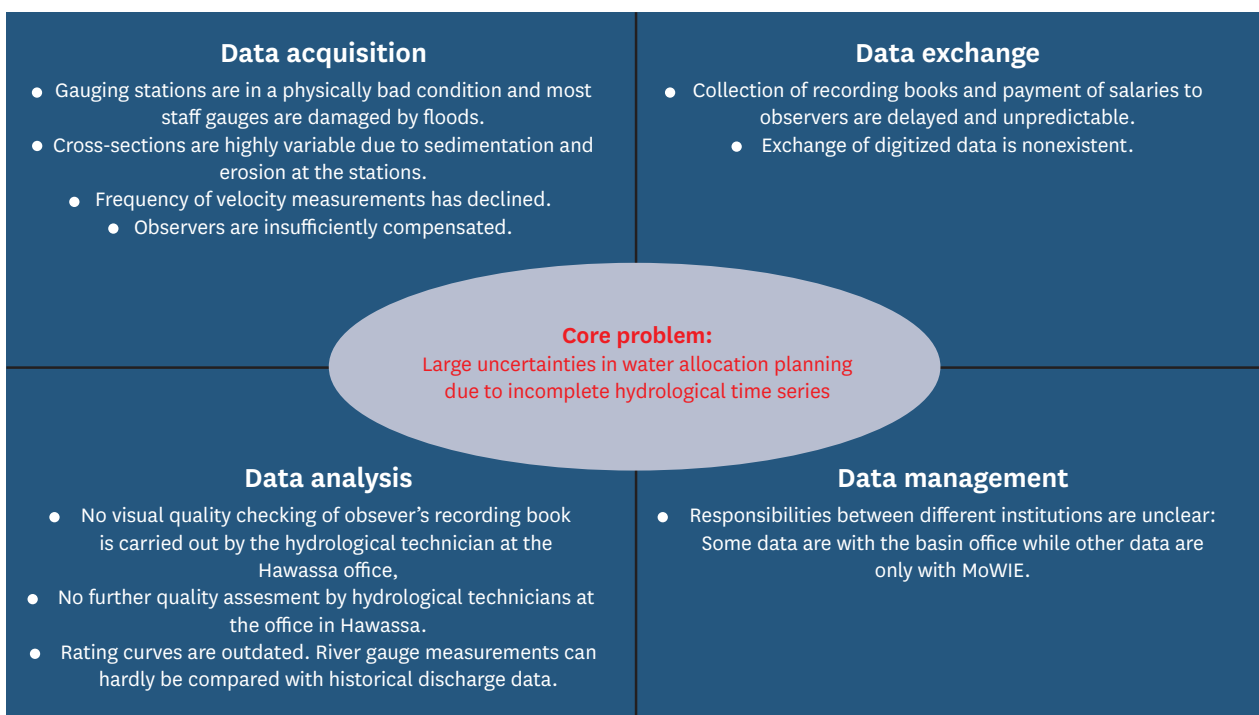
Figure 9. Stakeholder interviews revealed a variety of reasons for the poor monitoring in Ziway-Shala sub-basin.

deficiencies in the process described in Figure 8. These problems are presented in Figure 9 along the dimensions of data acquisition, exchange, analysis and management, and explained in detail in the following sections.

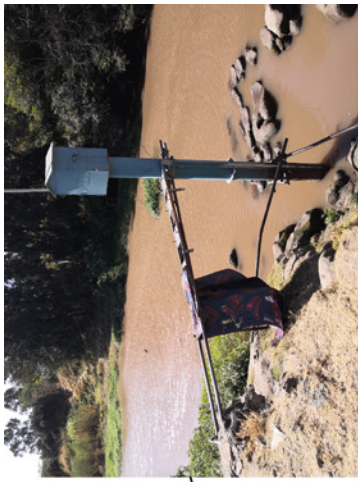
Katar at Ogolcho (2): The staff gauge is in an acceptable condition. Due to the wide cross-section, velocity measurements are difficult during high flow conditions.

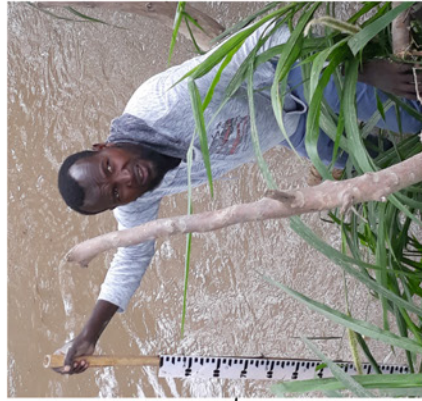
Bulbula at Desta Abijata (5): The lowest staff gauge is damaged by the flood. The observer uses a stick to measure the water level. No reference benchmark is visible.

- High-quality staff gauges that can withstand the high flow should be installed.
- Frequent maintenance of the stations is needed, and damaged staff gauges must be replaced soon after the flood season.
- Frequent updating of the rating curves is required.

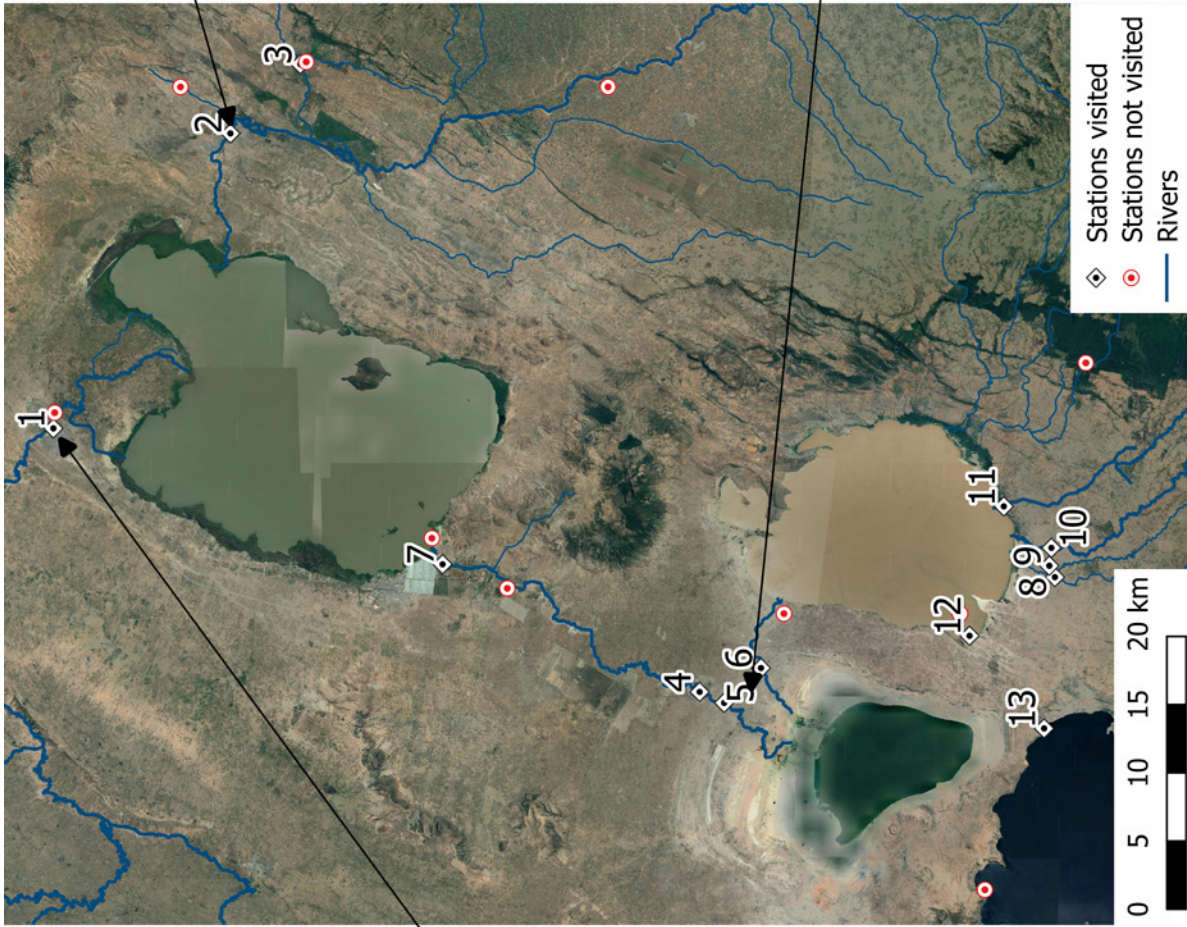
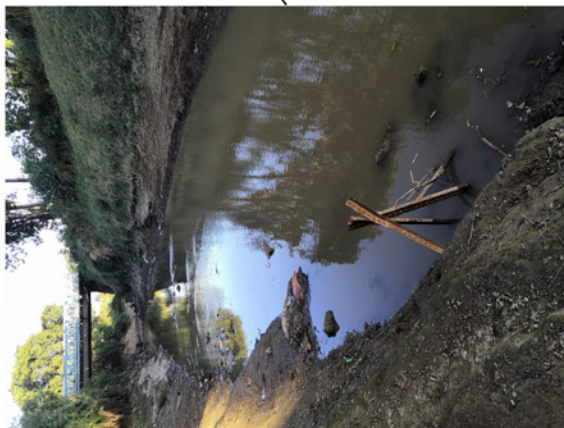
Figure 10. Overview of the gauging stations visited and their locations provided by RVLBDO.

Meki at Meki Town (1): Staff gauge is rusty and the reading has almost disappeared. There are waste and sediment deposits on the riverbanks. Open defecation near the station interferes with data recording.

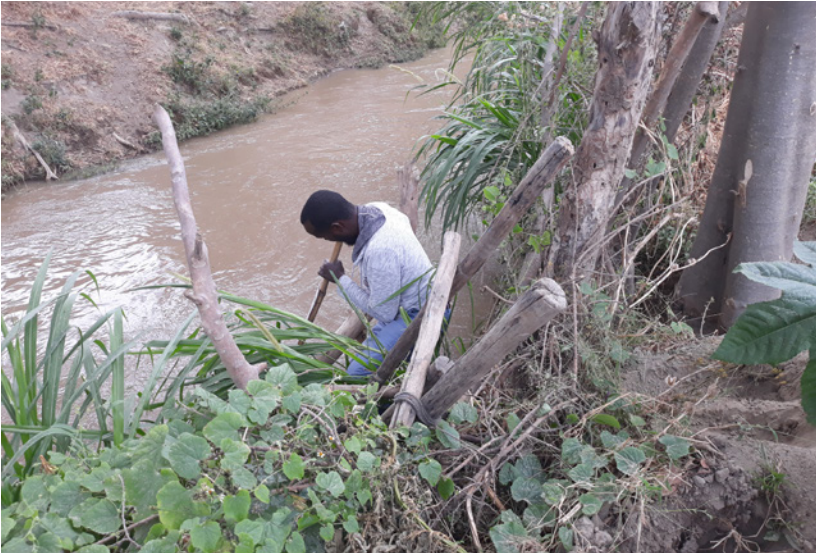
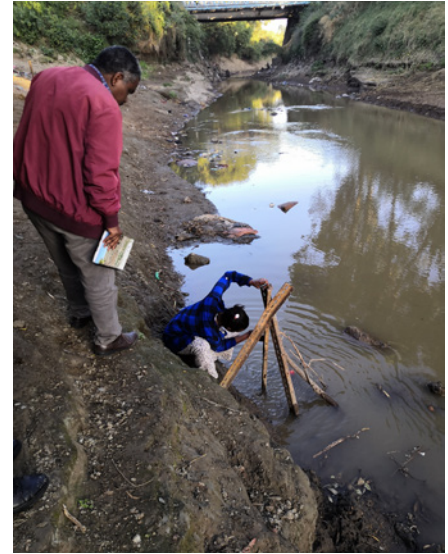
Figure 11. Observers taking measurements at gauging stations. (a) the observer at Desta Abijata (Station number 5) must climb a ladder to measure the water level with a stick, and (b) the observer at Meki at Meki Village (Station number 1) deals with a dirty and dangerous measurement location.

with centimeter marks to measure the water level, but it is often unclear to what datum their measurements refer (Figure 11). Moreover, most of the stations visited do not have stable cross-sections. Bank erosion and sedimentation have changed the channel bed profiles over the years. The observer at Chiufa Arata (station number 3) has even reported 1 m of sediment deposition on the channel bed. To allow for more accurate measurements at the gauging sites, the following measures are recommended:

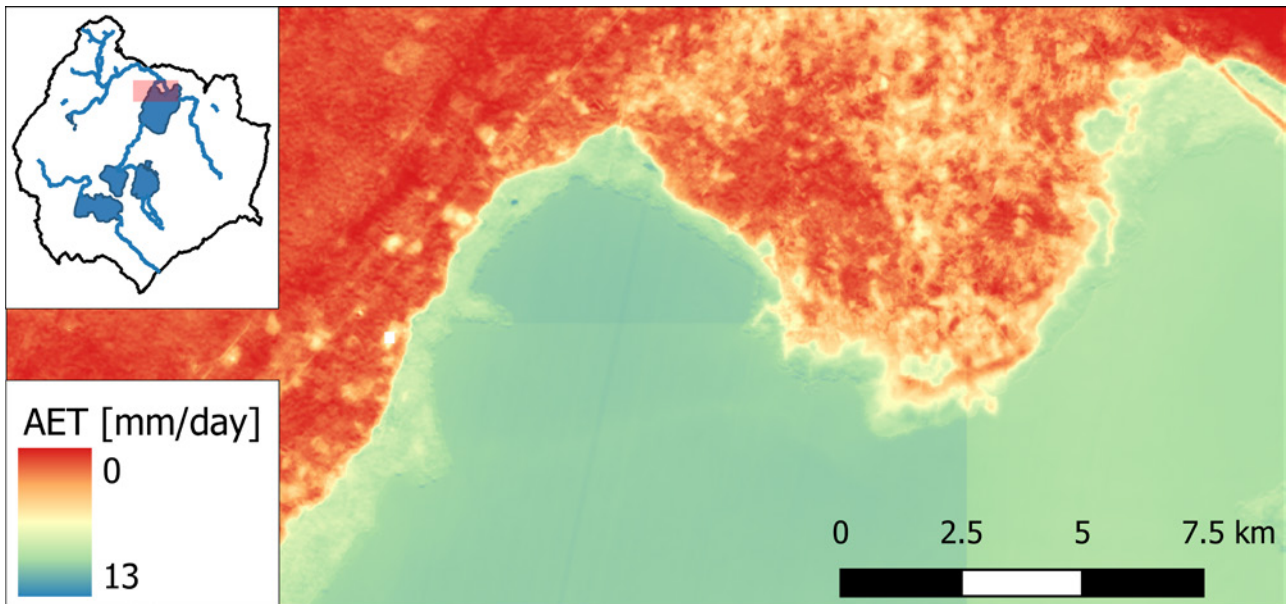
Figure 14. High-resolution map of actual evapotranspiration at the shore of Lake Ziway.

Notes: The Mapping EvapoTranspiration at high Resolution using Internalized Calibration (METRIC) algorithm (Allen et al. 2007) was used to estimate actual evapotranspiration from a Landsat image taken on January 16, 2019. The spatial resolution of 30 x 30 m allows for observing irrigation activity on a field scale. AET - Actual evapotranspiration.

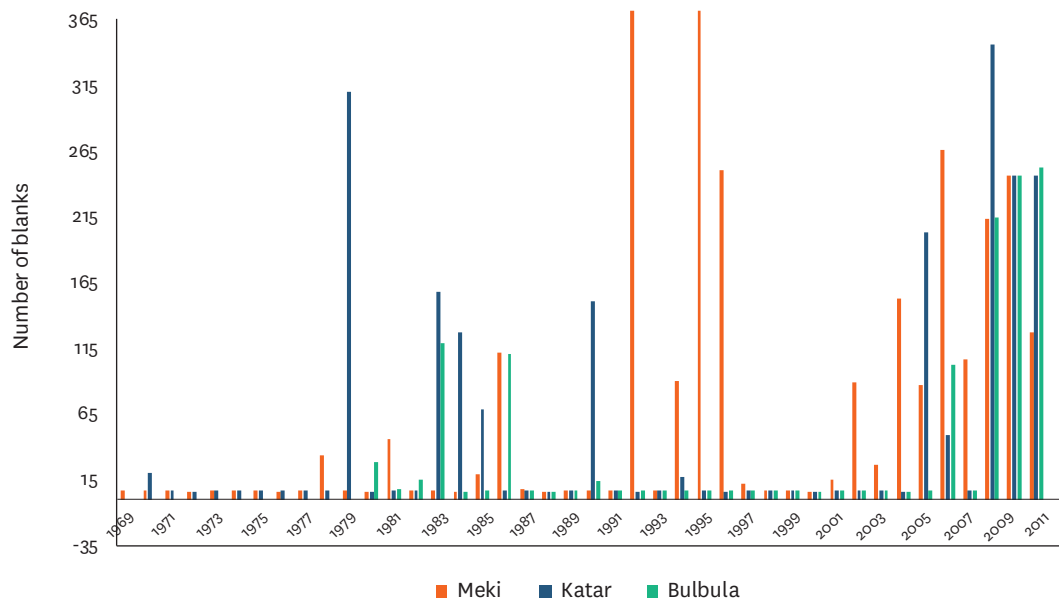
Figure A1. Blanks in historical streamflow measurement data at key gauging stations.

Streamflow measurements started in 1969 for Meki, 1970 for Katar and 1980 for Bulbula. Figure A1 shows blanks in the discharge data obtained for the Meki, Katar and Bulbula rivers. No data were accessible in digital form after 2010. However, the time series are very incomplete after 2005.

Notes: There are years with few recordings for Meki, Katar and Bulbula stations before 2000, but blanks in the data seem to accumulate systematically after 2005. Streamflow data for these stations were last available in 2010.

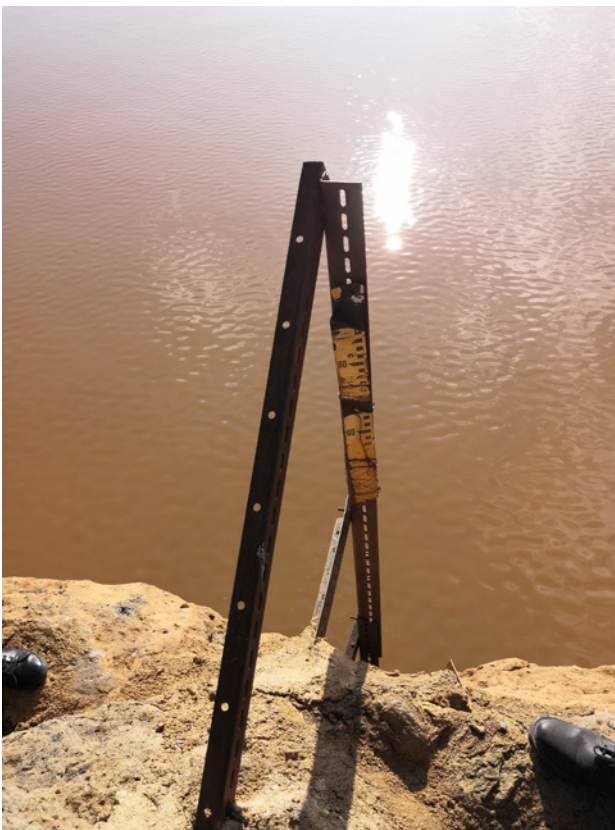
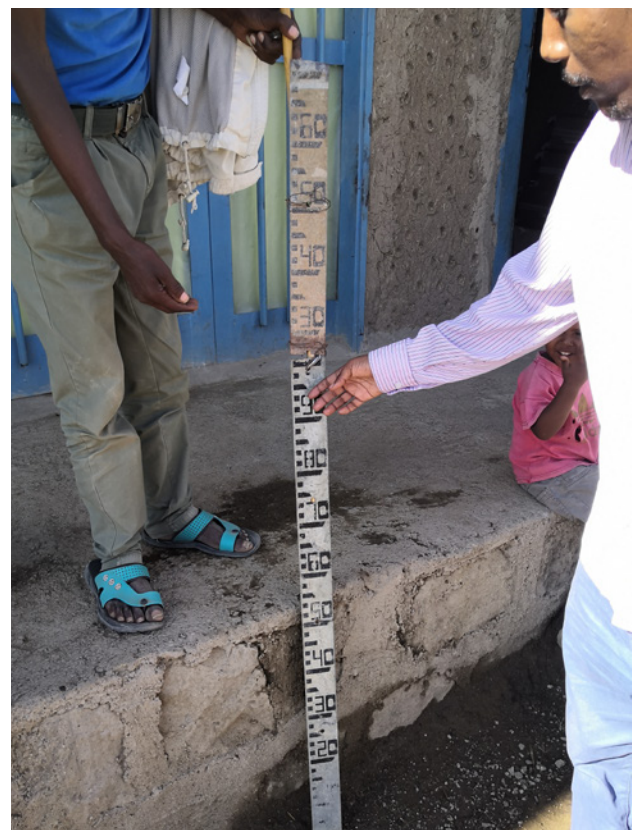
Figure A4.1. Lake level station at Lake Langano.

The gauging station at Lake Langano (station number 12) is located within a 10 minute walk from Langano village, which can be reached by a 3 km drive over a dirt road from the main road. Most of the reading on the gauge at the station is damaged and the observer uses a stick to take measurements (Figure A4.1). In the dry season, the lake recedes and the water level cannot always be captured. However, consistent data from this station is expected, since the observer's family has taken measurements with dedication since the gauge was installed around 1990. New staff gauges must be installed at this site, including additional staff gauges to capture low water levels.

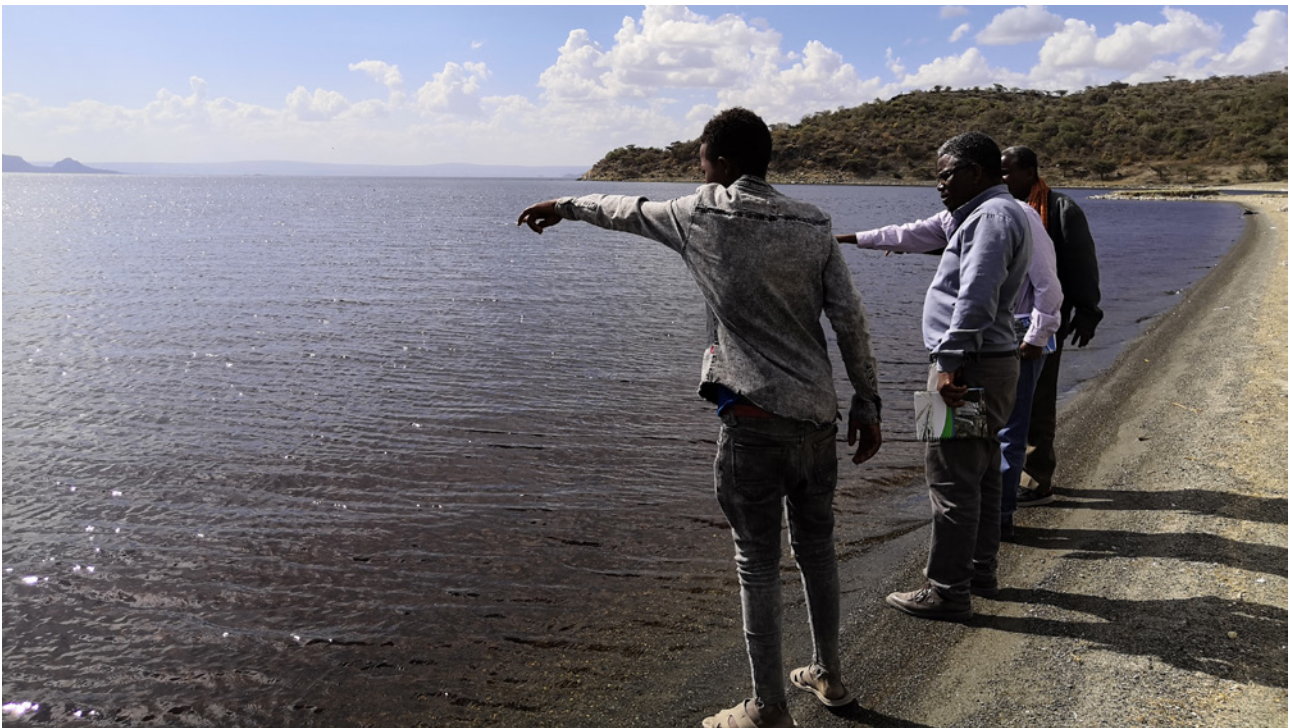
Figure A4.2. A local villager explains how the observer measures the water level in Lake Shala.

The gauging station at Lake Shala (station number 13) is located 6 km west of the main road. There is a dirt road leading to a village and from there, it is another 3 km walk or rough four-wheel drive down to the lake. There is no staff gauge installed. The location does not seem ideal, as there is nobody living nearby. Current data from Lake Shala cannot be trusted, as there are no signs of frequent reading, the observer could not be identified and there is no reference point to measure (Figure A4.2).

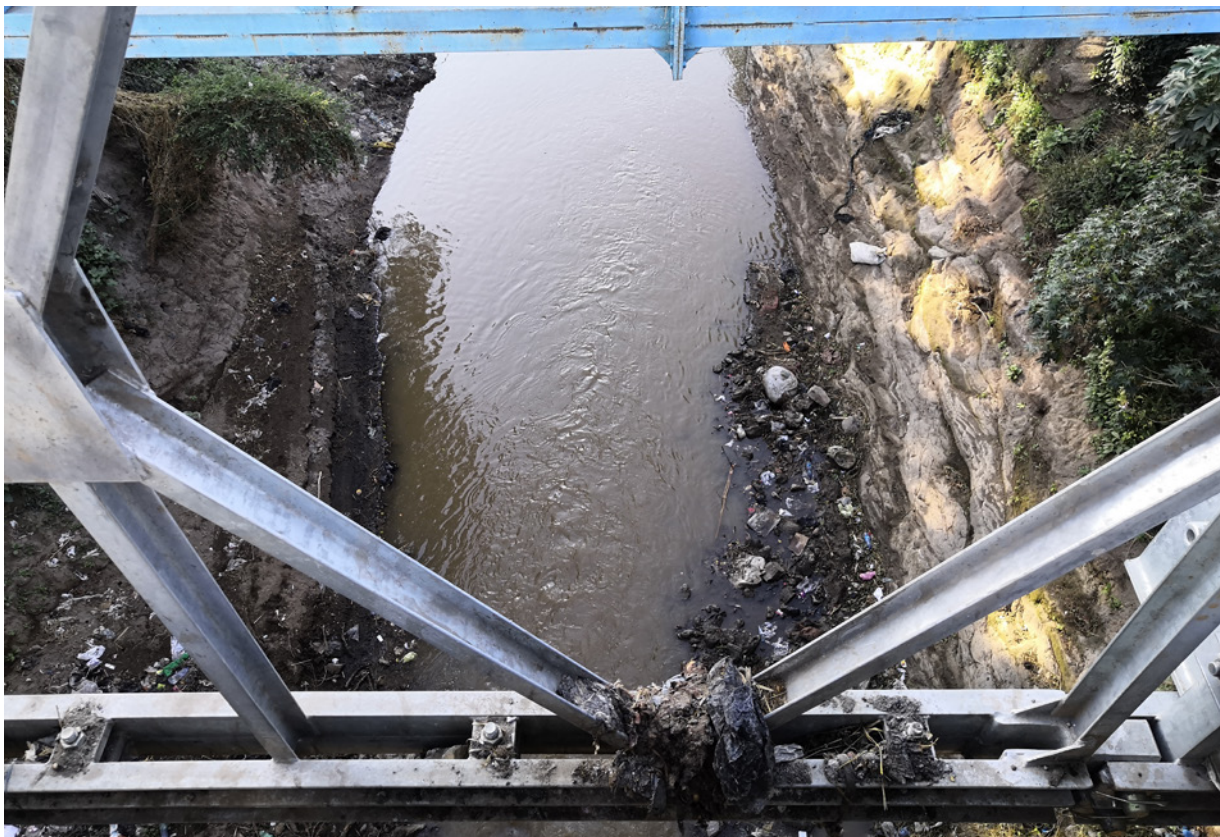
Figure A5.1. The bridge in Meki Town serves as a waste dump. The site is unsafe, dirty and prone to vandalism.

The gauging station Meki at Meki Village (station number 1) at the Meki River is located around 50 m downstream of the bridge at the main road in Meki Town. It used to be situated right under the bridge where the riverbed is stable, but was moved downstream some years ago.

The measuring site is strategic and important to quantify the inflow from Meki River to Lake Ziway. However, the location of the bridge in Meki Town is unsafe, prone to vandalism and there is a lack of awareness of the purpose of taking measurements. Many people dump their waste on the bridge (Figure A5.1) and open defecation takes place. An automated measurement station, which was previously installed, has been vandalized and is not in operation anymore. According to the surveys, it became apparent that any expensive equipment installed nearby would be stolen or damaged by gangsters within a few days. Parts of the staff gauge have also been vandalized and stolen in the past. It needs to be replaced, and frequent maintenance and cleaning are necessary in the future. The basin authority should look for solutions to prevent vandalism together with the population.

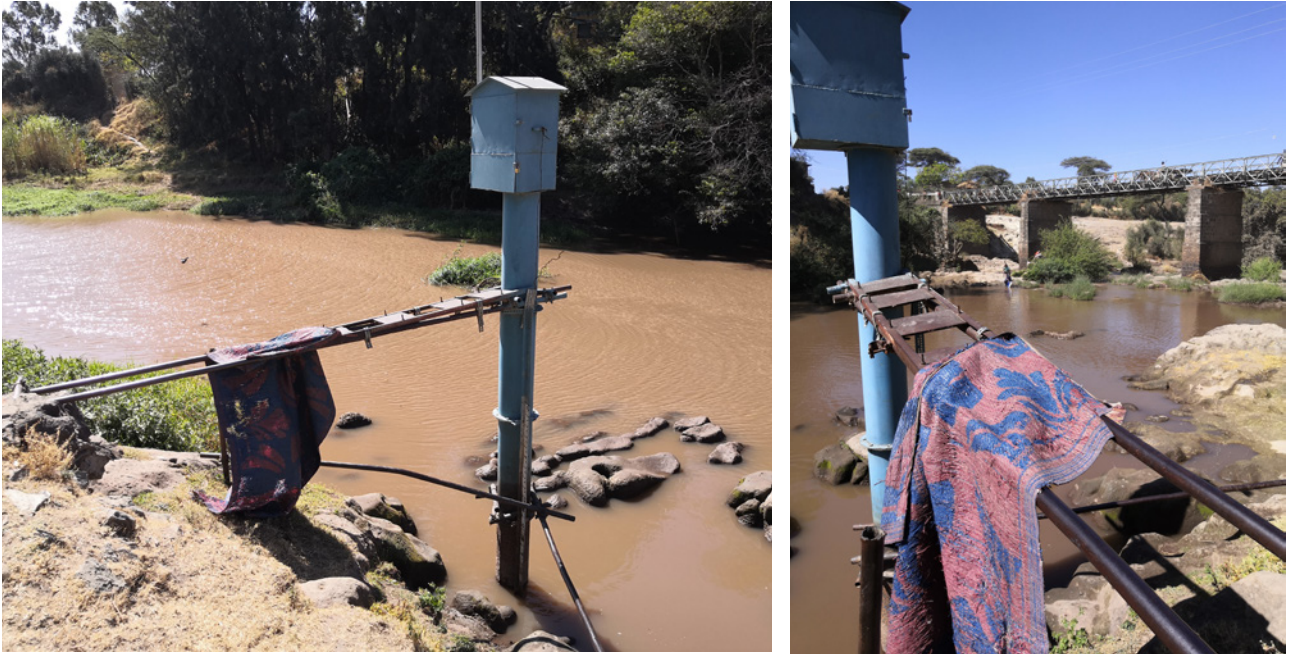
Figure A5.2. The majority of Katar catchment contributes to the discharge measured at the gauging station in Ogolcho.
 Photos: Tabea Donauer.

The gauging station Abura (station number 2) at the Katar River is located 50 m upstream of the bridge in Ogolcho. A 25-30 km drive on a dirt road from Meki Town is required to reach this bridge. The staff gauge is mounted on a solid structure built for the automated station (Figure A5.2). It is in good condition and can withstand floods. Data were collected from the automated station in 2019, so it is supposedly still in operation. The location is strategic, since the majority of Katar catchment (with an area of 3,740 km²) contributes to the discharge here.

The site does not feel safe. There have been problems with local people harassing and threatening the observer of the manual station. Furthermore, the staff gauge needs to be cleaned and maintained after flood events. For the automated station, data need to be downloaded after the rainy season to prevent the loss of valuable high flow data. The basin authority should, therefore, frequently visit the site to ensure continuous operation of both the manual and automated measurement.

The site has not been changed for a long time and the cross-section seems stable. Velocity measurements at this wide cross-section are challenging, especially during high flow conditions. As a first step, it is recommended to use the old rating curve to get an estimate of the discharge based on water level data which were collected in the last few years. In a second step, a new rating curve should be developed. This will require considerable time and effort due to the remote location of the gauging station.
