Jianguang BAO, Adil BENAARBIA, Siyuan BAO, Xiaofeng GUO, Yonghong WANG, Wei SUN - High temperature strain heterogeneities tracking within hole-specimens of fv566 turbine steel via digital image correlation - Materials Science and Engineering: A - Vol. 777, p.139068 - 2020

High temperature strain heterogeneities tracking within hole-specimens of FV566 turbine steel via digital image correlation

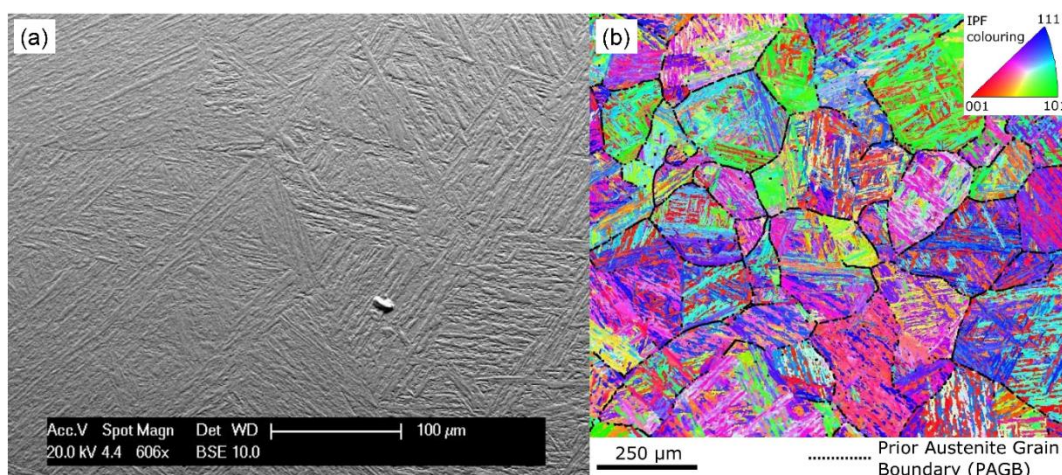
Fig. 1. (a) Backscattered electron image and (b) an EBSD orientation map of the as received FV566 material. The prior austenite grain boundaries are highlighted in black using 23° - 41° misorientation angles.

Fig.1a presents the microstructure of the FV566 steel after heat treatment with the average grain size of 30 μm. After tempering, a typical tempered martensitic microstructure in the as-received material can be seen in Fig.1b [33]. Prior austenite grains (PAGs), packets, blocks, sub-blocks and laths, were involved, as has been noticed in [34]. Also, according to the Kurdjumov-Sachs orientation relationship with the parental austenitic phases [35], the PAGs in the as-received material are less than 300μm in size with the misorientation in a range of 23° - 41°. Sub-blocks and laths have the average misorientation angles of 1.8° and 8.3°, respectfully.

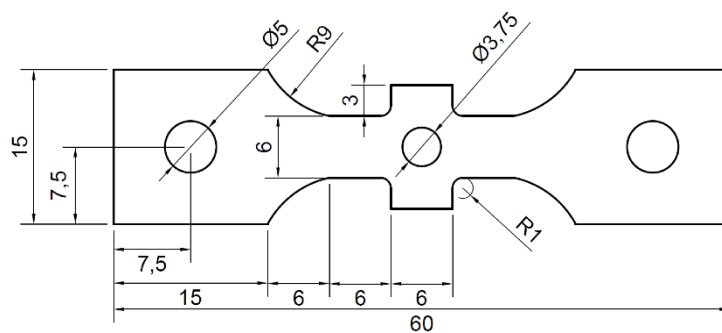
Fig. 2. Specimen configuration (All dimensions are in mm, the thickness is set at 2 mm).

Many structural components possess geometrical features such as holes, corners or gaps that are necessitated by design to accommodate fasteners, joints, or for weight reduction. Under the influence of combined thermal and mechanical loads, such stress concentration sites may become initiation sites of void nucleation and fracture [30]. The local strain fields can be highly inhomogeneous in such biaxial, or in general triaxial, stress states [36]. Hence, specimens with a hole of $\varnothing 3.75$ mm at the central part and symmetrical protrusions of 3 mm on both extremities were designed and tested under high temperature tensile loading. The holes of $\varnothing 5$ mm on both sides were machined to satisfy the loading pins' requirement. Dimensions of the specimen are shown in Fig. 2.

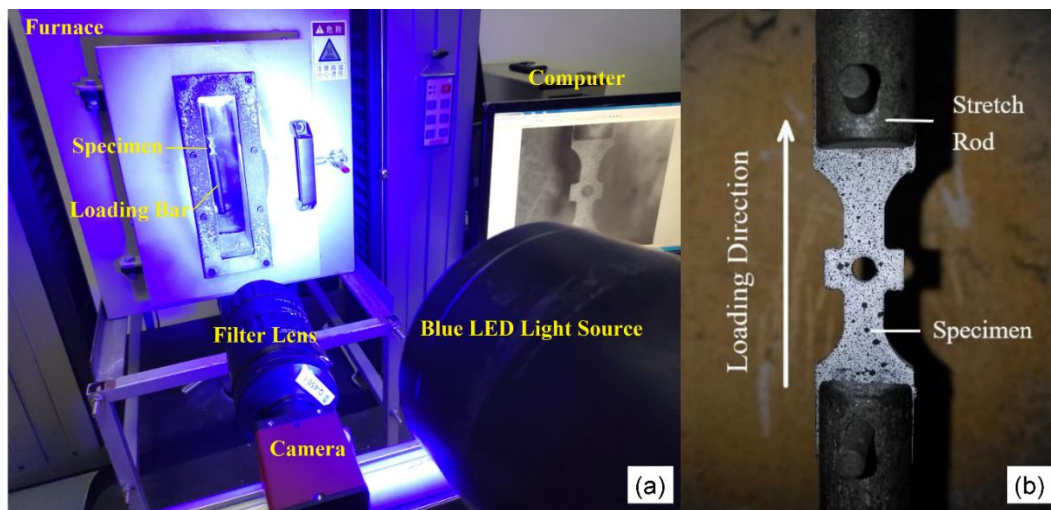
Fig. 3. (a) The experimental setup showing the digital camera used for the DIC measurements, a high temperature furnace, a narrow band pass filter lens of 441 nm ± 10 nm bandwidth and a monochromatic light source with the wavelength of 440 nm ± 20 nm. (b) The test specimen sprayed with a black/white speckle.

Different techniques are available in the literature to generate the high temperature resistance speckle for DIC [38]. In order to increase the contrast between the speckle pattern and the background, the specimens were first covered with white inks and then, after a drying process, the black ink speckle pattern was sprayed. The pretreatment was necessary for a better adhesion of spray painting for high temperature environments. The gauge part was first ground with coarse grind paper to increase its surface roughness. After cleaned the grease on the surface and rinsed with water, the specimens with white painting were placed in a furnace for 2 hours at 200°C in order to make the white paint solidified completely. The same procedure was repeated for the black one. Furthermore, the white uniform ink layer serves to avoid "shiny" surface, sensitive to the light reflection [39]. The example of obtained speckle pattern for the test specimens is presented in Fig. 3b.

The experimental setup is shown in Fig. 3. It consists of a high temperature furnace equipped with a glass window, a charged-coupled-device (CCD) camera (AVT Stingray F-504B), a band-pass filter (441 nm \pm 10 nm), a blue LED light source and a stretching machine. The

furnace was employed to monitor the test temperature up to 600 °C. The detector of the camera was operated with a 2452 by 2056 pixels window size and 19 μm pixel size. The camera was positioned on a tripod approximately 1 m from the specimen surface. It was fixed and kept perpendicular to the gauge part during the loading in order to collect reliable visible images. The camera frame rate was set at 4 frames per second to obtain enough sampled data while the integration time was set at 50 ms. The blue LED light source with a wavelength of 440 nm ± 20 nm was used to provide quasi-monochromatic illuminations.

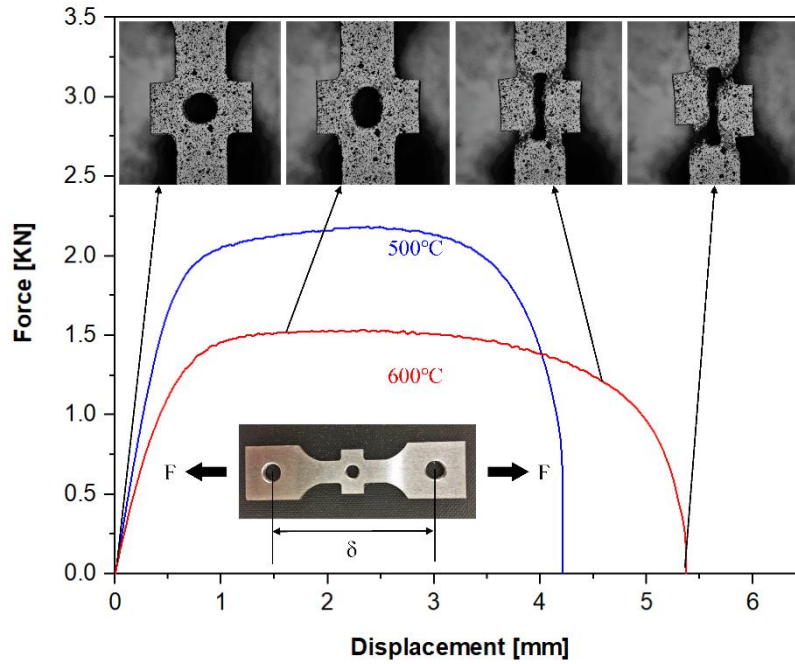
Fig. 4. The F (force) vs. δ (displacement) curve of the test specimens under both 500 °C and 600 °C temperatures, along with four images captured by the digital camera at different stages of the test.

The tensile responses (force vs displacement) of the investigated specimens for both 500 °C and 600 °C test temperatures are given in Fig. 4. The results show a maximum reachable load increases for low temperatures (the ultimate force decreases by about 30% when going from 500 °C to 600 °C). Also, the tensile strength at 500 °C was higher than that at 600 °C, showing a noticeable temperature dependence effect. A macroscopic structural softening, highlighted by a displacement of necking lips, is also observed followed by a broad plateau. This ductile behavior is more pronounced for the high test temperature conditions, exhibiting the fracture displacements of ~ 4.2 mm and ~ 5.4 mm for 500 °C and 600 °C, respectively.

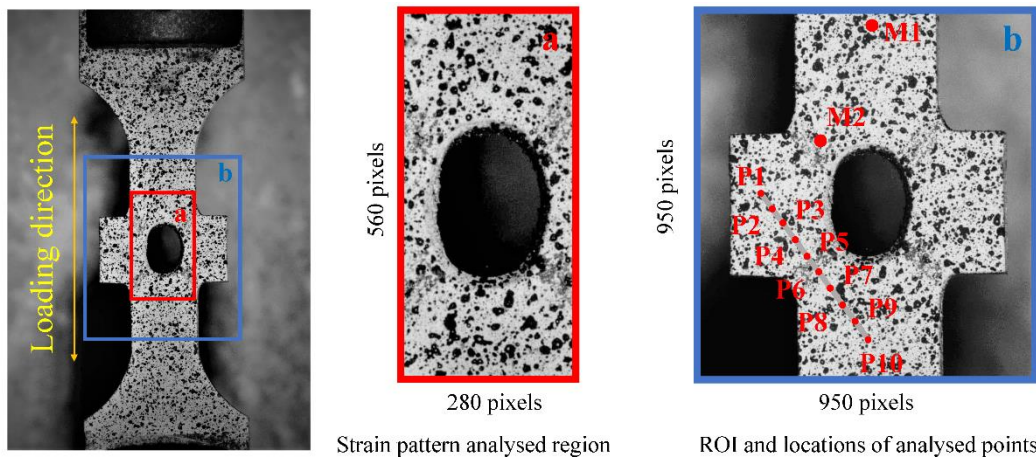
Fig. 5. Subfigures highlighting the region of interest, region for strain pattern analysis and locations of points of interest for the local kinematic analysis.

The kinematic assessments were analyzed in terms of the mean logarithmic strain components. The objective was to track the possible development of strain localization zones throughout the tensile test. The local mechanical response of the test specimens at the region of interest (ROI) was thus evaluated (see Fig.5). Dantec Dynamics software was used to post-process the visible images and assess the strain maps. Note that a preload of 100 N was performed prior to the tensile test in order to eliminate the superfluous load and strain resulted from the vacuum and thermal expansion. A subset of 41×41 pixels and a grid step of 17 pixels were used to evaluate the strain tensor at each point of interest. Cubic B-spline interpolations with normalized squared differences criterion were chosen. An area corresponding to a hole of $\varnothing 3.75$ mm at the ROI and symmetrical protrusions of 3mm on both extremities, with a size of 300000 pixels (Approximately 820 subsets per specimen), was chosen as the ROI (see Fig. 5).

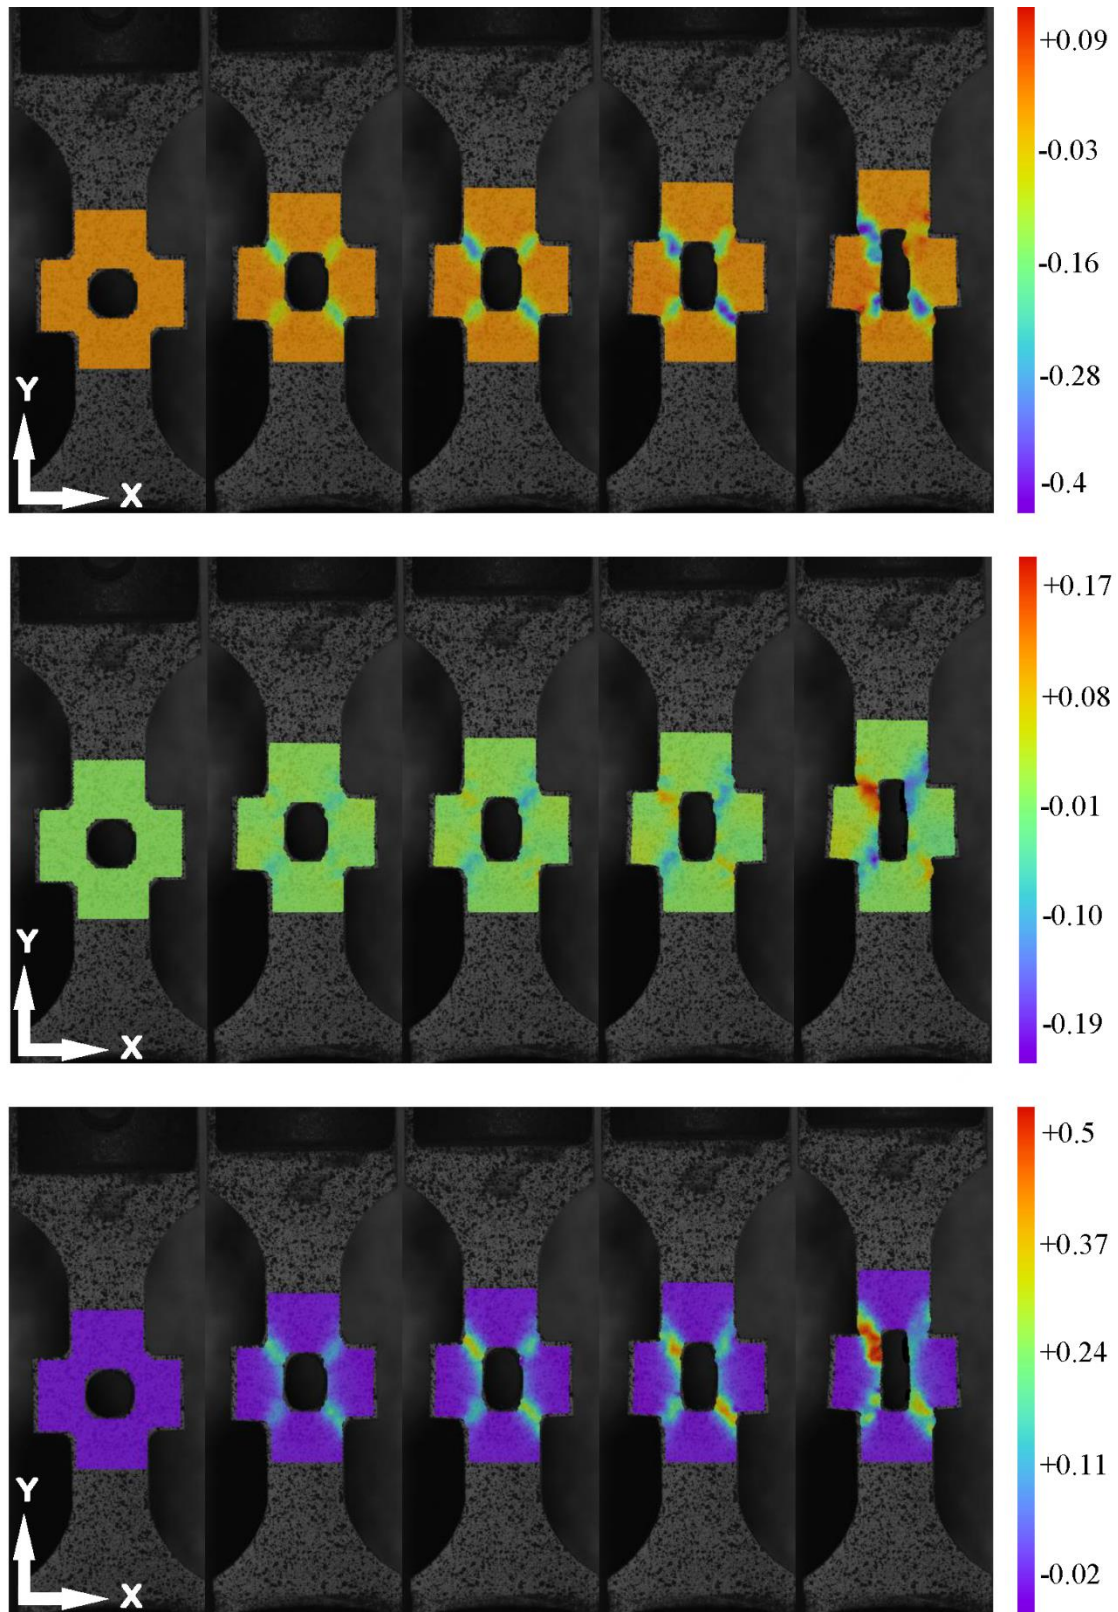
Fig. 6. 2D maps of the transverse strain, ϵ_{xx} (top), shear strain, ϵ_{xy} (middle), and longitudinal strain, ϵ_{yy} (bottom) at: the very beginning of the test ($\tau_1=0s$), intermediate times ($\tau_2=810s$, $\tau_3=1060s$ and $\tau_4=1310s$) and the last stage before the macroscopic fracture ($\tau_5=1877s$). These results were extracted from measurements performed under the 500 °C test temperature.

Fig. 6 and Fig. 7 show the full-field strain maps for the investigated FV566 tensile specimens at both 500 °C and 600 °C test temperatures, selected at different specimen life stages ($\tau_1, \tau_2, \tau_3, \tau_4, \tau_5$). The spatial resolution was set at 20 μm per pixel. The results show a precocious and gradual development of strain localization zones. These zones were clearly visible for all the strain components (longitudinal, ϵ_{yy} , transverse, ϵ_{xx} , and shear, ϵ_{xy} , components). For 500 °C condition, at the very beginning of the loading, the spatial heterogeneities were less visible as indicated at τ_1 . These heterogeneities started to intensify at the following life stages till the macroscopic failure (see Fig. 6). It is worth noting that the painting near the strain concentration zones (where the hole is located) eroded due to the high temperature and large displacement exhibited by the test specimens. This results in inaccurate strain estimate at the last stages before the macroscopic fracture. Note that most of the observed hotspots were located around the specimen hole at the ROI due to the geometry singularity. Nevertheless, the strain field contours show that the strain concentrations were not perfectly symmetric. For the transverse strain, the top-left and the bottom-right sides of the hole were slightly intensive than these on the top-right and the bottom-left sides. However, at the instant τ_5 , some of strain localization zones were significantly less intensive than others. This is probably caused by inhomogeneous features of the investigated specimen and/or the inaccuracy of the measurements. The spatial distributions of the longitudinal strain component on the top-left side of the hole were more intensive than these on the bottom-right side. From a statistical point of view, the absolute values of both the minimum and maximum longitudinal strain were almost the same at the

very beginning of the loading, highlighting the homogeneous character of the investigated gauge part. However, with the increase of the load, the absolute value of the minimum longitudinal strain was about thousand-fold lower than the maximum longitudinal strain. For the shear component, the spatial strain concentrations were mostly located on the top-left and top-right sides of the hole. As expected, the localization patterns seemed to progress preferably according to 45° angle (with a shape of “X” letter). At 600 °C (see Fig. 7), the strain localizations for the transverse and longitudinal components showed similar patterns as those obtained for the 500 °C condition while the higher values of the shear strain were appeared at top-right and bottom-left side with a shape of “/” from where sample fractured finally.

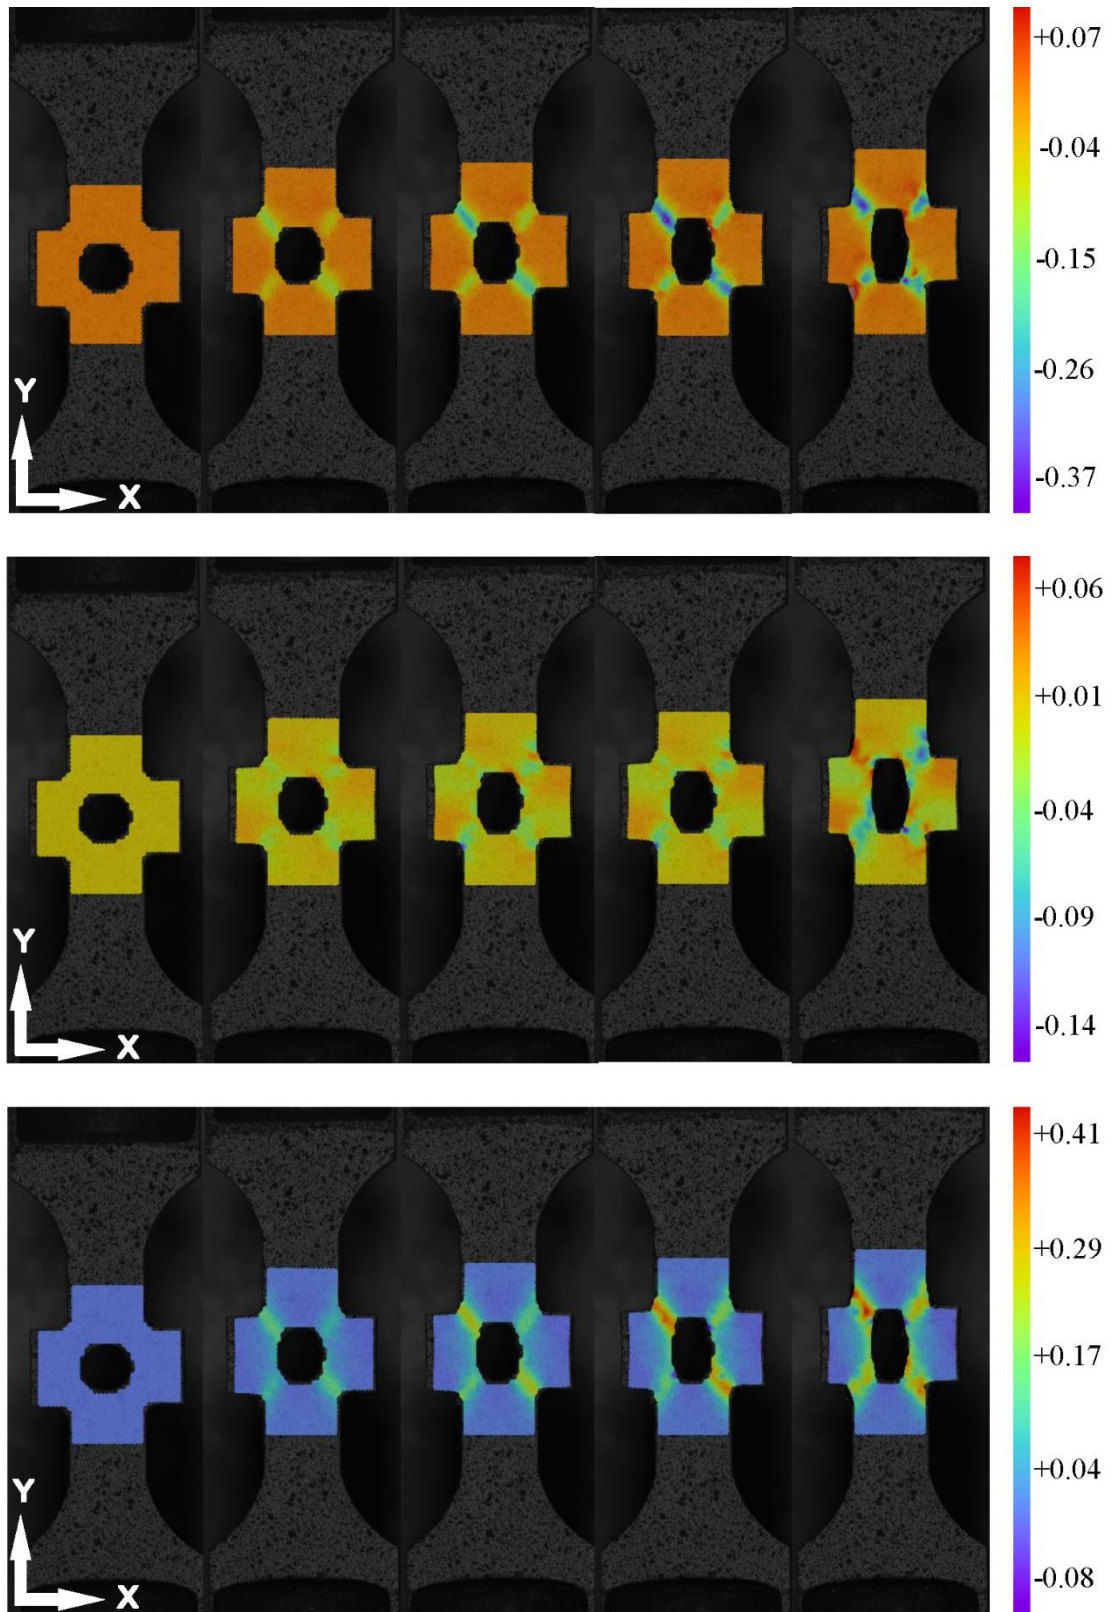
Fig. 7. 2D maps of the transverse strain, ϵ_{xx} (top), shear strain, ϵ_{xy} (middle), and longitudinal strain, ϵ_{yy} (bottom) at: the very beginning of the test ($\tau_1=0s$), intermediate times ($\tau_2=810s$, $\tau_3=1060s$ and $\tau_4=1310s$) and the last stage before the macroscopic fracture ($\tau_5=1709s$). These results were extracted from measurements performed under the 600 °C test temperature.

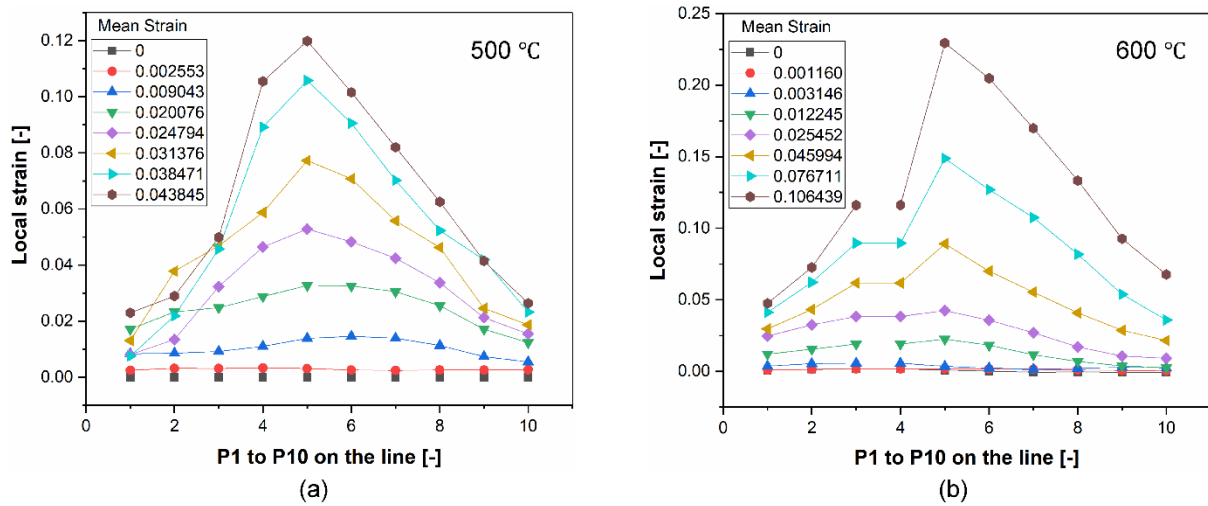
Fig. 8. Spatial-temporal distributions of the longitudinal strain component extracted at the selected points $\{P_i\}_{i=1,\dots,10}$.

Fig. 8 depicts the local spatial profiles of the longitudinal strain component, selected at different life stages (corresponding to different average strain values on the total line) and different location points $\{P_i\}_{i=1,\dots,10}$ (see Fig. 5b), from which a strain concentration zone is activated. At the very beginning of the loading, the strain distribution on the selected points was uniform. Then, strain concentrations started to appear for both temperatures when the local maximum strain magnitude reached 0.01. As expected, the local strain magnitude for both P5 and P6 was higher compared to that of the other location points. This is due to the fact that these points (where the peak of strain is occurred) are located close to the regions where the strain heterogeneities are more pronounced. The necking is especially driven by these high strain concentrations as it is highlighted in Fig. 4.

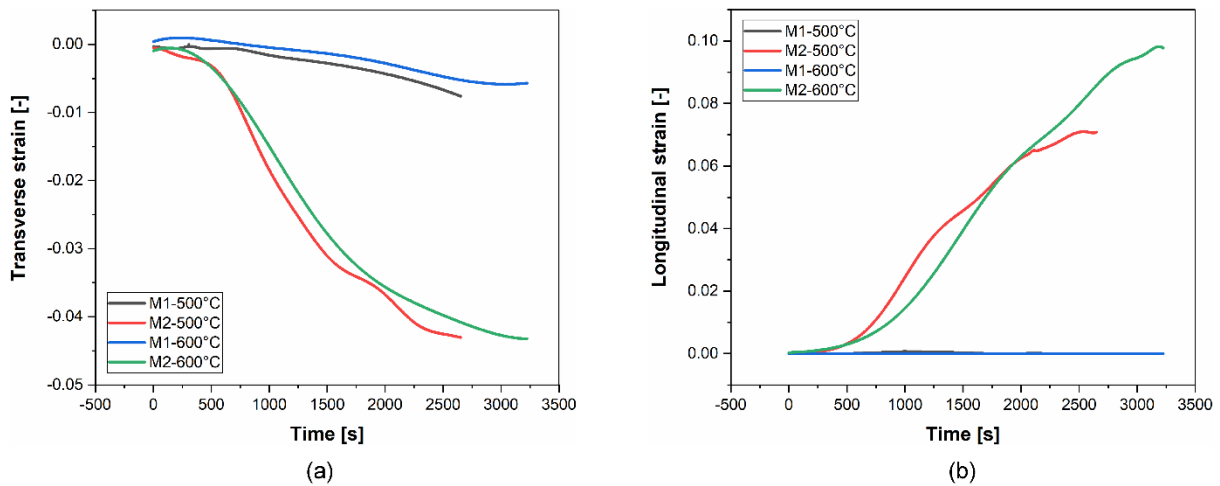
Fig. 9. (a) True transverse strain curves, and (b) true longitudinal strain curves with respect to the test time at M₁ and M₂.

Selected points $\{M_k\}_{k=1,2}$ were considered for the time dependent strain analysis (see Fig. 5b). Figs. 9a and b depict the temporal evolution at both 500 °C and 600 °C test temperatures of the selected longitudinal and transverse strain components, ϵ_{xx} and ϵ_{yy} , respectively. It can be seen that at the beginning of the tests, all strain components had very small magnitudes. After 300s, the absolute strain values at M_2 started to increase rapidly with time, while those at M_1 seemed to slightly evolve throughout the test. Indeed, Fig. 9a shows that the transverse strain curves at both temperatures were almost identical. Fig. 9b shows that the orders of magnitude of the longitudinal component for M_1 were smaller compared to those of M_2 ,

which were almost identical to the true principle strains under both test temperatures. This allows to suggest that the longitudinal strain component significantly contributed to the ductile failure of the specimen. The maximum longitudinal strain value at 600 °C was around 0.1, while this value reached 0.07 at 500 °C, highlighting the effect of temperature on the ductile damage evolution of the FV566 steel under investigation.

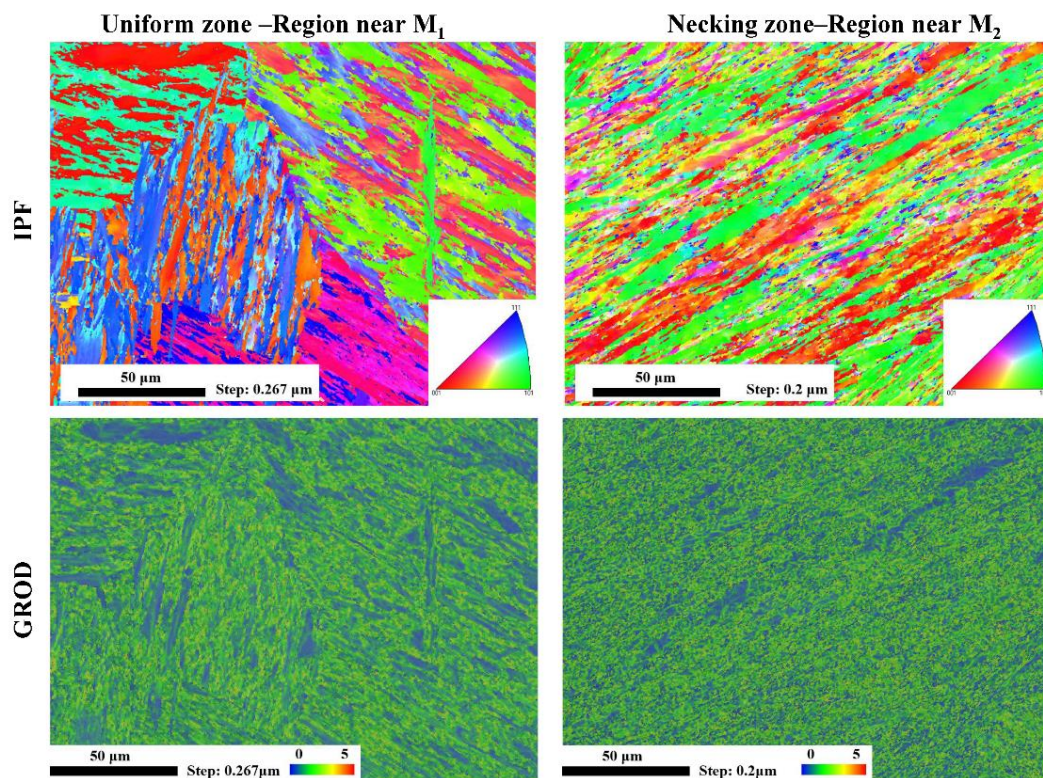
Fig. 10. EBSD results of the uniform M₁ (left) and necked M₂ (right) zones extracted from 600 °C test fractured sample.

Two areas from the ruptured surface, close to the DIC time dependent analysis regions (i.e. M₁ and M₂) were further investigated to highlight the microstructure evolution. Extensive EBSD examination has been conducted and the results are presented in Fig. 10. The inverse pole figure (IPF) images show that the pre-existing martensitic microstructure was significantly distorted along the principal loading direction, accompanied with the formation of a finer martensitic substructure. In addition, the presence of sub-block boundaries at 5 to 6 degrees in the as-received material as well as the variation of sub-block boundaries and the frequency of the low angles boundaries are highlighted in Fig. 11. The findings suggest that the dislocation slip could be the dominant deformation mechanism for the material, since dislocation slip activated by the high temperature and tensile loading may generate a large number of dislocation accumulations, which can contribute to the formation of the low angles boundaries [40]. As is well known, dislocation movement in the crystal is normally arrested by various obstacles (e.g. solid solution atom, forest dislocation, grain boundaries, etc.) during

the tensile deformation process, however the mobile dislocation can slip through the obstacles due to the thermal activation and the applied stress. In the present work, the slip system of the crystal in the FV566 steel was activated under the high temperature conditions, thereby a part of the crystal sliding was relative to the other part, which finally lead to plastic deformation.

Additionally, the grain reference orientation deviation (GROD) parameter was introduced to compare the local crystal deformation in two separate zones of the fractured specimens. It is proven to be linearly related to the nominal plastic strain under both tension and creep condition [41]. The higher value of GROD extracted from the necked zone implies that the plastic deformation in the necked area is larger than that in the uniform zone away from the fracture area, which is consistent with the aforementioned DIC measurement results. As is observed in Fig. 6 and Fig. 7, significant strain concentration was observed around the necked area due to the geometry singularity of the tested specimens. The strain concentrations in the necked area result in the deformation heterogeneity and microstructural rearrangements of the FV566 specimen at high temperature tensile conditions.

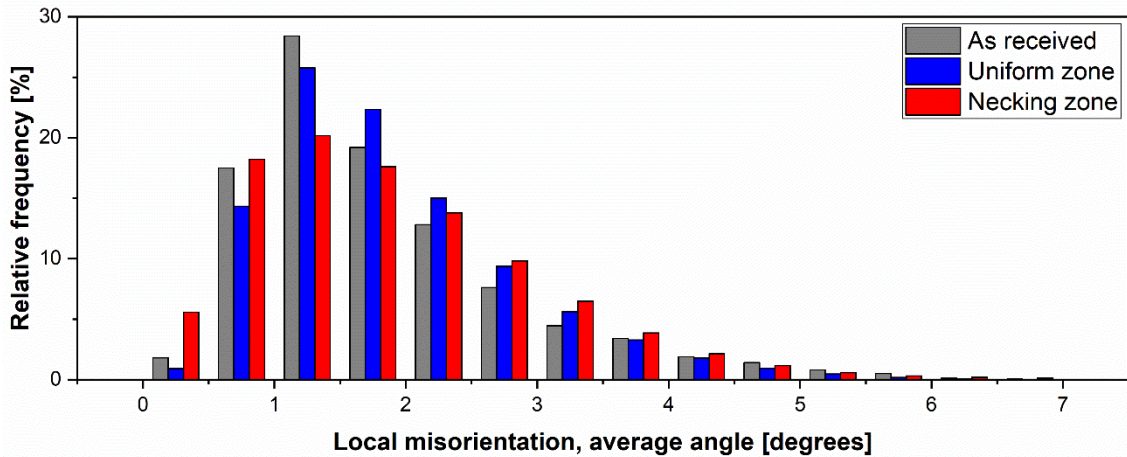
Fig. 11. The distributions of the misorientation angles across the lath and sub-block boundaries for the as-received material and uniform/necked zones of fractured sample.

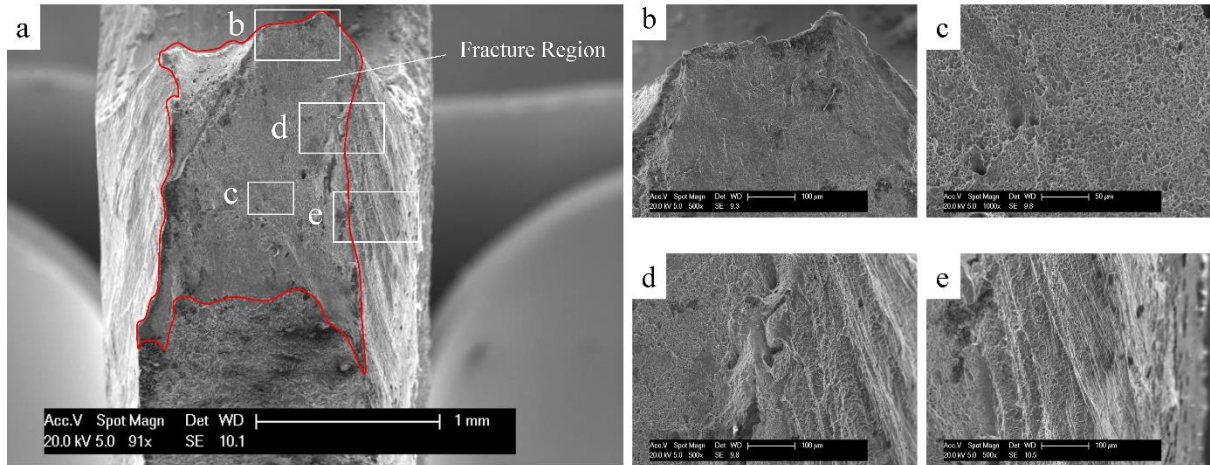
Fig. 12. Scanning electron micrographs of fractured specimens tested at 500 °C showing (a) the overall fracture morphology and (b-e) zoomed details of the local fracture features.

In Fig. 12a and Fig. 13a, a visible necked area as well as a rough surface can be observed on SEM fractography images of both fractured samples subjected to 500°C and 600°C test temperatures, highlighting a large amount of plastic deformation. Zoomed details of other subset areas (namely b, c, d and e in Fig. 12a and Fig.13a) are exhibited in order to deeply investigate the fracture characteristics. A typical dimpled zone and some equiaxed shear dimples surrounded by a shear lip show the typical ductile fracture behavior of the fractured samples at high temperature conditions. The rough surface caused by the large amount of plastic slip during tensile deformation is observable on the plastic deformation path and the micrographs near the shear lip of the sample are also illustrated. Different from the fracture surface of the sample tested at 500 °C, 600 °C tested sample involves a more distinct necking lip on the fracture surface as shown in Fig .13a. Highly correlated to the displacement of ~ 4.2 mm and ~ 5.4 mm for both 500 °C and 600 °C, respectively, see Fig. 4, this fractography observation proves, from micro scale aspect, that the ductile behavior is more pronounced for the specimen tested at higher temperature.

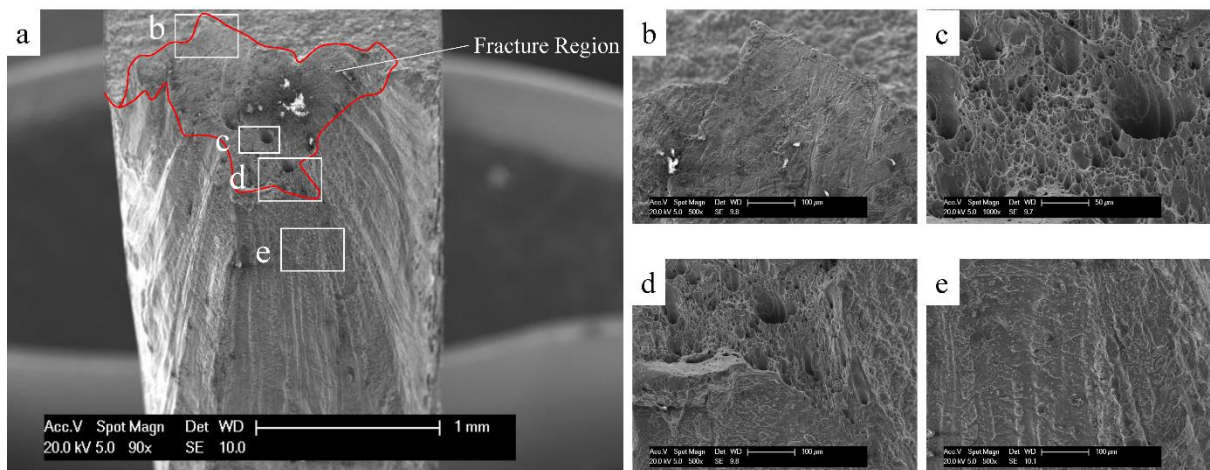
Fig. 13. Scanning electron micrographs of fractured specimens tested at 600 °C showing (a) the overall fracture morphology and (b-e) zoomed details of the local fracture features.

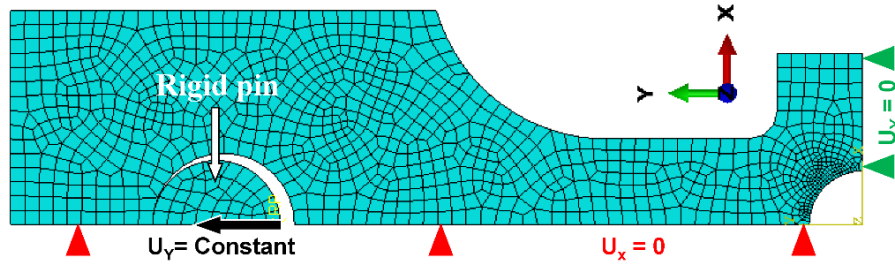
Fig. 14. FE model showing the mesh properties and boundary conditions ($U_y = 1.8\text{mm}$ for the 500°C test and $U_y = 2\text{mm}$ for the 600°C test) used for comparison with the experimental DIC results. Two symmetry conditions were considered with a sample quarter body modelled.

A quarter of the specimen was considered for the FE analyses as indicated in Fig. 14. The loading pins were modelled by a rigid body while a friction free contact was considered between the pins and the specimen holes. The contact between the pin and the specimen was assumed as standard surface to surface interaction where the outer surface of pin was the master surface and the inner surface of the specimen hole was the slave one. A constant displacement loading was applied in the Y-direction at the pin reference point in order to simulate a similar experimental protocol, for which the magnitude was set at 1.8 mm and 2 mm for both the 500 °C and 600 °C test temperatures, respectively. The 3D FE model mesh consisted of 4979 C3D8R elements with 8-noded linear brick, reduced integration, and hourglass controlled.

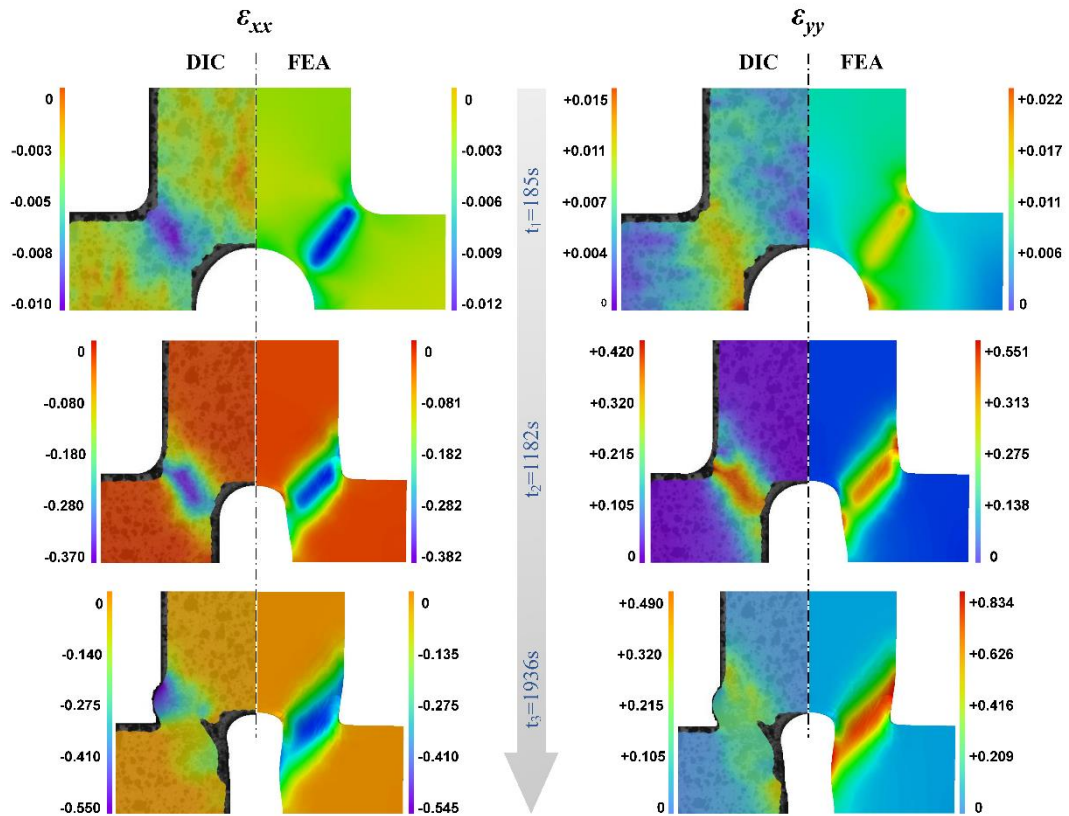
Fig. 15. Comparison of the DIC (left) and numerical (right) strain contours at 500°C test temperature.

Transverse and longitudinal strain patterns of the ROI obtained by DIC measurement and FE analysis are presented and compared in Fig. 15 and Fig. 16. For both 500°C and 600°C investigated temperatures, the spatial-temporal strain distributions and magnitudes were found to be in good agreement, revealing that DIC data trends were consistent with the FE simulation results. The strain localization zones for both experimental and FE data were almost identical even on an atypical strain concentrations area. However, an important difference in the strain magnitude was reported for the longitudinal strain component at the last stages of the loading. This difference may be attributed to the error accumulation of the loading rig, inaccuracy of the DIC measurements, inhomogeneous character of the investigated specimens and/or limitations of current FE model. Fig. 17 shows a comparison of the longitudinal strain plots for both DIC and FE analysis on positions extracted from the same line as introduced in Fig. 5b. The FE simulation results show strain magnitudes that were mostly higher than those of the DIC measurements especially for the high strain locations. Although the magnitude differences are not ignorable, it can be inferred that this methodology provides a good quantitative validation of the DIC measurements at high temperature conditions.

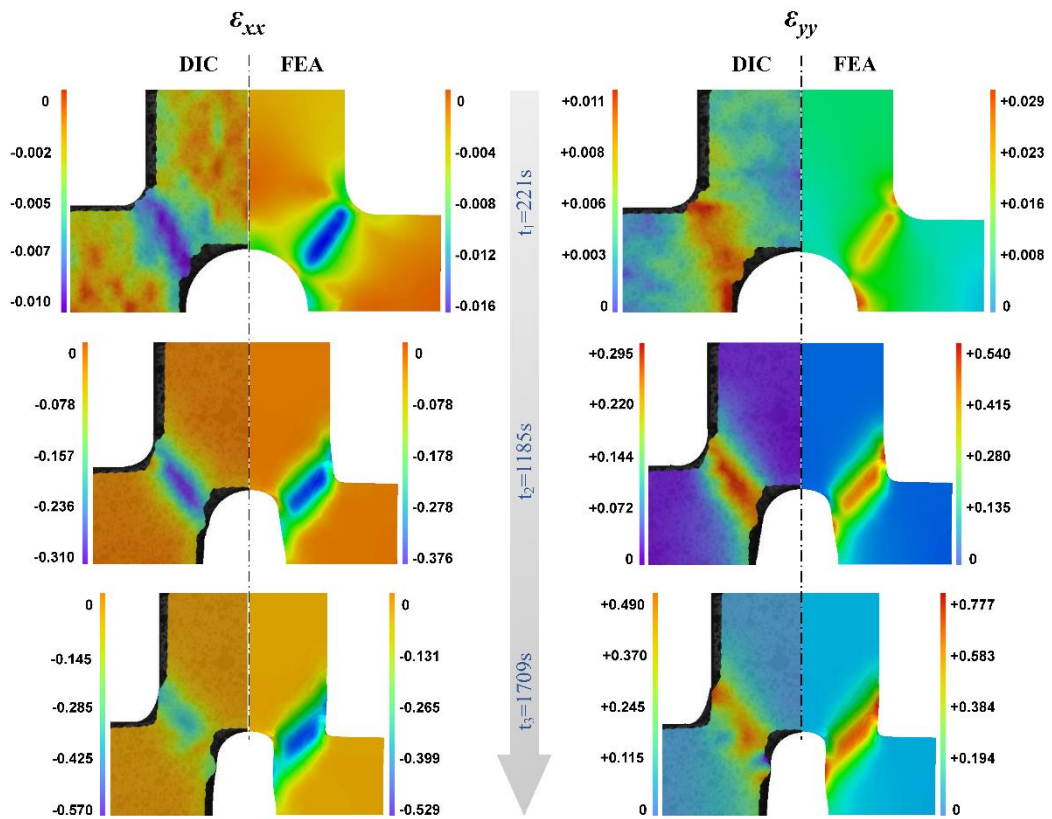
Fig. 16. Comparison of the DIC (left) and numerical (right) strain contours at 600°C test temperature.

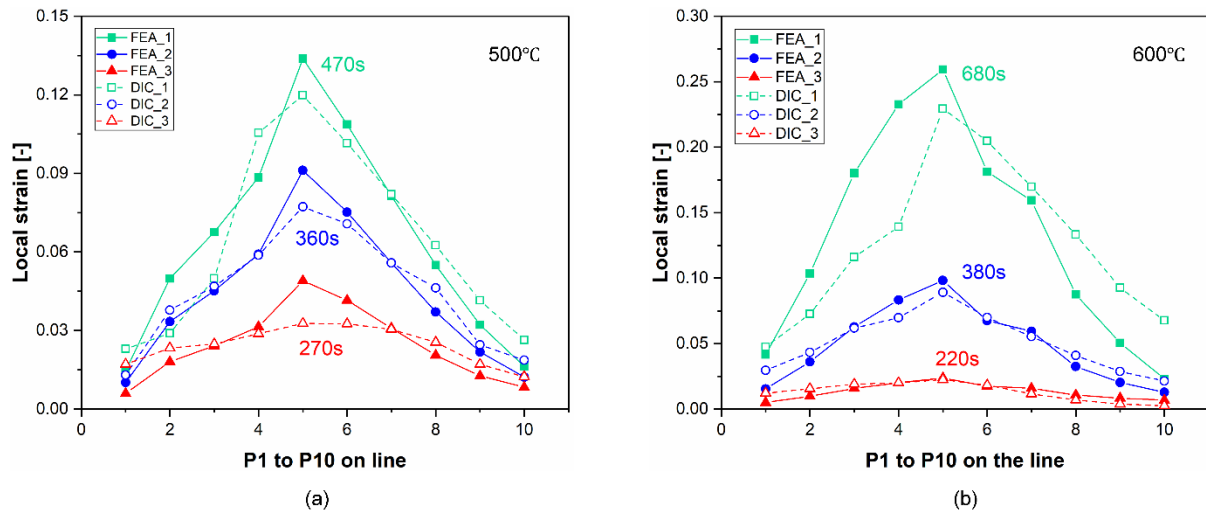
Fig. 17. DIC and FEA longitudinal strain profiles on positions extracted from the same line P1 to P10 (see Fig. 5b).
