**Evaluation of Three-Dimensional Photogrammetric Model from
Low-Cost Digital Camera Applied in the Cultural Heritage Registry**
Avaliação de Registro Arquitetônico por Meio de Modelo
Tridimensional Fotogramétrico Gerado a Partir de Câmaras Convencionais

George Deroco Martins; Henrique Cândido de Oliveira;
Rodrigo de Araújo Bezerra Gallis & Daiane Vieira Vaz

Universidade Federal de Uberlândia,

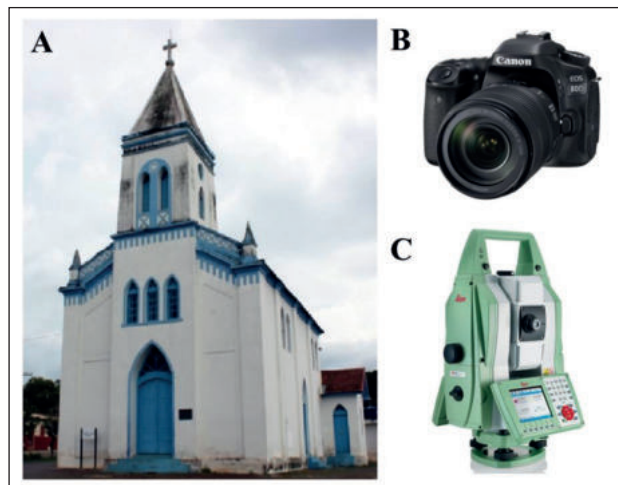
Figure 1 A Nossa Senhora do Rosario Church B Camera Canon 600D C Total Station Leica MS-50 with Laser Scanning

The object of study is the "Nossa Senhora do Rosario Church" (Figure 1 A), located in Monte

Carmelo, State of Minas Gerais, Brazil. This church was chosen due to its historical, cultural and social importance to the city. The data acquisition for the 3D reconstruction was carried out by using a Canon 600D low-cost digital camera. The reference point cloud for the evaluation of the reconstruction was obtained by a total station Leica MS-50, which is assembled with a laser scanning module.

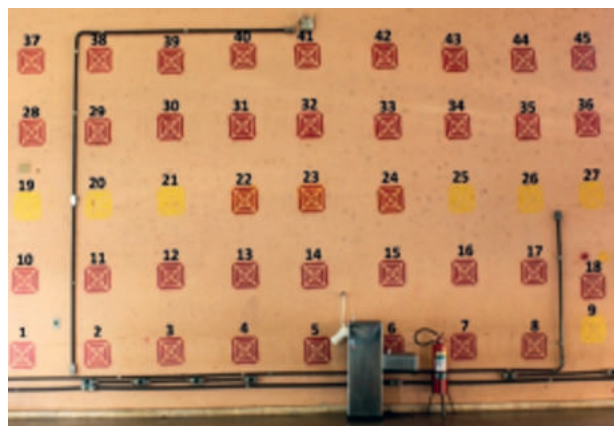
Figure 2 Calibration field adapted on a wall. In total, 45 targets of 0.26 m with a center of 0.02 m²

For the adjustment of the internal orientation parameters (IOP) of the camera, an auto calibration was performed, being used for this purpose a calibration field according to Figure 2. The coordinates of the field targets were measured using a total station Leica MS-50, considering a local coordinate system.

The necessity of a camera calibration is explained by the fact that the movement of the camera and the lack of geometric stability change the alignment between the lenses and the camera body, modifying the IOP. For the church data acquisition and camera calibration the focal length was set in 18mm.

Three photographs in convergent arrangement were taken, considering all images registering all targets and varying their rotations in relation to local coordinate system (2 in landscape and 1 in portrait orientation). This configuration was used to avoid parameters correlation during the bundle block adjustment process. After the data acquisition the calibration was performed in the CC software developed by (Galo, 1993).

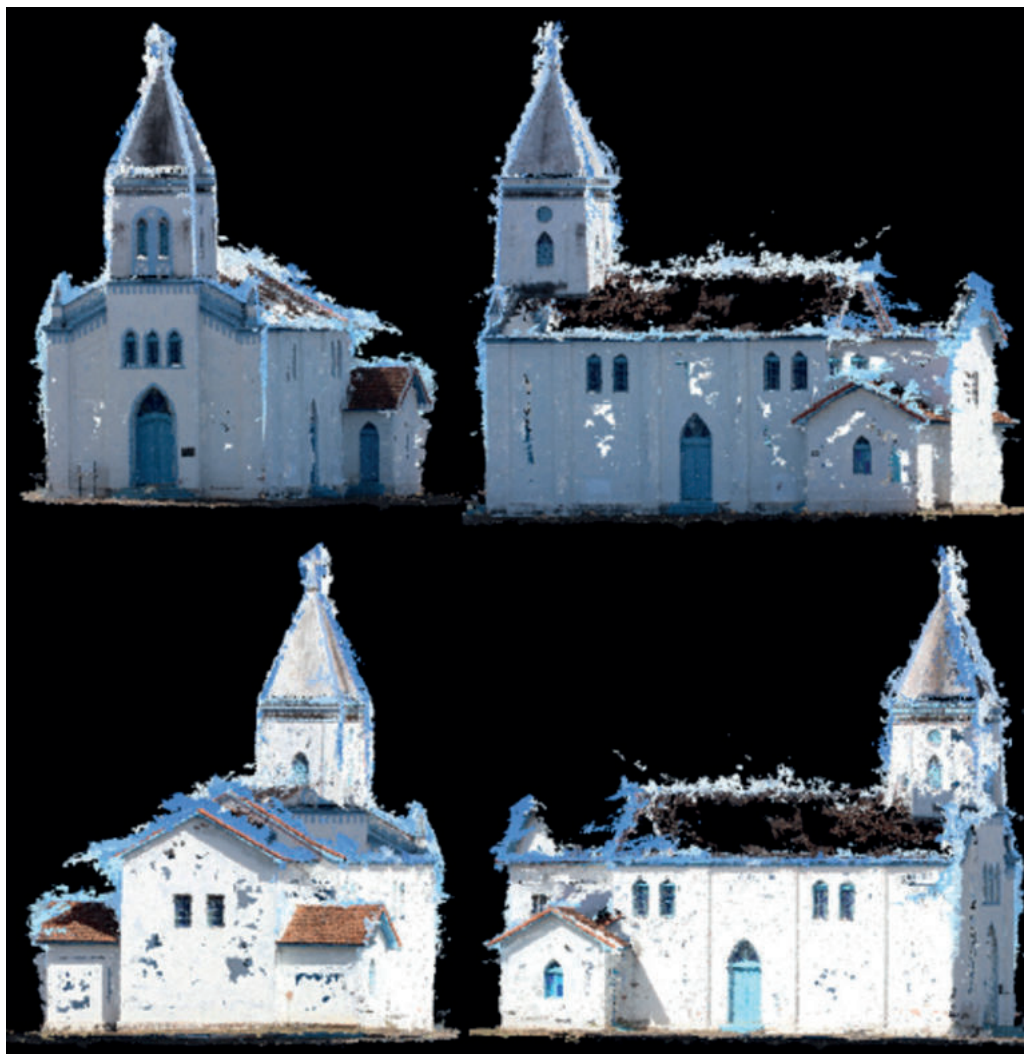
Figure 3 Densified point cloud of the facades of the Nossa Senhora do Rosario Church

92 images and their related information, including the calibrated focal length and other IOP, coordinates and estimated Euler angles are used for input information during the generation of a photogrammetric point colud (Figure 3).

With the adjusted coordinates and the overlays of the images, the software generated a point cloud and its densification, as shown by Figure 3.

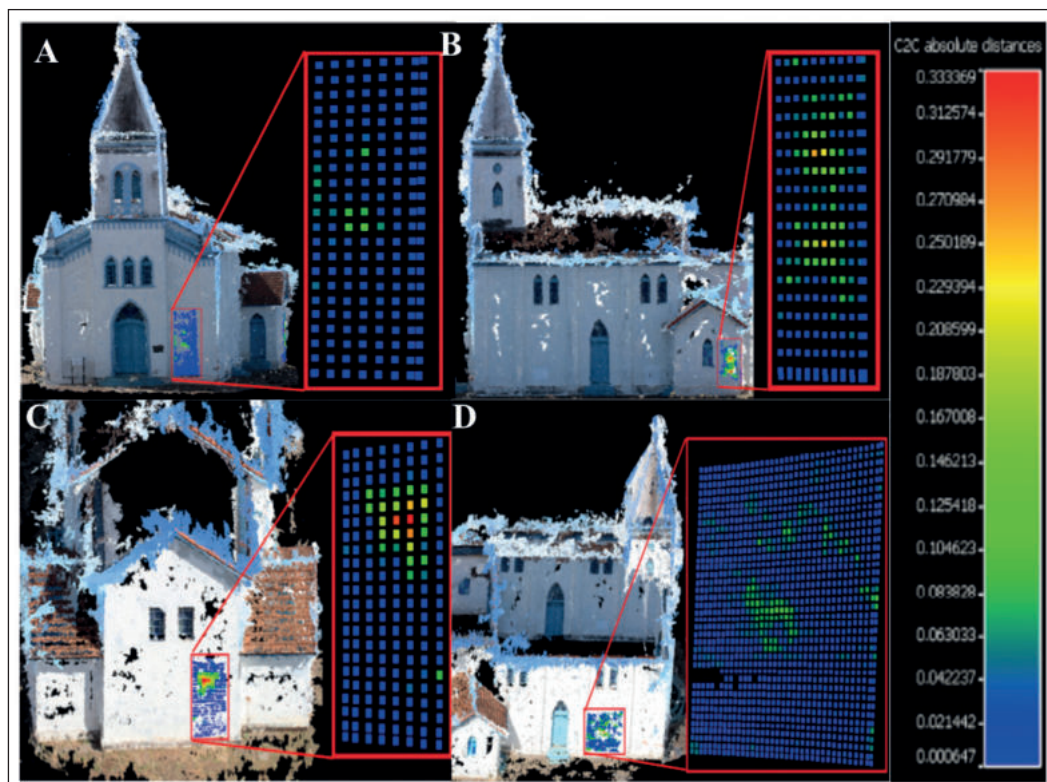
Figure 4 Comparison of the color scale distance of the Nossa Senhora do Rosario Church facades A Front B Back C Left side D Right side

The plot of points in relation to the difference in meters, also obtained from CloudCompare comparison tools, allowed the analysis of the distances in a color scale, therefore that colder colors correspond to a shorter distance and warmer colors at larger distances. This scheme of visualization (Figures 4 A, 4 B, 4 C e 4 D) facilitates the analysis of the distance between clouds belonging to each facade of the church.

The sample corresponding to the front of the church presented a predominance of distances below 0.5m (Figure 4 A). Nevertheless, there are some point's concentrations with bigger variation, reaching approximately 0.15 m. The right side facade (Figure 4 B) had a similar pattern to the front, however, containing higher number of points with high standard deviation. This pattern was repeated for the back and left side of the church, in Figure 4 C and Figure 4 D, respectively.

The back facade was the one that presented the highest distance values of the comparison, reaching more than 30 cm of difference. In addition, the left side had a variation limited to 0.12 m of difference.

Comparing the photogrammetric cloud and the distances, it is observed that the differences, approximately 0.15 m above the standard, correspond to regions of failures during generation the photogrammetric cloud, as shown in Figure 4 A, referring to the models of the front face of the church. This pattern was repeated for the other faces of the church (Figures 4 B, 4 C e 4 D), and the larger the void area presented in the cloud greater is the variation in distance observed in CloudCompare.

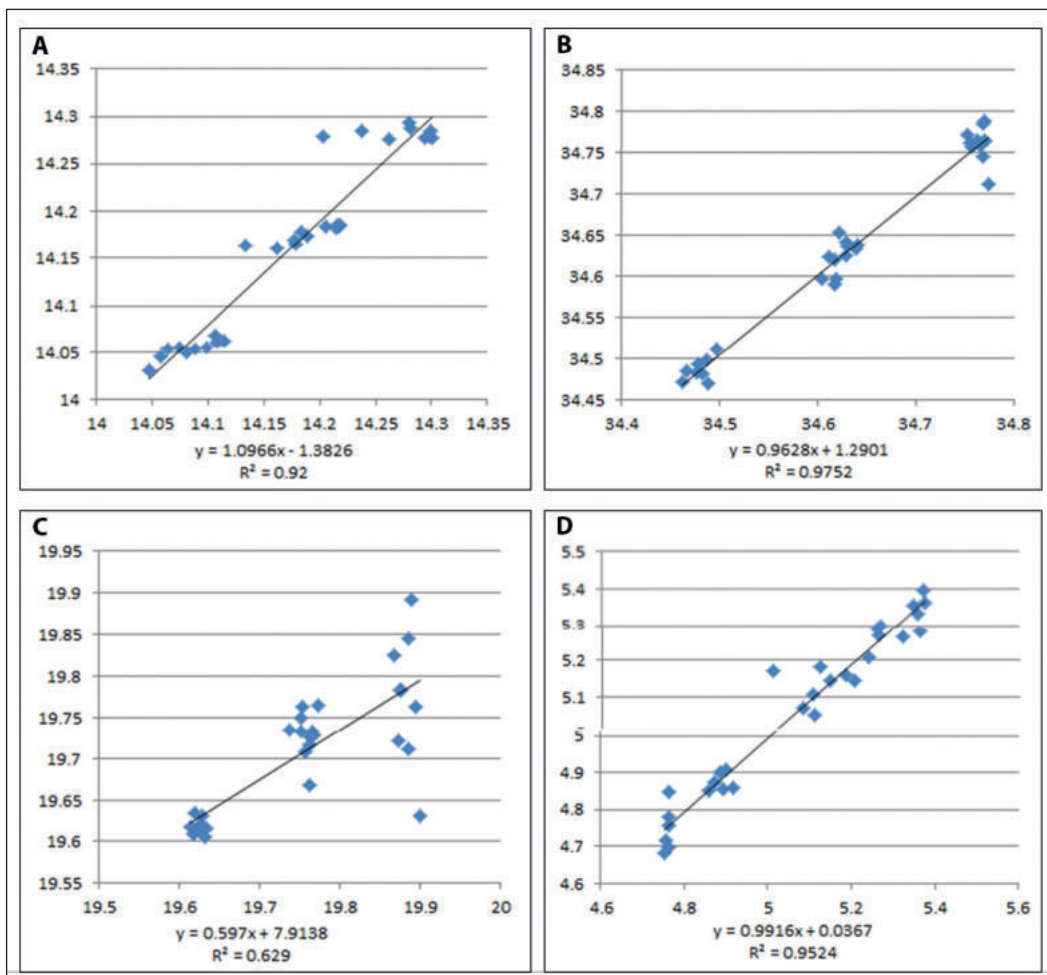
Figure 5
 Scatter plot between laser and photogrammetric scanning models of the Church facades
 A Front B Back
 C Left side D Right side

The coefficient of determination (r^2) of the linear regression describes the relationship laser and photogrammetric scanning models, for each facade. The front of the church presented a r^2 of 92%, for the back one is 97.5%, the right side with 62.9% and the left side a value of 95.3%. A r^2 above 95% can be considered ideal (back and side left), and above 90% can be considered good (front case), but values less than shows that the correlation between the models is weak (right side).

Analyzing the values for the RMSE, the proposed method had 0.029m for the front facade, 0.018m for the back facade, right side with 0.078m and left with 0.049m. This result represents the errors embedded in the clouds in relation to the dispersion of the points. Thus, the front and back faces presented minor errors, in agreement with the coefficient of determination greater than 95% and concentration of the data in the adjustment of the line, as the graphs A and B.

On the other hand, the result of the right side shows a high dispersion of the data (Graph C), with

a low correlation coefficient and high RMSE. While the left side, despite presenting considerable coefficient of determination, had a high RMSE, which can be explained by the low precision in the dispersion of data (Graph D).

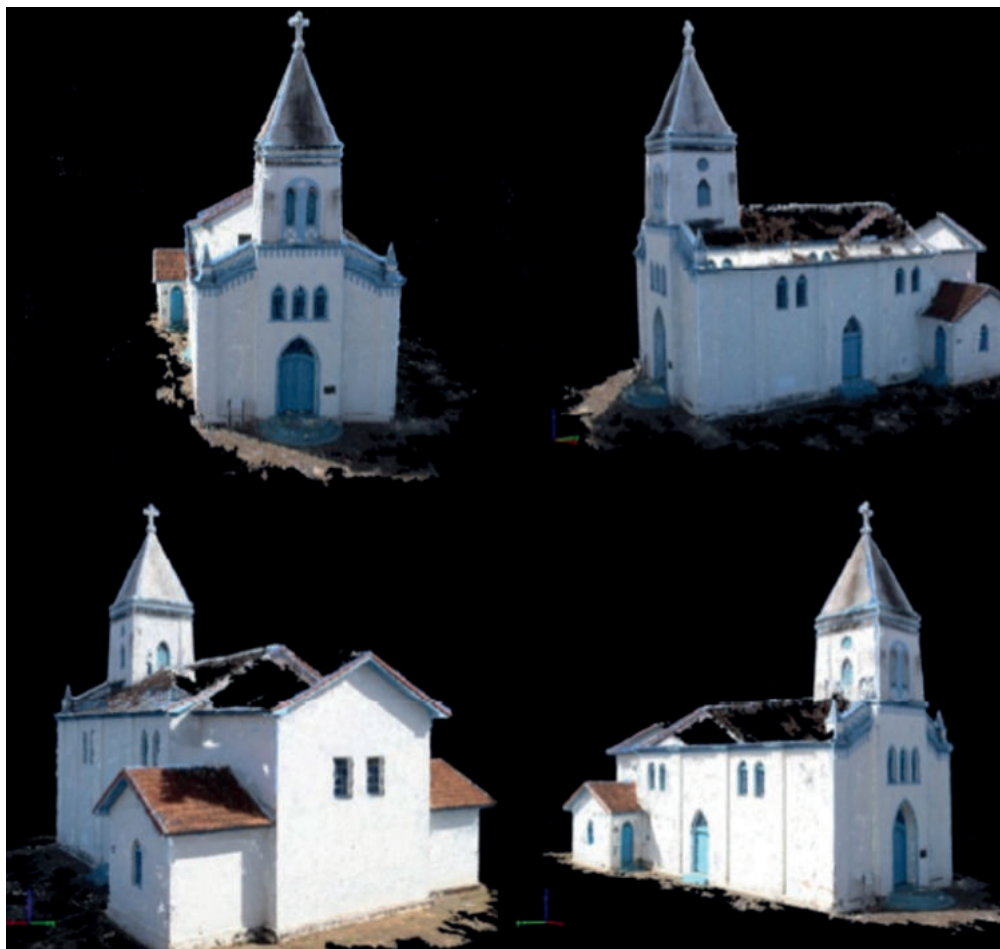
Figure 6 Texturizing 3D model of Nossa Senhora do Rosario Church

even closer of reality, with the addition of colors and textures to the cloud. Some products can be generated from the photogrammetric cloud, among these, we highlight the realistic representations as the textured surfaces (Figure 6).

The visual presentation obtained by texturing is very close to visual reality of the building. Analyzing the visible details in the structure, it is noted the divisions between the window panes (± 2.5 cm), the identification of the position of the targets used as control points (4 cm), and even the brick division of the foundation of the structure (± 1 cm). Still small imperfections are visible, such as stains on the building's paint and the detail pattern architectural can be easily extracted on the restitution.

In this letter, the three-dimensional model was not intended to represent the roof of the church, thus being presented in vain or empty. This is caused by the fact that the methodology used did not use tools to capture aerial images, such as an UAV (Unmanned Aerial Vehicle). However, the same procedure can be applied for a dataset acquired by this type of platform.

The product generated presented a very high luminosity difference, due to the church position in relation to the sun and the difficulty of using artificial lighting. The photos of the left side presented a high level of brightness, which apparently reflected in the texturing as a greater contrast. The reverse happens with the front and right side of the church, with a lower brightness in the images and lower contrast in the model.

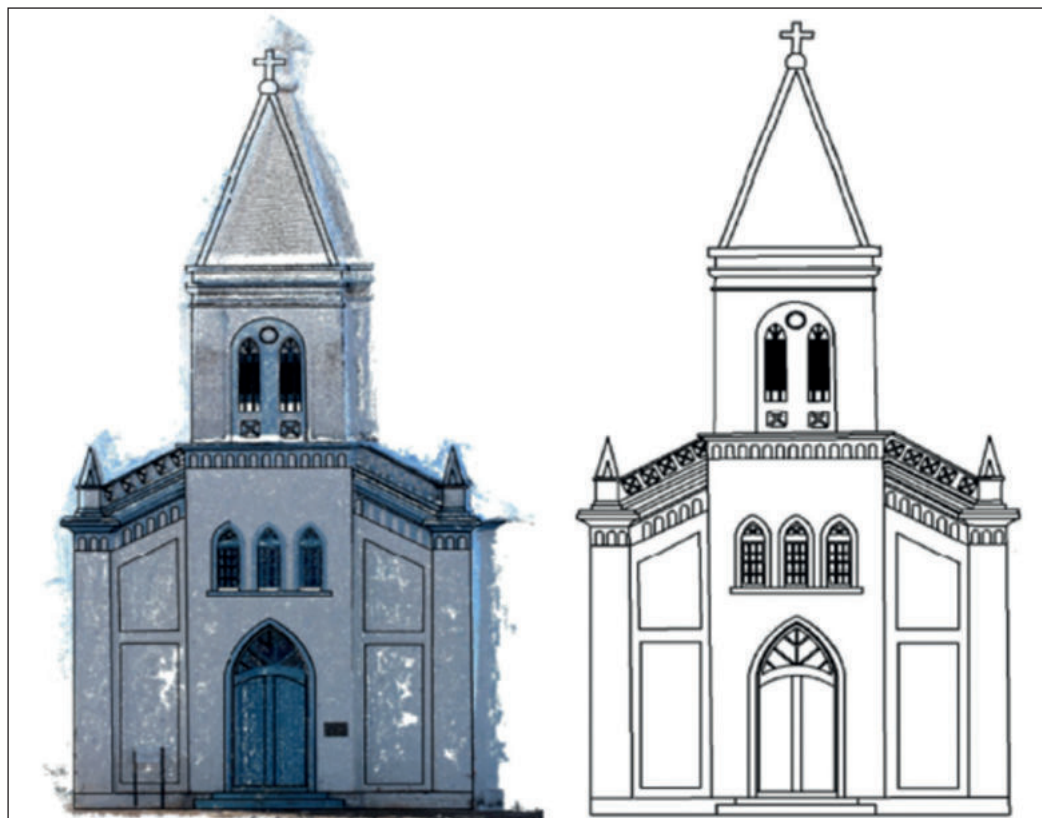
Figure 7
Restitution of
the facade of the
Church of the
Rosary

Another product generated was the restitution of the four facades of the church (Figure 7),

performed in AutoCad software based on the photogrammetric point cloud. This restitution is an example of possible point cloud application as used in this work. This type of product is a form of historical record, which according to Wutike *et al.* (2005), contributes to visual restorations of the structure, such as the National Museum in Rio de Janeiro – Brazil, that was destroyed during a fire in September of 2018.
