Sustainable building assessment of colonial shophouses after adaptive reuse in Kuala Lumpur

Sustainable Building Assessment of Colonial Shophouses after Adaptive Reuse in Kuala Lumpur

Keywords: adaptive reuse; heritage building; colonial shophouse; sustainability; indoor environmental quality; Malaysia

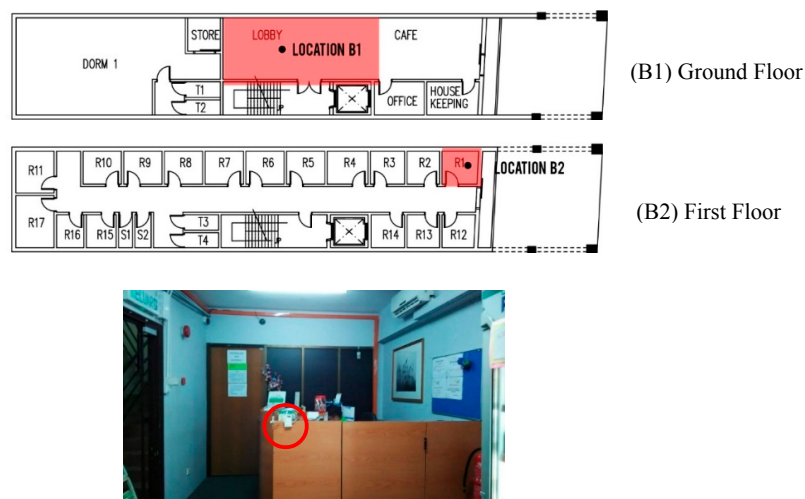
Figure 5. Location of data loggers in Building B.

In addition, the indoor environmental conditions of both case studies were monitored using four HOBO data loggers as shown in Figures 4 and 5. Each data logger was equipped with sensors to

- Location A1: Lobby (Ground Floor of Building A)
- Location A2: Room (First Floor of Building A)
- Location B1: Lobby (Ground Floor of Building B)
- Location B2: Room (First Floor of Building B)

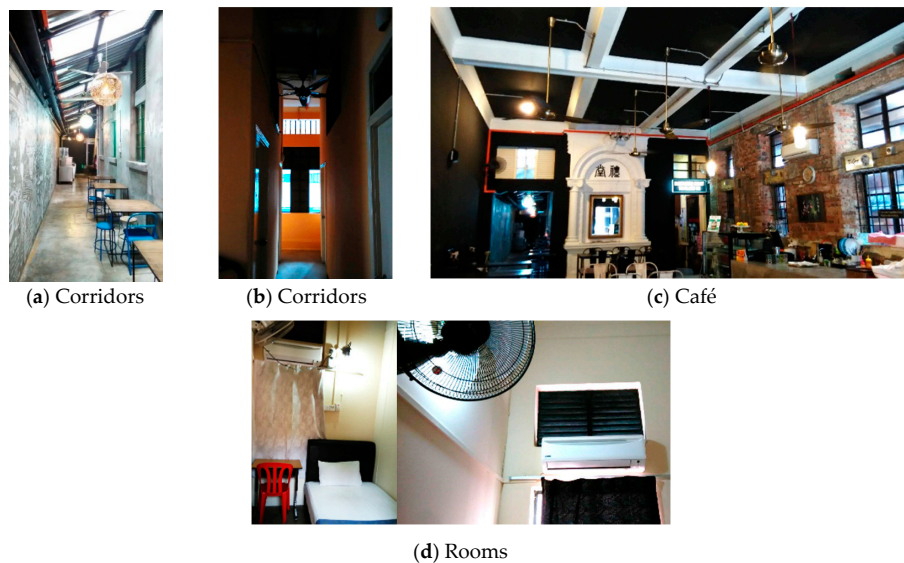
In Building A, mechanical ventilation such as fans are used to ventilate the interior public spaces such as the café, lobby, kitchen and even the corridor, as shown in Figure 6. The air-conditioners are only operated during the afternoon period in the café to provide a pleasant dining environment for the guests. Natural ventilation and fans are used in other parts of the day to reduce the operational cost. The hotel rooms in Building A are equipped with a fan and air-conditioners which allow the

guests to select their preferred type of ventilation as shown in Figure 6. In addition, smoke vents are provided in the kitchen, as well as openings in the toilets to remove unpleasant smell and moisture from the building.

Figure 6. Types of mechanical ventilation in corridors, café and rooms in Building A.

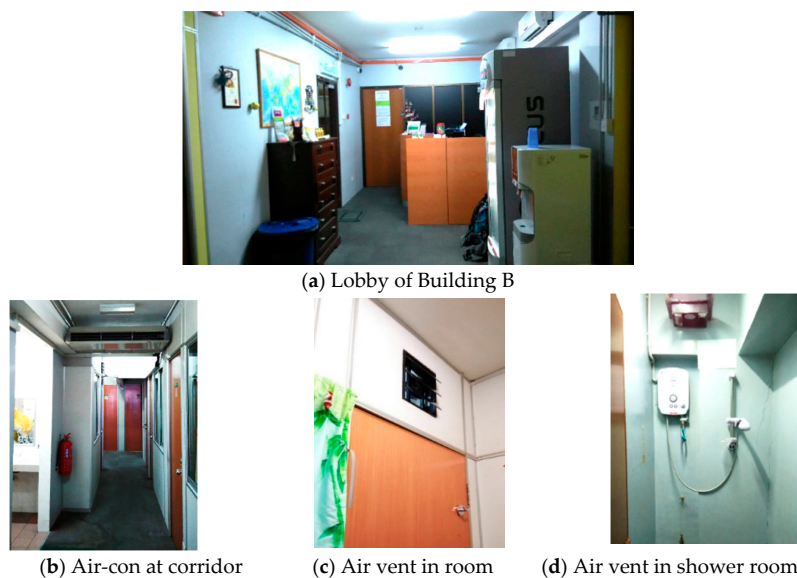
On the contrary, all spaces in Building B are entirely air-conditioned as shown in Figure 7. This building only has openings on the front and back facades. Side openings are not provided on the wall of the additional floors. During the adaptive reuse renovation, the courtyard area which was originally situated in the middle of the building was fully covered with new suspended floors. It was also found that Building B now consumes more electricity, as previously recorded by the building owner. All air-conditioning systems are positioned in the corridor while wall-mounted mechanical air vents are provided to distribute cold air into each hotel room. More air vents are provided at the toilets and shower rooms. For both case studies, neither obvious dampness on the indoor surfaces nor moisture was visually spotted in the interior spaces.

Figure 7. Building condition in Building B.

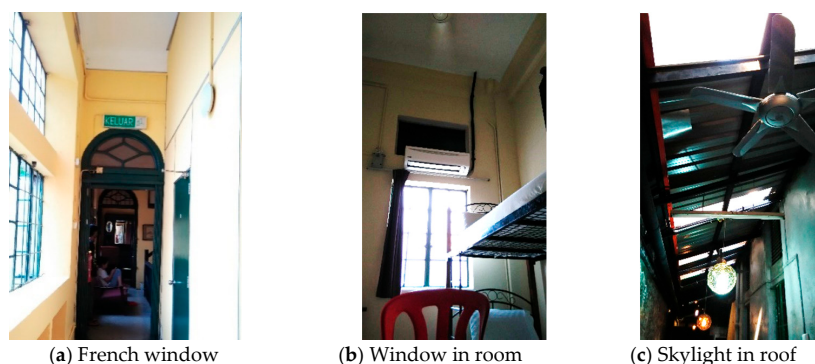
For Lighting, Visual and Acoustic section in the indoor environmental assessment, there are eight main requirements that were assessed. Building A shows more functional openings which were maintained, and provides sufficient level of daylight for the occupants as compared to Building B (Figure 8). Inadequate amount of openings at Building B, as mentioned earlier, plus the deep building plan causes the interior of this building to have a low level of natural light. It was also found that not all windows provided in each room are functional; they only act for decorative purposes. Both case studies provided flexible lighting control and blinds to prevent glare which meet the second and fourth requirements. In addition, energy saving lighting, such as LED lighting, was found in Building A, however, they were not functional, while Building B gained a zero rating for this assessment. In addition, both shophouses do not provide any motion sensors to further reduce the electricity usage.

Figure 8. Architectural features in Building A.

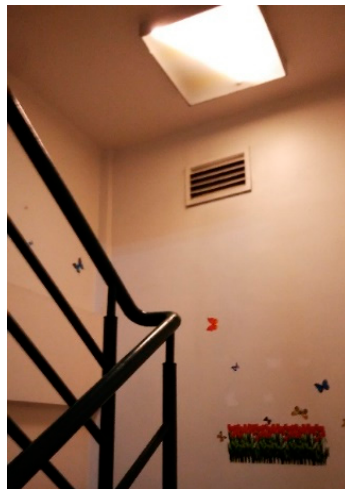
In Building B, the indoor spaces have fewer openings, as the building is hemmed in on both sides in a middle along the Jalan Sultan. From the assessment is found that Building B depends entirely on artificial lights as the structural adaptation of the building is not well-designed. Therefore, natural daylight is unable to reach the interiors which cause the building to use more energy for lighting. Fluorescent troffers are used on the staircase area (Figure 9) while parabolic louver fluorescent troffer and fluorescent light can be noticed along the corridor and rooms.

Figure 9. Lensed fluorescent troffer in Building B.

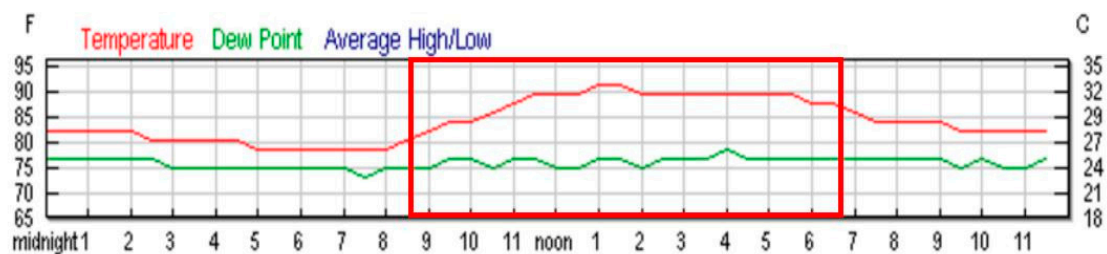
This section presents one day of data which represents a typical clear and sunny day in Kuala Lumpur. Figure 10 shows the air temperature of Kuala Lumpur on 18 March 2016 which was recorded and collected from a nearby weather station. The records showed that the air temperature ranged between 28 °C and 34 °C in the 24 h cycle and the average air temperature was approximately 30 °C. Besides this, the average air humidity for the same day as recorded by the same weather station was approximately 76% while the maximum was 89% and minimum 39%.

Figure 10. Air temperature in Kuala Lumpur on 18 March 2016.

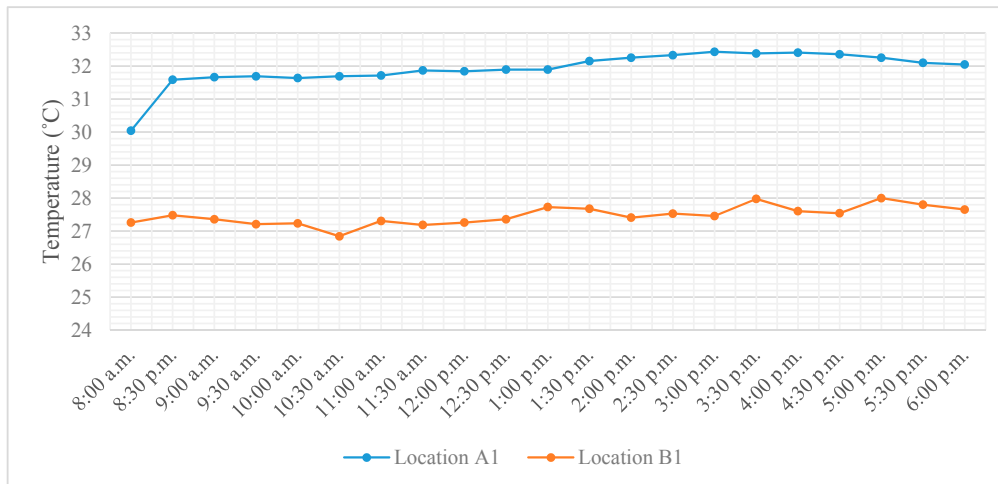
temperature range. According to Figure 11, the indoor air temperature at location of A1 recorded an average air temperature about 31.92 °C and the indoor air temperature fluctuated in a range between 30.04 °C–32.43 °C, due to reliance on fans for ventilation. At location B1 however, it was stable at around 27 °C as the lobby was situated in a fully air-conditioned space. From these findings, it was noticed that the indoor air temperature in lobby of both shophouses was quite stable throughout the recorded day and was not influenced by the outdoor air temperature.

Figure 11. Indoor air temperature in the lobby of Building A (Location A1) and Building B (Location B1).

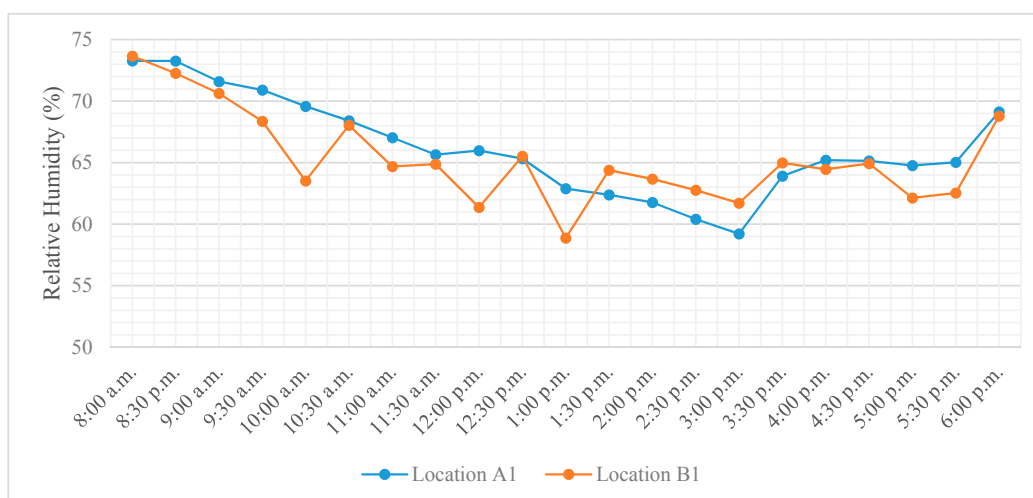
Relative humidity (RH) also plays an important role in achieving indoor comfort. As shown in Figure 12, location A1 and B1 started the day with the highest level of RH. RH at location A1 started at 73.28% which gradually decreased to the lowest level at 59.22% at 3:00 p.m. The RH level raised after 3:00 p.m. to 69.13% at 6:00 p.m. Overall, the mean indoor RH at location A1 was around 66.23%. In opposite, the RH of location B1 started with 73.66% and it gradually decreased until 10:00 a.m. then fluctuated until 1:00 p.m. The recorded RH increased steadily after 1:00 p.m. At the end, location A1 and location B1 recorded similar levels of relative humidity that ranged between 55–70% that is slightly above the requirement for comfort condition. The recorded RH levels at both location A1 and B1 are within the recorded outdoor RH levels of between 39% and 89% as mentioned earlier. This is due to the use of mechanical ventilation and air-conditioning at both locations.

Figure 12. Indoor relative humidity in the lobby of Building A (Location A1) and Building B (Location B1).

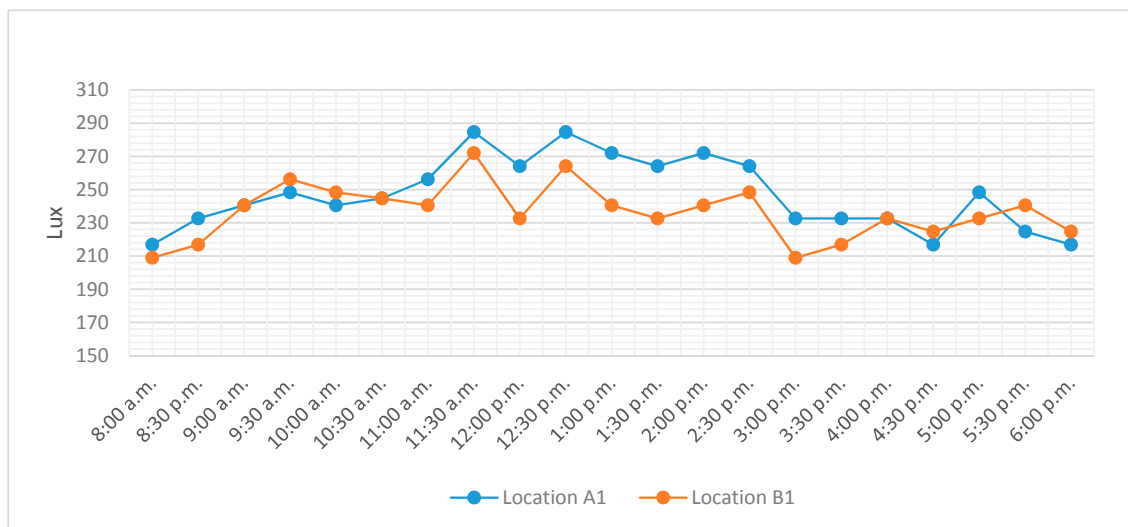
In Figure 13, the light intensity at location A1 and location B1 were within the acceptable level of 250 Lux for easy office task in the lobby area. The lowest light intensity received at location A1 was 208.9 Lux, while the minimum light intensity in location B1 was 201.0 Lux. The maximum light intensity in location A1 was slightly higher than location B1, which was 284.6 Lux at 11:30 a.m., while location B1 had the highest light intensity of 264.1 Lux at the same time. The mean light intensity of location A1 was also slightly higher than location B1, as the lobby of Building A has more openings as compared to Building B.

Figure 13. Indoor light intensity in the lobby of Building A (Location A1) and Building B (Location B1).

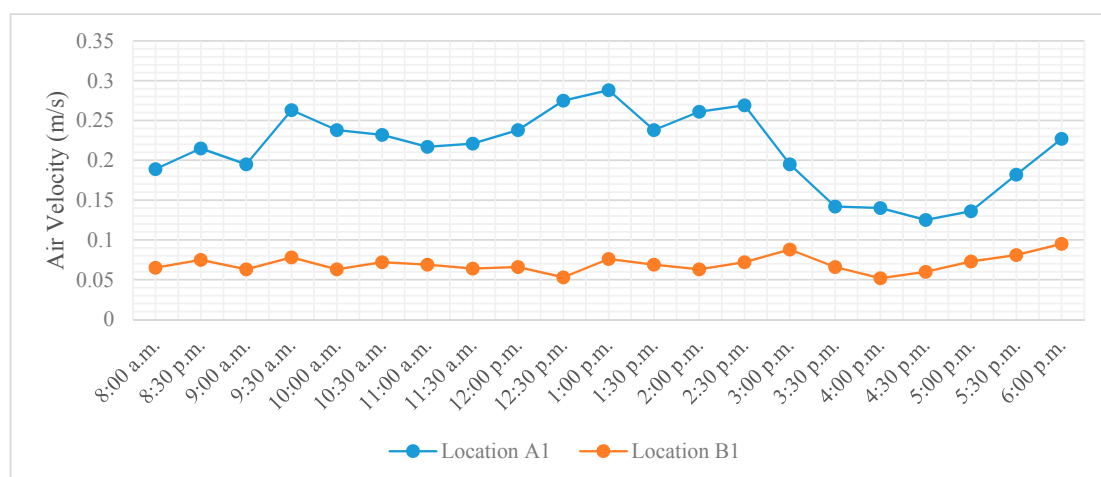
Figure 14 shows the air velocity at Building A compared to Building B. The air velocity at location A1 fluctuated in the range of 0.13 m/s to 0.28 m/s, in which it reached the highest speed of 0.28 m/s at 1:00 p.m. The air velocity at location A1 dropped significantly to 0.13 m/s from 2:30 p.m. to 4:30 pm and increased up to 0.23 m/s afterwards. Besides this, the air velocity at location B1 steadily remained between 0.05–0.10 m/s as air-conditioning was used. The mean air velocity at location A1 was around 0.21 m/s, which was higher compared to the mean air velocity at location B1 (0.07 m/s). According to Malaysia Standard MS 1525:2014, the air velocity in the room should be around 0.10–0.50 m/s. Therefore, the air velocity in Building A meets the requirement of comfort while air velocity in location B1 was below the range.

Figure 14. Indoor air velocity in the lobby of Building A (Location A1) and Building B (Location B1).

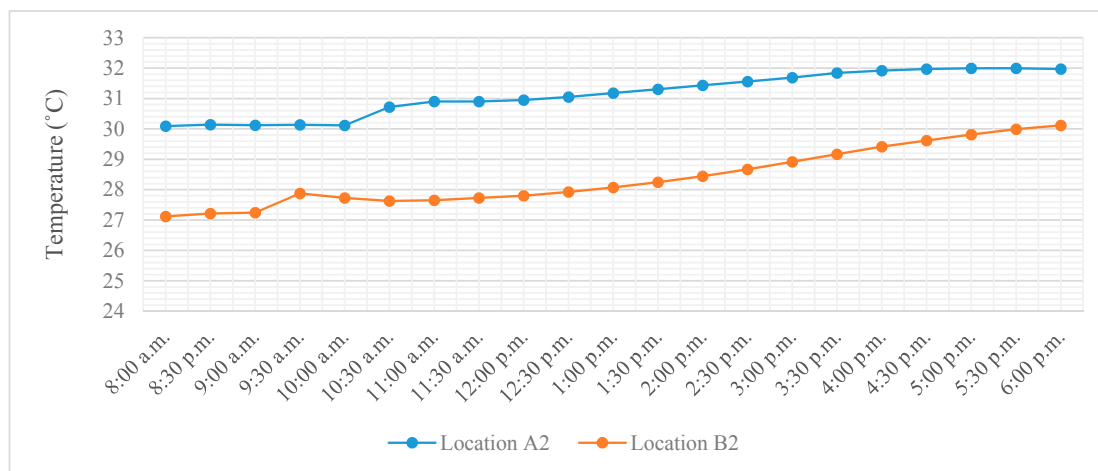
According to Figure 15, the overall air temperature in location A2 was higher than location B2 as location B2 was exposed to nearby corridors that were air-conditioned. Nevertheless, both of room air temperatures were above the optimum comfort temperature standard throughout the day. The air temperature at location A1 increased steadily from 10:00 a.m. to 6:00 p.m. where it finally reached 32.00 °C. Similarly, air temperature at location B1 increased from 10:30 a.m. to 6:00 p.m. and finally reached 30.12 °C. The mean air temperature at location B2 was 28.54 °C which was lower than the mean air temperature at location A2 which was 31.16 °C.

Figure 15. Indoor air temperature in the room of Building A (Location A2) and Building B (Location B2).

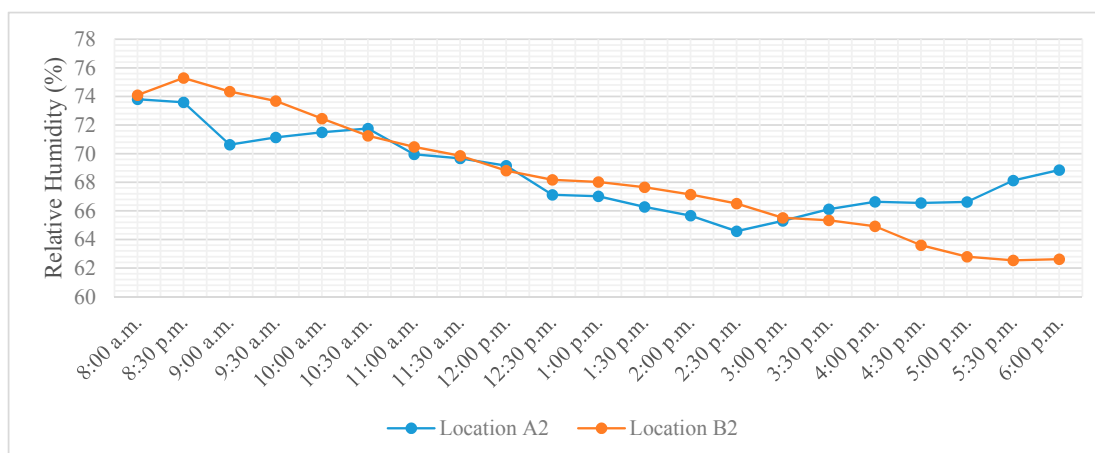
According to Figure 16, the overall mean RH at locations A2 and B2 were similar at 68.58% and 68.54% respectively. In the morning, the highest relative humidity was 73.81% at location A2 while the highest at location B2 reached 75.30% in the morning. Then, the RH decreased steadily throughout the day at both locations. Overall, the RH level at both locations was as slightly above the MS 1525:2014 standard.

Figure 16. Indoor relative humidity in the room of Building A (Location A2) and Building B (Location B2).

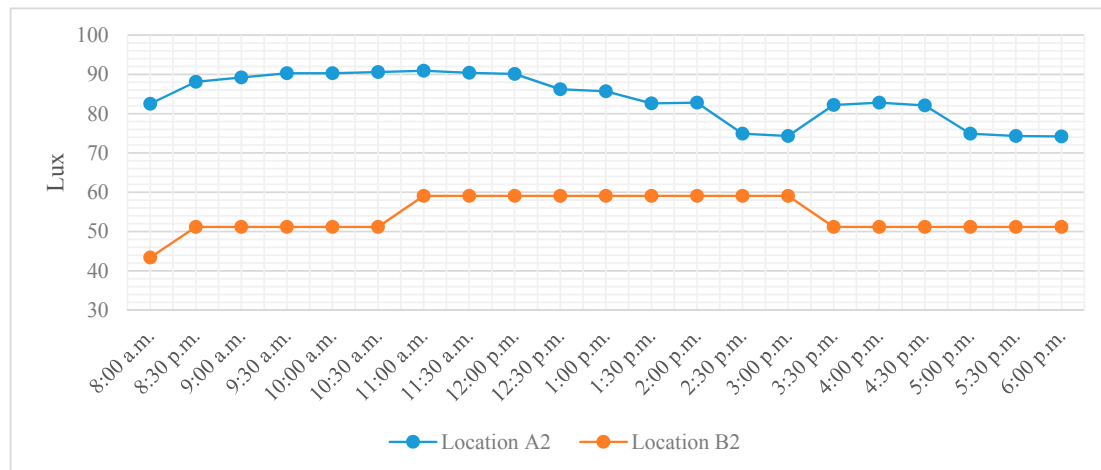
Referring to Figure 17, the overall light intensity at locations A2 and B2 did not comply with the acceptable value of 100 Lux as recommended for a hotel room in MS 1525:2014. The mean light intensity at location A2 was 84.7 Lux compared to location B2 which was 54.2 Lux. Location A2 had a steady light intensity of 90 Lux in the morning and a slight decrease to 74.9 Lux on 2:30 p.m., followed by a rise to 82.8 Lux from 3:30 p.m. In addition, a slight drop could be noticed at location A2 in the evening due to the openings that allowed natural daylight to enter. On the other hand, the light intensity at location B2 increased from 43.3 Lux at 8:00 a.m. to 59.1 Lux in the afternoon then dropped to 43.9 Lux in the evening.

Figure 17. Indoor light intensity in the room of Building A (Location A2) and Building B (Location B2).

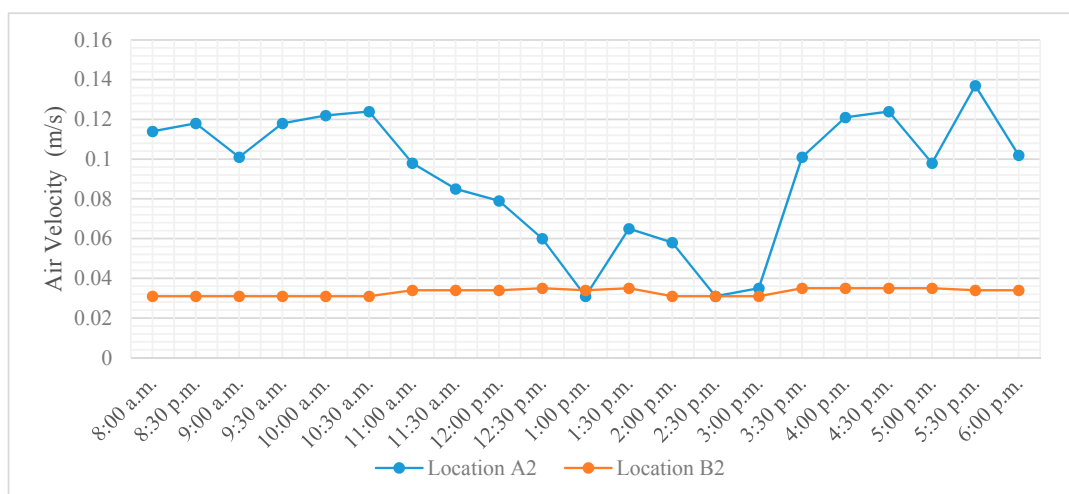
Figure 18 shows the relationship between air velocity and time at locations A2 and B2. The mean air velocity at location A2 was 0.10 m/s, higher than the mean air velocity at location B2 at 0.03 m/s. The existence of operable windows at location A2 allowed for natural ventilation. The air velocity at location A2 fluctuated throughout the day with a maximum air velocity of 0.14 m/s and a minimum of 0.03 m/s. On the other hand, the air velocity in location B2 remained steady with a range of 0.03–0.04 m/s. Generally, the air velocity at location B2 was not sufficient for occupants' comfort, while the air velocity in Building A was slightly higher than the optimum air velocity in the morning and evening according to the MS 1525:2014.

Figure 18. Indoor air velocity in the room of Building A (Location A2) and Building B (Location B2).
