Fabrication of a Multi-Physics Integral Structural Diagnostic System Utilizing Nano-Engineered Materials

Seth S. Kessler¹, Ajay Raghavan¹, Christopher T. Dunn¹,
Sunny S. Wicks², Roberto Guzman deVilloria² and Brian L. Wardle²

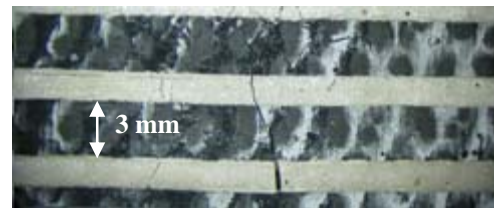
Figure 3: Photograph under microscope of impacted region of FFRP laminate. Painted silver electrodes are 1.5 mm wide and spaced 3 mm edge-to-edge.

Initially a single FFRP laminate (114 x 25 x 3 mm) was tested to prove the concept. Silver-ink electrodes were painted onto the specimen surfaces using simple tape masks (Figure 3). On the top plate surface, 14 parallel conductors were patterned in the short-dimension. On the opposite surface, 4 parallel conductors were patterned in the long dimension (so that they were perpendicular to the top side conductors through the thickness). These traces were all 1.5 mm wide and spaced 3 mm edge-to-edge. Prior to testing, the electrical resistance was measured using a Fluke 189 model multimeter with resolution 0.01 Ω and accuracy of $\pm 0.05\%$. Initial data showed significant variability when probing directly on the silver traces. Subsequently, a procedure was developed to bond thick gauge wires to the traces using silver epoxy, resulting in $< 1\%$ change ($< 0.1 \Omega$ for $\sim 10 \Omega$ trace) across 10 repeat trials. The specimen was centrally impacted with a 13 mm diameter steel ball at using a guided dropped weight to initiate damage. Following impact, post-damage resistance measurements were collected again for each possible combination.

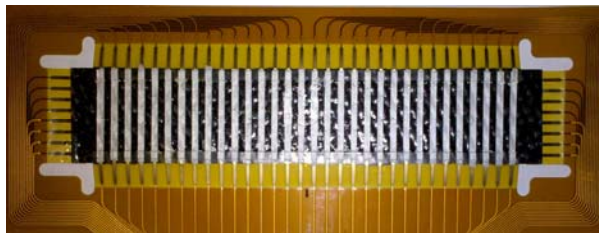
Figure 4: Photograph of flex-frame with FFRP sample

Next, rather than using soldered wires connect to the traces, a single double-sided copper-coated-Kapton w/coverlay flexible circuit was designed to make connections with the direct-write (DW) traces. In a processes developed by the investigators during the course of separate research, the flex circuit was bonded to the specimens first, then the DW traces were applied onto the specimens, including overwriting the flex-circuits (which included alignment marks). The flex circuit was designed in the shape of a rectangular frame, with flaps on all 4 inside edges with exposed pads for the DW process. The specimens fit inside the frame window with the top and bottom flap overlapping onto the front of the FFRP, and the left and right flap overlapping on the back of the FFRP. Traces are then routed along the edges of the frame to an 80 pin connector located on a bottom tab for hardware connection. This “flex-frame”, as seen in Figure 4, provides reliable, durable and consistent electrical continuity from traces to hardware, specifically because it eliminates all contract resistance issues. Finally, a PCB was designed to mate with this flex-frame, containing switches to multiplex the channels and simple and reliable connections for a multimeter probe and PC readout. After being instrumented, each FFRP specimen was progressively impacted at 15, 30 and 45 ft-lbs, using the same guided dropped weight setup, with in-and-out-of-plane resistance measured after each subsequent impact.

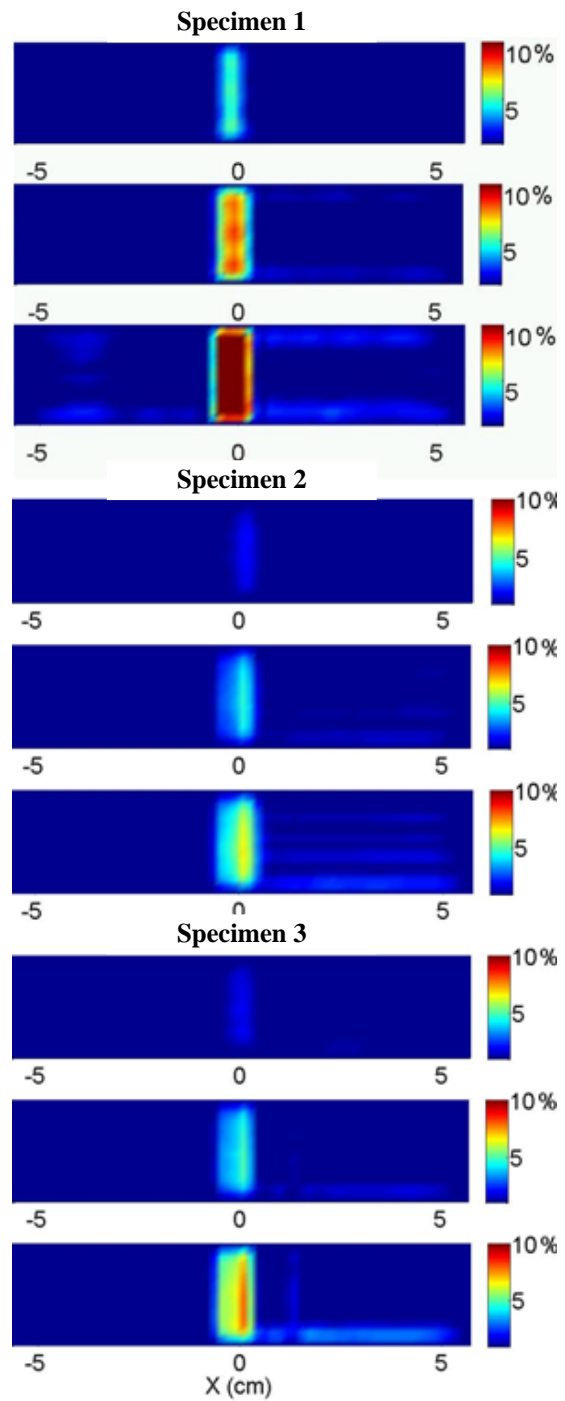
Figure 6 (b): Visualization of impact-induced % change for through-thickness resistance values. First plot in each set presents changes following 15 ft-lbs impact, second follows 30 ft-lbs and third presents results following 45 ft-lbs impact. Matlab was used to generate all images.

For through-thickness results, the initial impact again caused small changes of ~2-4%, with the second impact causing ~4-8% changes and the final impact registering ~8-10% changes. In this case, the pattern of the results appeared to be much less sensitive to impact location, likely because these were narrow specimens, however the damage severity measured did seem dependant on the impact point. It was also observed that the improved setup appeared to resolve the issue seen in the initial test results for the through-thickness measurements, where no DC off-set was calculated to the "right" of the damage region due to electrode cracking. No visible damage was present in any of these cases, however testing on witness specimens indicated that the specimens would completely fracture between 50-60 ft-lbs. The main difference in damage mode as compared to the initial specimen was the reduction from 2% to ~0.5% void fraction for these new specimens, likely concealing visible precursors to failure.
