Destruction of Cryogenic Pressure Vessel and Piping by Shock Wave

In recent years, the usage of cryogenic fluids as coolant are gaining more attention due to their capability to fulfill the requirements of today's advancing low temperature industrial applications. As a result, the use of a cryogenic pressure vessel and piping in LNG-tank, LN₂, O₂ tank for food processing applications and medical applications are becoming more important. In a cryogenic pressure vessel and piping, the reduction of thermal insulation by a small initial damage leads to an internal pressure rise and occurrence of flashing, which leads to a secondary crush of the vessel. In this study, a shock wave was applied to a pressure vessel and piping filled with cryogenic fluid and various observations were made. The internal pressure time history was measured and the safety of the cryogenic pressure vessel and piping was considered.

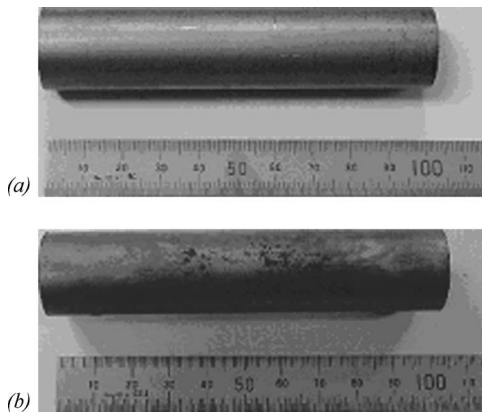
Fig. 3 Photographs of SUS 304 pipe before and after the application of shock wave at cryogenic temperature (87 K). (a) Before; (b) after.

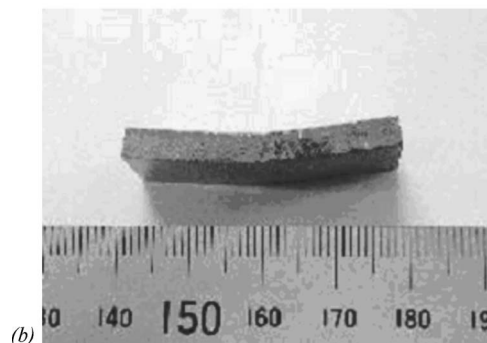
Fig. 5 Photograph of shocked SUS 304 at cryogenic temperature (87 K). (a) Top view; (b) side view.

The overview photograph of the SUS 304 test piece shocked at room temperature and cryogenic temperature are shown in Figs. 4 and 5, respectively. Fracturing was not observed in the test piece, even though the pieces were bent by the shock wave for both room and cryogenic temperature. The amount of bending was more at a room temperature shocked piece compared to that of cryogenic temperature. The test samples were cut in the transverse direction and the Vickers hardness was measured. The measured position is shown in Fig. 4(b). The positions 1, 2, and 3 correspond to the center of bending, the surrounding part of bending, and an undeformed part, respectively. At each position, the hardness was measured at intervals of 1 mm from the shocked surface. The measured hardness values are shown in Fig. 6. The short dashed lines represent the hardness value of the material before shock and the long dashed lines represent the hardness value at cryogenic temperature. SUS 304 does not experience more change

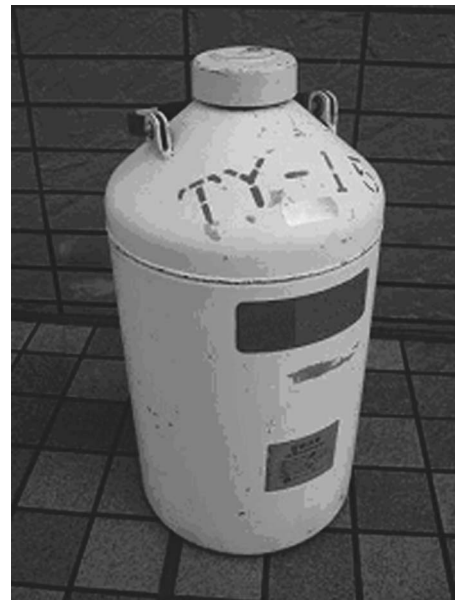
Fig. 8 Photograph of LN₂ tank before shocked

3.2 Results and Discussions. The photograph of the LN₂ tank before and after the application of a shock wave is shown in Figs. 8 and 9, respectively. The outer wall of the liquid nitrogen tank was initially maintained at room temperature by a layer of thermal insulation. When the shock wave was applied, the outer wall deformed by shock and thermal insulation dropped, resulting in frost on the walls tank (see in Figs. 9–11). In this case a pressureless tank was used, and thus there was no rise in pressure inside the tank. The internal pressure may increase in the case of a pressurized tank leading to the destruction of the tank.

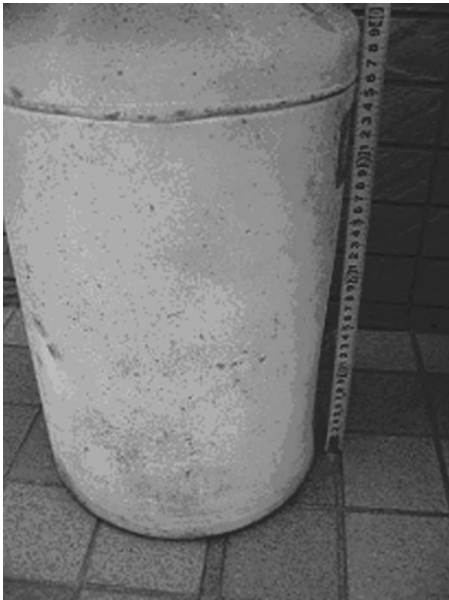
Fig. 11 Photograph of LN₂ tank after shocked (side view)

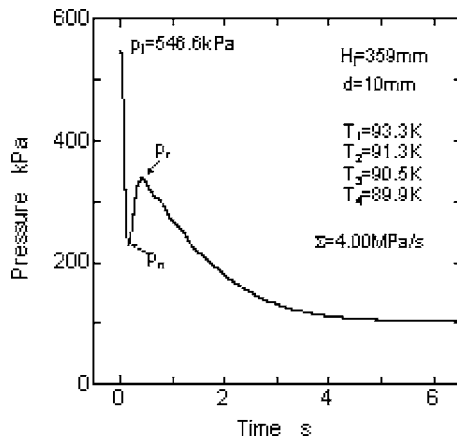
Fig. 14 Pressure-time history under depressurization in the pressure vessel
