# Identifying Causes for Certain Types of Electrically Initiated Fires in Residential Circuits

**Abstract** – While there are many circumstances that can lead to an electrical fire, it is helpful to identify and document known hazardous conditions that can occur in residential electrical wiring. Conditions that can be reproduced in a laboratory, intended to duplicate real-life conditions, can be used to increase knowledge for augmenting fire forensics and as a guide for manufacturers to develop safer, more fire resistant electrical systems. Failure modes for a variety of situations are described along with electrical data, photos, and video frames to show the conditions that produced a hazardous condition. Generally, the electric current produces an overheated condition in the presence of some type of combustible material. This work identifies some of the various conditions that can create the hazardous conditions and shows how wire insulation or other insulating materials, commonly used in homes, can ignite. Fires can initiate simply from exceeding the current rating of the wire or by having the wire bundled or having thermal insulation surround the wire. The types of cases explo

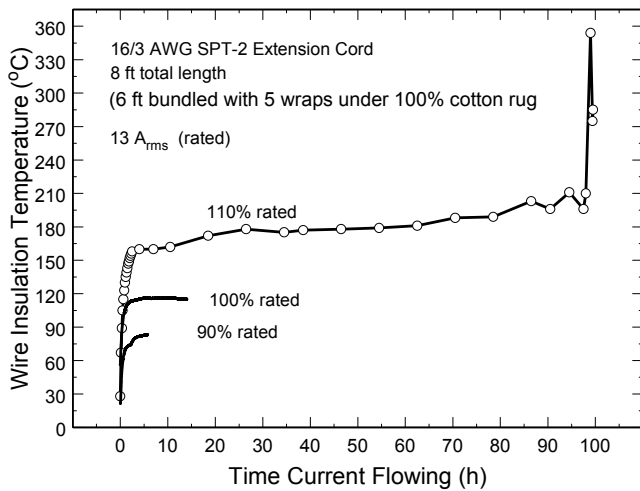
**Figure 6.** Insulation surface temperature measured inside 16/3 SPT-2 extension cord bundle under a 100% cotton rug.

With the wire rating on the packaging of 13 A<sub>rms</sub>, a current of 14.3A<sub>rms</sub> (110% of rating) was conducted approximately 8 h each day except on weekends (the work week). Temperature was measured inside the wire bundle with a type T thermocouple connected to a Fluke Hydra data acquisition unit with results as shown in Fig. 6. Temperature slowly increased over time as the wire insulation degraded. Elevated temperature increases wire deterioration, decreasing expected lifetime. The higher the temperature, the shorter the life of the wire insulation. High temperatures cause an increase in leakage current that causes the run-away effect seen in the temperature results in Fig. 6.

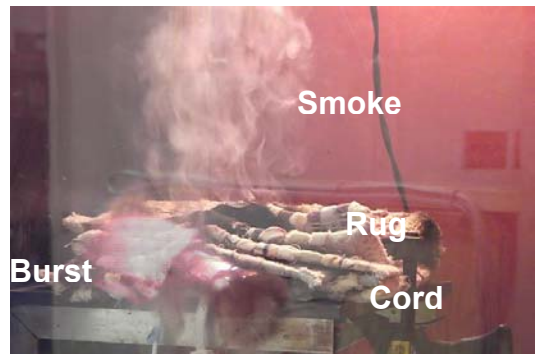
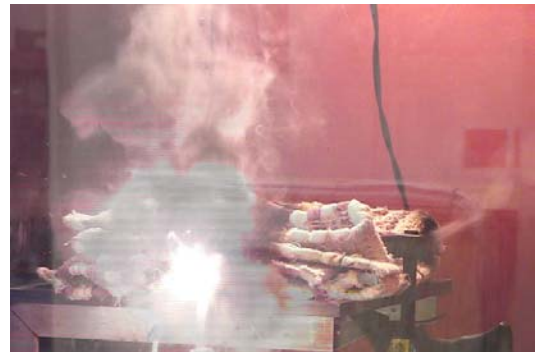
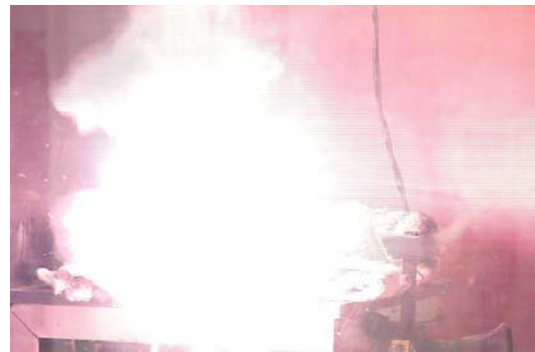
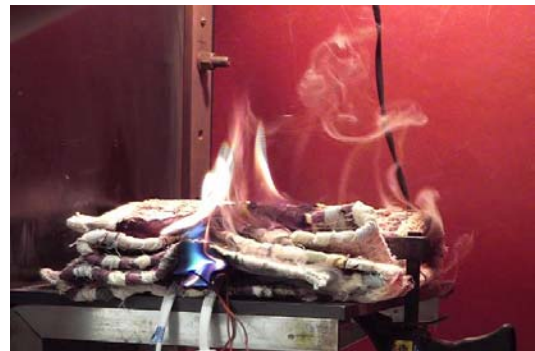
**a).** Initial flame burst from gases produced from PVC wire insulation after 100 h.

**b).** Second flame burst 400 ms later.

**c).** Large flame burst from wire insulation 433 ms later.

**d).** Rug burning.

**Figure 8.** Still frames from video footage of 3-wire SPT-2 extension cord bundled in cotton rug at ignition.

A test was conducted by placing a bundled SPT-2 16/3 (3-wire) 8ft extension cord (white color Slimline model 2241 made by Woods Industries, Inc.) under a rug. 110% (14.3A<sub>rms</sub>) of rated current was conducted for 100 hours. The initial steady-state temperature of the insulation inside the bundle was 165 °C. Shown in Figs 6 -8 are the temperature of the bundle, the waveforms at the start of fire, and the resulting fire damage to the bundle.

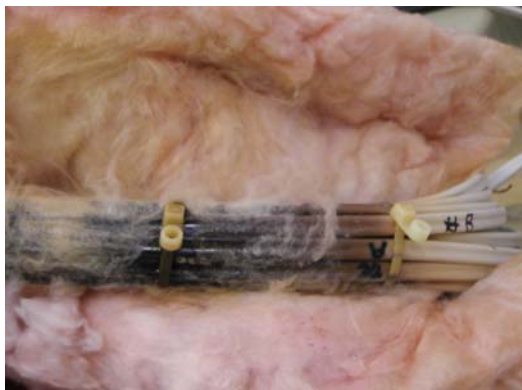
**Figure 11.** Photograph of NM-B thermally insulated 20-wrap coil after arcing.

Temperatures were increased with thermal insulation as expected. Surprisingly, however all cases with thermal insulation exceeded the thermal rating of the cable insulation for rated current. Also, the highest actual temperature depended on the thermocouple position in the wire bundle and thus may not have been at the hottest spot. Three thermocouples (TC's) were inserted in the center of the bundled cables that were covered in the fiberglass. Each TC was spaced apart by approximately 8 cm. Fiberglass insulation was only wrapped around one-third of the coil as seen in Fig 11.

Steady-state current was applied for approximately 2 to 3.5 hours in each case. Short-circuiting occurred for the 20-wrap case with fiberglass insulation after 3.5 h. Three out of five tests, with 20 wraps, at 18 A<sub>rms</sub> with fiberglass insulation produced smoke and cable fire ignition and eventually caused the circuit breaker (Westinghouse SWD BA 20 Amp) to trip after the cable arced for approximately 0.3 to 0.6 s. An example of one of the arcing waveforms, shown in Fig. 10, reveals leakage current initially in the ground wire, then after about 4 cycles, a sputtering arc develops between the line and neutral wires with a further increase in the ground current. The three temperatures shown in Fig. 9 above 200 °C at 18 A<sub>rms</sub> are due to a rapid deterioration of the insulation and subsequent escalation of the temperature many seconds before actual short-circuiting occurred. Even though this particular breaker did not have ground fault or arc fault protection, it still tripped. However, there was significant smoke and heat damage to the insulation and the potential to start a fire was present as seen in the photograph, in Fig. 11, of the cable after this test.

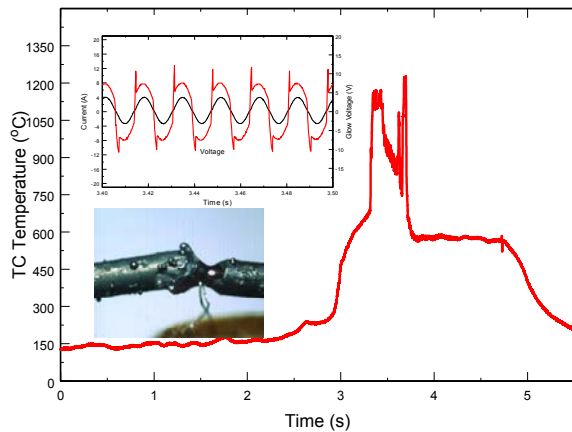
**Figure 16.** Temperature measured on oxide bridge at 2.5A<sub>rms</sub> as the glowing filament moved across the oxide surface [12].

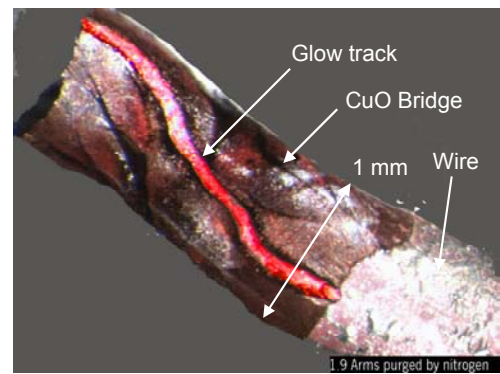
**Figure 18.** An optical image of open circuit glow track impression on bridge [12].

A micrograph of the remaining oxide bridge from a glowing connection in which the current was slowly lowered to extinguish the glow, Fig. 18, shows a conductive “glow track”. The significance of this track was the ability for the glow to be reestablished with only the application of voltage across the connection. Typically, however once the glowing connection is extinguished, the copper oxide forms a non-conductive bridge that insulates the connection and prevents the circuit from reestablishing current flow. To reestablish current flow the oxide had to typically be removed or broken through to establish metal-to-metal contact. The “glow track” phenomenon was an exception.

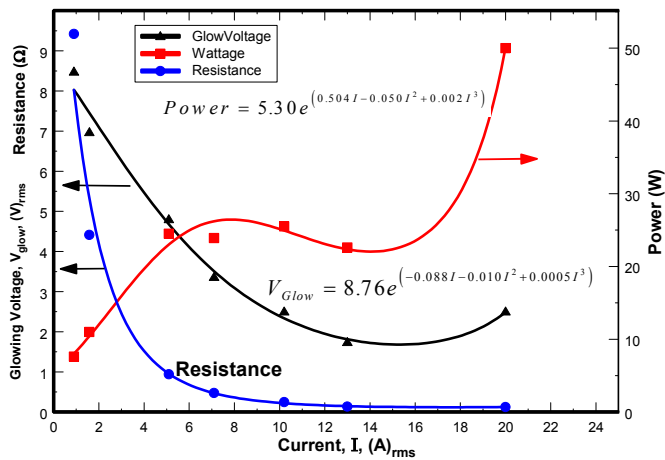
**Figure 20.** Typical average glowing contact voltage and power dissipated in contact for 1 mm diameter copper wire pair. Measurements taken just after glowing contact formation stabilized [16].

The average glowing contact voltage was measured at seven different current levels, at the time the glowing was initiated, to determine the average power dissipated in the connection as a function of current, as shown in Fig. 20. As the current rises from 0.9 A<sub>rms</sub> to 5 A<sub>rms</sub>, the wattage rises from 7 W to 25 W and remains fairly constant at 25 W up until about 16 A<sub>rms</sub>. At this point the wattage rapidly increases to 50 W at 20 A<sub>rms</sub>. A voltage minimum is seen near 13 A<sub>rms</sub> and increases for both higher and lower currents. The voltage is also well below minimum arc voltage for copper (12 V) for all currents, with the exception of an occasional spike in the voltage, due to oxide cracking and particles ejecting from the glow region [12,16].

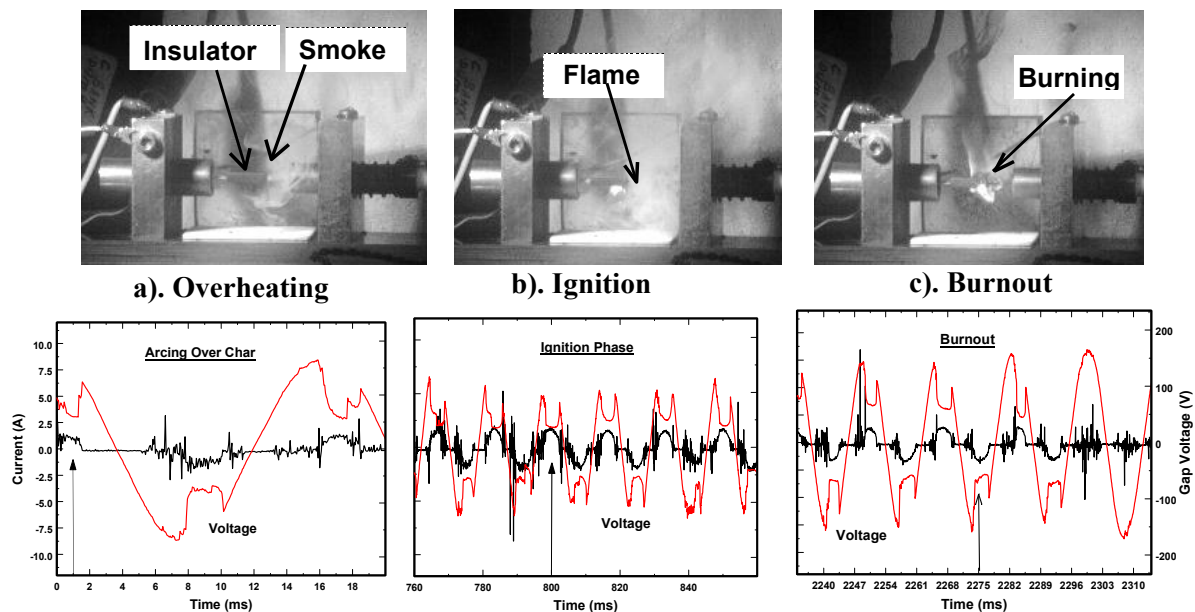
**Figure 22.** Selected synchronized high-speed video frames and waveforms showing a) overheating via over surface charring b) ignition, and c) burn out for  $1.67 A_{rms}$  PVC insulation. Arrows indicate time of image [16].

The second geometry, select images shown in Fig. 22, illustrates an over-surface charring condition, rather than a glowing contact, that produced the initial overheating of the insulation. This is apparent in the corresponding waveforms

for the overheating phase (Fig. 22a). The current consists of high frequency bursts of arcing rather than a smooth continuous waveform as compared to Fig. 22a. This low level intermittent arcing, during the overheating phase, continued for about 250 ms. The current then transitioned from intermittent arcing into continuous arcing (half-cycles of current with “shoulders” around current zero as shown in Fig 22b). The first visible flame appeared outside the insulation at 800 ms (Fig 22b). After approximately 2296 ms, the series arcing transitioned to low level high frequency sputtering, as indicated by the waveforms in Fig. 22 c) at burnout.

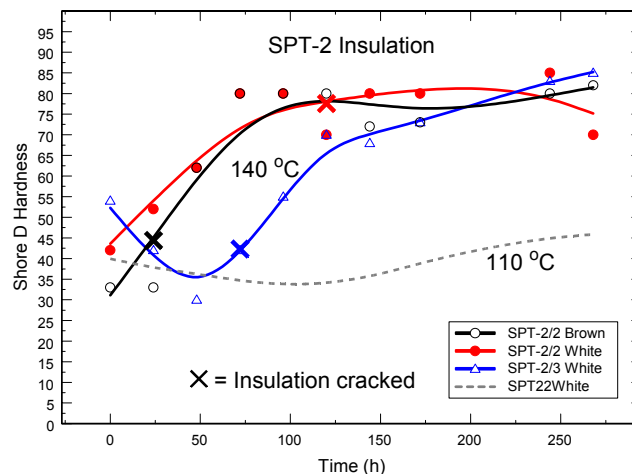
Figure 25. Durometer results of accelerated aging of various SPT-2 wires at 140 °C and 110 °C.

Another set of aging tests was also performed on a set of various wire types, shown in Figs. 25-29, to show how the durometer or hardness of the insulation on the wires changes with accelerated thermal aging. Depending on the durometer of the insulation, either the Shore A (model 1500-A-07496) or Shore D (model 1500-D-02013) scale durometer, made by Rex Gauge Co., was used for measurements. The wire samples were removed from the oven and allowed to cool prior to making a measurement. The spring-loaded indenter head of the handheld durometer was pressed into the wire insulation and the depth of the indenter indicated the durometer. The wire was then wrapped around a 0.5” diameter mandrel to determine if the insulation was brittle enough to crack. A new section along the length of the wire was used for each bending test to eliminate fatigue failures. An equation was developed, based on measured values of Shore A versus Shore D scales, to convert Shore A results to Shore D. This conversion, shown below, allowed for continuous curve fit plots to be made as seen in Figs. 25 – 30. There was little change in durometer at 110 °C. However, at 140 °C durometer changed significantly. It is

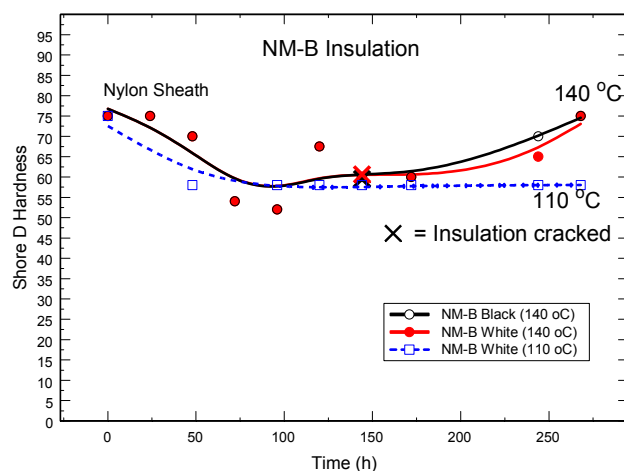
Figure 26. Durometer results of accelerated aging of NM-B wire at 140 °C and 110 °C (line and neutral wires).

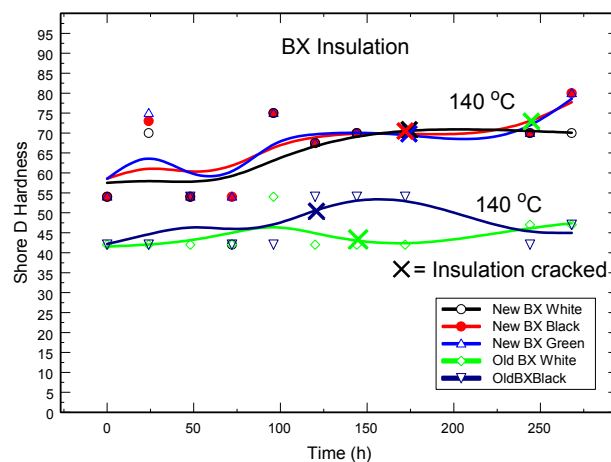
Figure 27. Durometer results of accelerated aging of BX wire at 140 °C.

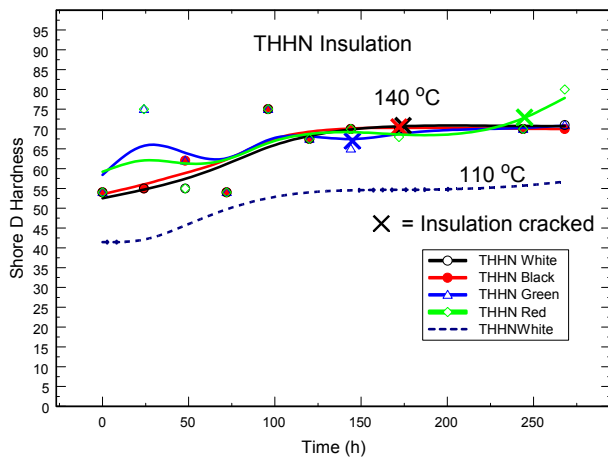
**Figure 28.** Durometer results of accelerated aging of THHN wire at 140 °C and 110 °C

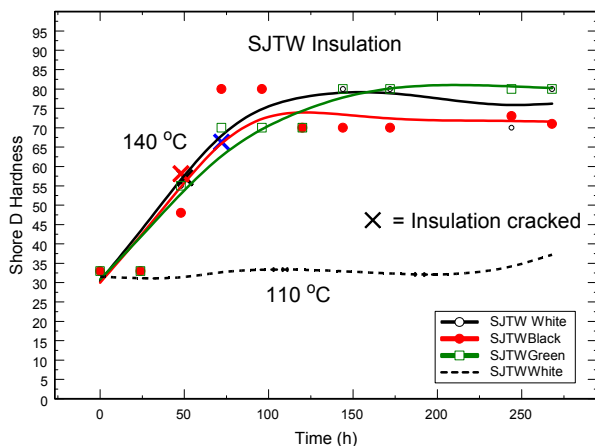
**Figure 29.** Durometer results of accelerated aging of SJTW wire at 140 °C and 110 °C
