A Novel Approach to Spent Fuel Pool Decommissioning

R. L. Demmer

*Idaho National Laboratory, Idaho Falls, Idaho
USA*

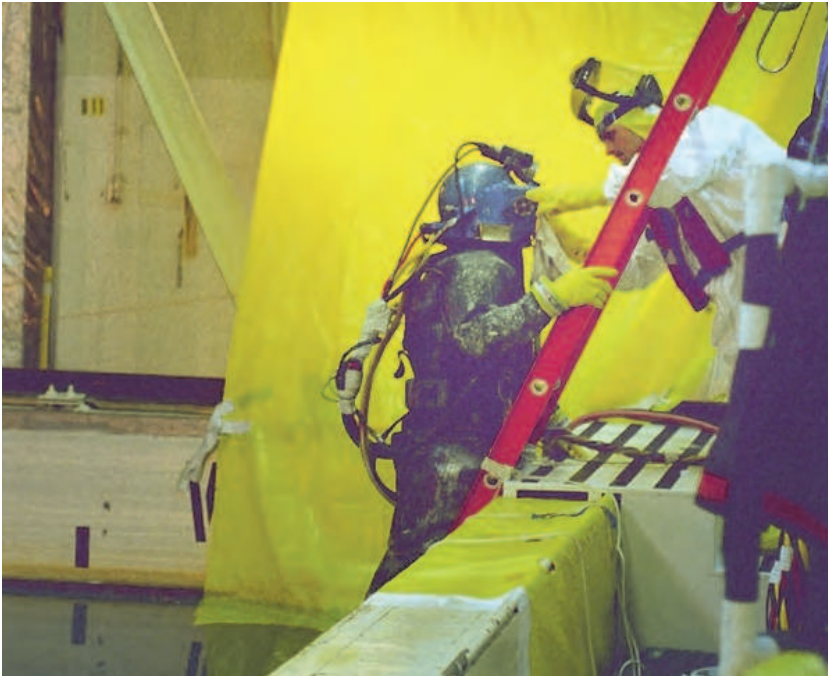
Fig. 1. Diver at INL completing entry into basin for underwater cleaning and coating.

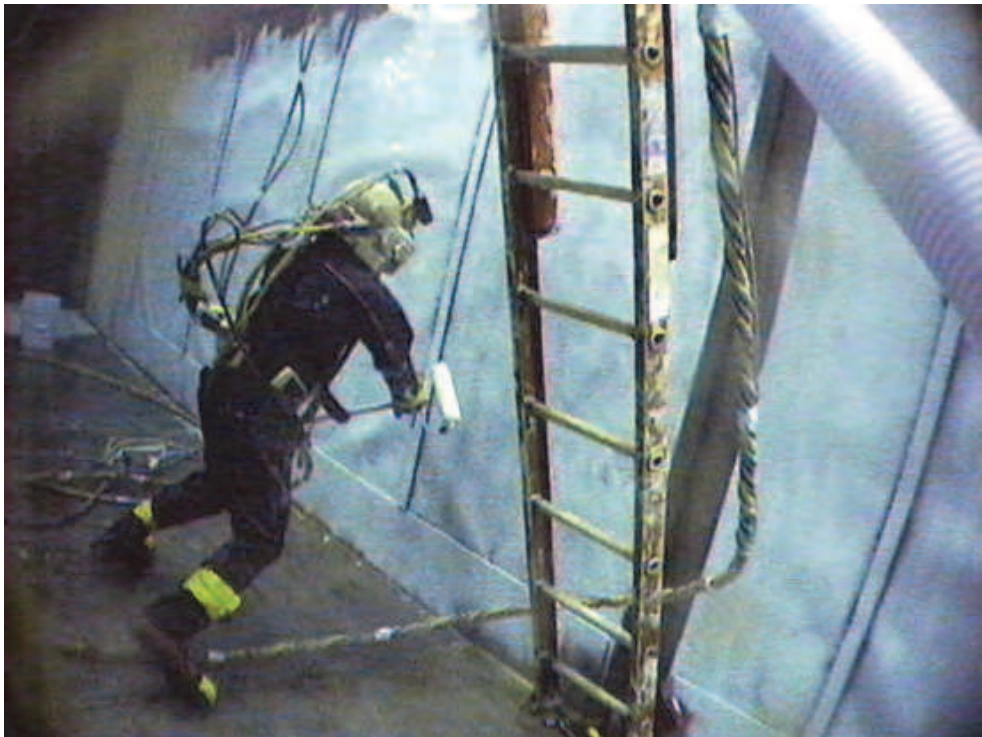
Fig. 2. Special two hose roller system used for wall coating at the MTR pool.

A special type of paint roller system was used for underwater application of the epoxy coating, which is shown being applied underwater in Figure 2. The system had two separate pumps for the epoxy resin and hardener, which were pumped through separate hoses to a mixing manifold about 1.5 m from the roller. The roller/extruder system was flexible up to that point, and like a solid wand from there to the roller head.

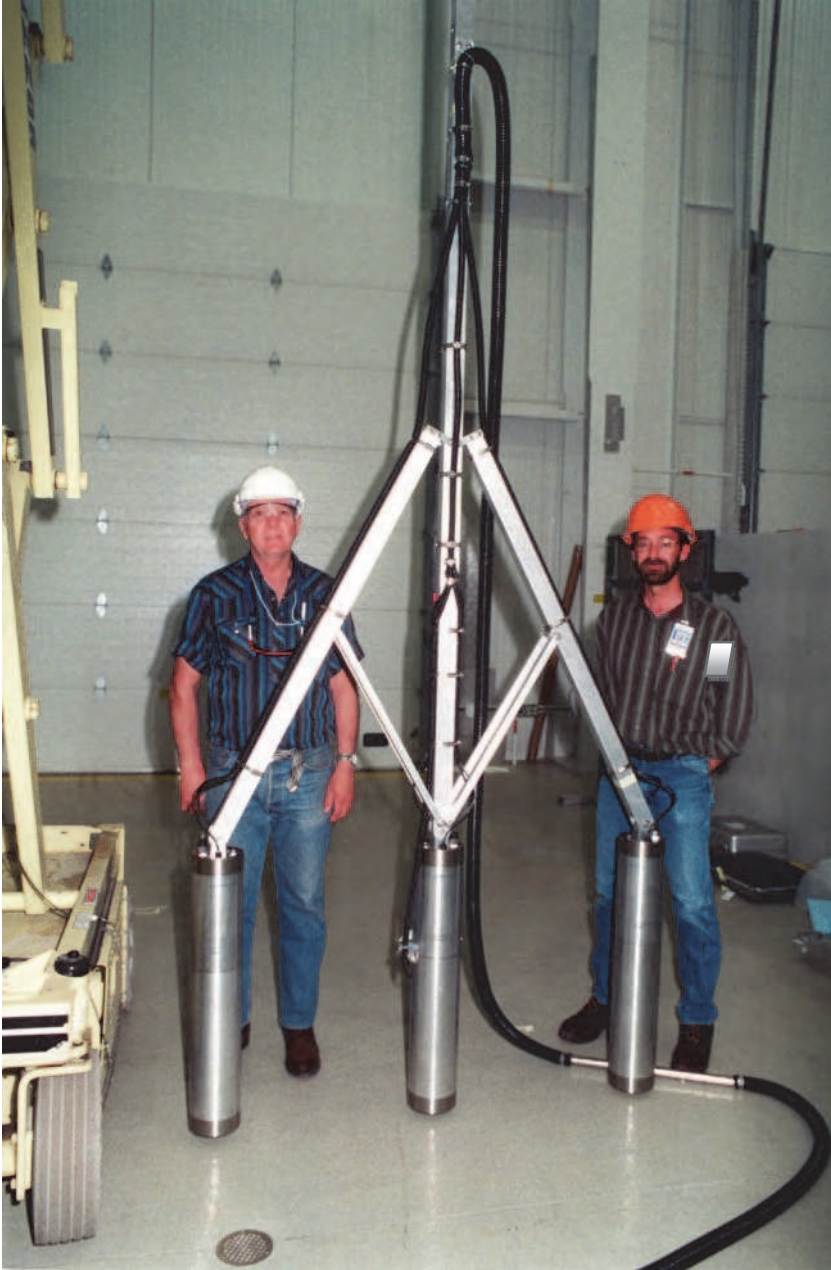
Fig. 3. Multi Detector Basin Scanning Array for INTEC-603.

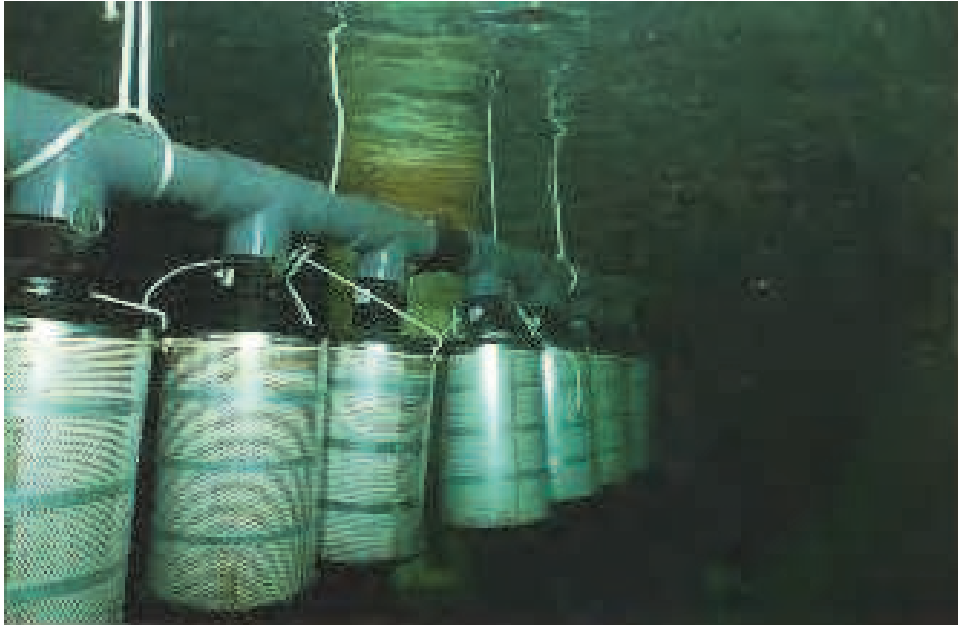
Fig. 4. UCC vacuuming filtration system underwater manifold.
