OIL CORROSION AND CONDUCTING Cu_2S DEPOSITION IN POWER TRANSFORMER WINDINGS

CLAES BENGTTSSON¹, MATS DAHLUND¹, JAN HAJEK¹,
LARS F PETTERSSON¹, KARIN GUSTAFSSON²,
ROBERT LEANDERSSON², ARNE HJORTSBERG³

¹ ABB Power Technologies AB, Ludvika
Sweden

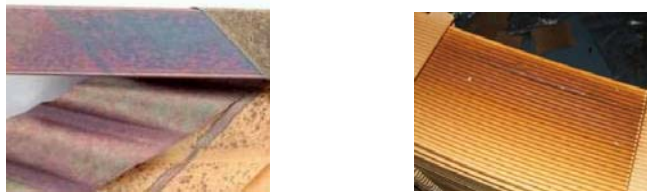
Fig 1. Corroded copper conductor (left) showing clear Cu_2S deposition on the wrapping paper. Right shows deposits on paper between spacers in disc winding. This type often also contains sludge.

Deposits have also been observed on the outside of the paper wrapping as shown in fig 1. In this case deposits are observed which sometimes appear more fundamentally different in type, with varying colours and general appearance but also with different chemical and electrical properties. A large variation in the electrical conductivity was observed, some with little or no conductivity at all, and others showing the typical conductivity of Cu_2S deposits. There is often a substantial amount of normal sludge in these deposits.

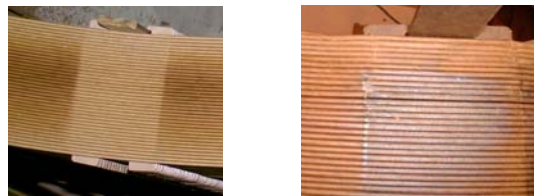
Fig.3. Examples of deposition between spacers left, and under spacer right

In disc windings we have observed that the amount of deposition can sometimes vary drastically close to versus under a spacer, from low too high or from high to low, as shown in fig 3 below. In both cases the temperature is similar but somewhat higher under the spacer, since the oil has no access for cooling in this area. Clearly, other factors than temperature must play an important role for deposition here.

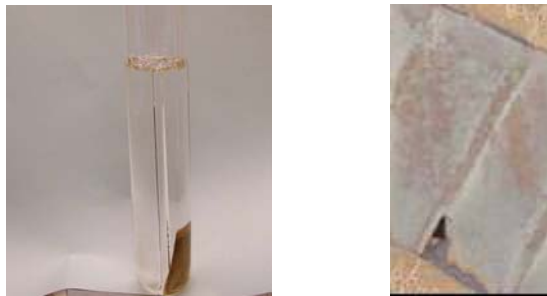
Fig 4. Laboratory experimental arrangement for Covered Conductor Deposition (CCD) test, and examples of Cu₂S deposition on Kraft paper

To investigate the cause of the deposition phenomenon, detailed laboratory studies have been performed. After a substantial variation of experimental parameters, the deposition of Cu₂S on the insulation has been reproduced in the laboratory. A flexible set-up was chosen, using IEC 61125 equipment, with a 3 cm long real copper conductor in a glass tube with 40 g oil. The conductor was wrapped in a few layers of insulation Kraft paper. A gas mixture can be bubbled through an inner glass tube to control the gas in oil content, in order to simulate the actual environment in a transformer as accurately as possible, and the temperature of the arrangement is conveniently controlled by an external thermostat. The complete set up for this Covered Conductor Deposition (CCD) test is shown in fig 4 below.

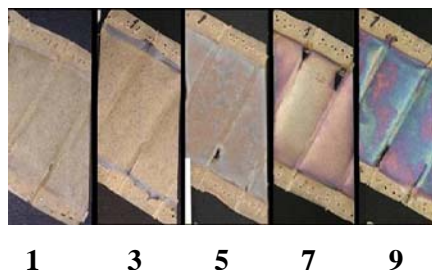
Fig.5. Scale for evaluation of CCD. 0 = no deposit, 5 thin covering of complete area, 10 very heavy deposition. This reading is used as a semi-quantitative measure of the amount of deposition.

The major overall conclusion from these deposition experiments is that only certain oils do actually create Cu₂S deposition. These oils are also the very oils that have caused real transformer failures in the field as will be discussed in section 4 below. For oils which do create corrosion and deposition the influence of various environmental parameters has been studied. A very large number (> 1000) of samples have been studied. In order to facilitate a simple quantitative evaluation of the amount of deposition a deposition scale 0-10 has been defined, as shown in fig 5 below.

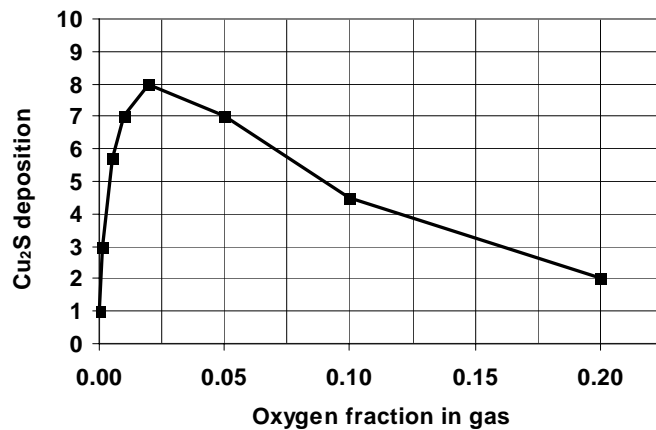
Fig 6. Relative deposition amount on Kraft paper in CCD test versus levels of oxygen in oil A. CCD- tests performed at 120°C for 32 days, 1 l/h of gas bubbled through oil.

When depositing oil is studied, very pronounced oxygen dependence can be observed as shown in fig.6 below for oil A. The amount of deposition on the paper increases dramatically as the amount of oxygen in the gas is increased from pure nitrogen. For the oil used in this case the amount of deposition has a maximum at approximately 2-3 % oxygen in the gas, corresponding to 3-5000 ppm in the oil, and then falls to a lower value at very high oxygen levels.

The interval in which strong CCD-deposition occurs is clearly in the range of normal transformer operation for sealed units, while the high end corresponds to the typical oxygen levels of free breathing transformers. In a general way these data may also indicate that sealed units would be more at risk than free breathing units, at least for the oil under study here.

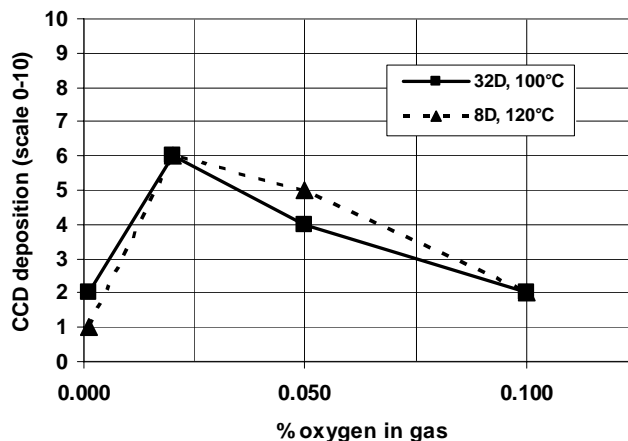
Fig 7. Relative deposition amount on Kraft paper in CCD test versus levels of oxygen in oil A. CCD- tests performed at 100°C for 32 days, and 120°C for 8 days, 1 l/h of gas bubbled through oil.

When sufficient oxygen is supplied to the CCD test the Cu₂S deposition is found to be thermally accelerated as expected. The rate of deposition is doubled after a 10°C increase, four times as high for 20°C etc. Figure 7 shows the amount of deposition after 8 days at 120°C and 32 days at 100°C with varying oxygen content in the gas for oil A. Evidently the deposits at each of these oxygen levels is approximately the same for the two series, i.e. 20°C temperature increase corresponds to a rate increase of approximately four times.

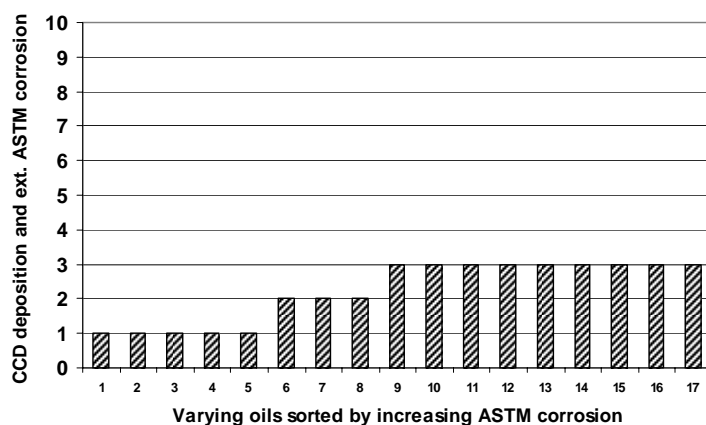
Fig. 8 Results of Extended ASTM D1275 corrosion tests for group of commercial oils

We have used 17 different new unused commercial transformer oils from different suppliers produced at various times during the last 15 years as a representative set of real transformer oils in use today. They vary widely in total sulphur content and many other characteristics, but they all fulfil the respective standards. These oils have all been tested with an extended version of the ASTM D1275 test, in which the time has been extended from 19 to 48 h, and the temperature raised from 140 to 150°C. For evaluation of the result, the pass/fail criterion from the D130 scale (range 1-4) has been applied, i.e. less than 4 means pass, 4 means fail or “corrosive”. This corresponds to a dark or grey surface deposition on the copper. The results of the selected group of oils are shown in Fig. 8 below.

The results shows that all the oils tested here with the extended ASTM D1275 test actually did pass this tougher metal strip test, and hence also the standard ASTM D1275 test. We would accept all these oils, but would suspect oils 9-17 of be closer to being “corrosive”. However, since there is relatively little variation between the oils it is hard to define a natural more stringent fail/pass criterion.

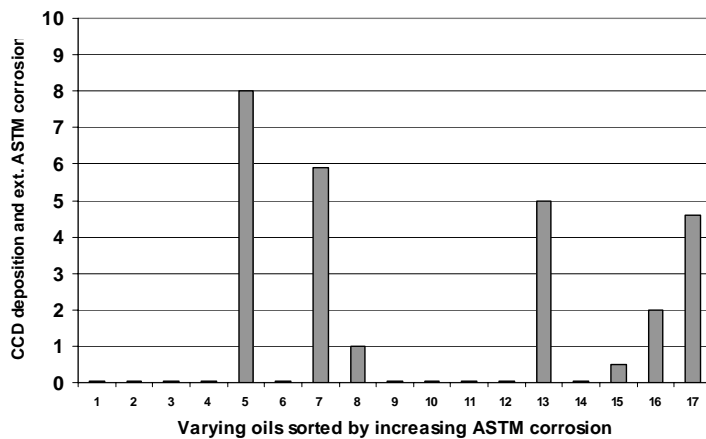
Fig. 9 Results from CCD test of selected group of commercial transformer oils

The same set of commercial oil samples have been tested and evaluated with CCD, showing a very good reproducibility. The results in Fig. 9 below show that there are large differences in Cu_2S - deposition between the different oils. Some oils show essentially no deposition. These oils also in most cases show no deposition even if the test is continued for longer time. Other oils have varying degree of deposition, in some cases extremely strong. If the pass/fail criterion is set to “less than 1”, oils number 5,7,13,16 and 17 have clearly failed this test clearly, while number 8 is on the borderline.

CCD: With pass criterion deposition “1 or less”, the CCD test would screen out oils number 7, 13, 16 and 17 as clearly depositing, and 8 as borderline. Hence all the confirmed depositing oils in the failure group1 (oils 7, 13, 16, and 17) were correctly identified by the CCD method, whereas the No- failure oil number 8 was on the borderline. If the pass criterion instead is set as “2 or less” the method correctly screens out exactly the known failure oils.
