# Increased UV transmission by improving the manufacturing processes for FS

<sup>a</sup>Optimax Systems Inc, 6367 Dean Parkway, Ontario, NY, USA 14519

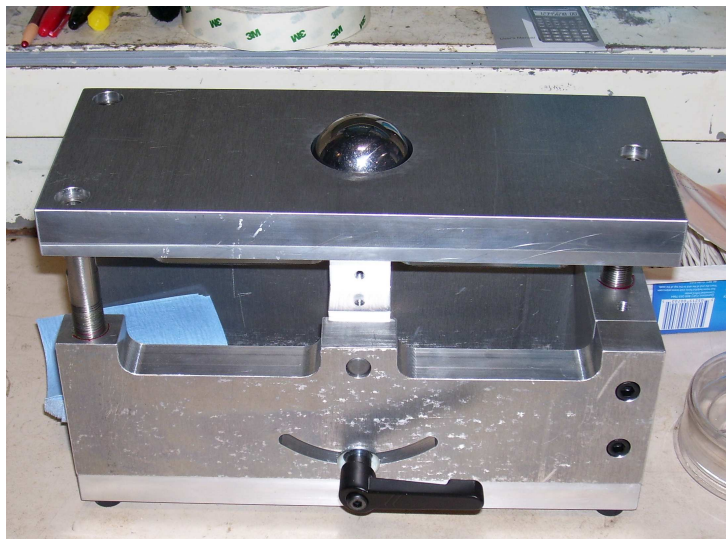
Phase one of this project entailed implementing the COM ball test<sup>7</sup> to destructively measure sub-surface damage (SSD) as a function of material, abrasive type and size, pressure and speed. Figure 1 is a picture taken of the COM ball testing apparatus constructed at Optimax.

Figure 1: Photograph of the COM ball SSD testing apparatus

This test is a destructive test where a ground surface is first lightly etched to expose all of the sub-surface cracks, and then a small circular hole is polished into the surface using diamond paste and the chrome steel ball shown in Figure 1. The resulting surface has a circular polished area, the sub surface damage is calculated with a delta sag equation shown as Equation 1.  $D_1$  is the diameter of the circle of the edge of the ground surface,  $D_2$  is the diameter of the circle of the last visible portion of damage,  $R$  is the radius of the chrome-steel ball. Figure 2 contains a schematic drawing of a dimple and a photograph of a portion of the dimple. The diameters were measured on a white light microscope.

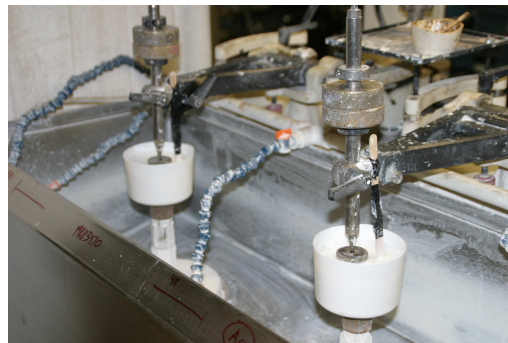
Figure 3: Photograph of the polishing test set-up

For phase two, we focused on the UV material fused silica, reducing surface roughness and optimizing removal rate and transmission. The variables we chose to adjust in our experimental design were abrasive, pH and polishing lap material. There were four different types of abrasives used, all were approximately  $1\mu\text{m}$  mean particle size and the Mohs hardness values were 6 (Abrasive 1), 6.5 (Abrasive 2), 9 (Abrasive 3) and 10 (Abrasive 4). The pH values ranged from 6 to 10, depending on the abrasive type, and we chose to use both a traditional natural pitch and a synthetic pitch with similar viscosity. Figure 3 contains a picture of the side by side experimental set up. Two parts were run at the same time, each with the same abrasive but different pitch types. Polishing conditions such as pressure, speed, concentration, abrasive size and part diameter were all kept constant. Material removal rates were measured by weight change utilizing an analytical balance. Surface roughness measurements were made on a white light interferometer, and transmission measurements were made using a spectrophotometer.

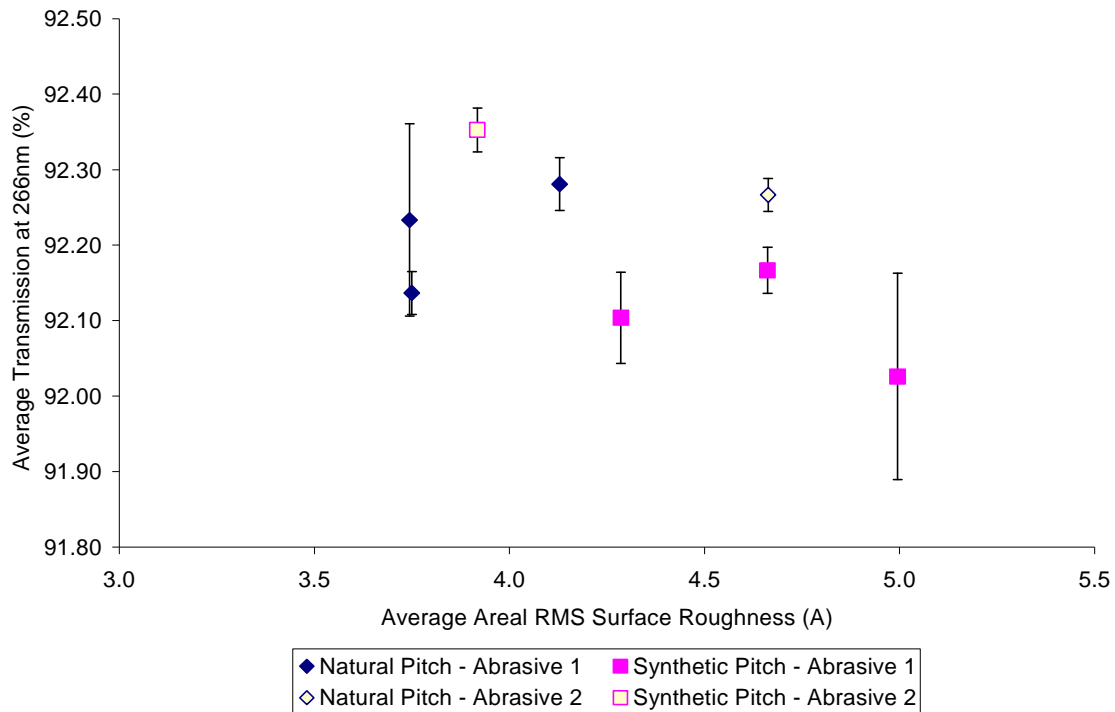
In addition to absorption, it is also important to consider the effect of surface scatter (reflection) on the transmission quality of an optic. The average transmission at 266nm is plotted versus the average areal RMS surface roughness in Figure 8. The first observation from Figure 8 is that the surfaces polished with Abrasive 2 have higher transmission compared to those polished with Abrasive 1 for similar surface roughness values, as was shown in Figure 7. The second observation is that there is a trend, where the smoother the surface, the higher the transmission. This shows a direct relationship between the amount of light lost to scatter to the surface roughness value, a relationship that is very intuitive and especially important to applications in the UV.

Figure 8: Average transmission of FS (bare window substrate) at 266nm as a function of surface roughness
