IMECE2005-81300

EVALUATION OF HEAVY TRUCK ROLLOVER CRASHWORTHINESS

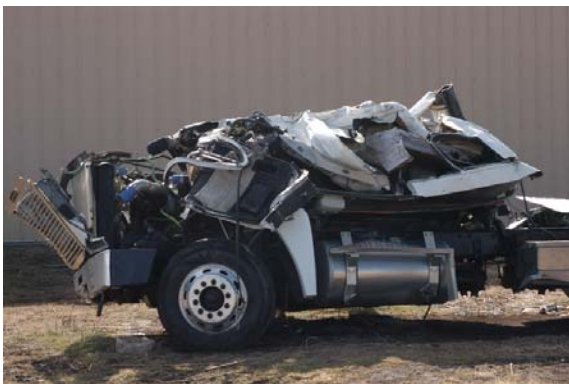
The cab of this vehicle was not designed to withstand a rollover collision. The cab was made almost entirely of relatively light-gauge aluminum, with only a very few pounds of steel. A survey of the panels was undertaken using a magnet, and the only steel found was in screws and some U-channel beneath the floor to provide strength and rigidity. The rivets were also made of aluminum.

An inspection of the rear of the cab gave no indication that it was forced into the dirt. There was no dirt or gravel present, and the scratch and buckling fold patterns indicated that the cab damage was from the rollover proper and matchboxing to the passenger side, not from movement on the ground in a backwards direction.

The vertical survival space as measured from the center front edge of the passenger seat was 29 1/4". Measured at the same location on the driver's side, there was 30" of vertical survival space (see Figure 2).

Figure 2. Photograph of the accident vehicle

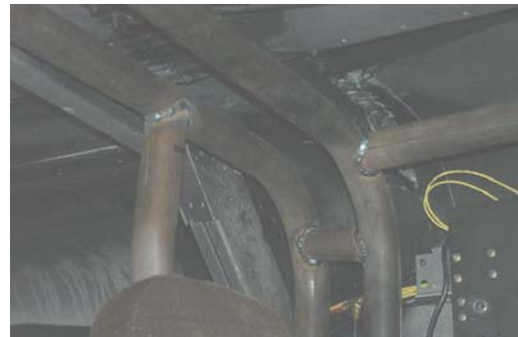
In order to demonstrate that this cab can be made more crashworthy relatively inexpensively and easily, a roll cage was constructed within the existing cab structure, with no modifications made to the exterior envelope of the structure (see Figure 3). The cage was constructed from 1.5" diameter DOM (drawn over mandrel) seamless tubing, 1020 plain carbon steel. The tubing was hot formed, with scale still present. Over the scale, the manufacturer printed C1020 HT39759 150016-06 in white ink. Radii were bent using an air bender, preventing local buckling. Welding was done with a MIG (metal inert gas) system using low carbon filler metal. No ancillary padding or cosmetic enhancements were applied to this demonstrative roll over protective system (ROPS).

As installed, the roll cage consisted of three inverted-U shaped hoops to provide resistance to rollover-induced forces. The first hoop was located to the rear of the A-pillar in the existing space behind the dashboard, from the floor to the ceiling. This hoop was approximately 67" wide and 58" high, and was angled from the base backwards at an approximate 8° angle to match the rake of the dash and windshield. This reduced the headspace by approximately 2.5", but not the functionality of the cab. The hoop endpoints were welded to 1/4" mild steel plate, 6" square, that was further fastened to the floor pan using 4 bolts. A horizontal knee bar, 17.5" from the floor,

further added rigidity to this hoop. The upper corners of the hoop were not gusseted, but bent at a 6" radius.

The primary occupant protection was provided by two hoops at the B-pillar location, behind the seats, with the first hoop ~28" behind the A-pillar hoop. These two hoops were separated by approximately 5", center to center. These rear hoops attached to the front hoops by 4 symmetrically spaced horizontal members, welded at each end. A single gusset was used at the front B-pillar hoop, behind the driver's head. It was an elbow, approximately 15" long horizontally and 12" vertically. The rearmost B-pillar hoop was welded to a 6" square plate at the bottom, while the forward hoop was welded to a 4" square plate at the bottom. Each plate was bolted to the floor pan. The plates were the only direct interface between the cab and the roll cage. Thus, above the floor pan, the cage "floated" within the vehicle. Based upon a steel density of 0.3 lbs/in³, this cage weighed approximately 148 lbs.

Figure 3. Photograph of the exemplar roll cage

The quickest and most effective immediate structural fix for the weak roofs of heavy trucks would be to include an appropriately sized roll cage within the existing structure. This cage could be made of only a few pieces of mild steel tubing, which would encapsulate the primary cabin area. The Sports Car Club of America (SCCA) has established certain requirements for roll bars and roll cages for racecars. The SCCA requires that roll bars or roll cages be constructed out of the mild steel alloys SAE 1010, 1020, or 1025 or the higher strength chrome-moly alloys SAE 4125 or 4130. The higher strength alloy can be made in thinner sections but it is more difficult to weld than is mild steel. Within the "rally car" races,

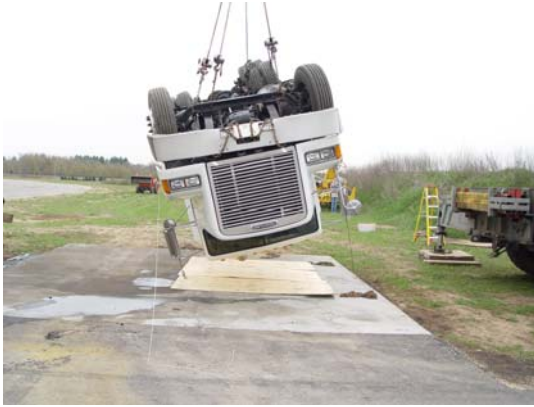
The roll-caged exemplar vehicle was inverted using two cranes in order to suspend it in an undamaged state. It was held at rest 12 inches (30.5 cm) above the plywood that covered the concrete test surface. The lowest point of the truck was the upper corner of the A-pillar on the driver's side. The chassis was oriented at a 24.8° degree roll angle and a 5.5° pitch angle, within the stated ±0.5 tolerance given in the 25° and 5° angles in accordance with the SAE recommended practice J996, *Inverted Drop Test*. A quick-release mechanism was attached to ensure a "clean" drop without hesitation or energy loss. Note that the exhaust stack was cut off flush with the cab roofline

prior to the inversion of the cab in order that it would not interfere with the test (see Figure 4).

Figure 4: Inverted vehicle, ready for testing.

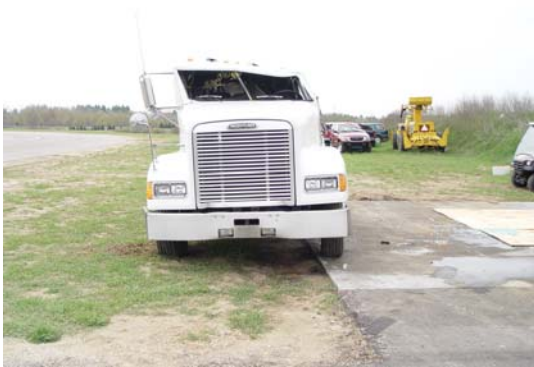
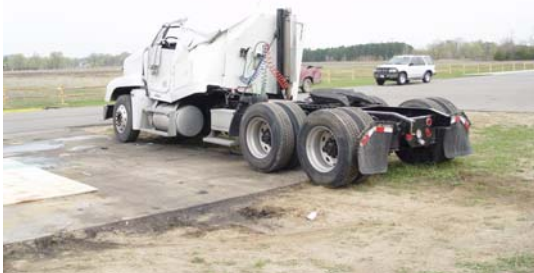
The vehicle was dropped causing major cosmetic damage to the cab, as can be seen in Figures 5 and 6. While this cab would have to be replaced after this test, the occupant survival space is not compromised sufficient to be life threatening. Even the sleeper component, which was largely unprotected by the roll cage, was not grossly deformed during the test.

Figure 5: Exemplar roll-caged vehicle, post drop test.

Figure 6: Exemplar roll-caged vehicle, post drop test.

survival space described in the previously mentioned case study could have been maintained by a roll cage that was properly designed and manufactured. Such a protection system would be modestly priced, and unobtrusive to the user. The vertical loss of space was a mere 1.5", well less than the amount shown in statistical studies to be threatening to human life.

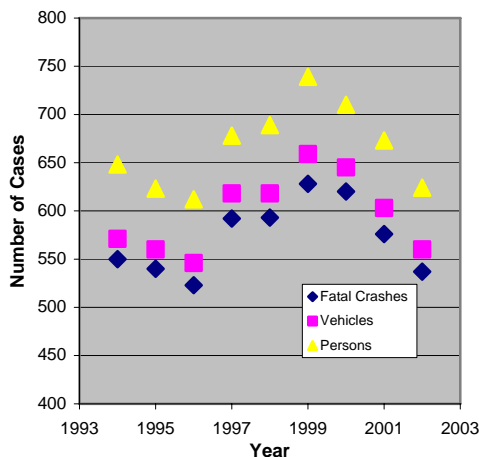
Figure 7 shows the results of all accidents from 1994-2002. The number of fatal accidents per year for heavy trucks peaked in 1999 at 659. The lowest number of fatal accidents for this time period was 523, which occurred in 1996. A downward trend is apparent from 1999-2002, with only 537 fatal crashes occurring in 2002. Since this data looks at all fatal heavy truck accidents, the number of vehicles and persons involved are somewhat higher every year than the number of fatal accidents.

Figure 7. FARS data for all fatal and incapacitating heavy truck crashes from 1994-2002.

The rollover data shown in Figure 8 shows some similar trends as the data for all heavy truck accidents shown in Figure 7. The highest number of fatal and incapacitating crashes, 126, occurred in 1998, with the lowest number of crashes, 93, being reported in 1993. A downward trend from 1998 to 2001 is seen, but in 2002 the number of crashes rose slightly from 107 in 2001 to 115 in 2002.

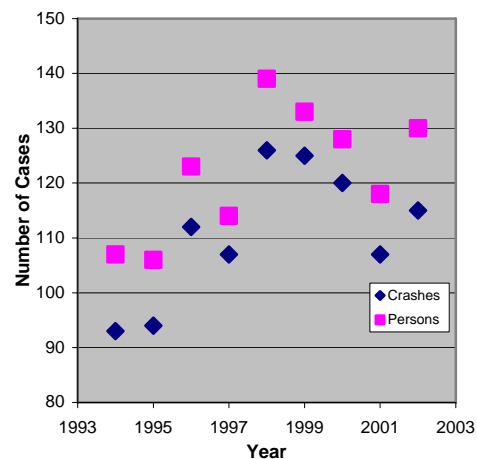
of this query is shown in Figure 8. The average percent of fatalities and incapacitating injuries, which matched the rollover query, was 18%, with a high in 2002 of 21% and a low of 17% occurring in 1994, 1995, and 1997. Therefore, on average, 18% of all heavy truck incapacitating and fatal injuries were a result of a single vehicle rollover accident where the rollover was the most harmful event, either the first or subsequent event with contained occupants receiving fatal or incapacitating injuries and the truck receiving severe and disabling damage. This is a very high percentage given such a specific type of accident.

Figure 8. FARS data for heavy truck rollover accidents from 1994-2002 that meet the described query.
