## Some Failure Patterns in Small Diameter Water Pipelines in the City of Houston

Wei Qiao and C. Vipulanandan, PhD, P.E.

Center for Innovative Grouting Materials and Technology (CIGMAT)

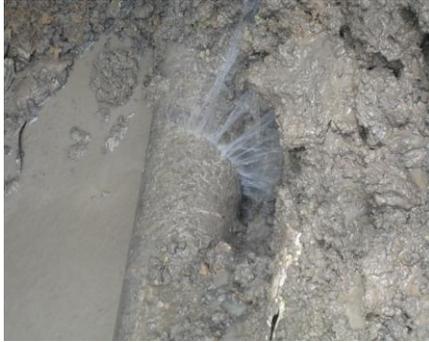
In our study, we found that circumferential cracks could be partial circumferential cracks (Figure 1) due to bending and fully circumferential cracks due to temperature changes (Figure 2). Based on the monthly break data from July 2003 to February 2008, when the temperature fluctuated by  $\pm 10^{\circ}\text{F}$  which could add to the cause of failure (Figure 3), the failure rate was higher just after the largest fluctuation in temperature. It was also found that most cast iron pipes were corroded internal and external and average ages of those pipes was about 40 years. Therefore corrosion also played an important role in the failures.

Figure 1 Partial Circumferential Cracking

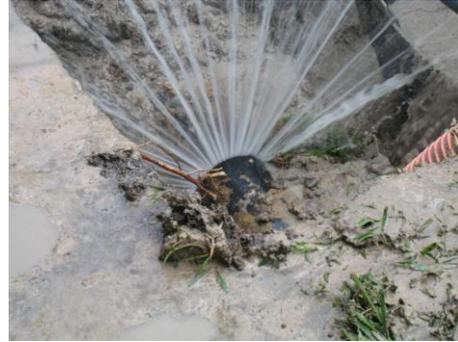
Figure 2 Full Circumferential Cracking

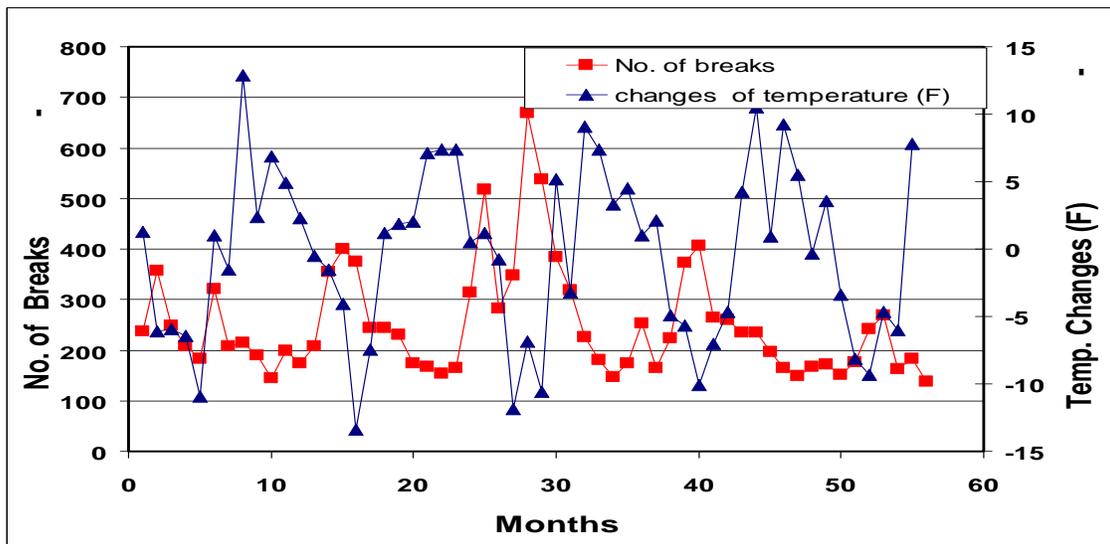
Figure 3 Changes of temperature compared to number of breaks each month
