OMAE2004-51024

## RESTORING INTEGRITY TO AGED PETROLEUM PRODUCTION FACILITIES

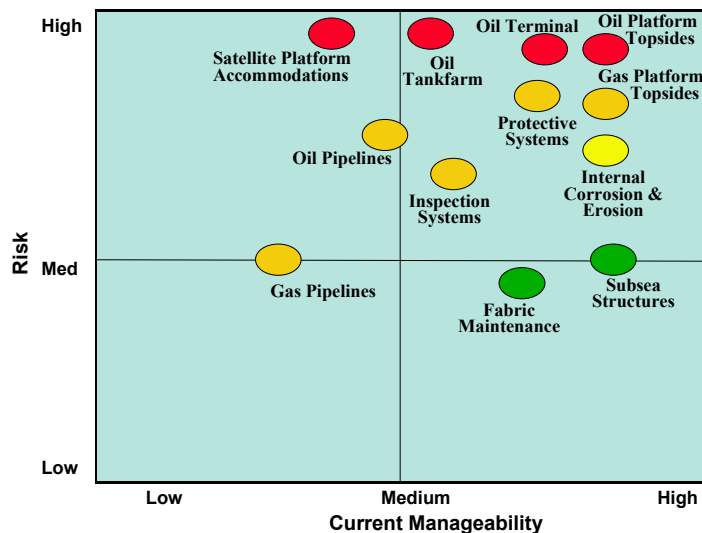
Figure 2 – Year 2000 qualitative risk matrix.

defined as the product of likelihood and consequence of failure, from safety, environmental, business and reputation perspectives. Likelihood of failure was estimated based on existing records and recollections of staff. High likelihood was assigned to events which had happened at least once in the prior two years. Medium and low likelihoods were similarly defined as the 2-10 year range and greater than 10 years (or never), respectfully. Interestingly, a major historical cause of hydrocarbon leaks was due to external corrosion (versus process corrosion), particularly in smaller diameter piping. In fact, experience has shown that unprotected steel (such as flanged connections) exhibit substantial deterioration within two years due to the warm, humid conditions and substantial Atlantic sea-spray. Hence, age of facilities and current state of external corrosion protection figured prominently in likelihood of failure.

Not surprisingly, events associated with high-pressure gas releases and major business interruptions (e.g., terminal or tankfarm events) were categorized as high consequence. Although potential oil leaks themselves were generally regarded to have medium consequences in the model, most oil production facilities use high-pressure gas lift, hence possible failures of these systems placed the older oil production plants into the high-risk category.

Manageability in Figure 2 was estimated based on technical difficulty and time to implement effective corrective actions. For example, once scopes of work were assembled and contracts awarded, terminal and offshore topsides punch-list repairs, blasting and painting were relatively easy and quick to execute, hence, manageable. By contrast (as described below), lack of existing pigging facilities made pipeline integrity work complex, time-consuming and costly, i.e., less manageable.

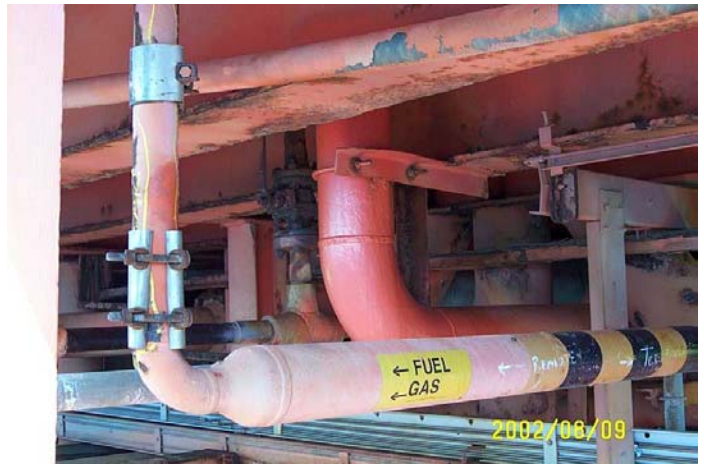
**Figure 3 – Temporarily repaired fuel gas line replaced during offshore TAR.**

- Repairs to and sectional replacements of process and fuel gas piping systems, particularly associated with supports. Figure 3 shows a typical “before” example.
- Removal and/or seal welding repairs to threaded connections into pressure piping.
- Replacement of defective shut-down valves (SDVs), especially for pipeline risers.
- Replacement of fuel gas scrubbers, Figure 4.

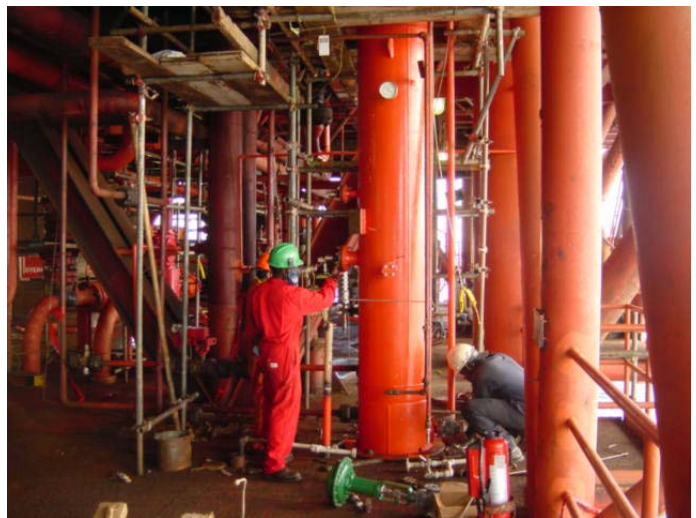
**Figure 4 – Installation of replacement fuel gas scrubber during offshore TAR.**

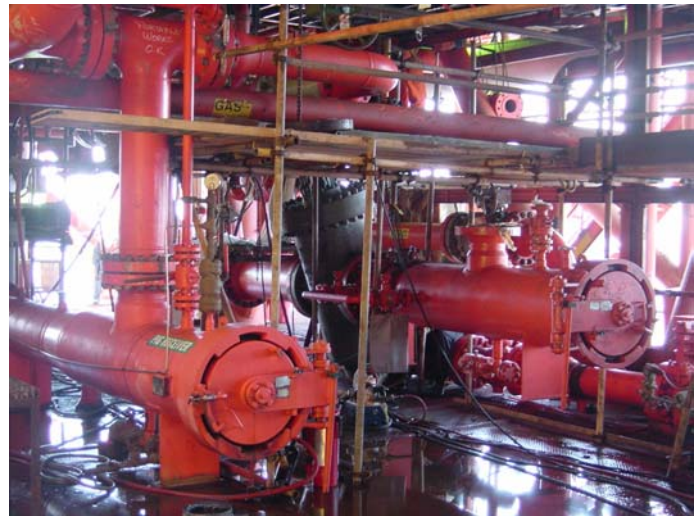
**Figure 5 – Two 18” pig traps installed on Poui. Note angled gate valve (grey) on the right trap.**

Some representative photos from the oil line rehabilitation works are shown in Figures 5-8.

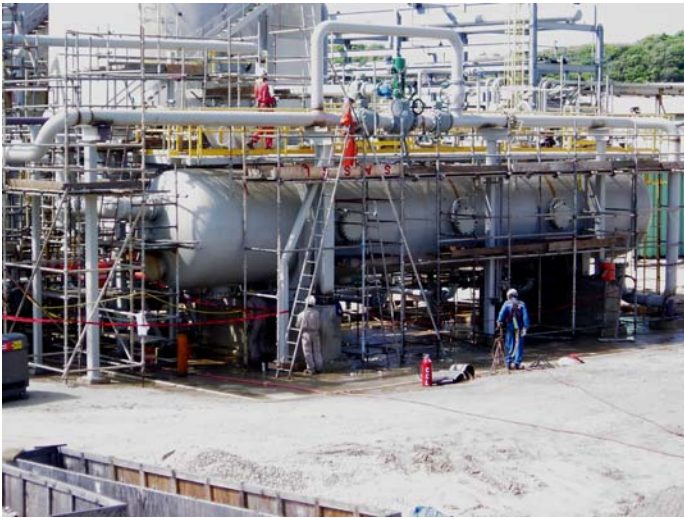
**Figure 6 – New separator at the Galeota Point oil terminal to collect pigging debris from incoming pipelines.**

- Hard scales made repeated pigging with descaling tools necessary (e.g., 88 pig runs were required for the 18” pipeline noted above).
- A separator or similar vessel is required on the receiving end of pipelines to collect debris and enable continued production and oil sales; if a suitable vessel does not exist, it may have to be built at great expense and time (as was the case here).

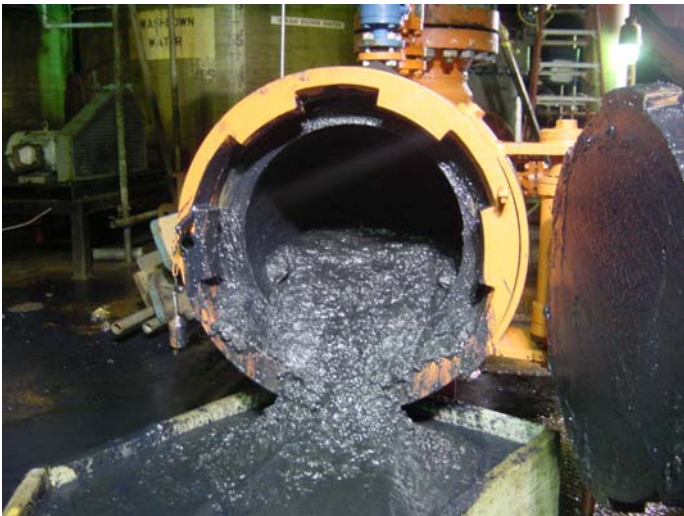
**Figure 7 – Receiver on Pouli platform with pigged debris.**

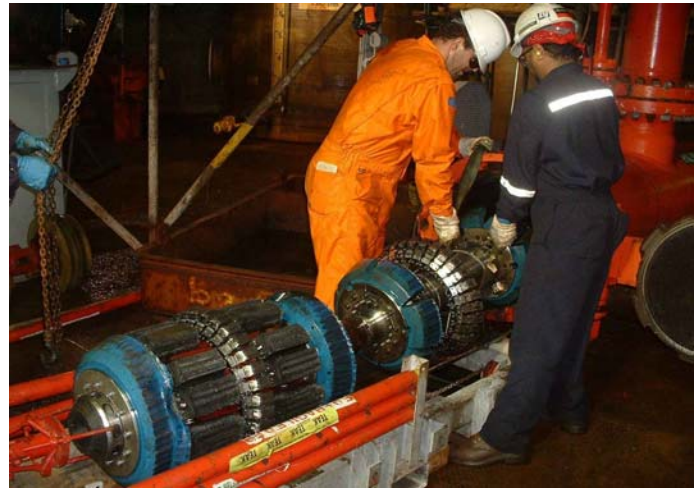
**Figure 8 – Receipt of intelligent pig on Pouli platform.**

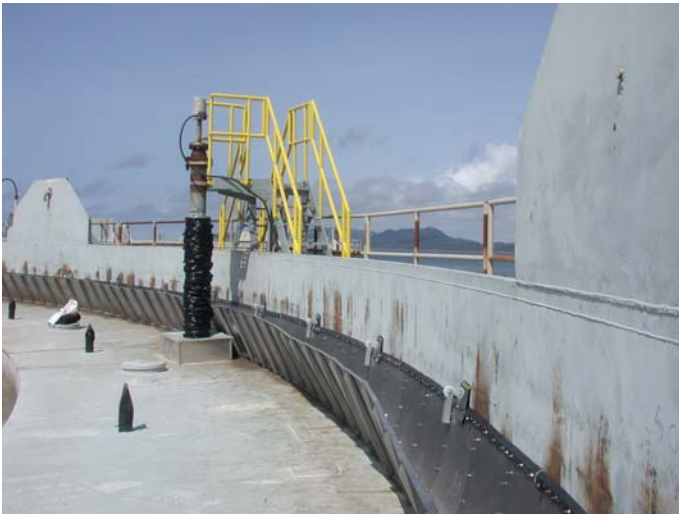
**Figure 9 – Secondary floating roof seal on oil storage tank.**

- Cleaning of tank bottoms sludge and thorough internal inspections.
- Replacement and repairs of corroded annular plates.
- Installation and upgrading of low and high level alarms.
- Upgrade and/or installation of secondary roof seals to reduce emissions and the likelihood of rim seal fires, Figure 9.
- Installation of secondary roof drains, improved pontoon manway covers and upgraded rim seal foam firefighting systems.
- Upgrade of cp protection and installation of lightning dissipation systems.

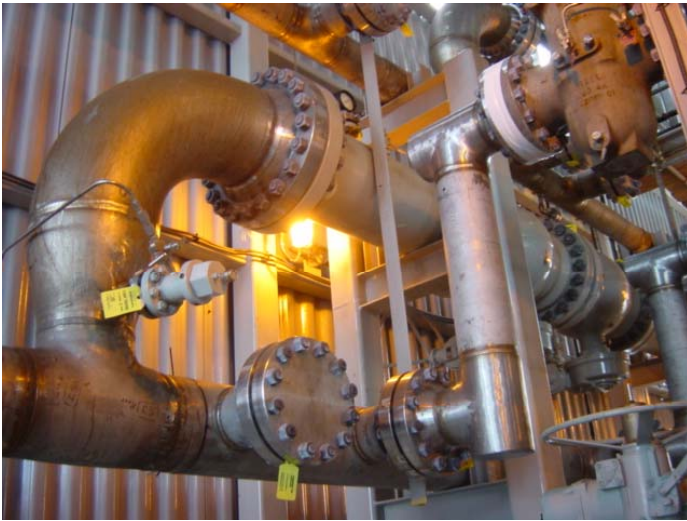
**Figure 10 – Duplex stainless steel flowlines and production manifold on the Kapok platform.**

- Incorporation of corrosion and materials lessons learned into the new platform projects. One highlight of these is the application of duplex stainless steel for the Kapok platform flowlines and production manifold, Figure 10.

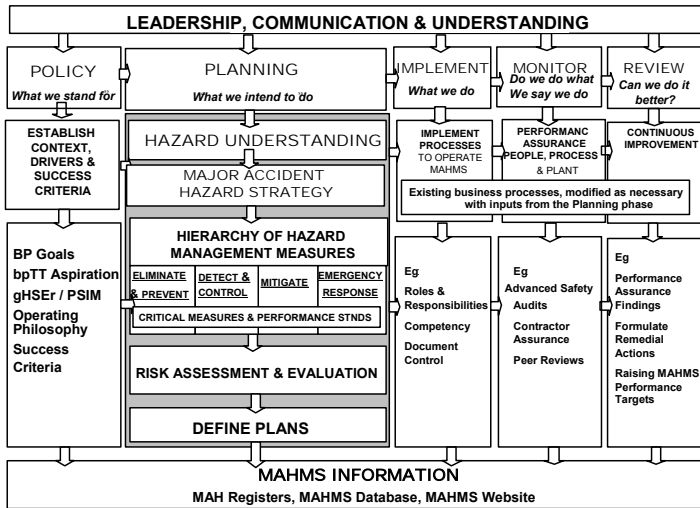
Figure 11 – Major Accident Hazards Management System process.

A process map of MAHMS is shown in Figure 11. As seen, the process follows a typical, “plan, do, measure and improve” cycle. Note that critical measures coming from the hazard identifications and risk analyses can be of three types, i.e., people, process and plant. The latter are currently producing a next round of facilities integrity improvement projects, with major emphases on leak, gas and fire detection, active mitigation and emergency response. Clearly it will be some time before the full benefit of MAHMS with respect to risk reduction are realized.
