CORRELATION BETWEEN MICROSTRUCTURE AND MECHANICAL PROPERTIES OF DIFFUSION BRAZED MAR-M 247

W. Miglietti
Mattek — Csir
Pretoria, South Africa

Presented at the International Gas Turbine and Aeroengine Congress and Exposition
Cincinnati, Ohio May 24-27, 1993

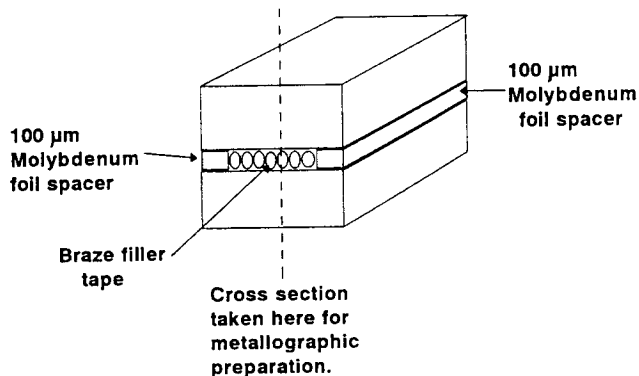
Figure 1: Schematic representation of braze sample set up.

Test sample faying surfaces were polished up to a 1 200 emery grit paper and then cleaned with toluene and ethanol. The joint gap was maintained at 100 μm by placing two, 100 μm molybdenum foil sections between the faying surfaces as seen in Figure 1.

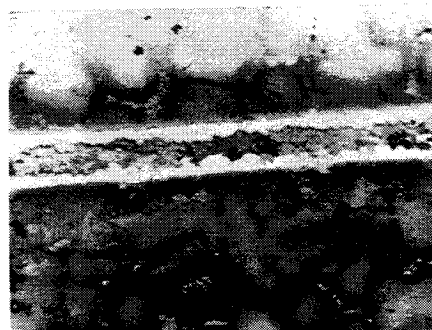
Figure 2: T = 1125 °C; t = 20 minutes
Mag 80x

Figure 2 shows the microstructure of the joint after brazing at 1125 °C for 20 minutes. A continuous, dense, hard and brittle center-line phase existed which is undesirable as it provides a continuous path for crack propagation. Figure 3 shows the microstructure of the joint after brazing at 1125 °C for 60 minutes. The continuous center-line phase which existed previously had partially disintegrated forming a semi-continuous boride phase consisting of large and small particles.

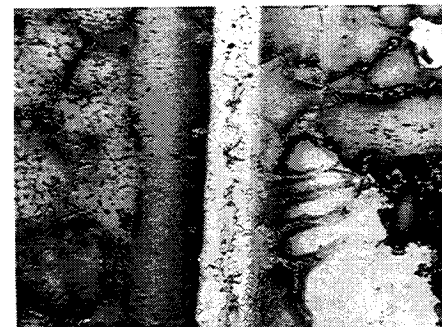
Figure 3: T = 1125 °C; t = 60 minutes
Mag 80x

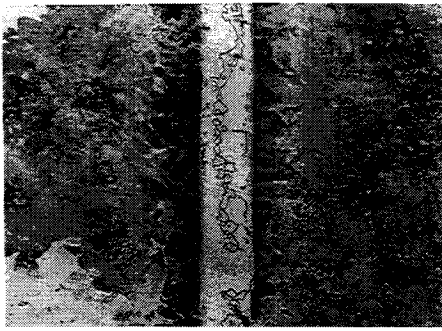
Figure 4: T = 1 125 °C; t = 120 minutes
Mag 80x

Figure 4 shows the microstructure of the joint after brazing at 1125 °C for 120 minutes. The semi-continuous center-line phase still existed. The width of the center-line phase has partially diminished and the individual boride particles have also decreased in size. Figure 5 shows the microstructure of the joint after brazing at 1125 °C for 240 minutes. Clearly the center-line phase has disintegrated a great deal and only isolated particles are present.

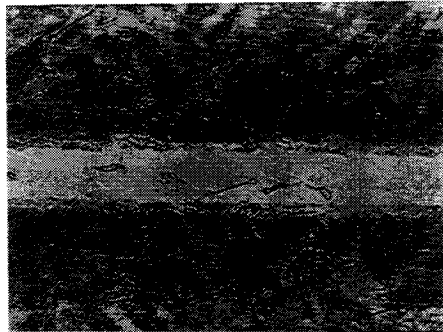
Figure 5: T = 1 125 °C; t = 240 minutes
Mag 100x

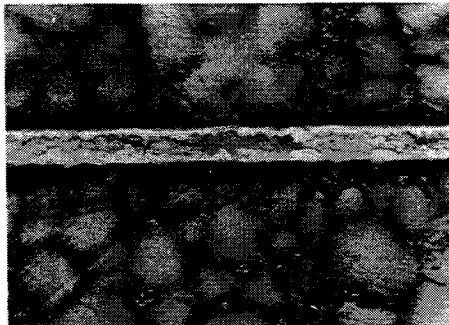
Figure 6: T = 1 150 °C; t = 20 minutes
Mag 50x

Figure 6 shows the microstructure of the joint after brazing at 1150 °C for 20 minutes. As was the case with the joint brazed at 1125 °C for 20 minutes (Figure 2), a large continuous center-line phase existed. Figure 7 shows the microstructure of the joint after brazing at 1150 °C for 60 minutes. The width of the center-line phase has decreased marginally but it is still continuous. Boride needle-like phases can also be seen at the joint interface as a result of B diffusing away from the joint into the parent metal.

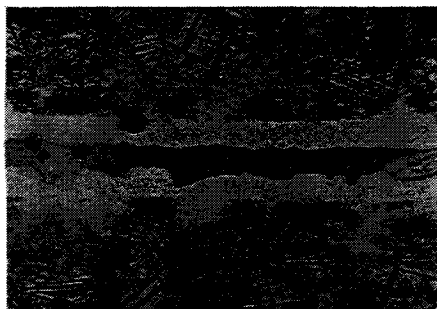
Figure 7: T = 1 150 °C; t = 60 minutes
Mag 150x

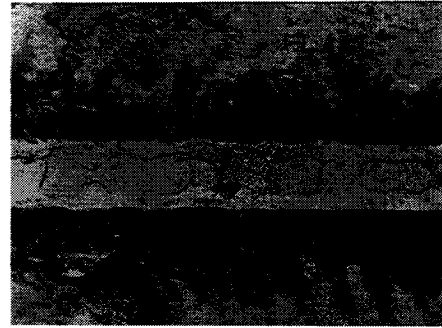
Figure 8: T = 1 150 °C; t = 120 minutes
Mag 150x

Figure 8 shows the microstructure of the joint after brazing at 1150 °C for 120 minutes. The formation of grains in the joint area has occurred. Figure 9 shows the microstructure of the joint after brazing at 1150 °C for 360 minutes. In comparison with previous figures, clearly a tremendous change in the microstructure of the joint has occurred. The Ni-solid solution area (i.e. the area adjacent to the center-line phase) and the joint interface has totally disintegrated as a result of both diffusion of elements from the parent metal into the joint and vice versa.

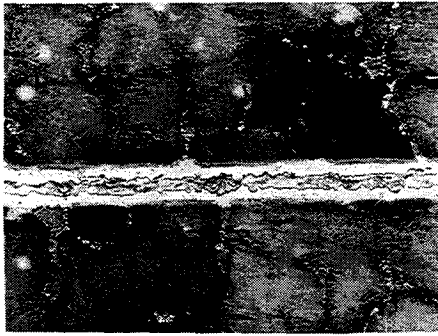
Figure 10: T = 1 200 °C; t = 20 minutes
Mag 50x

Figure 10 shows the microstructure of the joint brazed at 1 200 °C for 20 minutes. As in the case in Figures 2 and 6, when brazing for 20 minutes, a large continuous centre-line boride phase existed. Figure 11 shows the microstructure of the joint brazed at 1 200 °C for 60 minutes. A very narrow centre-line phase existed. This phase does not run planar but branches like a river with its tributaries towards the joint interface. Boride needle-like phases were also present at the joint interface as was the case when brazing for 60 minutes at 1 150 °C (Figure 7).

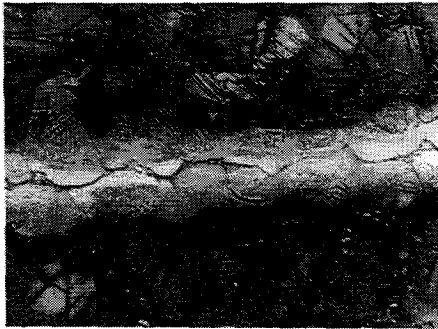
Figure 11: T = 1 200 °C; t = 60 minutes
Mag 150x

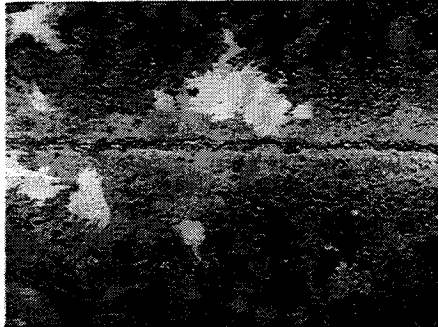
Figure 12: T = 1 200 °C; t = 120 minutes
Mag 50x

Figure 12 shows the microstructure of the joint brazed at 1 200 °C for 120 minutes. The narrow centre-line phase still existed, however the Ni-solid solution area and the joint interface have disintegrated due to diffusion of elements from the parent metal into the joint. Figure 13 shows the microstructure of the joint brazed at 1 200 °C for 180 minutes. The centre-line phase has now become discontinuous. Eutectic phases have formed along the boride centre-line phase as well.

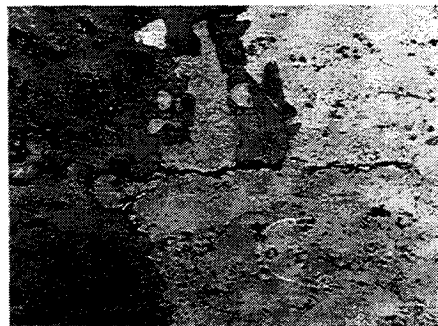
Figure 13: T = 1 200 °C; t = 180 minutes
Mag 50x

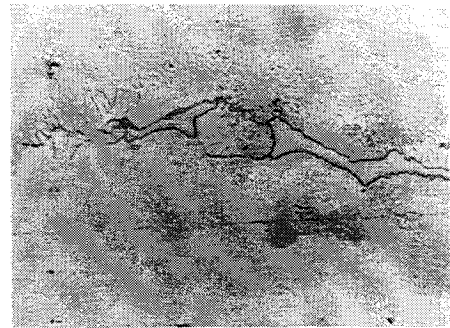
Figure 14: T = 1 200 °C; t = 360 minutes
Mag 500x

Figure 14 shows the microstructure of the joint brazed at 1 200 °C for 360 minutes. The centre-line phase has totally disintegrated. The only means of detecting the joint area was to look at higher magnifications for eutectic and carbide phases which resembled eutectic and carbide phases found along the grain boundaries of the parent metal microstructure.

As evident in Figure 14, the joint area was becoming indistinguishable from the parent metal. Thus as time is increased it was realised that detecting the joint and analysing the microstructure may become a difficult task. Thus electrolytic etching with H_3PO_4 was used for the following micrographs.

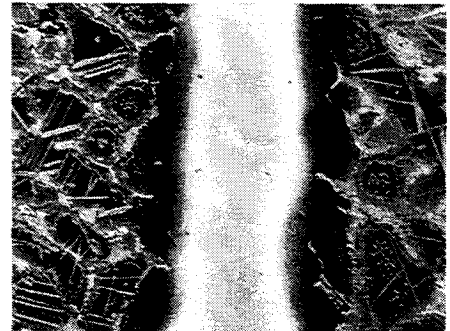
Figure 15: T = 1 200 °C; t = 59 hours (3 540 minutes)
Mag 200x

Figure 15 shows the microstructure of the joint brazed at 1 200 °C for 59 hours (3 540 minutes). Clearly no centre-line boride phase, carbide or eutectic phases were present in the joint. However boride needle-like phases were present in the parent metal and γ' precipitates (although not clearly visible in Figure 15) were present in the joint area. The mechanism for this phenomenon is that B has diffused away from the joint into the parent metal and formed boride needle-like phases. Also Al and Ti diffused from the parent metal into the joint to form the fine γ' phase. The boride needle-like phases were actually W-Cr-Ni boride phases as confirmed by Auger analysis as seen in Figure 16(a). Carbides were also found in the joint and these were Ta-Hf-W rich as evident in the Auger analysis of Figure 16(b).

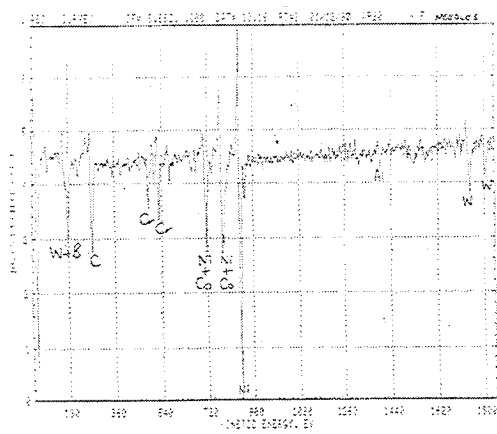
Figure 16(a): Auger analysis of needle-like phase

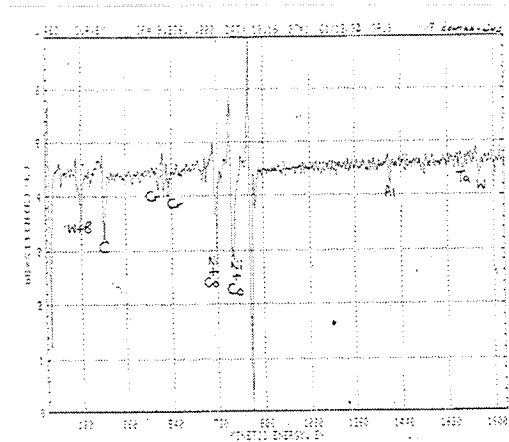
Figure 16(d): Auger analysis of centre-line phase

The centre-line phase of all the joints shown in Figures 2→14 generally consisted of both Cr boride phases, as seen in the Auger analysis of Figure 16(c), and Ni-Cr-Co-Al-W boride phases as seen in Figure 16(d).

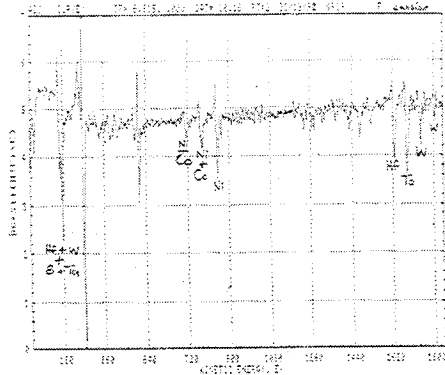
Figure 16(b): Auger analysis of carbide phase

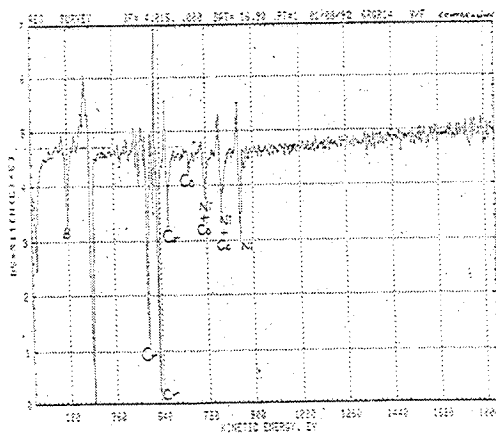
Figure 16(c): Auger analysis of centre-line phase

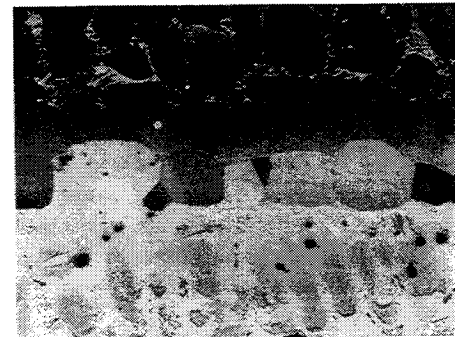
Figure 17: T = 1 200 °C; t = 168 hours (1 0080 minutes)
Mag 200x

Figure 17 shows the microstructure of the joint after brazing at 1 200 °C for 168 hours (1 0080 minutes). The formation of equiaxed grains in the joint had occurred. No boride phases were found present in the joint and parent metal. As can also be seen in Figure 17, microporosity is evident in both the parent metal and joint, hence it was decided that a post-braze heat treatment involving 'hipping' would be carried out. The use of a real time microfocus X-ray machine revealed microporosity in the joint as well as the parent metal. The voltage and current used to detect defects in the joint was 130 kV and 0,9 mA. Although not evident in the figures, the levels of porosity was higher in the parent metal than in the joint. However, both levels of porosity were acceptable using the South African standard which is that the reference area for area percentage is 1 mm x 1,4 mm. The maximum value for microporosity area percentage is 0,5 %. For gas pores (cavities) the maximum allowable size of a single pore, depending on the location, is 3 mm. The distance between 2 pores must be at least 12 mm in case of hollow blades and at least 8 mm in case of solid blades. Figure 18 shows the microstructure of the joint after brazing at 1 200 °C for 240 hours (14 400 minutes). The equiaxed grains in the joint were still present with carbide phases along these grain boundaries. This is an ideal situation as one has equiaxed grains in both the parent metal and joint area. The volume fraction of γ' in the joint was 59 % and 62 % in the parent metal. The volume fraction was measured by using a software program on an image analyzer facility.

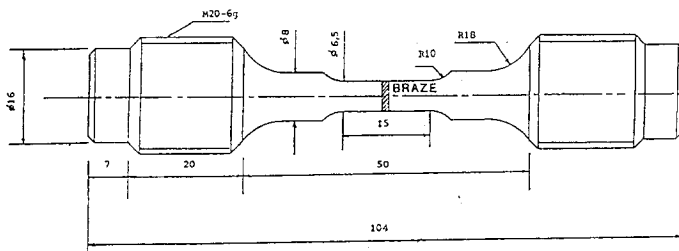
Figure 19(a): Tensile strength test configuration for brazed joints

As can be clearly seen in the previous paragraphs a large range of microstructures existed for a variety of brazing times and temperatures. The obvious question is what properties do these microstructures have. Hence tensile tests at room temperature and $760\text{ }^{\circ}\text{C}$ as well as creep rupture tests at $980\text{ }^{\circ}\text{C}$ were carried out. Tensile tests were conducted based on the tensile test butt configuration shown in Figure 19(a). Creep rupture tests were conducted based on the configuration shown in Figure 19(b). The two test configurations shown are a 100 % full penetration butt joint. All mechanical property results are an average of 3 samples, or 2 samples where otherwise stated.

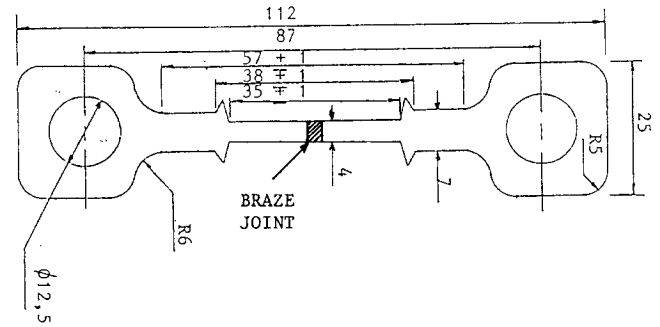
Figure 19(b): Creep rupture strength test configuration for brazed joints

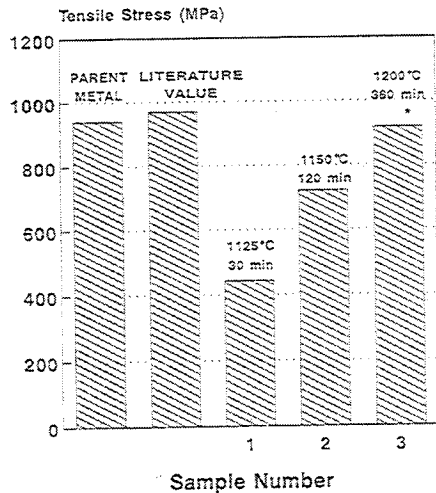
Figure 20:

MARM 247 Tensile Stress Variation As A Function Of Brazing Parameters For Butt Joints With NICRO 150 Filler Metal

*Sample Failed In Parent Metal
 - Note: Numbered Sample Values Are Each The Average Of Two Results

Figure 20 shows the tensile stress variation at room temperature as a function of brazing parameters for butt joints with Microbraz 150 filler metal. After brazing at $1125\text{ }^{\circ}\text{C}/30\text{ minutes}$, the joint failed at an U.T.S. of 443 MPa. It was deduced that the low U.T.S. value resulted from the easy crack propagation path provided by the continuous centre-line phase as seen in Figure 2. Increasing the brazing temperature and time to $1150\text{ }^{\circ}\text{C}/120\text{ minutes}$, the joint failed at an U.T.S. of 720 MPa. The increase in strength of the joint is due to the formation of equiaxed grains in the joint (Figure 8) and the disintegration of the continuous centre-line phase. Increasing the temperature and time still further to $1200\text{ }^{\circ}\text{C}/360\text{ minutes}$, the parent metal now failed at an U.T.S. of 918 MPa. It can be recalled that the joint area resembles in morphology that of the parent metal (Figure 14). Hence the joint area is homogenised after brazing at $1200\text{ }^{\circ}\text{C}$ for 360 minutes. This briefly explains why parent metal tensile strength was achieved.

Thus based on Figures 20 and 21, when the brazing time exceeds 360 minutes at $1200\text{ }^{\circ}\text{C}$ the failure during tensile testing at room temperature occurred in the parent metal.

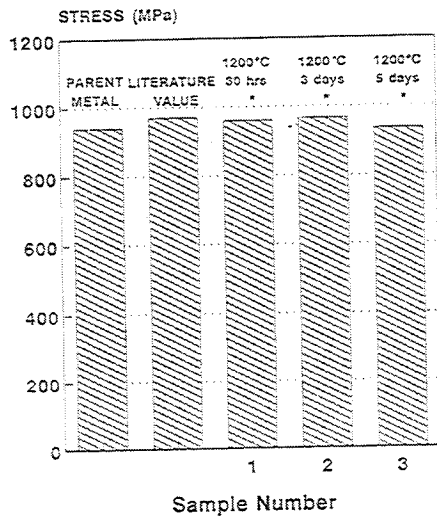
Figure 21:

MARM 247 Tensile Stress Variation As A Function Of Diffusion Brazing Parameters For Butt Joints With NICRO 150 Filler Metal

*Sample Failed In Parent Metal

Figure 21 shows the tensile stress variation at room temperature as a function of diffusion brazing parameters for butt joints with Microbraz 150 filler metal. After diffusion brazing at $1200\text{ }^{\circ}\text{C}/30\text{ hours}$ the parent metal failed at an U.T.S. of 960 MPa. Increasing the diffusion brazing time still further to $1200\text{ }^{\circ}\text{C}/3\text{ days}$, the parent metal failed at an U.T.S. of 966 MPa. Finally increasing the time to $1200\text{ }^{\circ}\text{C}/5\text{ days}$, the parent metal failed at an U.T.S. of 935 MPa.

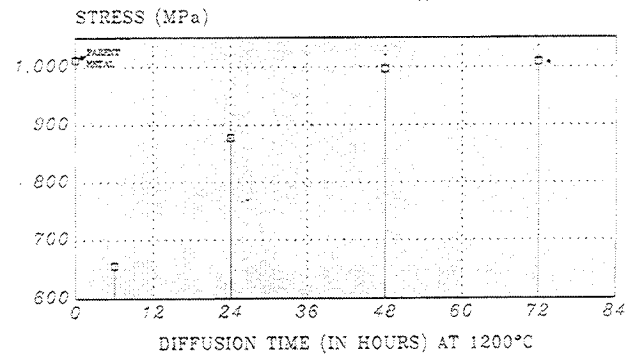
Figure 22:

TENSILE TEST RESULTS AT 760 °C OF DIFFUSION BRAZED MAR M 247

ALL BRAZED JOINTS WERE POST HEAT TREATED AT 1250°C AT 50MPa FOR 4 HOURS + 870°C FOR 20 HOURS
 * - FAILED IN PARENT METAL

Figure 22 shows the tensile stress variation at $760\text{ }^{\circ}\text{C}$ as a function of diffusion time at $1200\text{ }^{\circ}\text{C}$ for butt joints. As can be seen, as the diffusion time is increased, the tensile strength of the joint increased. After diffusion brazing for times of 6, 24 and 48 hours at $1200\text{ }^{\circ}\text{C}$, tensile testing revealed failure in the joint. However after 72 hours of diffusion brazing at $1200\text{ }^{\circ}\text{C}$, fracture occurred in the parent metal during tensile testing. Hence the optimum diffusion brazing cycle from a tensile strength point of view is to hold the joint at $1200\text{ }^{\circ}\text{C}$ for 72 hours, followed by a solution heat treatment under a hipping pressure of 50 MPa, followed by an aging treatment.

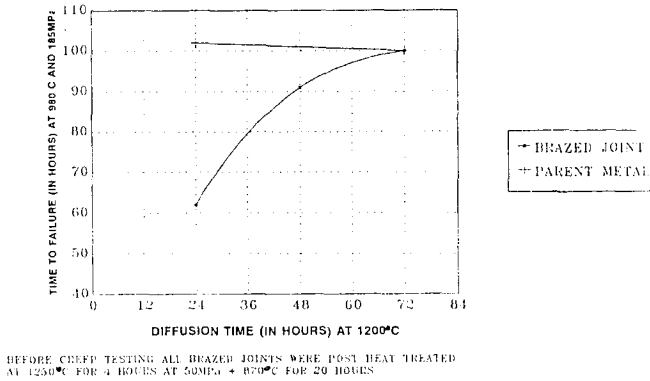
Figure 23:

CORRELATION BETWEEN DIFFUSION TIME AND TIME TO FAILURE FOR MAR M 247 DIFFUSION BRAZES

Figure 23 shows the correlation between diffusion time and time to failure during a creep test undertaken at 980 °C and stress of 185 MPa. Prior to creep testing, all diffusion brazed samples were post-solution and aged heat treated. As can be seen the time to failure is only equivalent to the parent metal, after diffusion brazing for 72 hours at 1 200 °C. The other important result seen in Figure 23 is that if the parent metal strength was thermally degraded by holding for 24→72 hours, then the post solution/hipping and aging heat treatment certainly restores the mechanical strength. This is evident in Figure 23 as the parent metal sample after 24 hours at 1 200 °C followed by the solution/hipping and aging heat treatment, failed at 102 hours when held at 980 °C and 185 MPa whereas the parent metal sample after 72 hours at 1 200 °C, followed by the same post heat treatment, failed at 100 hours. This decrease of 2 hours is minimal.

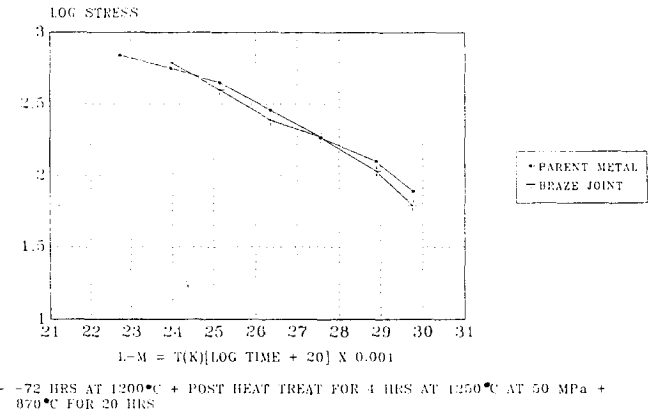
Figure 24:

CREEP RUPTURE PROPERTIES OF MAR M 247 DIFFUSION BRAZED JOINTS

Figure 24 shows the creep rupture properties for joints diffusion brazed at 1 200 °C for 72 hours. The creep samples were post-solution heat treated at 1 250 °C for 4 hours at 50 MPa, followed by an age heat treatment at 870 °C for 20 hours. The diffusion brazed joints had nearly an equivalent creep rupture strength to that of the parent metal. Joint efficiencies greater than 95 % was achieved when diffusion brazing at 1 200 °C for 72 hours followed by a subsequent heat treatment.

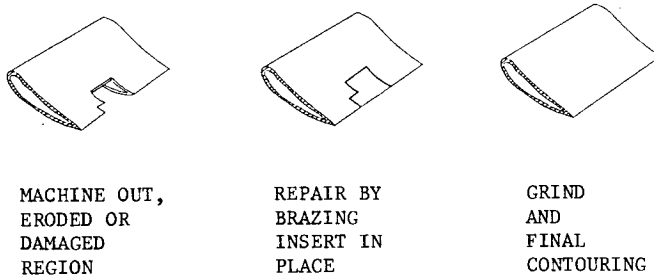
Figure 25: Schematic representation of a brazed replacement insert method for repairing cracks on nozzle aerofoils

In this investigation the influence of the joint gap was not studied due to the fact that a 100 µm filler metal was used. However, it is envisaged that if the filler metal or joint gap was decreased to 50 µm or even 25 µm then the diffusion brazing time could be significantly reduced. This is a recommendation for future work. Also based on the fact that the gap width can be controlled by using standard thickness filler metal, a braze replacement insert method shown schematically in Figure 25 could be a viable repair technique for repairing cracks on the nozzle aerofoils. The replacement insert method has been successfully demonstrated by Adam, 1987.
