## DESIGN OF QUEENSLAND ROAD INFRASTRUCTURE FOR HIGH RISK ENVIRONMENTS

Alan Carse<sup>A</sup> and Allan Bell<sup>B</sup>

<sup>A</sup> Queensland Department of Main Roads, Brisbane, Australia.

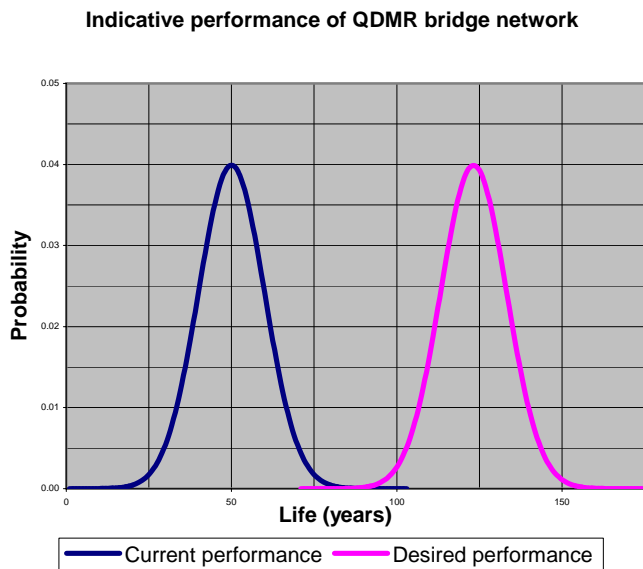
**Figure 1. Schematic view of bridge service and design lives**

Probably the dominant two issues have been (ii) and (iv). Optimised and improved concrete technology is needed to have an appreciable affect on (i) to (vii) inclusive. Hence, Road Authorities need to invest their first dollars available in understanding their local concretes and optimising the durability performance of the concrete and then look at other potential strategies. Fig. 1 shows a schematic representation of the actual histogram of bridge performance and the desired position. The average design life needs to shift to 125 years at least to guarantee a 1% failure criterion at 100 years. The Austroads Bridge Design Code (1992) requires a design life of 100 years.

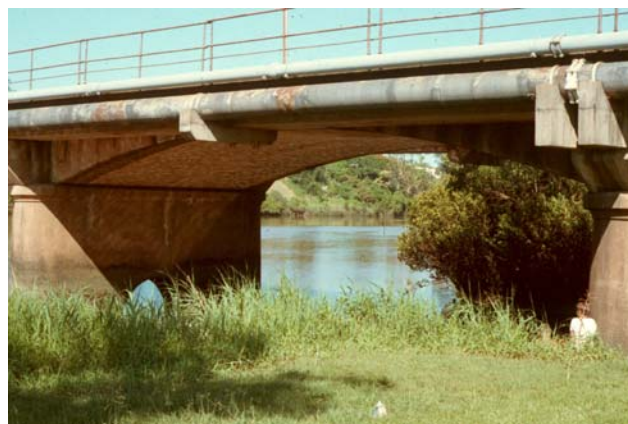
**Figure 2. View of Lamington Bridge built in 1896 now 107 years old**

The definition of design life in the Austroads Bridge Design Code does not mean that the bridge reaches its end of life at that age or that no maintenance is needed during its life. A regular normal maintenance plan should be undertaken to counter any localised distress due to construction defects or the affects of wear and abrasion. Fig. 2 shows a view of one of the few concrete bridges in Queensland which has met and exceeded the aims of the 1992 Bridge Code even though it was built in 1896 some 96 years before the Code was published.

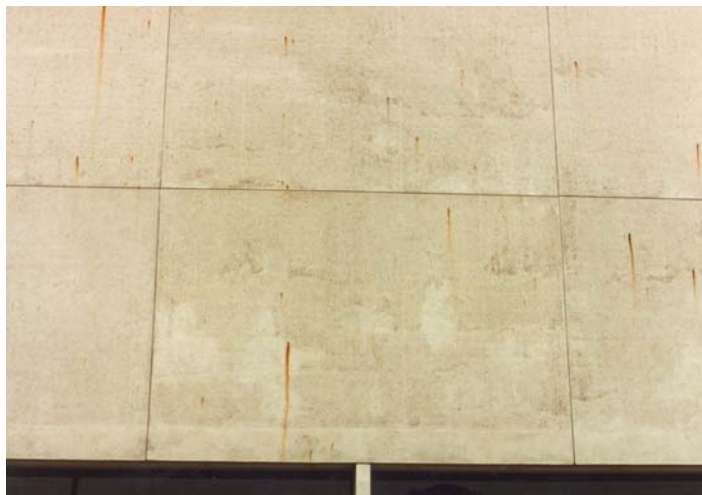
**Figure 4. View of pyrite staining on wall panel**
