International Journal of Electromagnetics and Applications 2012, 2(5): 105-113 DOI: 10.5923/j.ijea.20120205.03

Effect of Radiated Field Due to ESD on Ones and Zeroes of the Serial Data Stream

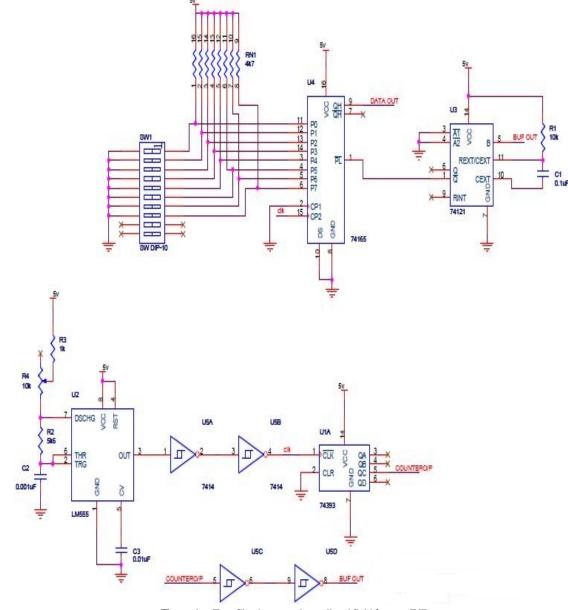
Figure 1. Test Circuit exposed to radiated field from an ESD

A simple circuit as shown in Figure 1 is designed which gives an output of specified data stream. The 8 bit data can

be changed in the DIP switch provided. We can have a specified stream of one's and zeroes. The data stream chosen is 01110111. The 555 timer is used for clock generation. The clock frequency can be varied from 62.5 KHz to 118 KHz by varying the 10 KW potentiometer. The dual 4 stage binary counter IC 74393 is used as an , 8 counter. The IC 74121 is a monostable multivibrator which accepts new data after every 16 bits. The IC 74165 is an 8 bit parallel into serial output shift register. The circuit gives an output of specified serial data stream.

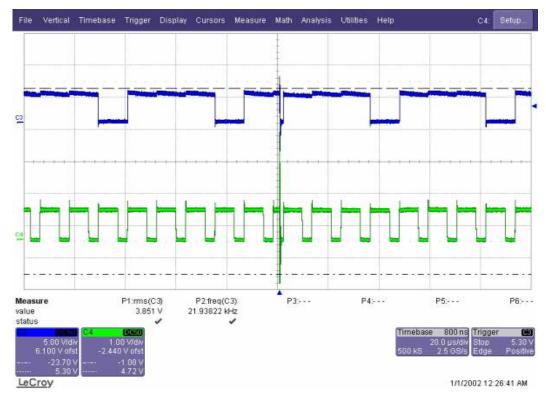
Figure 2. Effect of ESD Transient on the data and clock

A short duration transient is introduced in the data as well as the clock stream as shown in the Figure 2, which affected the data transmission. The clock and data voltage level is set to 5V. The transient introduced in the clock as shown in Figure 3, had a top peak of +16.85V and bottom peak of -7.25V and the data stream as shown in Figure 4, had a top peak of +7.35V and a bottom peak of -4.6V. As soon as the ESD transient is introduced in the clock and data, the data shown at the top in Figure 2 changed from 1 to 0 and also the clock shown at the bottom in Figure 2 momentarily changed from 1 to 0 for 2.5 μ s.

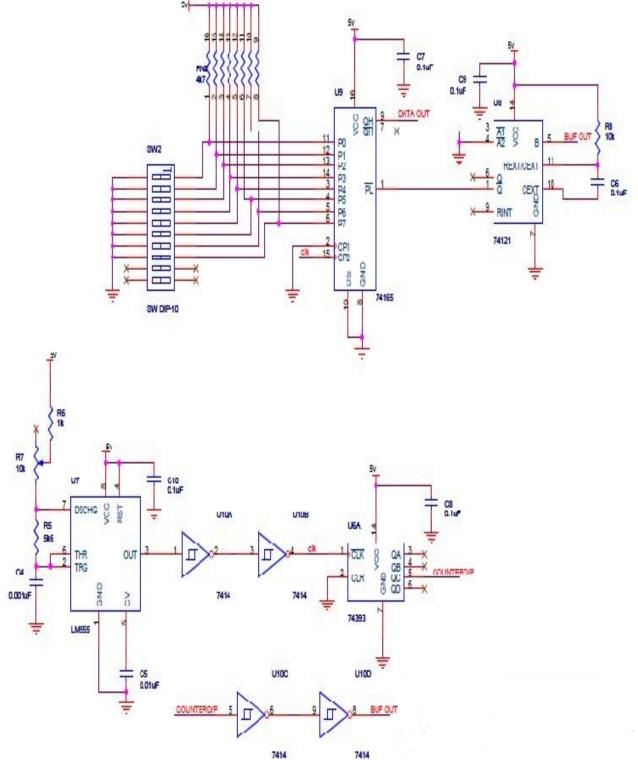
Figure 6. Test Circuit with decoupling capacitors

The malfunctioning of the counter IC and the change in the data stream is analysed. An effective ESD protection solution in the form of decoupling capacitor is considered for improving the ESD robustness of the IC. Another circuit as shown in Figure 6 is designed with the decoupling capacitors of value 0.1µF connected to the V_{cc} supply of all the IC's. This circuit is again exposed to radiated field from an ESD generator. An indirect test on the horizontal coupling plane is done for various voltages and distances. A transient spike of lower magnitude is introduced momentarily but it does not affect the clock stream as well as the specified data stream. So the use of decoupling capacitors reduced the impact of the transient on the functioning of the IC's, which resulted in proper functioning of the circuit. The ESD transient however had an effect on the amplitude of the data stream and its effect on the ones and zeroes of the data stream are observed.

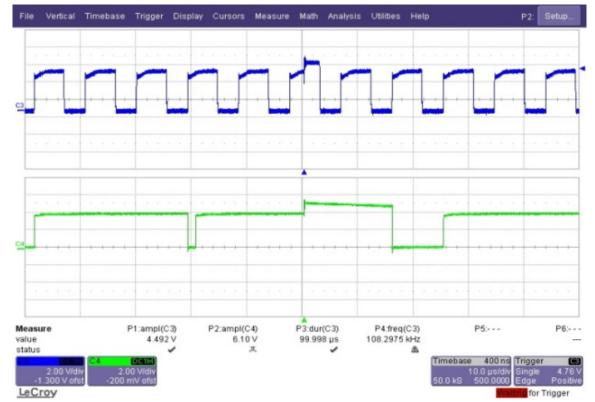
Figure 7. Clock and data stream with ESD transient introduced on ONE data bit at the distance of 1 meter

A short duration transient is introduced in the data as well as the clock stream as shown in the Figures 7, 8, and 9, which affects the amplitude of clock and data momentarily but does not affect the order of transmission of clock stream and the data stream[11101111]. In conclusion, it has been observed that when the transient is discharged during the data transmission of ONES, it affects the amplitude of the data but it does not disturb the order of transmission of the bits as the increase in amplitude is well within the threshold limits.

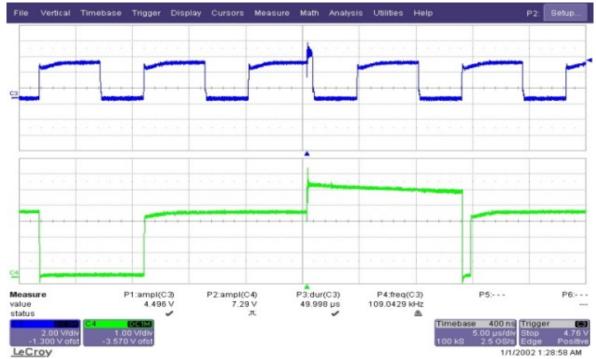
Figure 9. Clock and data stream with ESD transient introduced on ONE data bit at the distance of 0.1 meter

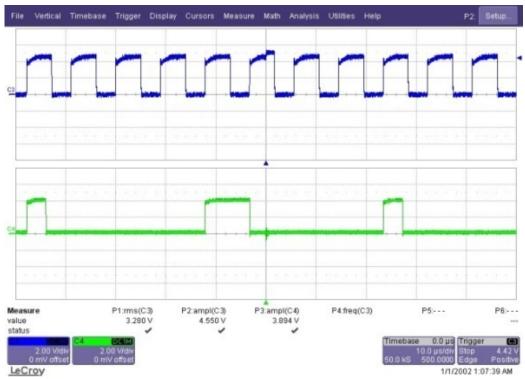
Figure 11. Clock and data stream with ESD transient introduced on ZERO data bit at the distance of 1 meter

A short duration transient is introduced in the data as well as the clock stream as shown in the Figures 11, 12 and 13, which affects the amplitude of clock and data momentarily but does not affect the amplitude and the order of transmission of the data stream[00010001]. In conclusion, it is observed that when the transient is discharged during the data transmission of ZEROES, it does not disturb the amplitude of the data and the order of transmission of data bits.

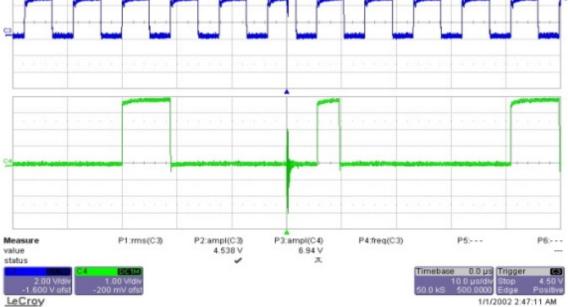
Figure 13. Clock and data stream with ESD transient introduced on ZERO data bit at the distance of 0.1 meter
