Optimization of Railroad Bearing Health Monitoring System for Wireless Utilization

Cuanang, J, Tarawneh, C, Amaro, M, Jr., Lima, J, & Foltz, H. "Optimization of Railroad Bearing Health Monitoring System for Wireless Utilization." Proceedings of the 2020 Joint Rail Conference. 2020 Joint Rail Conference. St. Louis, Missouri, USA. April 20–22, 2020. V001T03A007. ASME. <https://doi.org/10.1115/JRC2020-8060>

**OPTIMIZATION OF RAILROAD BEARING HEALTH MONITORING SYSTEM
 FOR WIRELESS UTILIZATION**

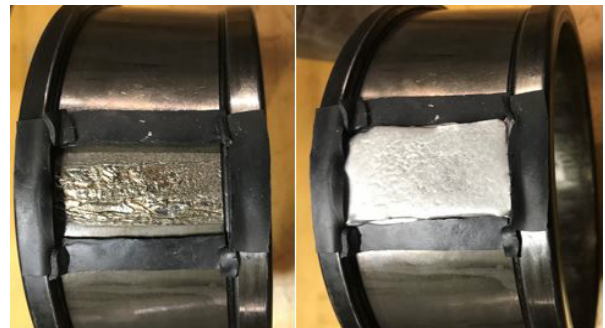
The vibration levels within a bearing were closely tracked and monitored by the various installed accelerometers. If the RMS value for the bearing exceeded the typical threshold for a healthy bearing, the experiment was stopped, and the bearing was pressed off the axle and disassembled for a thorough inspection of all its components. If a spall was found one any of the bearing raceways, a casting of the defect was created by surrounding the defective area with sealant (tacky) tape having a melting point of 204°C (400°F). Then, a molten bismuth alloy with a melting temperature of 80°C (176°F) is poured into the cavity created by the tacky tape, as depicted in Figure 6.

Figure 6. Casting procedure using Bismuth alloy; spalled surface outlined with tacky tape (left); Bismuth alloy cast (right).

After hardening, the casting is removed from the mold (cavity) and the spalled region is painted to highlight the defect.

Creating a casting of the defect allows for further analysis and measurements without having to delay experimentation once the bearing has been reassembled and pressed on the axle. The casting is used to measure the defect area. To do so, an image of the painted spall region is obtained, and post-processed utilizing codes created in MATLAB™ which enhance the contrast of the darkened spall region. These images are then imported to Image Pro-Plus® where a digital analysis of the defect is performed through optical techniques to acquire accurate defect area parameters.

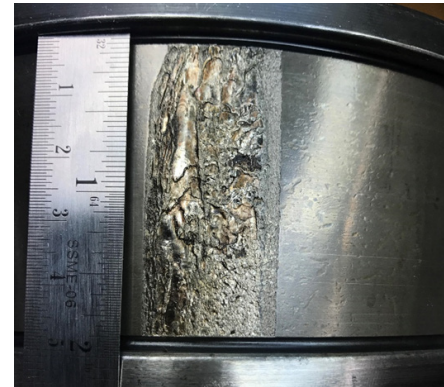
In Experiment 202, a class K bearing with a spalled cone (inner ring) raceway at the inboard side of the bearing was run on the single bearing tester (SBT). During the experiment, the cone spall grew to a total area of 10.51 cm² (1.63 in²). A picture of the spall is presented in Figure 7. Ten different speeds at two different loading conditions simulating an empty and a fully loaded railcar were utilized for this experiment.

Figure 7. Post-experiment cone spall defect (ruler is in inches).

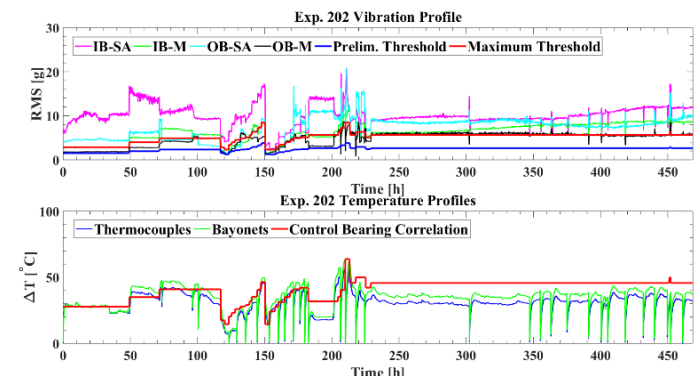
The temperature and vibration signatures of the test bearing during Experiment 202 are provided in Figure 8. The root-mean-square (RMS) vibration values plotted in Figure 8 were calculated from four seconds of data acquired at a sampling rate of 5,120 Hz every ten-minute interval from four wired 70g accelerometers. It is apparent from the vibration signatures captured by all four accelerometers that the bearing is defective

since the RMS values are greater than the maximum RMS threshold for healthy bearings indicated by the solid red line in Figure 8. The inboard smart adapter (IB-SA) accelerometer recorded the highest RMS values, which is not surprising given that the spalled cone resides in the inboard side of the bearing. Interestingly, looking at the temperature profile for this test bearing, it can be seen that the operating temperature of this bearing is consistently lower than the threshold temperature for healthy (control) bearings indicated by the solid red line. The only times the bearing operating temperature exceeded the threshold value is immediately after sudden changes in operating conditions that require some settling time before the bearing operating temperature reaches steady-state conditions. At steady state, the operating temperature of the bearing remains lower than the threshold temperature. This reinforces the conclusion that bearing operating temperature is not a reliable metric for assessing bearing health.

Figure 8. Vibration (4 seconds of data) and temperature profiles for Experiment 202.

Figure 9 is a re-plot of Figure 8 with the sole difference being that the vibration signatures were generated using only one second of accelerometer data (5,120 samples). Comparing the vibration profiles of Figure 8 and Figure 9, it can be observed that the RMS values are very similar in both cases, which implies that Level 1 analysis is not compromised by using 1-second sample windows as opposed to 4-second sample windows. In both cases, the bearing is determined to be defective since the RMS values are greater than the maximum threshold.

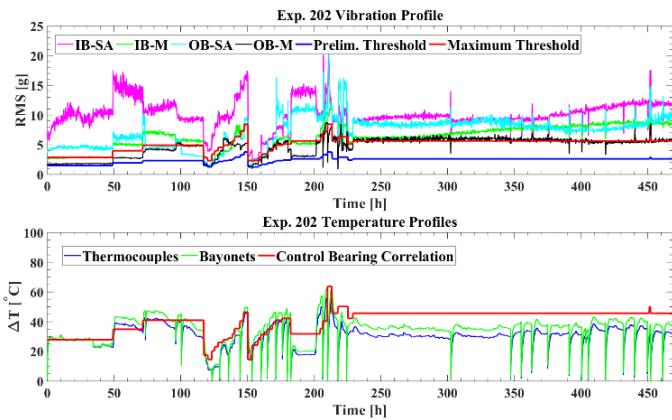
Figure 9. Vibration (1 second of data) and temperature profiles for Experiment 202.

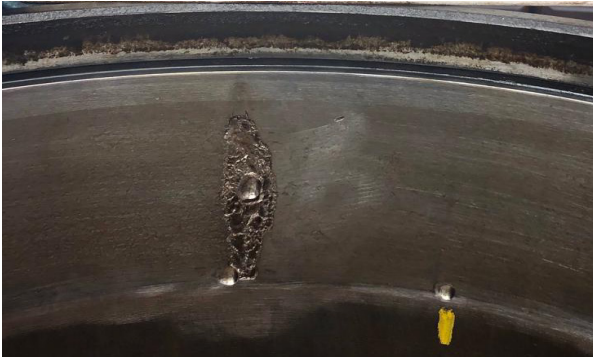
In Experiment 221, a class F bearing with a cup (outer ring) spall located at the inboard raceway of the bearing was run on the single bearing test rig. Prior to testing, the cup spall size was initially 3.76 cm² (0.58 in²), as pictured in Figure 10. The main objective of this experiment was to evaluate the performance of the wireless onboard condition monitoring module as compared to the wired accelerometers. The wireless module was affixed on

Figure 10. Initial cup spall on the bearing inboard raceway.

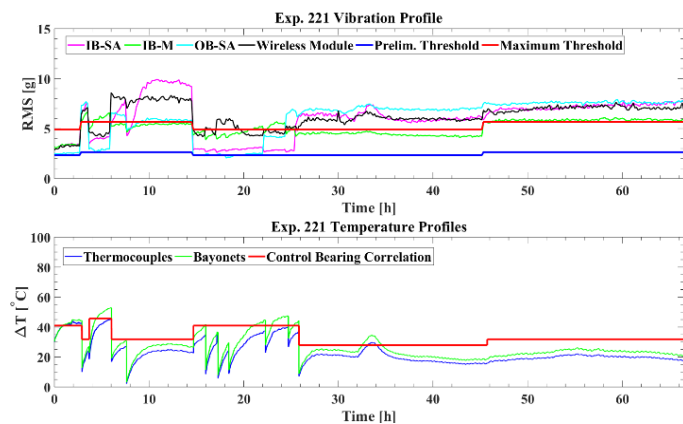
Figure 11 presents the temperature and vibration signatures acquired during Experiment 221. As demonstrated earlier, the operating temperature of the bearing remained below the threshold value (red line) throughout the experiment exhibiting no abnormal operation or bearing defect. Note that the RMS values plotted in the figure were calculated from 4-second sample windows acquired by the three wired accelerometers, whereas, the RMS values for the wireless modules were calculated from 1-second sample windows. The results shown are very promising as RMS values for both wired accelerometers placed in the smart adapter (SA) locations are very comparable to the RMS values for the wireless module. Moreover, both wired and wireless devices indicate that the bearing is possibly defective (Level 1 analysis) since the RMS values are above the maximum threshold represented by the solid red line.

Figure 11. Vibration and temperature profiles for Experiment 221.
