## Estimating the Outer Ring Defect Size and Remaining Service Life of Freight Railcar Bearings Using Vibration Signatures

**JRC2019-1284**

**ESTIMATING THE OUTER RING DEFECT SIZE AND REMAINING SERVICE LIFE OF FREIGHT RAILCAR BEARINGS USING VIBRATION SIGNATURES**

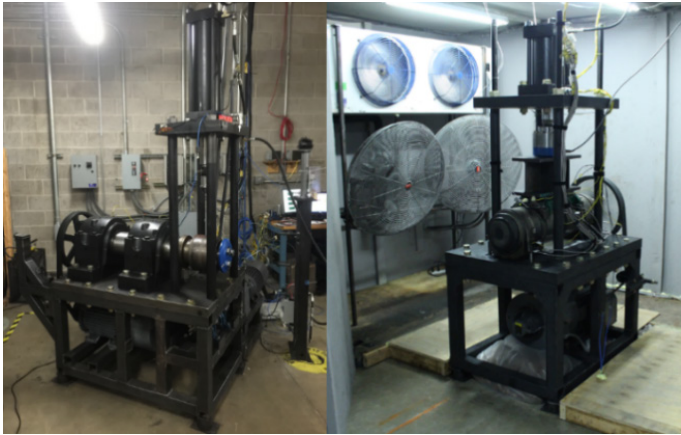
Figure 3. A picture of the single bearing test rig (left), and the four-bearing test rig (Right)

To acquire all the required data needed for this study, the University Transportation Center for Railway Safety (UTCRS) designed and fabricated two dynamic bearing test rigs shown in Figure 3. Both test rigs can accommodate Class F (6 ½" × 12") and Class K (6 ½" × 9") tapered-roller bearings. A fully-loaded railcar applies a load of 153 kN (34.4 kip) per bearing, and each tester is equipped with a hydraulic cylinder that allows each test bearing to be loaded up to 175% of a fully-loaded railcar if desired. The data provided in this paper was collected utilizing three loading conditions: 100% of full-load, which corresponds to a fully-loaded railcar, and 110% and 125% of full-load, which both simulate an overloaded railcar. The test rigs are equipped with a 22 kW (30 hp) variable speed motor which allows the bearings to be tested at different velocities. However, a wheel speed of 796 rpm or a track speed of 137 km/h (85 mph) was used for this study. The bearings are air-cooled utilizing two industrial-size fans that produce an air stream traveling at an average speed of 5 m/s (11.2 mph). The defective area of the raceway is placed in the 90° position shown in Figure 4 in order to apply maximum load to the spall. The latter practice has been proven to cause the defect to propagate at the fastest possible rate, thus, providing a worst-case scenario.

The Single Bearing Tester (SBT) shown in Figure 3 (left) accommodates a single railroad tapered-roller bearing in a cantilever setup, which closely mimics the bearing loading conditions on a freight railcar. A bearing adapter was specially machined to accept four 70g accelerometers placed in the Smart Adapter (SA) and Mote (M) locations at the inboard and outboard sides of the bearing, one 500g accelerometer placed in the Radial (R) location on the outboard side, and four K-type bayonet thermocouples, two inboard and two outboard. A picture of the modified bearing adapter showing the Smart Adapter (SA), Mote (M), and Radial (R) locations is provided in Figure 5. In addition to the four thermocouples affixed to the bearing adapter, there are seven K-type thermocouples placed equidistantly around the circumference of the bearing outer ring (cup) and held in place tightly via a hose clamp.

The Four-Bearing Tester (4BT) shown in Figure 3 (right) accommodates either four Class F or Class K bearings pressed onto a test axle. The axle and bearing setup for the 4BT is given in Figure 6. In order to replicate field service conditions, only data collected from the middle two bearings (B2 and B3) were used for this study since they are both top-loaded. Thus, the middle two bearing adapters were machined to accept two 70g accelerometers placed in the outboard (SA) and (M) locations, one 500g accelerometer placed in the outboard R location, two

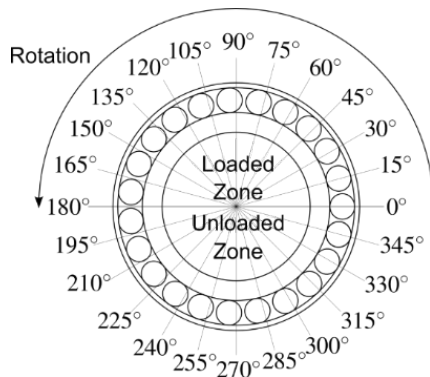
Figure 4. Bearing schematic and spall placement locations

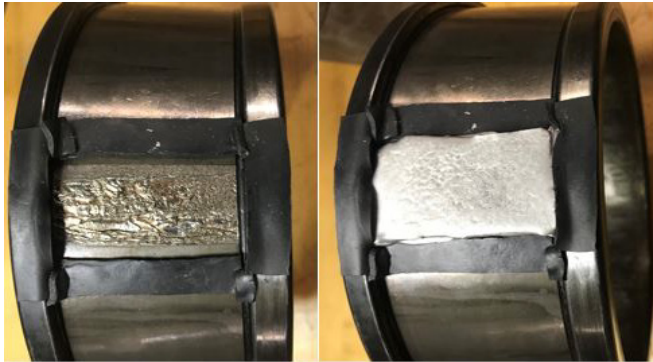
Figure 7. Casting procedure using Bismuth; spalled surface outlined with tacky tape (left); Bismuth alloy cast (right)

Subsequent to vibration level changes during an experiment, the test is stopped, and the bearings are pressed off. They are then completely disassembled, cleaned out, and undergo a thorough visual inspection. Castings of the spalled areas are made using a low-melting, zero-shrinkage bismuth alloy. To create the casting, tacky tape is applied around the edges of the defect area to create a mold border for the molten alloy, which melts at 80°C (176°F). The molten bismuth alloy is then poured into the cavity to obtain a casting of the spalled region. This process is depicted in Figure 7.

After the casting hardens, it is removed from the cavity and painted to highlight the borders of the spalled region. Spall sizes were measured using optical techniques coupled with digital image analysis, as well as, with a manual coordinate measuring instrument with the resulting field of points manipulated in

MATLAB™. In more detail, the casting impression is photographed, and the images are post-processed in MATLAB™ to enhance the contrast. The enhanced images are imported to Image Pro-Plus®, where measurements of area and other pertinent geometric parameters are made.

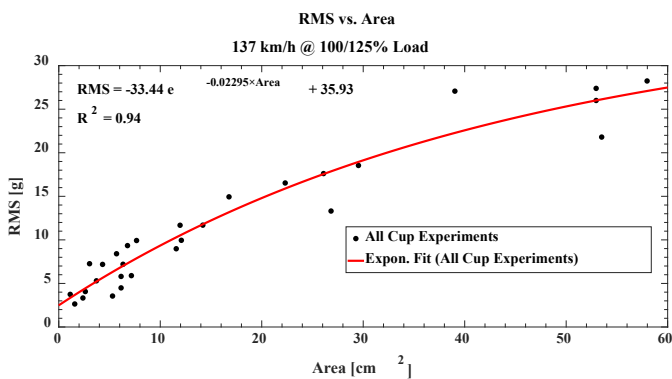
Figure 8. RMS versus cup spall area correlation

Several experiments with defective outer ring raceways were carried out to study the effect that the defect size has on the vibration levels within railroad bearings and to develop defect size growth rate models in order to estimate the remaining service life of the bearing. The data in Figure 8 was acquired by averaging the last two hours of vibration data of the defective bearing operating at a speed of 137 km/h (85 mph) and under a load ranging between 100% and 125% of full-load and comparing it against the defect size. This data is the result of over a decade of testing performed at UTRGV. Table 1 lists the different defect area growth rates acquired from a parallel study also performed at UTRGV [7].

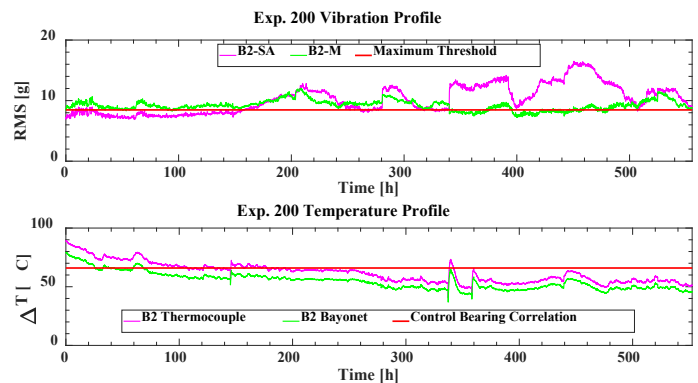
Figure 10. Vibration and temperature profiles for Experiment 200.

Figure 10 presents the vibration and temperature profiles of Bearing 2 (B2) operating at 110% of full-load and 796-wheel rpm (corresponding to a track speed of 137 km/h) during Experiment 200. The bearing was deemed defective using the UTCRS-developed bearing condition monitoring vibration thresholds. Any bearing operating with a vibration signature having an RMS value that is above the “Maximum Threshold” has been verified to be defective. As demonstrated in a previous study, an increase in the vibration levels signifies an increase in defect size [5]. This vibration increase can be seen around the 150-hour mark in Figure 10. The oscillations in the vibration levels shown after the 150-hour mark are signs of spall growth.

Contrary to the vibration increase, the operating temperature above ambient ( $\Delta T$ ) decreased around the 150-hour mark. This

decrease in temperature is generally a by-product of an increase in defect size. Meaning that the spall region provides a pocket for the grease to accumulate, which in turn lowers the operating temperature of the bearing once the grease goes back into circulation. The B2 temperature profiles are below the Control Bearing Correlation, which would signify a healthy bearing [4].

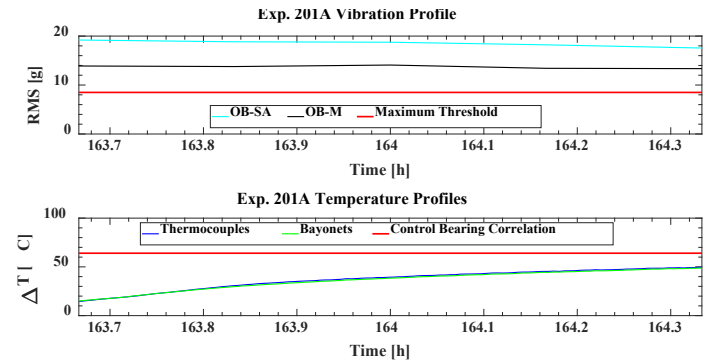
Figure 12. Vibration and temperature profiles for Experiment 201A.

Figure 12 shows the outboard (OB) vibration and temperature profiles for the experiment at 100% of full-load and a track speed of 137 km/h (85 mph). It is important to note that Table 4 shows the average of the peak temperatures is nearly 15°C (27°F) below the Control Bearing Correlation, whereas, the accelerometers are detecting vibrations significantly higher than the Maximum Threshold. The defect size correlation from Figure 8 overestimates the defect by about 8.4%. Again, assuming the defect propagates at the maximum growth rate of 6.52×10<sup>-4</sup> cm<sup>2</sup>/km, it would take approximately 246,000 km (153,000 mi) for the defect to grow to 50% of a single cup raceway area.
