EXPERIMENTAL TESTING OF A LIGHTLY REINFORCED CONCRETE SHEAR WALL

A Project  
presented to  
the Faculty of California Polytechnic State University,  
San Luis Obispo

In Partial Fulfillment  
of the Requirements for the Degree  
Master of Science in Architectural Engineering

by  
Jerry Luong & Rory de Sevilla  
Fall 2020

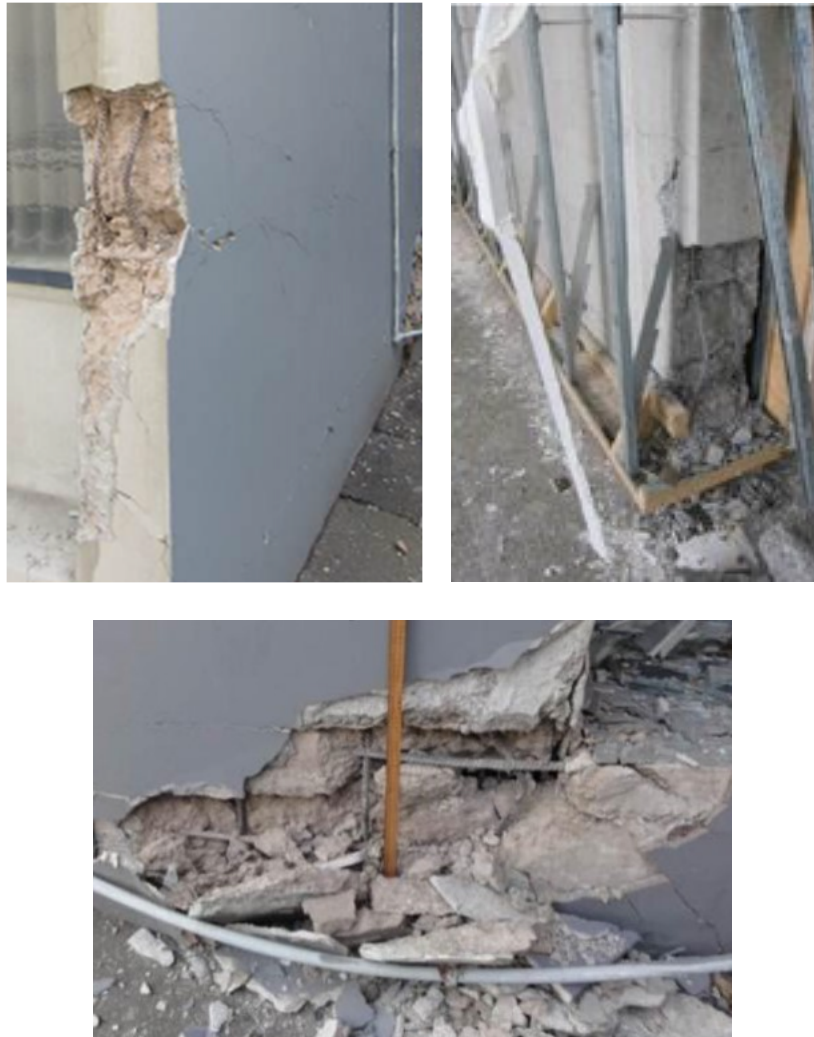
*Figure 2-1: Compressive Boundary Element Damage in the 2011 Christchurch Earthquake, Kam et al. (2011)*

Compressive boundary element damage is evident when the end zones of a rectangular wall have become highly stressed usually due to excessive cyclic loading. Flexural-compression failures typically result from this type of damage and are visually identifiable by bar buckling and/or concrete crushing in the wall end zone. Examples of this failure mode are shown in Figure 2-1. A survey of 91 damaged buildings with reinforced concrete walls spanning between the 1957 Mexico City Earthquake to the 2010 Chile Earthquake reveals that this damage type was the governing behavior in about 50% of the damaged walls in the U.S. and Chile (Birely, 2012). Similarly, the 2011 Christchurch Earthquake produced many flexural-compression wall failures, especially in pre-1980s construction (Kam et al., 2011). It is widely accepted

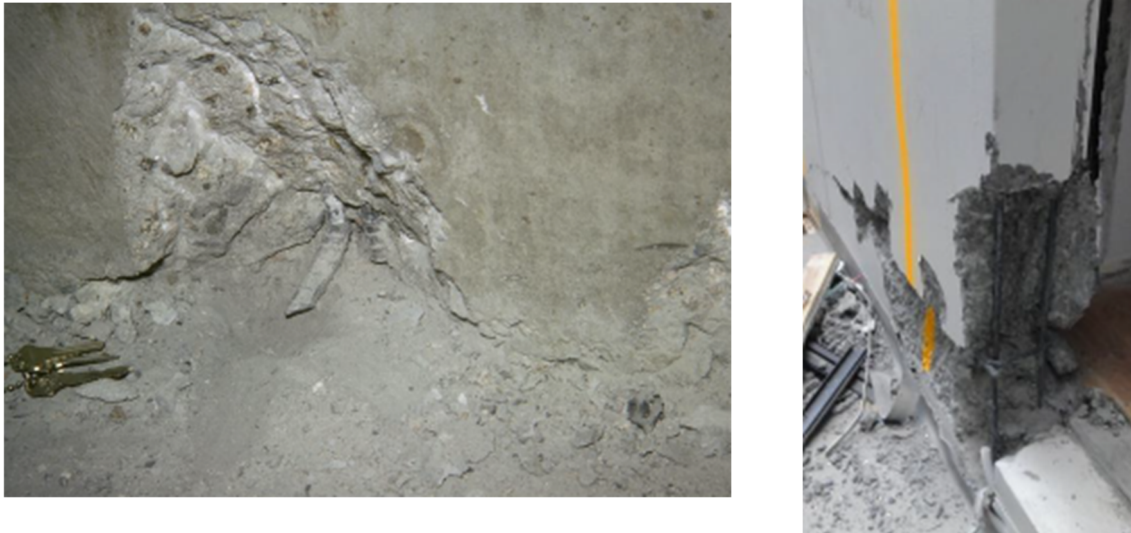
*Figure 2-2: Fracture of Longitudinal Reinforcement in Major Earthquakes  
(Left) Longitudinal rebar fracture following the 1971 San Fernando Earthquake (Birely, 2012) and  
(Right) Longitudinal rebar fracture following the 2011 Christchurch Earthquake (Kam et al., 2011)*

Figure 2-2 (right) shows a structural wall in the Gallery Apartments building in Christchurch is a particular case of flexural tension damage where vertical rebar fractured along a single primary crack plane (Kam et al., 2011; CERC, 2012; Hoult et al., 2018). The concentrated yielding of the vertical rebar crossing the primary crack was due to the lack of secondary crack formations (CERC, 2012). This failure mode was also observed in the El Faro building 1<sup>st</sup> floor shear walls during the 1985 Chile Earthquake (Hoult et al., 2018).

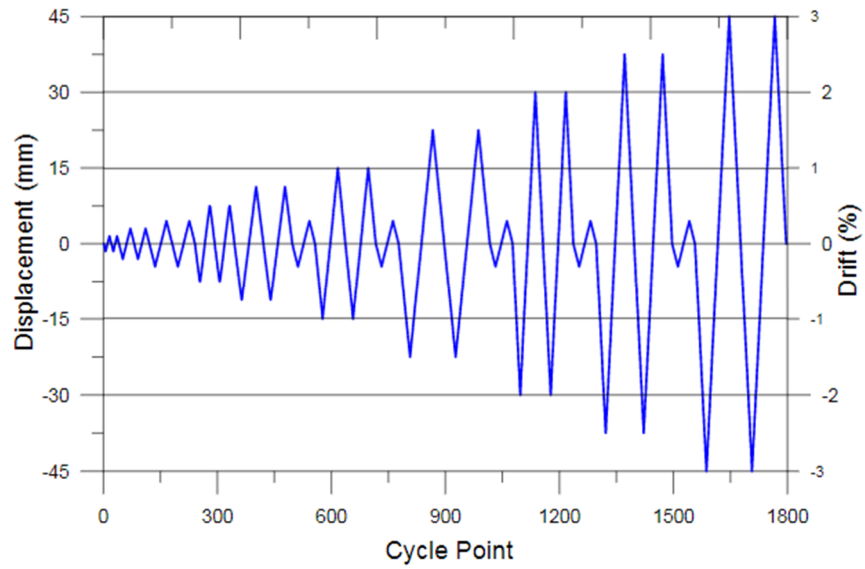
Figure 2-8: Loading Protocol for Specimen W1, Ireland et al. (2007).

The loading protocol used for specimen W1 was displacement controlled and is shown in Figure 2-8. At each drift level, two complete cycles were performed. The researchers based this loading protocol off the ACI T1.1-01, 2001 recommended regime but used two-cycle sets instead of three-cycle sets, expecting the three-cycle set to be too demanding on the wall.

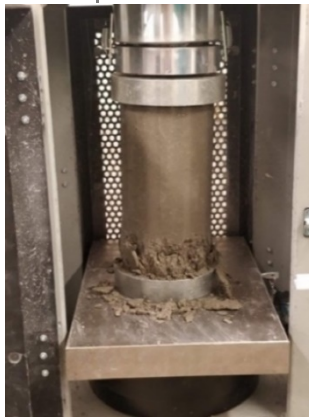
Figure 3-4: Footing Concrete Cylinder Compression Failure

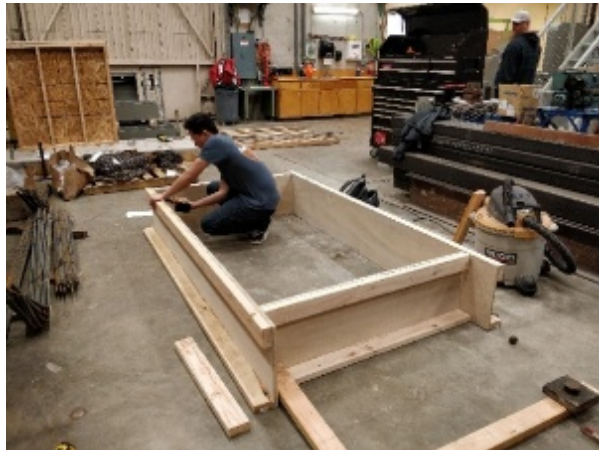
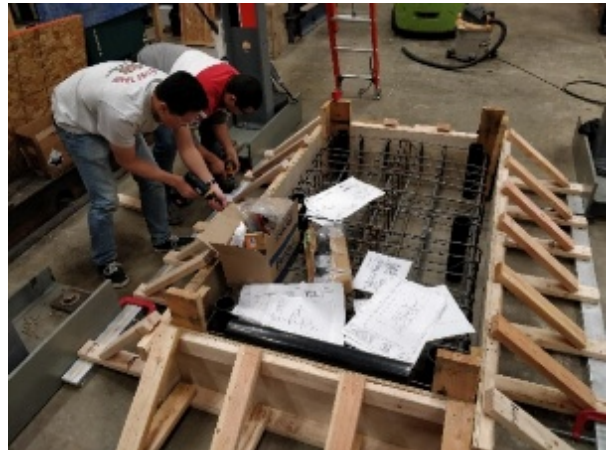
*Figure 4-5: Shear Wall Footing Formwork Construction*

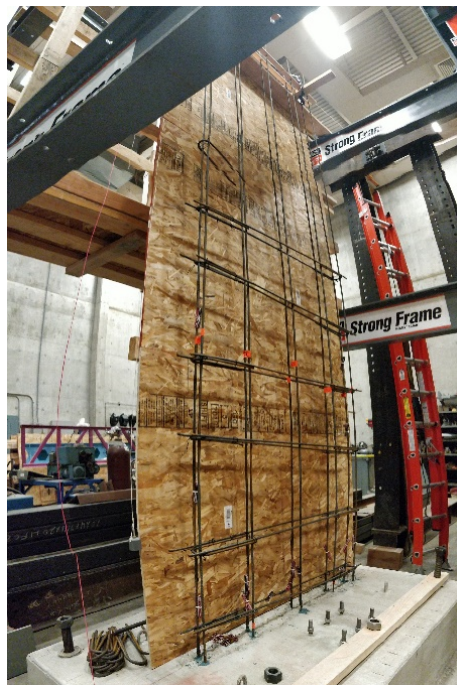
*Figure 4-7: Shear Wall Formwork & Rebar Cage Construction*

The design of the shear wall is discussed previously in Section 3.3. Construction of the wall rebar cage and formwork are shown in Figure 4-7. Before setting the wall formwork in place, 7/16” diameter holes in the footing were first drilled and vacuumed in preparation for embedding and epoxying the longitudinal reinforcing steel. Additionally, the footing surface was roughened to increase shear friction between the wall and footing. The longitudinal reinforcement for the wall was then epoxyed into the footing using Simpson ‘SET-XP’ epoxy with 1’-0” of embedment. After the longitudinal bars were in place, the transverse reinforcing (straight bars and U-hooks) was tied to complete the rebar cage per the wall design in Figure 3-2. The reinforcing steel cage was completed with vertically oriented U-hooks installed at the top of the wall. After the completion of the rebar cage, the formwork was secured on each side of the cage with careful considerations to concrete cover, strain gauges and their lead wires. The schematic drawings of the wall formwork can be found in Appendix Section D. During this process, scaffolding was also designed and constructed by the project team to increase accessibility to higher portions of the wall.

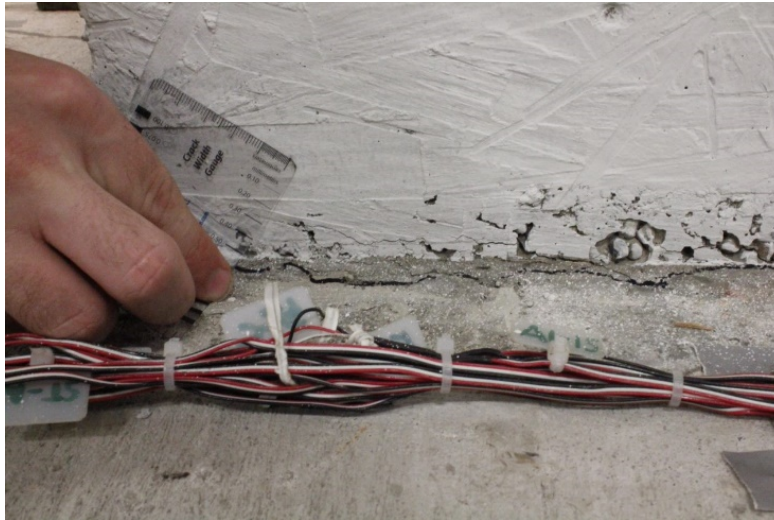
The first yield of rebar occurred at load step 13, with an applied lateral force of 12.6 kips and approximately 0.075% global drift, which resulted in a 7" long by 0.01" wide at the wall-footing interface.

Figure 5-3: Minor Base Cracking at First Yield of Rebar

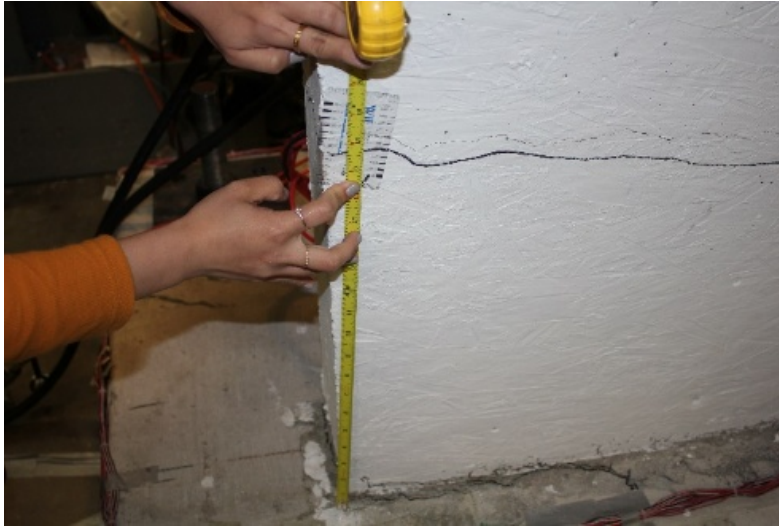
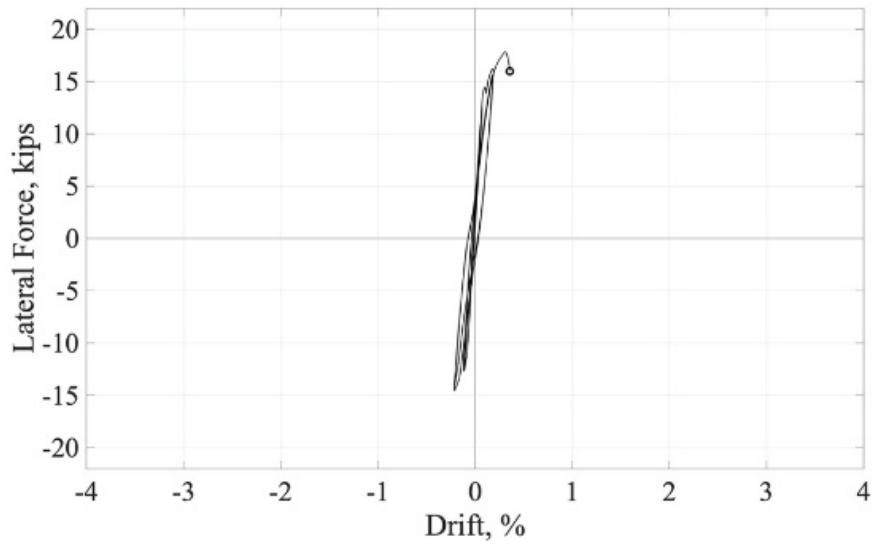
At load step 21, a flexural crack formed 17" above the footing. At load step 23, a 25" long by 0.025" wide crack formed at the base. The recorded drift and lateral force applied were 0.4% and 17.2 kips, respectively.

Figure 5-5: Wall Damage at 0.4% Drift

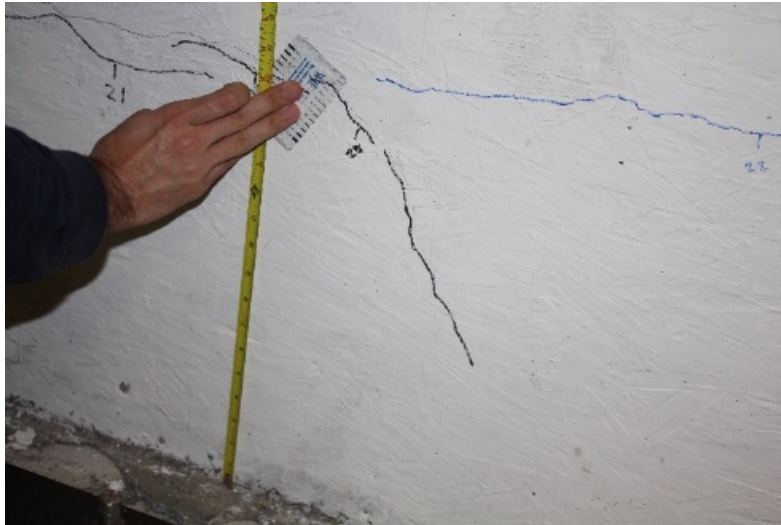
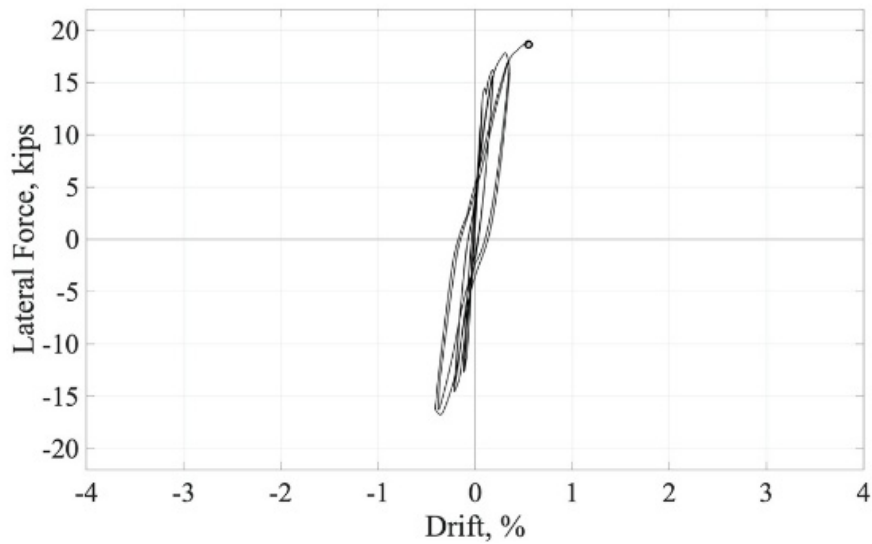
At load step 25, the first diagonal crack appeared and was 0.005" wide. The crack formed at a height of about 16" and extended 11" inches down at a 60-degree angle. The recorded drift and lateral force were 0.6% and 18.6 kips, respectively.

Figure 5-6: Wall Damage at 0.6% Drift

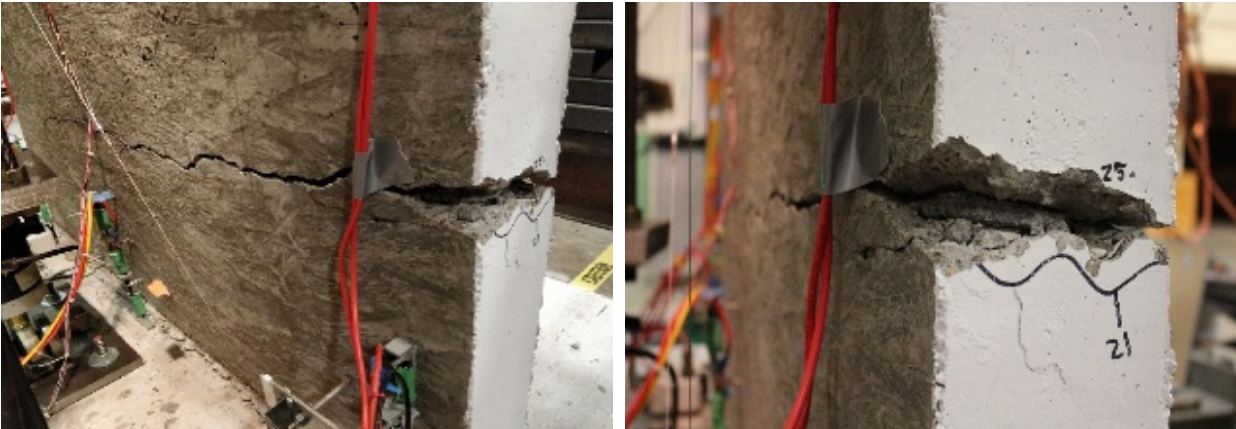
At load step 41, new horizontal cracks continued forming and the previous horizontal cracks began to expose transverse rebar. The maximum crack width measured is 0.6875". Additionally, vertical cracks begin to form in the concrete near the exposed rebar. The recorded drift and lateral force were 1.67% and 21.1 kips, respectively. A residual drift of about 1% remained in the wall at the unloaded state between load steps at this point (when the lateral force was zero).

Figure 5-8: Wall Damage at 1.67% Drift

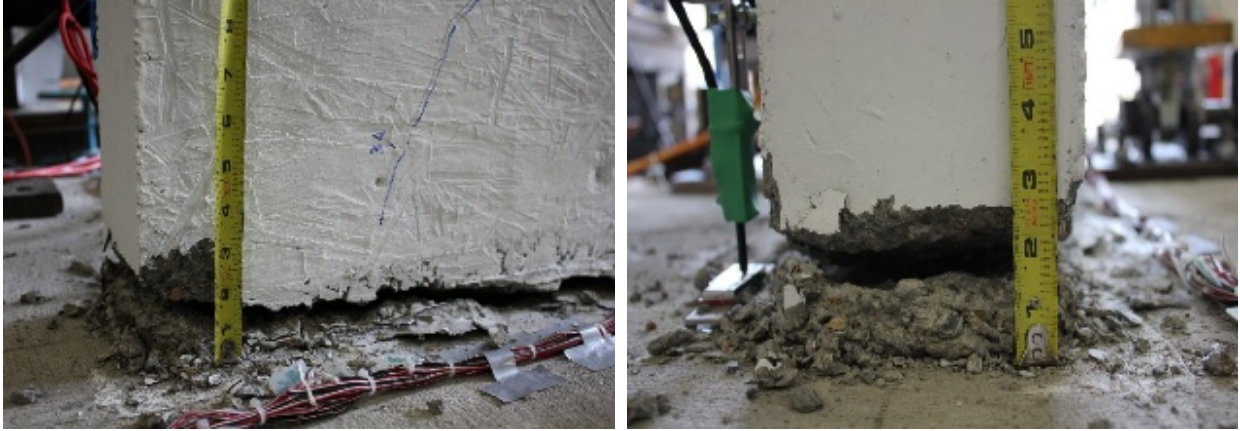
The monotonic loading began at load step 45 and the recorded drift and lateral force were 2.00% and 20 kips, respectively. At this load step, it was noted that there was a slight decrease in the lateral capacity. There was significant base uplift at one end of the wall and minor concrete spalling on the opposite end of the wall.

Figure 5-9: Wall Damage at 2% Drift

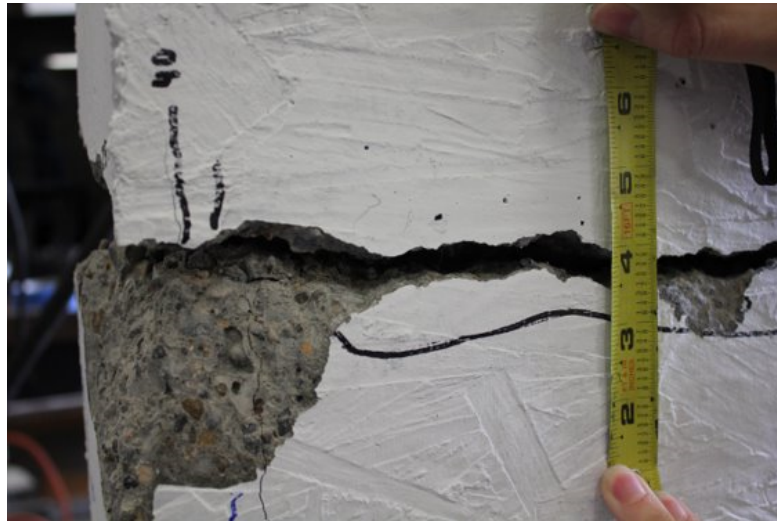
Figure 5-10: Wall Damage at 3.33% drift.

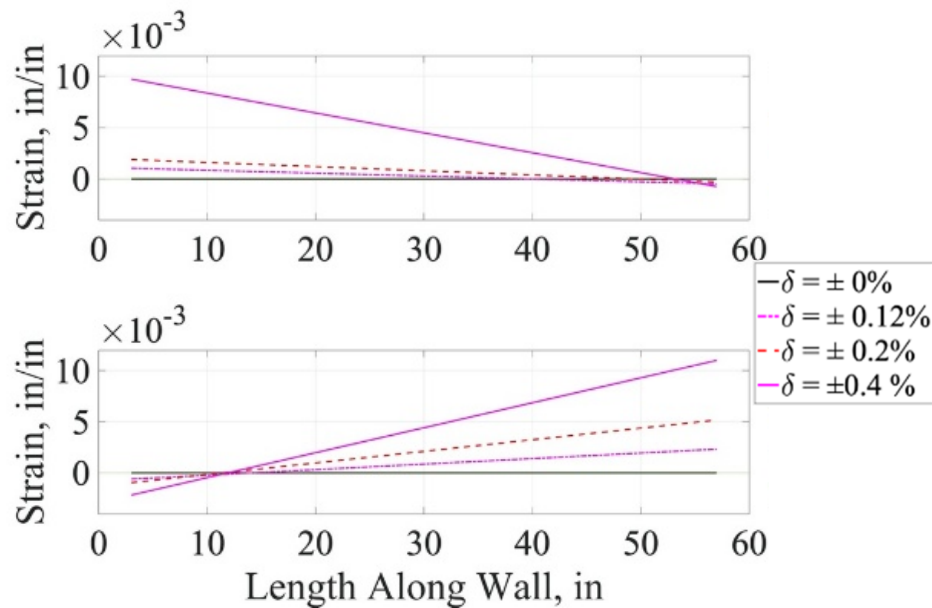
Figure 5-14: Average Strain Profile Along Length of Wall in Push (Top) and Pull Direction (Bottom)

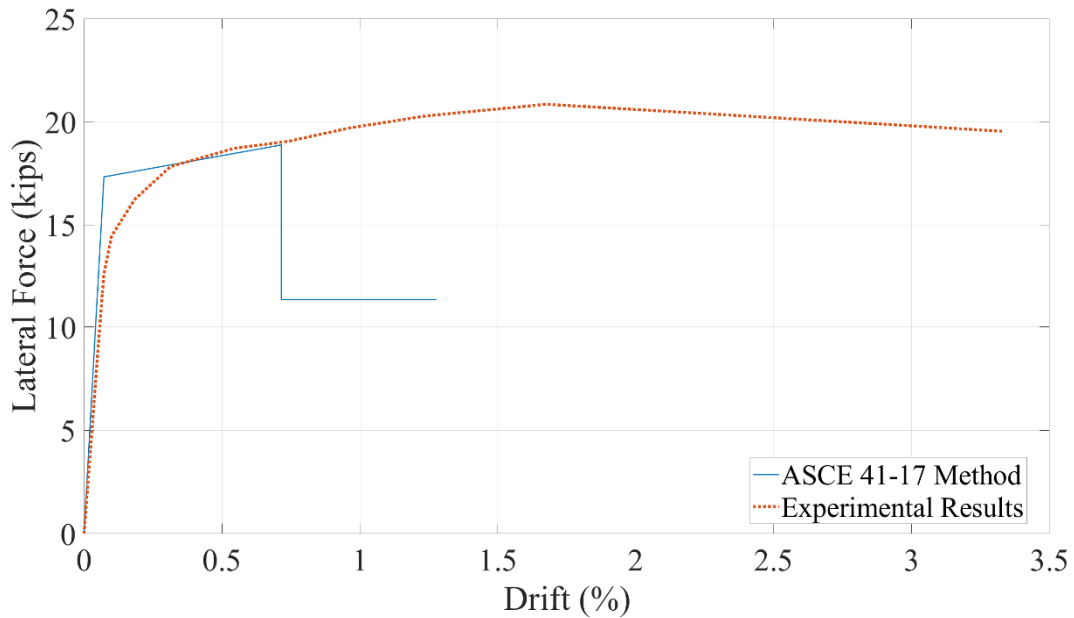
Figure 6-2: ASCE 41-17 Predictions Compared to Experimental Results
