# MONITORING THE AXIAL SHORTENING OF PRINCIPAL TOWER USING EMBEDDED DISTRIBUTED FIBRE OPTIC SENSORS

*N. de Battista<sup>1\*</sup>, C. Kechavarzi<sup>1</sup>, N. Cheal<sup>2</sup>, R. Harvey<sup>3</sup> and S. Wong<sup>4</sup>*

<sup>1</sup>*Centre for Smart Infrastructure and Construction, Department of Engineering, University of Cambridge, Cambridge, UK*

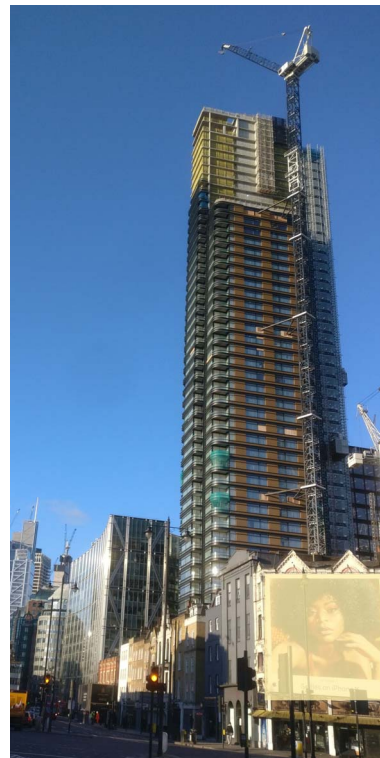
Figure 1 Principal Tower in April 2018, after construction was completed.

Principal Tower is a 163 m-tall residential high-rise building, designed by Foster + Partners and situated between the City and Shoreditch areas of central London (Figure 1). It consists of two underground car park levels and apartments on 50 storeys above ground. The structure is made of reinforced concrete and comprises a central core, 12 perimeter columns, post-tensioned concrete floor slabs ranging from 200 to 225 mm in thickness, and outrigger walls at specific levels. Construction started in July 2016 and was completed in March 2018, with practical completion scheduled for mid-2019. Further details about the design and construction of Principal Tower are provided by de Battista *et al.* (2017a, 2017b).

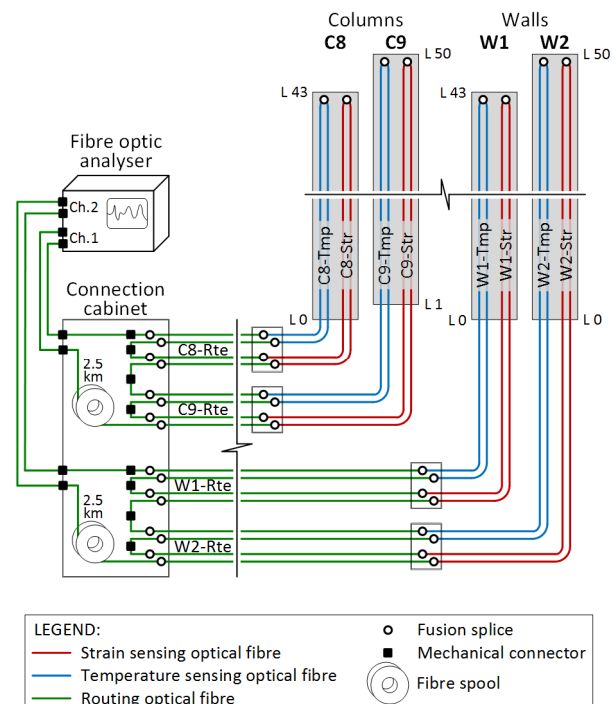
Figure 2 Schematic layout of the axial shortening monitoring system installed at Principal Tower, using distributed fibre optic sensors.

The ASMS installed at Principal Tower is illustrated schematically in Figure 2, and can be described as having three parts: the embedded FO sensing cables, the FO routing cables, and the FO Brillouin spectrum analyser. The sensing part consists of FO cable pairs embedded in four vertical load-bearing members: two columns (referred to as C8 and C9) and two walls within the core (referred to as W1 and W2), which are located as shown in Figure 3. C8 and W2 extend up to level 43 (138 m above the ground floor) while C9 and W1 extend to the top of the building (161 m above the ground floor).

Before any of the instrumented members were concreted, the two self-returning fibres at the bare ends of each of the eight FO cables were fusion spliced to four-core FO routing cables (also Excel 205-300), with one routing cable per instrumented element, as shown in Figure 2. The role of the routing cables was to connect the sensing cables to the FO spectrum analyser, which was housed in a secure location inside a nearby building within the construction site. The routing cables were terminated in a connection cabinet next to the analyser, where the fibres in the routing cables were connected to each other using mechanical FC/APC connectors to form two separate circuits, one for the two columns and another for the two walls. The purpose of having independent circuits and of using connectors instead of fusion splices was to enable parts of the sensing system to be easily isolated and by-passed if any of the sensing cables were damaged.

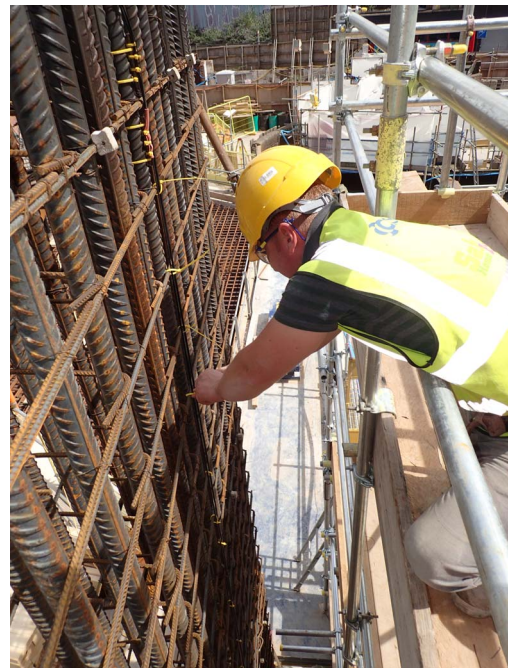
Figure 4 The fibre optic sensing cables being attached to the reinforcement of column C8 before being concreted.

In August 2016, the bare ends of the FO cables were attached to the reinforcement of the instrumented elements just above the ground floor structural level, which was taken as being the datum level for axial shortening purposes. The two cables in each pair were cable tied securely to the bottom and top of the same vertical reinforcement bar, with the strain cable being pre-tensioned by hand. The FO cables were also held loosely to the reinforcement bar using cable ties, to keep them aligned vertically along the member. Every time that the construction progressed to a new level, the cables were un-reeled and the process was repeated to extend the cables to the top of the reinforcement of the new level. The construction operatives were trained on this cable installation process such that it was incorporated in the sequence of the contractor's steel-fixing works (Figure 4).

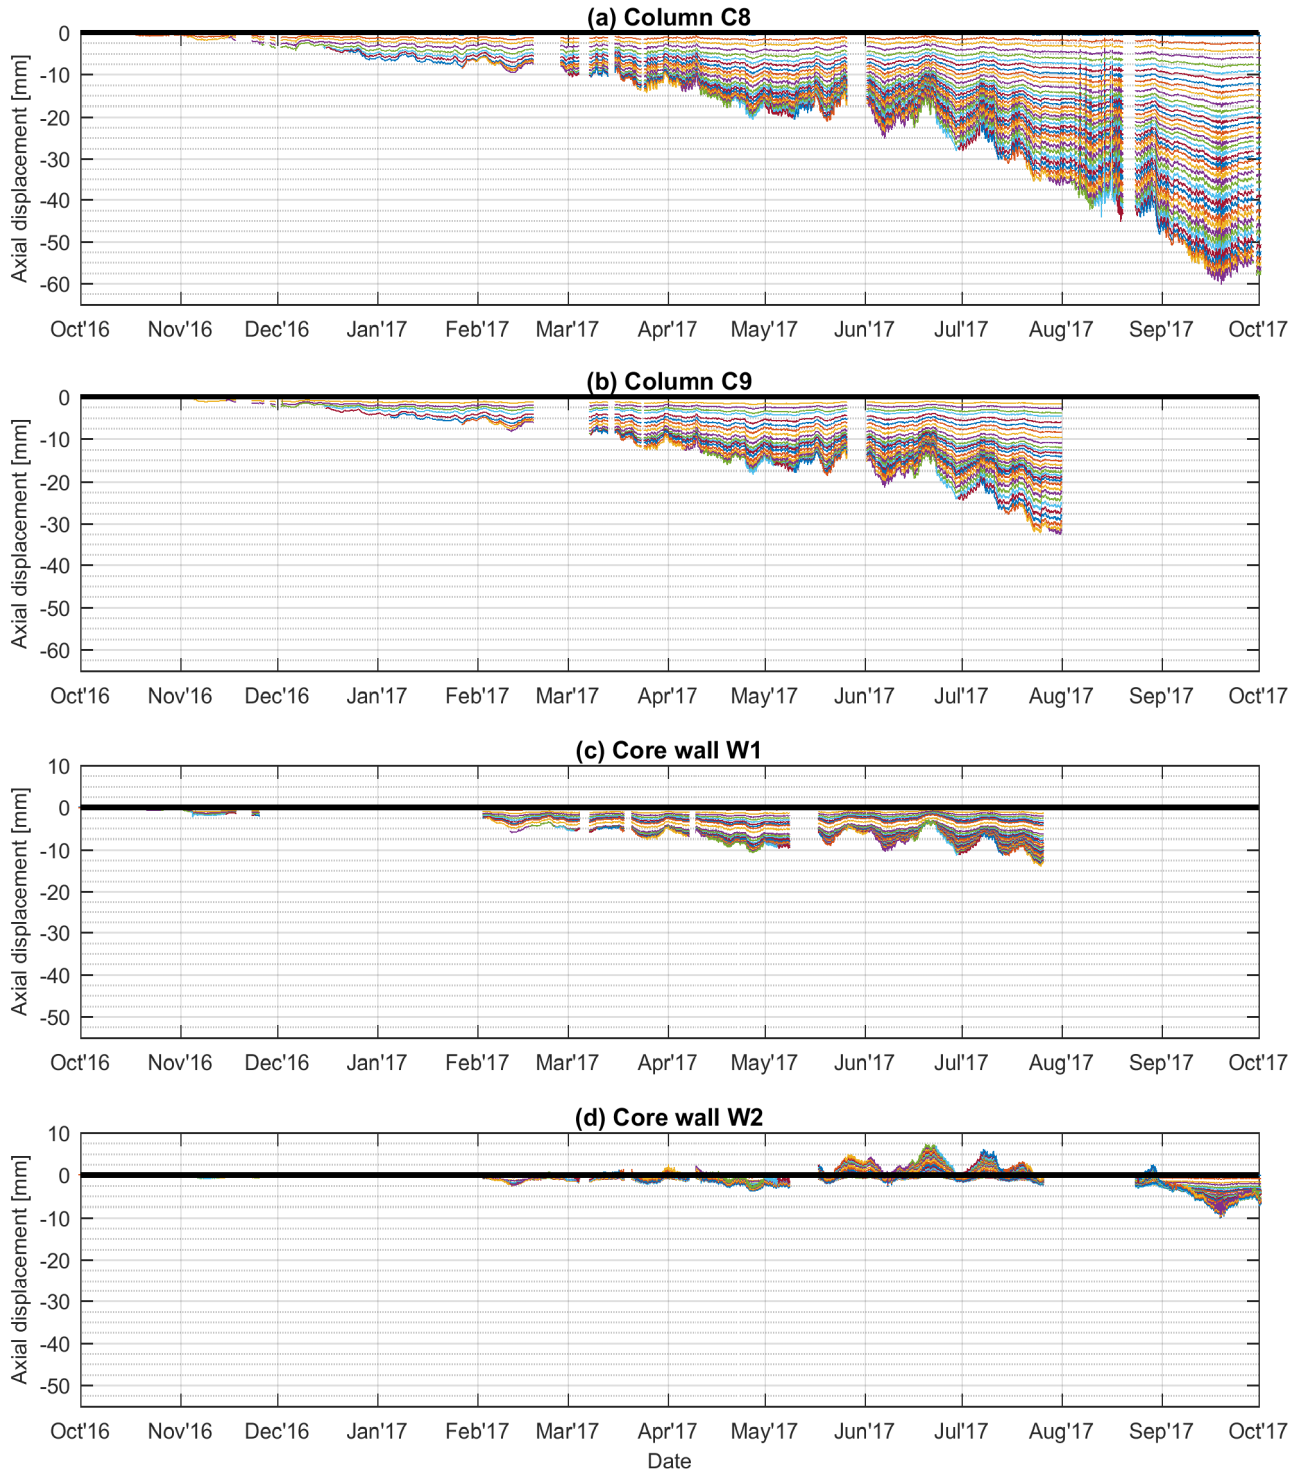
Figure 5 The total cumulative axial displacement (negative = shortening) of the instrumented columns and walls measured at the mid-height of every level (one plotted line per level) from the embedded fibre optic monitoring system at Principal Tower during the first 12 months of construction.

The cumulative axial displacement measured from the instrumented elements during the first 12 months of construction is shown in Figure 5, with negative displacement indicating a shortening of the element. By the end of September 2017, the core and columns had been built up to level 39, the floor slabs up to level 37, and the façade had been clad up to level 19. Although the displacement was measured every 0.20 m along the height of the four elements, the data plots only show the average displacement of a 1 m section (5 data points) at the mid-height of each building level. The results discussed in this section relate to these average mid-height displacement values.

The occasional periods with missing data that can be seen in Figure 5 are due to the monitoring having been stopped on one or more of the elements for maintenance to be carried out on the instrumentation, such as software updates or repairing of sensor cables that were accidentally damaged during installation. The monitoring on column C9 and wall W1 was stopped at the end of July 2017, when the sensor cables in these elements were damaged and could not be repaired. When this happened, construction had reached level 31.

As expected, the columns shortened significantly more than the walls throughout the construction. The maximum shortening recorded during this 12-month period was of 60.3 mm, at level 38 of column C8 during the morning of 19<sup>th</sup> September 2017. By contrast, the shortening recorded on wall W2 during the same morning was only 10.2 mm. This highlights the importance of taking into account differential shortening between columns and walls when setting floor slab levels, in order to not end up with sloping floors when the building is completed.

Differential shortening happens not only between the columns and core walls, but also between individual columns, as the plotted data confirm. At the end of July 2017, the maximum shortening recorded at level 31 on C8 was 36.6 mm while that on C9 was 32.6 mm, approximately 11% less. This is due to C8 having a more slender profile, about 25% larger surface to area ratio than C9, and 15% less vertical reinforcement than C9, and despite the fact that C8 supports about 10% less dead load than C9.

The data also show that, although to a much lesser extent, core walls also undergo axial shortening that could add up to a significant amount. This is contrary to the assumption that is commonly made when carrying out shortening estimates, for which core walls are assumed to have negligible shortening. The maximum shortening recorded from any of the two walls during the first 12 months of construction was of 14.1 mm, at level 30 of W1, on 25<sup>th</sup> July 2017, just before that wall stopped being monitored.

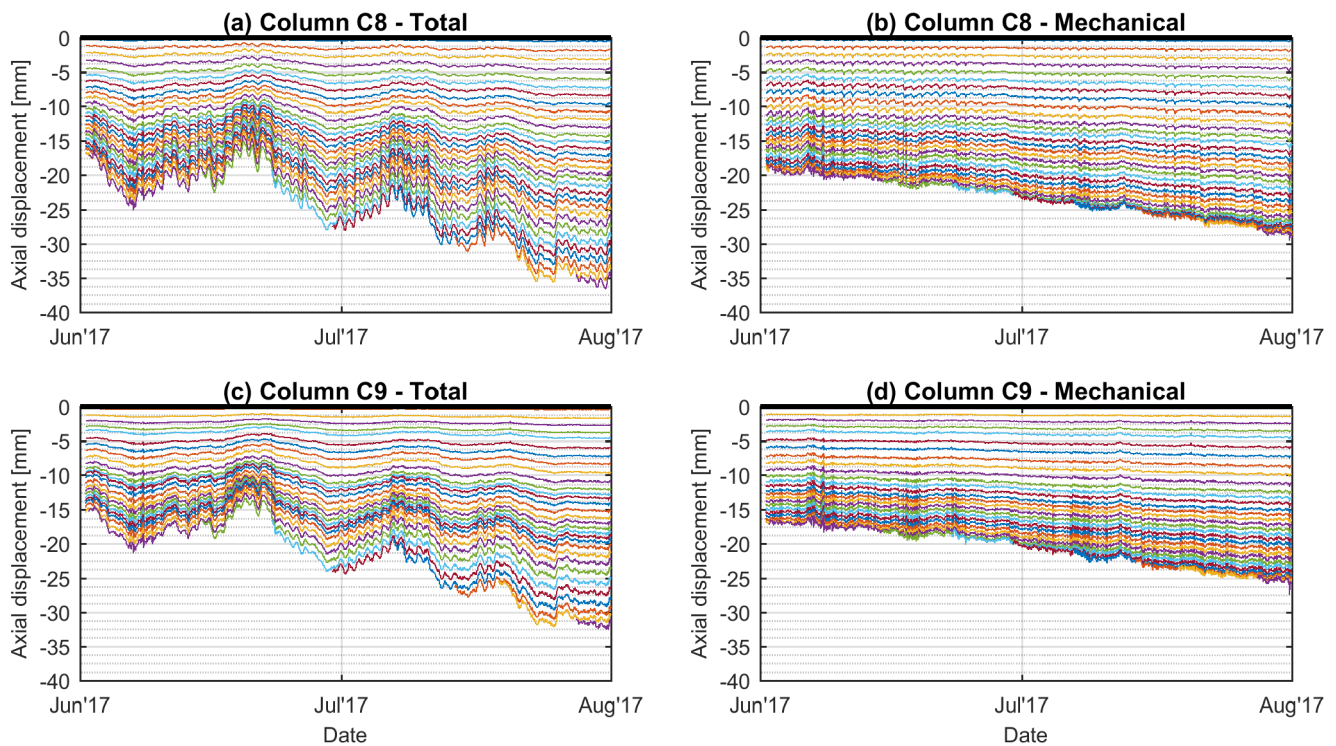
Figure 6 The total (left side) and mechanical (right side) cumulative axial displacement (negative = shortening) of the instrumented columns measured at the mid-height of every level (one plotted line per level) from the embedded fibre optic monitoring system at Principal Tower during June and July 2017.

The effect of thermal movement can be observed by comparing the total (measured) shortening with the mechanical shortening (i.e. the total shortening less the estimated thermal displacement, as explained in Section 2.3). An example of this is shown in Figure 6 for the two columns, during June and July 2017. During these 2 months, the maximum daily air temperature recorded in London (Heathrow Airport) reached highs of 32°C on 19<sup>th</sup> June and 6<sup>th</sup> July, with both days having 10 hours of sunshine (Source: [www.weatheronline.co.uk](http://www.weatheronline.co.uk)). These dates correspond with the upward fluctuations observed in the total shortening of both columns (Figure 6a and c), as a result of the thermal expansion of the structure counteracting the elastic and inelastic shortening.

The minimum total shortening (i.e. when thermal expansion was at its maximum) recorded on these two days for C8 and C9 are shown in Table 2, together with the corresponding estimate of mechanical shortening and the percentage difference between the two. From these data, it can be seen that the axial shortening arising from mechanical actions was reduced by up to 29% due to the counteracting effect of thermal expansion.

Interestingly, on both occasions the minimum shortening of C8 was recorded a few hours earlier than that of C9. This is likely due to the fact that C8, which is on the south façade, was exposed to direct sunshine from about 10:00 to 18:30 while C9, which is on the west façade, was shaded until 14:00 and was then exposed to direct sunshine until sunset (around 21:00). Therefore C8 reached its maximum internal temperature earlier than C9.
