# **Influence of cooling rate on residual stresses and chipping of porcelain on zirconia restorations**

A thesis submitted in partial fulfilment for the degree of

**Doctor of Clinical Dentistry in Prosthodontics**

At the Department of Oral Rehabilitation  
University of Otago, Dunedin  
New Zealand

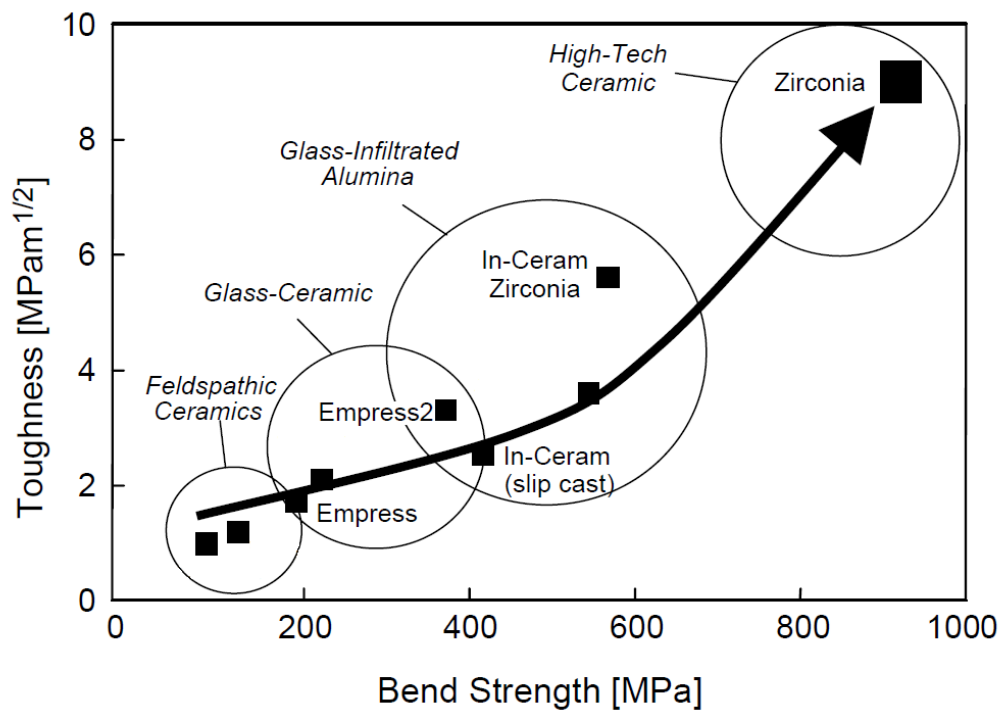
Figure 1-1: Mechanical properties of dental ceramics (modified from Luthy et al. 2005)

Of all the currently available ceramic systems, zirconia is the only ceramic which is indicated for fabrication of all-ceramic crowns and FPDs in both the anterior and posterior of the mouth (Raigrodski 2004b; Conrad et al. 2007). This is because mechanical properties of zirconia are the highest ever recorded for any dental ceramic, thus permitting the reduction of core thickness and the fabrication of long-span fixed prostheses (figure 1-1).

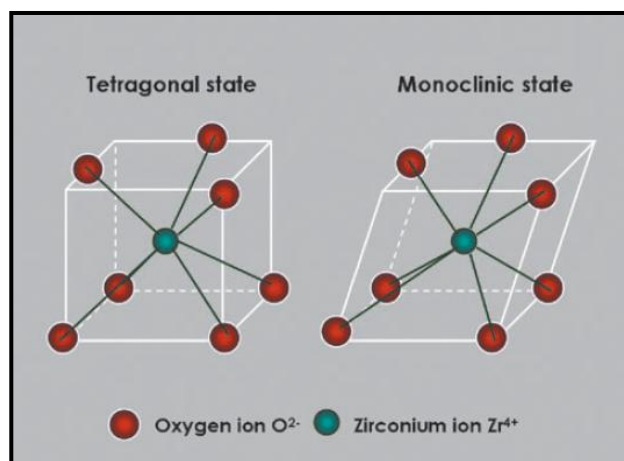
Figure 1-2: Tetragonal (left) and monoclinic (right) crystallographic phases of zirconia (from Vagkopoulou et al. 2009)

Zirconia is unique in its polymorphic crystalline makeup, in that it occurs in three temperature dependant forms that are: monoclinic (at room temperature to 1170°C), tetragonal (1170°C – 2370°C) and cubic (2370°C – up to melting point) (figure 1-2) (Denry et al. 2008). However, when stabilising oxides such as yttria, magnesia, ceria, and calcia are added to zirconia, the tetragonal phase is retained in a metastable condition at room temperature, enabling a phenomenon called phase transformation toughening to occur (Kelly et al. 2008a). The partially stabilised crystalline tetragonal zirconia, in response to mechanical stimuli, such as tensile stress at crack tips, transforms to the more stable monoclinic phase with a local increase in volume of approximately 4%. This increase in volume closes crack tips, effectively impeding crack propagation (figure 1-3). It is this transformation toughening process which gives zirconia its superior strength and toughness, exceeding all of the currently available ceramics (table 1-1 and figure 1-1). Compared to alumina, zirconia has twice the flexural strength, partly due to the higher sintered density, smaller particle size, and transformation toughening process (Piconi et al. 1999).

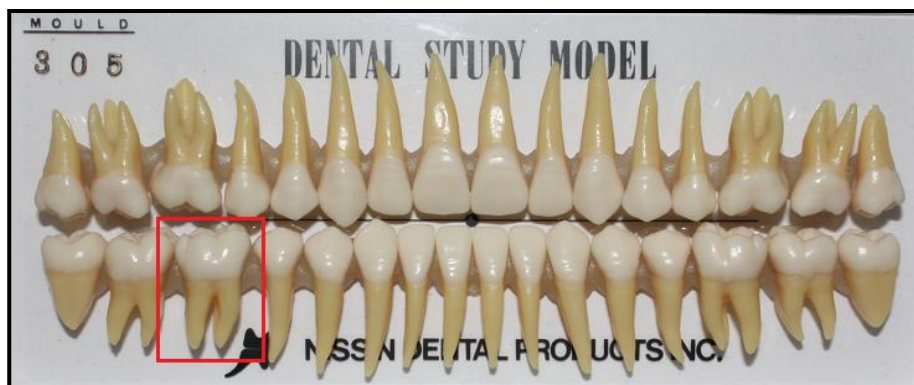
Figure 3-1: Mandibular right molar selected for the study

The zirconia crown preparation was completed on an acrylic replica of an anatomical mandibular right molar obtained from a dental morphology teaching kit (Nissin Dental Study Model Mould 305, Nissin Dental Products, Kyoto, Japan) (figure 3-1).

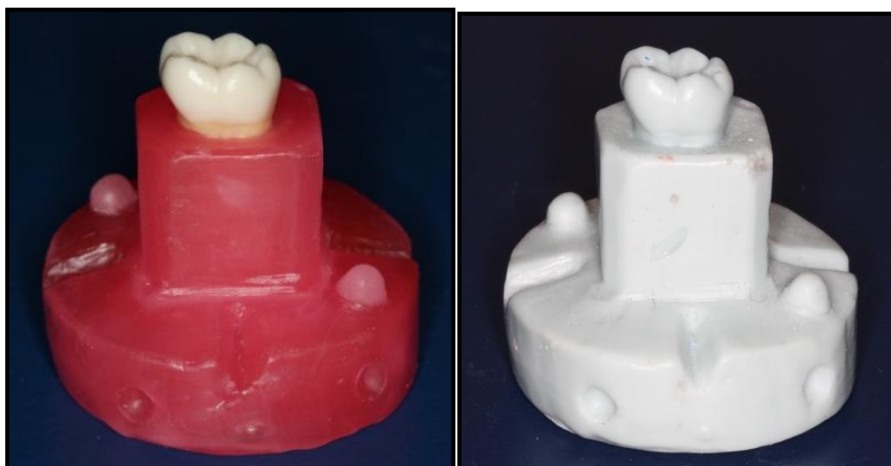
Figure 3-2: Model tooth in waxed jig (left), epoxy resin duplicate of jig (right)

The roots of the molar form were imbedded into the top platform of a waxed jig with multiple indexing features. The jig was waxed using pink tray wax (Toughened wax no.4, Komdent, Wiltshire, UK) (figure 3-2). A silicone mould (Deguform, Degudent, Hanau, Germany) was made of the waxed jig and imbedded molar, an epoxy resin material (Masterflow 622 Heavy Duty Epoxy Resin Grout, Degussa, Hanau, Germany) was mixed according to manufacturer's instructions and poured into the mould (figure 3-2).

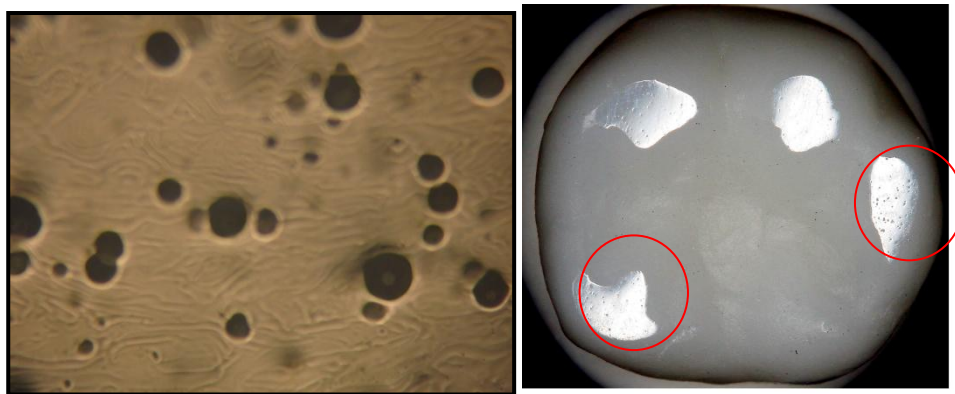
Figure 3-9: Porosities found on the surface of zirconia copings pressed with IPS e.max ZirPress, light microscopic view (left), porosity can also be seen without magnification (right)

The zirconia copings were veneered with IPS e.max ZirPress (High translucency BL1, Lot K31321, Ivoclar Vivadent) pressable feldspathic porcelain, which were then hand-layered with a 0.5 mm thickness of IPS e.max Ceram (Dentin BL1, Lot L51615, Ivoclar Vivadent) to overcome a severe porosity problem that was noted on the surface of the pressed veneer (figure 3-9).

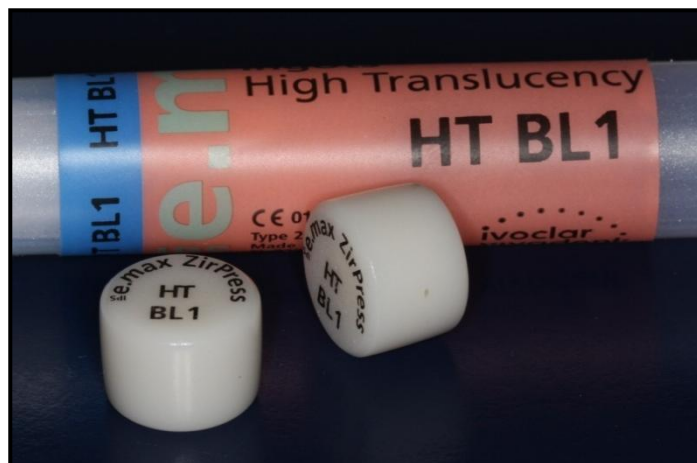
Figure 3-10: Sample of IPS e.max ZirPress ingots used in this study

IPS e.max ZirPress (pressing temperature 910 °C, CTE of  $9.8 \pm 0.25$  ppm/°K (100 – 400 °C), and Tg of  $530 \pm 10$  °C [manufacturer data]) comes in an ingot form in various translucencies and shades (figure 3-10).

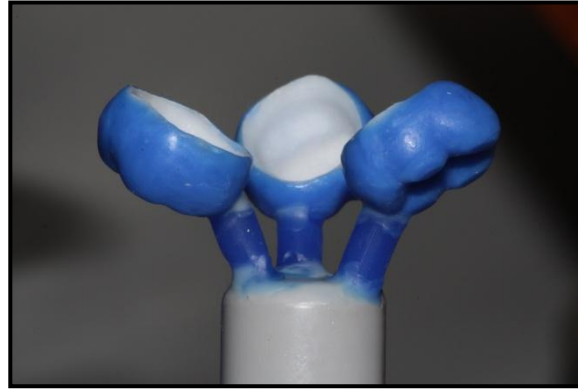
**Figure 3-11: Three waxed zirconia copings sprued and ready for investment**

The pressing procedure involved sprueing the waxed zirconia copings (figure 3-11) and investing using a 200g IPS Investment ring and IPS Press Vest Speed powder (Lot NL3046, Ivoclar Vivadent) with 32ml IPS Press Vest Speed Liquid (Lot NL3025, Ivoclar Vivadent) diluted with 22ml distilled water mixed to the manufacturer's instructions.

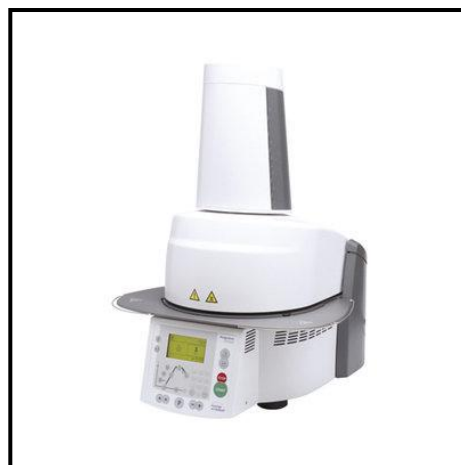
**Figure 3-12: Images of the Programat EP500 pressing machine (Ivoclar Vivadent)**

After a setting time of 40 minutes, investment rings were transferred to a pre-heated burnout furnace at 850°C and held for 1 hour. Upon completion of the preheating cycle, the investment rings were removed from the burnout furnace and two cold IPS e.max ZirPress ingots were placed into the investment rings and an alumina plunger (IPS Alox Plunger, Ivoclar Vivadent) was inserted before being transferred to a pre-heated Programat EP500 pressing machine (Ivoclar Vivadent) (figure 3-12).

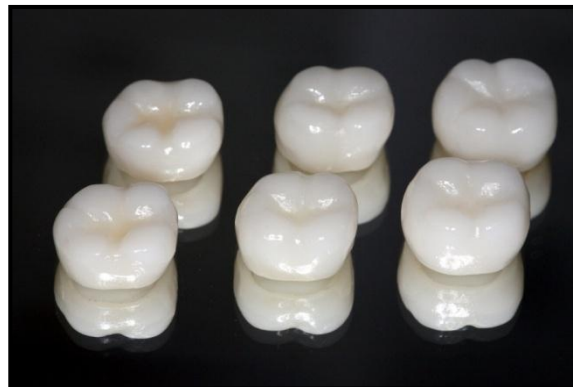
Figure 3-14: 1mm, 2mm and 3mm cusped zirconia crown samples from left to right

Six fabricated zirconia crowns were divided into a fast and slow cooled group (figure 3-14).

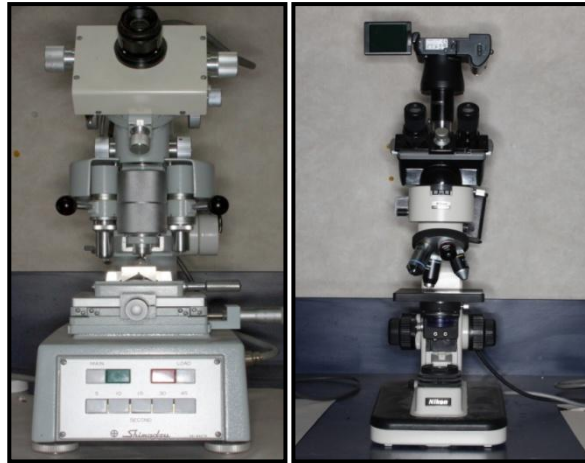
Figure 3-16: Vickers indentation machine (left); optical light microscope with digital camera fixed to the top viewer (right)

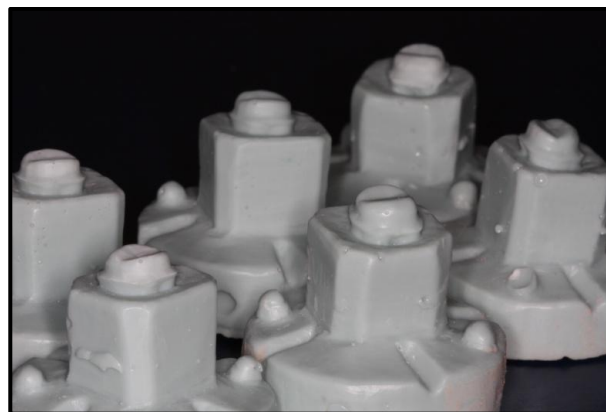
**Figure 4-3: Prepared epoxy resin abutments ready for sample cementations**

Ten duplicate epoxy resin abutment jigs (Masterflow 622, Heavy Duty Epoxy Resin Grout, Degussa, Germany) were made using a silicone mould of the original full crown preparation resin model that was used for the scanning procedure and for the fabrication of the zirconia copings in section 4.1.1 (figure 4-3).

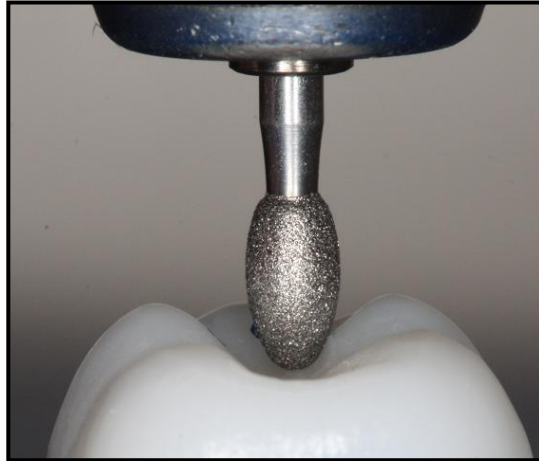
**Figure 4-6:** Image demonstrates the angle which the pear-shaped bur was held during the occlusal adjustment

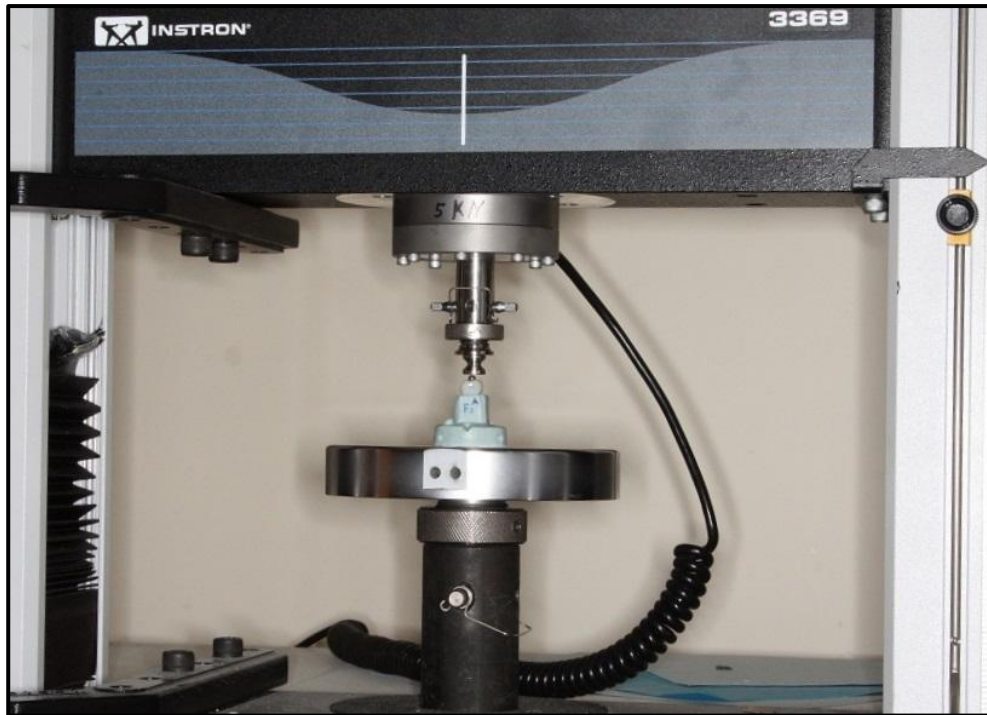
Figure 4-7: Sample set-up in the Instron testing machine

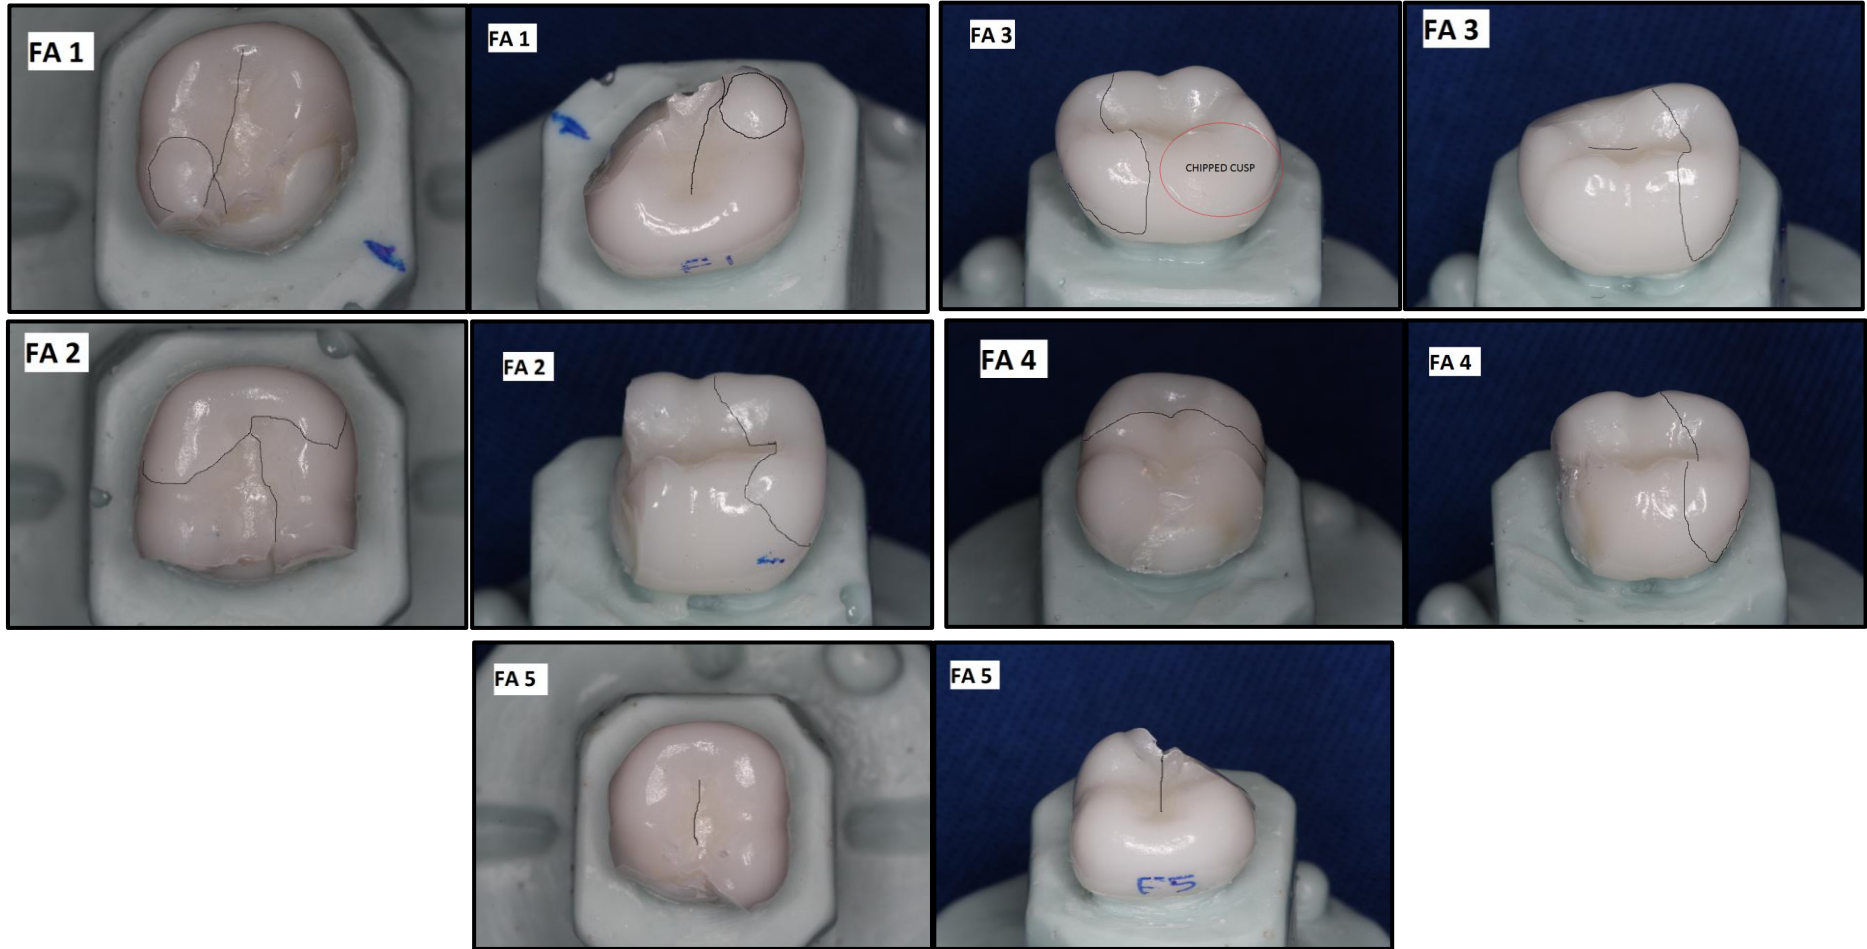
**Figure 4-9: Images of loaded fast cooled samples showing modes of fracture and extent of cracks found via light transillumination drawn on (two images per sample)**

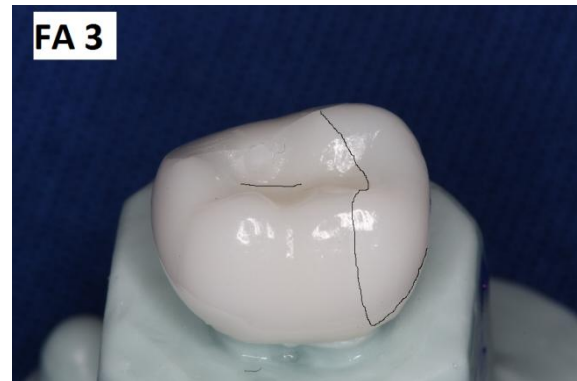
This is the only sample that failed by pure chipping fracture of the disto-lingual cusp, which extended to the distal aspect of the mesio-lingual cusp (figure 4-11 to 4-19). The non-loaded mesial aspect of the crown had an encircling crack, in addition to a midline fissure crack which did not meet.

Figure 4-11: FA3 - Photographic image of fracture

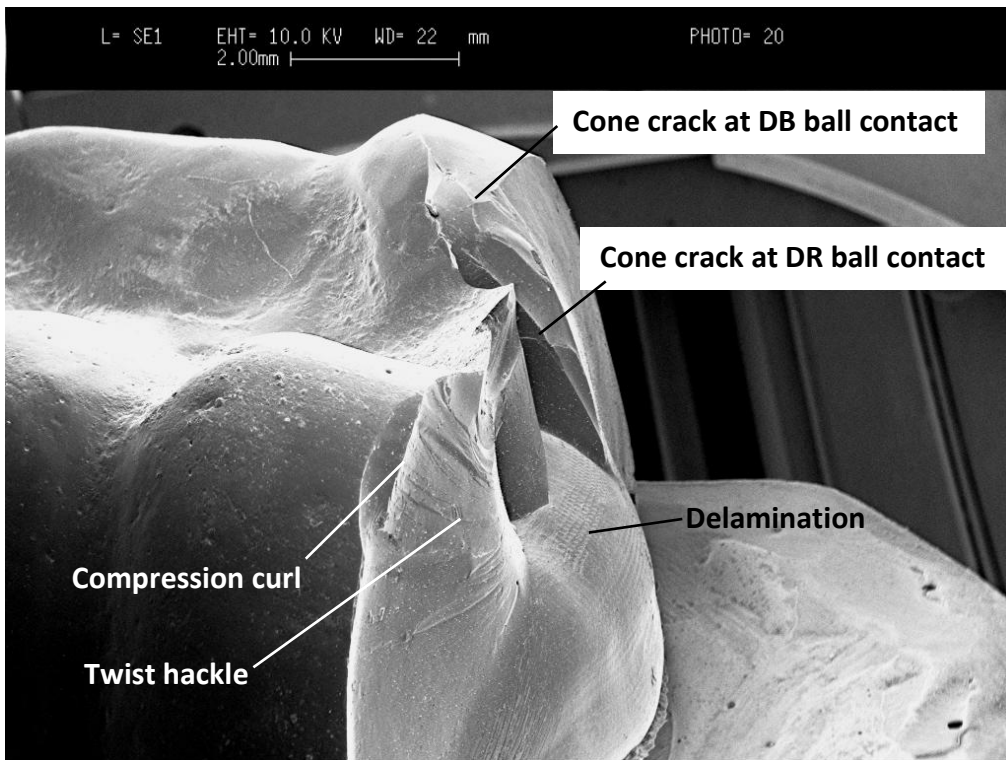
Figure 4-23: FA2 - Overview of distal fracture from the lingual side [magnification x 10]

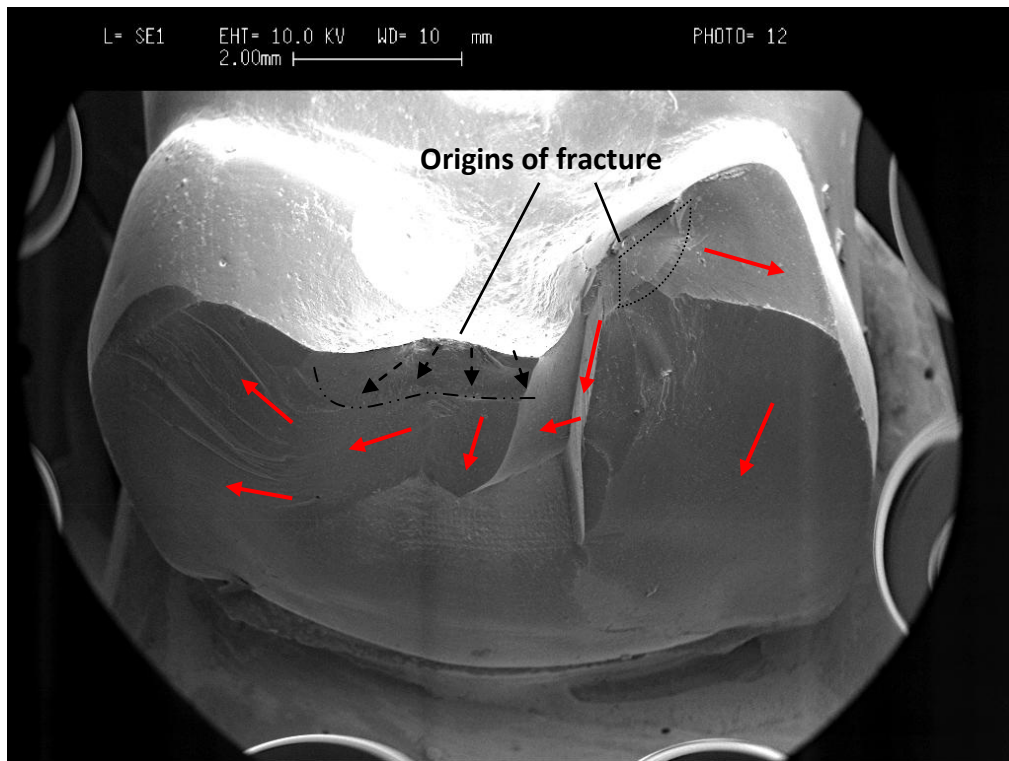
Figure 4-34: FA2 - Origin of fractures and path of crack propagations [magnification x 10]

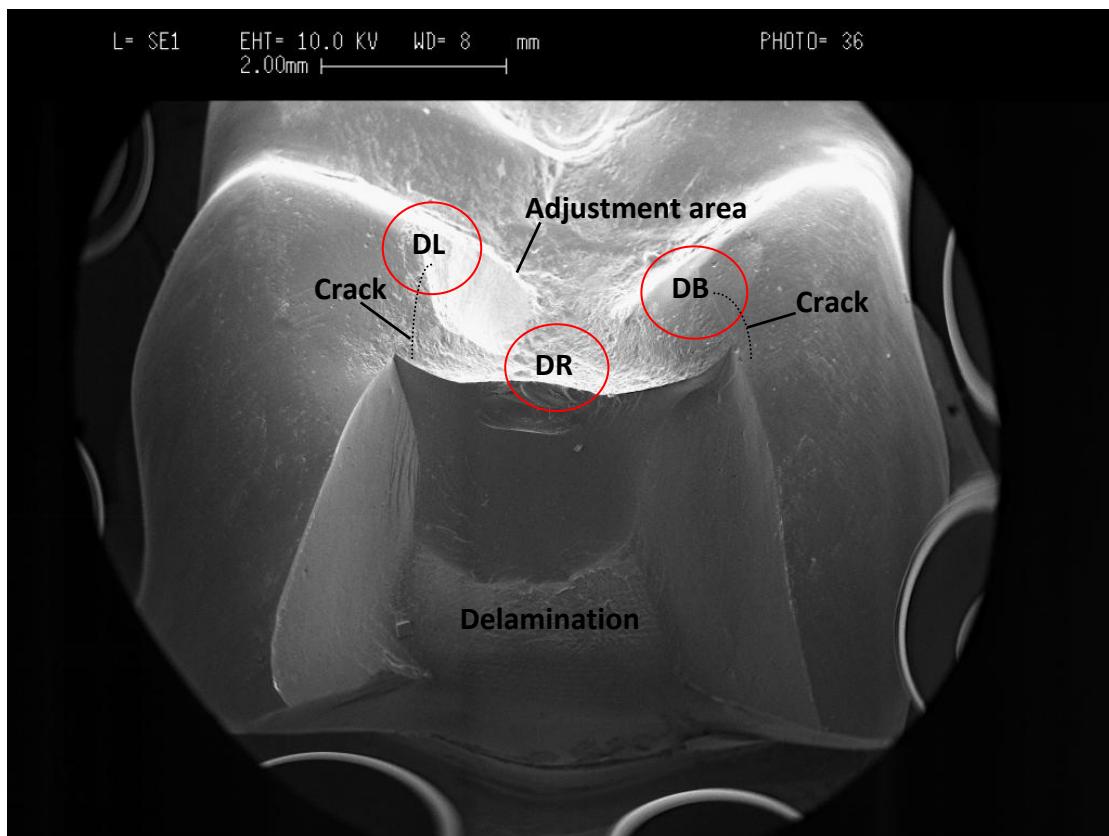
Figure 4-36: SA1 - Overview of distal fracture with contact areas and crack lines highlighted [magnification x 10]

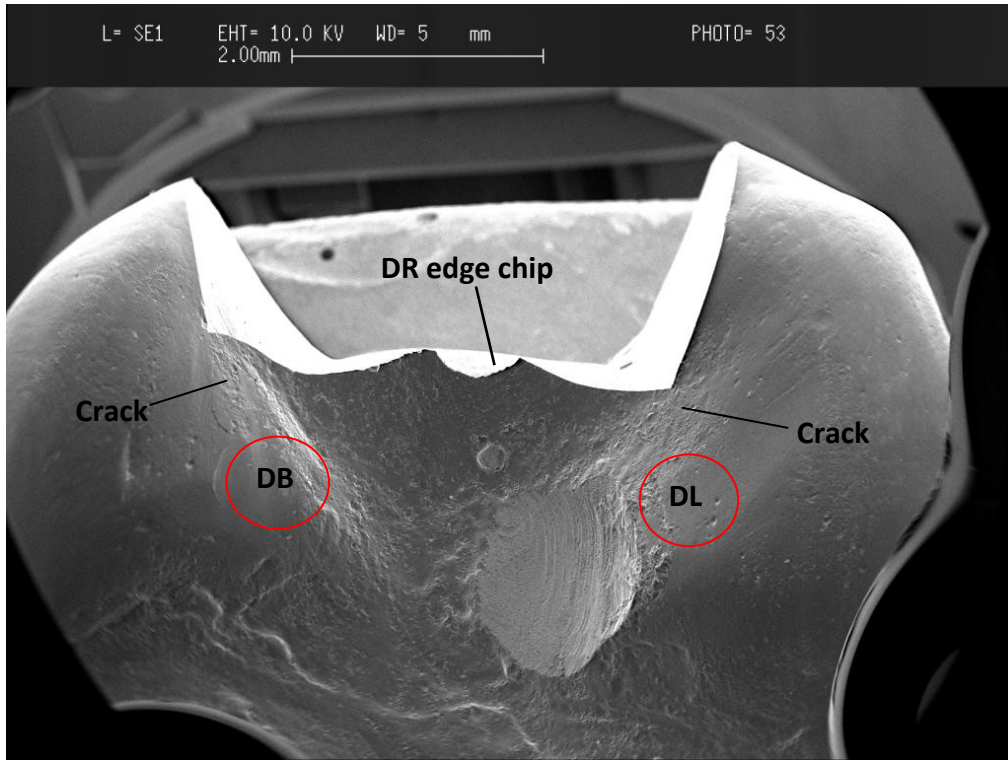
Figure 4-37: SA1 - Occlusal view of fracture [magnification x 15]

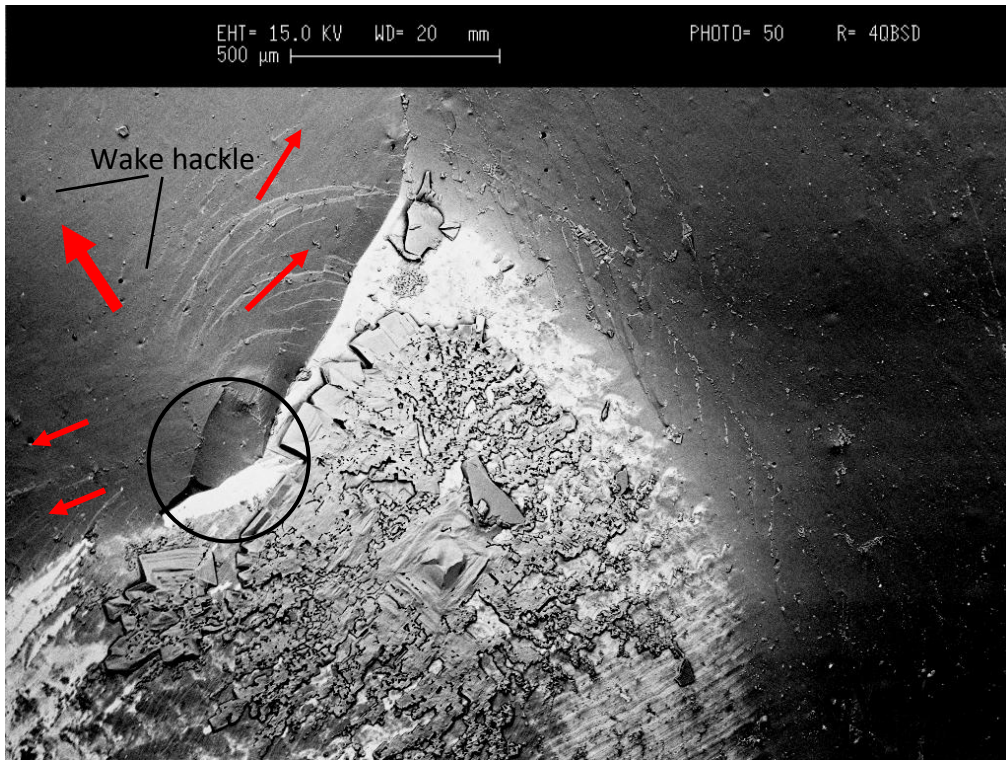
Figure 4-45: SA1 - Back scatter detector image of delamination zone shows primary origin of fracture at the base of veneering porcelain (black circle) [magnification x 50]

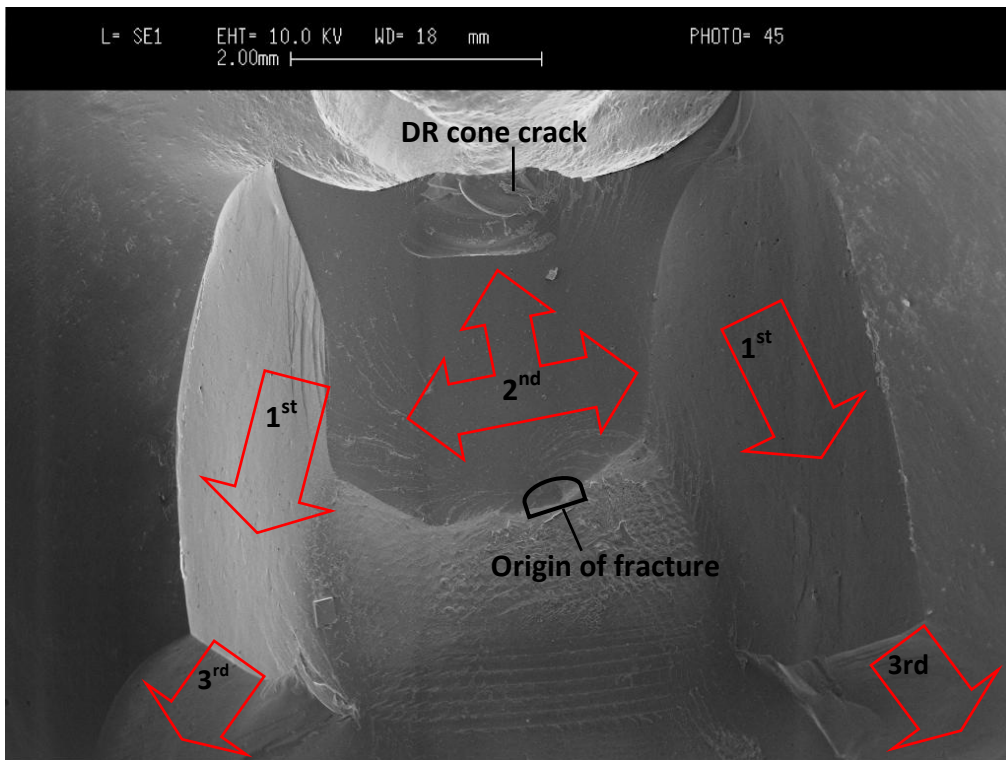
Figure 4-48: SA1: Order of crack planes propagations indicated by numbered arrows [magnification x 15]

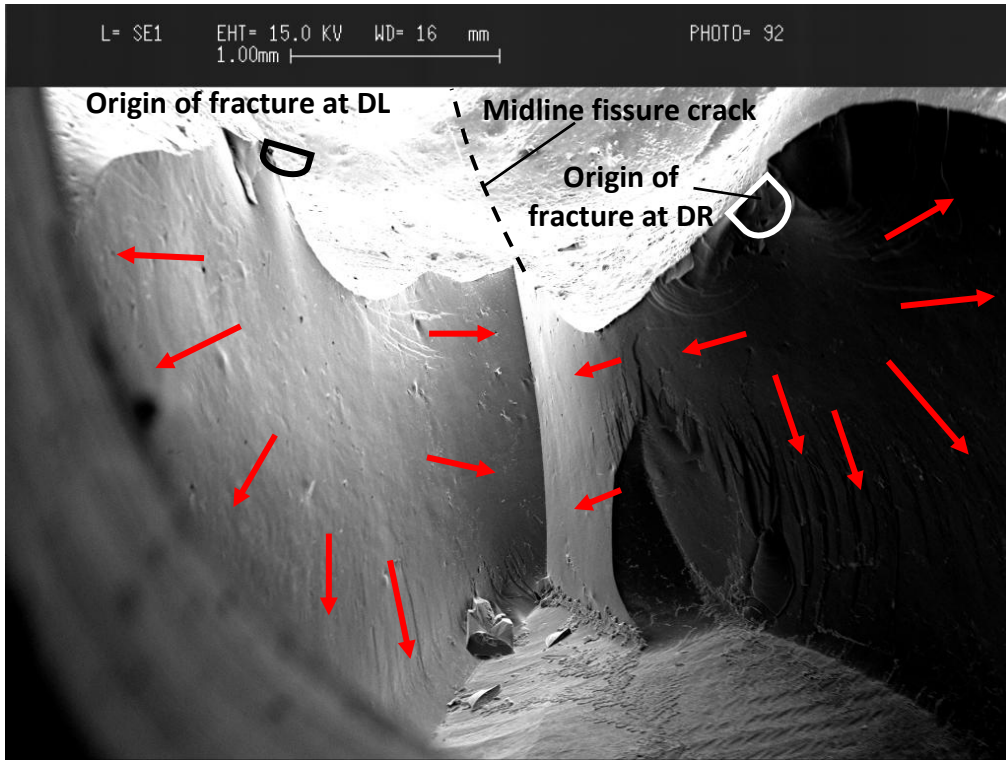
Figure 4-61: SA5 - Origins of fracture and directions of crack propagations joining at the midline fissure crack [magnification x 25]
