Corrosion Durability of a Nano-Particle Enriched Zinc-Rich Coating System For Highway Steel Bridges

A dissertation submitted in partial fulfillment of

DOCTOR OF PHILOSOPHY

CIVIL ENGINEERING

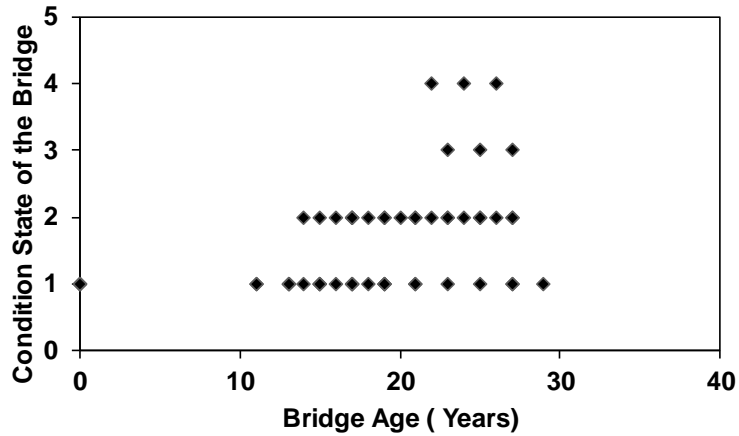
Figure 2.8. Bridge Condition State over Age (FDOT Bridge Inspection Report).

Figure 2.8 shows the condition state of different bridges over the service life. As can be seen, bridge coating started to deteriorate and changed from condition state 2 to 1, typically after 14 years. Severe coating degradation (condition state 3/4) was observed after service of 22 years. Figure 2.9 illustrates the length of bridge condition state over the service life of four different bridges located over inland and water body. The typical recommendation for spot painting was reported at the age of ~15 years. After initial spot painting, a full repair was recommended when a significant portion of the bridge turned to condition state 2/3 typically at the age of ~25years.

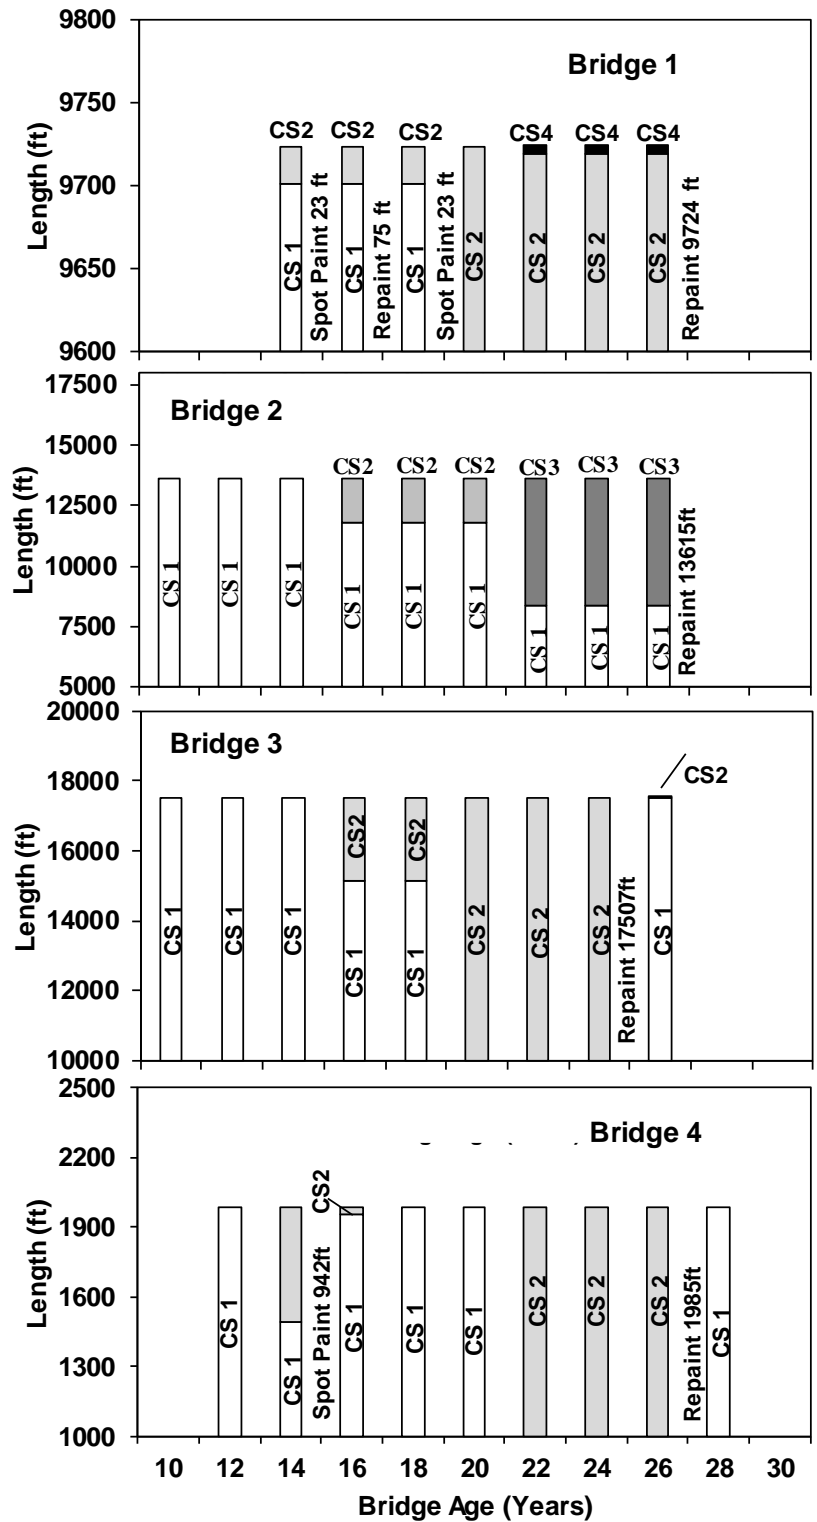
Figure 2.9. Condition State over the Service Life (FDOT Bridge Inspection Report).

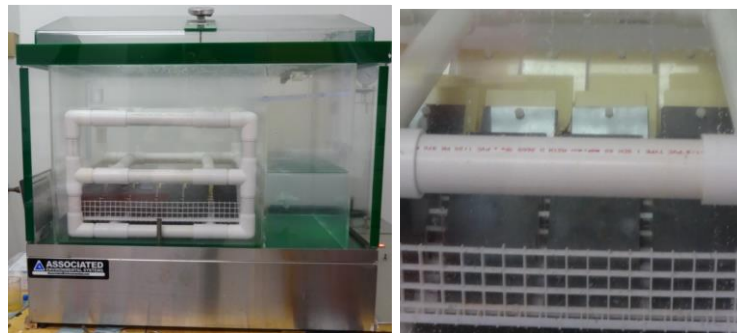
Samples were exposed to a salt-fog chamber conforming to ASTM B117-16 at Florida International University as shown in Figure 3.3. Tests included exposure in a salt-fog chamber with the use of 5% NaCl saturated salt solution for 24 months (~18,000 hours) to evaluate the effects of aggressive exposure conditions on the integrity of the coating and corrosion of the steel coupons. The salt-fog chamber temperature was maintained at ~32°C. The samples were placed at ~40° inclination with support along the bottom edge of the coupon and along an edge at the upper third of the sample. Corrosion development was assessed by photo documentation over time. A set of test panels were removed at 4 months, 8 months, 12 months and 24 months (~3600 hours, ~6000 hours, ~9000 hours and ~17,500 hours) from environmental exposure to identify degradation of the coating by physical testing and other material testing. The amount of chloride deposition was measured using a laboratory test kit. After 4 months the chloride deposition at the salt-fog exposed samples was 50 $\mu\text{S}/\text{cm}^2$. The similar deposition was also identified after 24 months of exposure.

Figure 3.3. Test setup for Salt-fog Exposure.

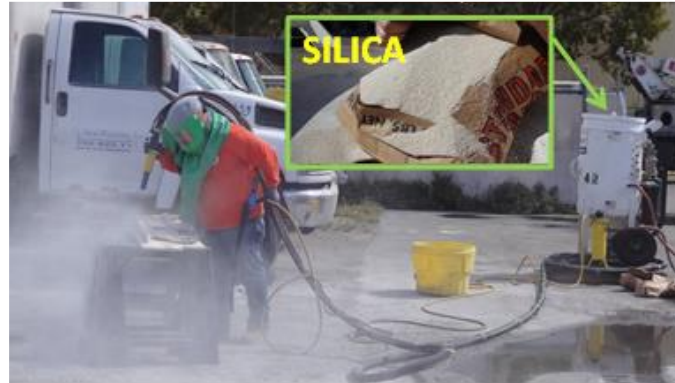
All tested samples (3 in x 5 in x 1/8 in) were cut from a plain carbon-steel sheet with chemical composition as shown in Table 3.1. A set of test panels were sandblasted to near white-surface conditions according to SSPC 10 by a professional coating's applicator, as shown in Figure 3.6. To minimize waste in the test sample preparation steps, uncoated steel plates were sandblasted in lieu of blast removal of a pre-coated three-coat system. The entire surface area of each coupon was prepared for repair coating

Figure 3.6. Sandblasting of the Coupons (Plain Steel Coupon).

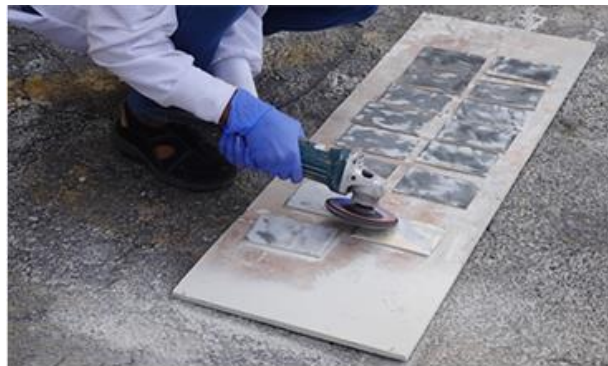
A portable grinder was used to hand clean (surface abrade) another set of samples. The coated panels were ground with 60-grit sandpaper according to SSPC 3 as shown in Figure 3.7. The polyurethane topcoat and the epoxy midcoat were completely removed by the grinding process, but sporadic areas of zinc-rich primer were intentionally left, as shown in Figure 3.8. The panels were cleaned with a strong cleaning solvent (methyl ethyl ketone, MEK) and immediately stored in a controlled-humidity chamber close to 0% RH to prevent any flash rust formation.

Figure 3.7. Surface Preparation by Grinding of Three-coat System.

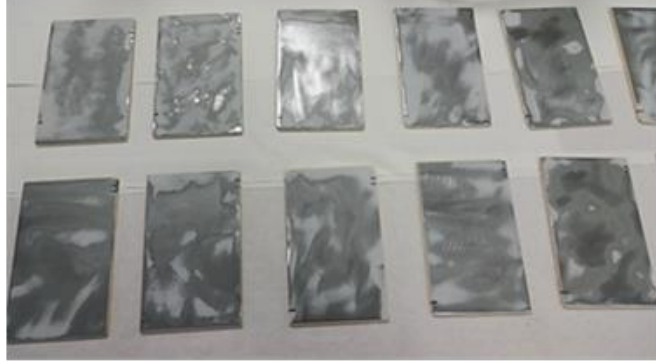
Figure 3.8. Hand Cleaned Steel Panels (Three-coat System).

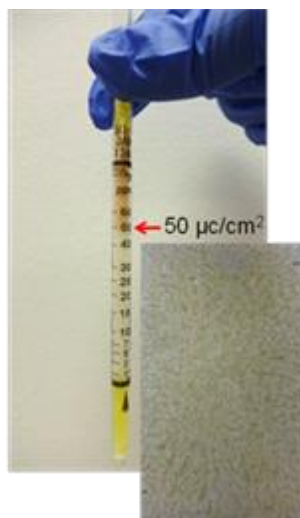
In Florida marine environments, air-borne chlorides, salty sea mist, and yearlong high humidity create challenging conditions for coating repair applications. As part of the test setup, surface contaminations by exposure to moisture and chloride were considered. To simulate adverse exposure conditions before repair coating application, the panels were exposed to different levels of humidity (5%, 75%, and 100% or soaked in tap water) and surface salt contamination. Salt contamination was introduced within the first day of surface cleaning. A salt solution, 0.5 ml of 3.5% NaCl, was placed on the sample surface (~15 in²) and then immediately dried with warm air to leave salt precipitates remaining on the surface. The expected surface chloride concentration was ~82 $\mu\text{g}/\text{cm}^2$. Results using a commercial test kit showed reproducibility of the surface chloride concentration between samples but with values ~50 $\mu\text{g}/\text{cm}^2$ as shown in Figure 3.9. Susceptibility to soluble salt varies with coating type, thickness, and exposure environment. Even though, the measured ~50 $\mu\text{g}/\text{cm}^2$ Cl⁻ of salt concentration was considered to be borderline marginal for coating degradation, the surface rust formation provides a condition to assess coating robustness. These surface chloride levels were thought to be sufficient to induce some level of coating distress but not necessarily overly aggressive.

Figure 3.9. Measurement of the Chloride Contamination Level.

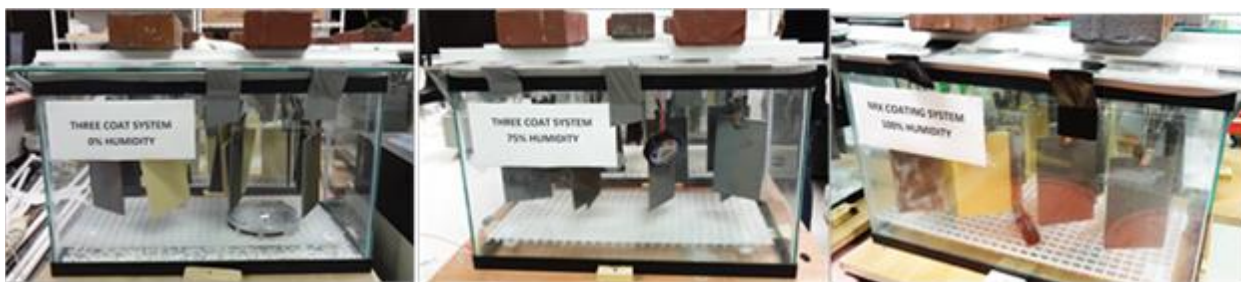
To expose the panels to different levels of humidity, the test panels were sealed in controlled-humidity glass chambers, as shown in Figure 3.10. All samples had approximately 3 days of environmental preconditioning after surface cleaning (~1-day storage in <5%RH and 2 days of exposure in 5-100%RH) and before application of the coating, as summarized in Table 3.2. A desiccator was used to maintain low relative humidity less than 5%RH. Saturated sodium chloride solution and deionized water were used in a sealed humidity chamber to maintain 75% and 100% relative humidity conditions, respectively at room temperature.

Figure 3.10. Humidity Chamber for Test Panel Exposure.

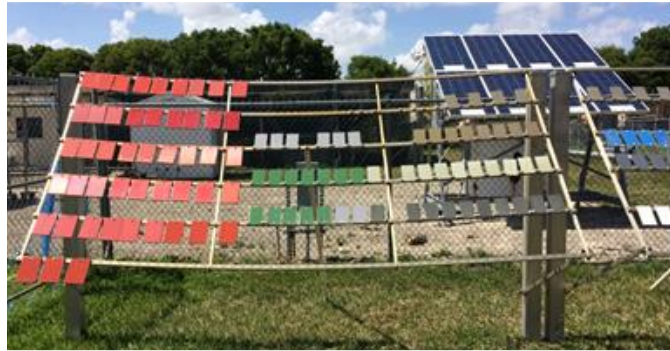
A set of repair coupons were exposed at an outdoor inland test site on July 10, 2017, in South Florida, ~16 km (10 miles) from the coast. Subsequent evaluations were made after 4 and 8 months. The coated coupons were exposed at 45° facing south according to ASTM G 7M. The outdoor test site during the exposure is shown in Figure 3.12. Weather conditions such as temperature, relative humidity, and rainfall were monitored during the time of testing as shown in Figure 3.13.

Figure 3.12. Outdoor Sample Exposure at FIU.

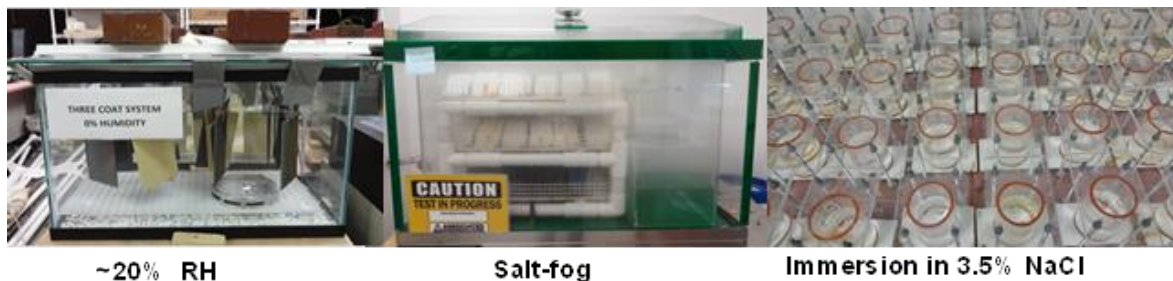
A set of the coated samples were exposed to cyclic alternate wet/dry conditions. Samples were divided into two subgroups. One subgroup had an extended conical defect formed on the center of the coupon, exposing the steel substrate below the coating. The second subgroup did not have any surface coating damage. For the former, a 3.2mm diameter drill bit was used to introduce the coating defect with a nominal depth from the coating outer surface to the tip of the drill cavity of ~1 mm. A cycle lasted 7 days and consisted of a sequence of exposures including 2 days of saltwater immersion (3.5 wt% NaCl), 3 days of drying, and 2 days of salt-fog exposure (following ASTM B117) as represented in Table 3.3 and shown in Figure 3.14. A total of 20 cycles were made. The ~140 days of exposure was not meant to simulate actual field exposure conditions but rather to provide early indicators of coating performance with the effects of the coatings with non-ideal surface preparation exposed to aggravating wet/dry salt exposure.

Figure 3.14. Cyclic Wet/Dry Exposure in Three Different Condition (20 Cycles).

Electrochemical tests were made during the water immersion phase of the exposure sequence. These comprised of open circuit potential (OCP) measurements, linear polarization resistance (LPR). The test set-up had a three-electrode cell arrangement. A 2.5-inch diameter acrylic cylinder was centered on the coated steel coupons to create a pond for the addition of a 3.5% wt NaCl solution. The coated steel coupon was the working electrode. The surface area of the coupon surface in contact with the solution was ~126 cm². An activated titanium rod was used as a counter and reference electrode for each test cell for electrochemical testing. The activated titanium reference electrode was calibrated with a saturated calomel electrode (SCE). LPR testing was done from the initial OCP to -25mV vs. OCP at a scan rate of 0.05mV/s.

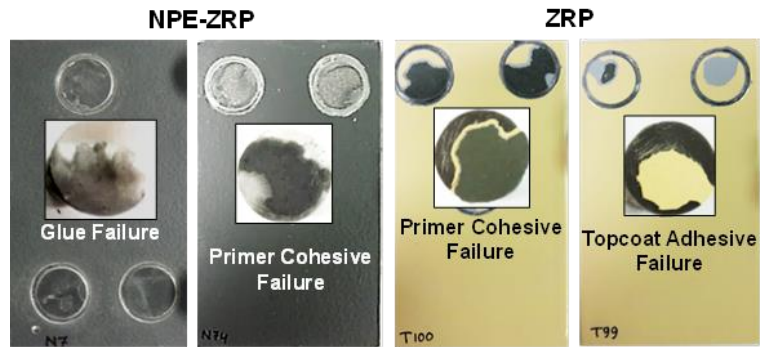
Coating thicknesses were measured, using a magnetic thickness gauge and verified by optical microscopy of the cross-section of the sample. The average thickness for NPE-ZRP and ZRP test samples was ~250 μm and ~420 μm , respectively. Pull-off strengths were measured by means of a pull-off strength adhesion tester and the average strength was >10,000 kPa for NPE-ZRP and ~5,000 kPa for ZRP in the as-received condition. Pull-off testing for NPE-ZRP coated samples mostly failed due to glue failure whereas for ZRP samples failed mostly due to topcoat adhesive and for some cases by primer cohesive failure. A representative picture of different failure modality is shown in Figure 4.3.

Figure 4.3. Different Coating Failure Modality.

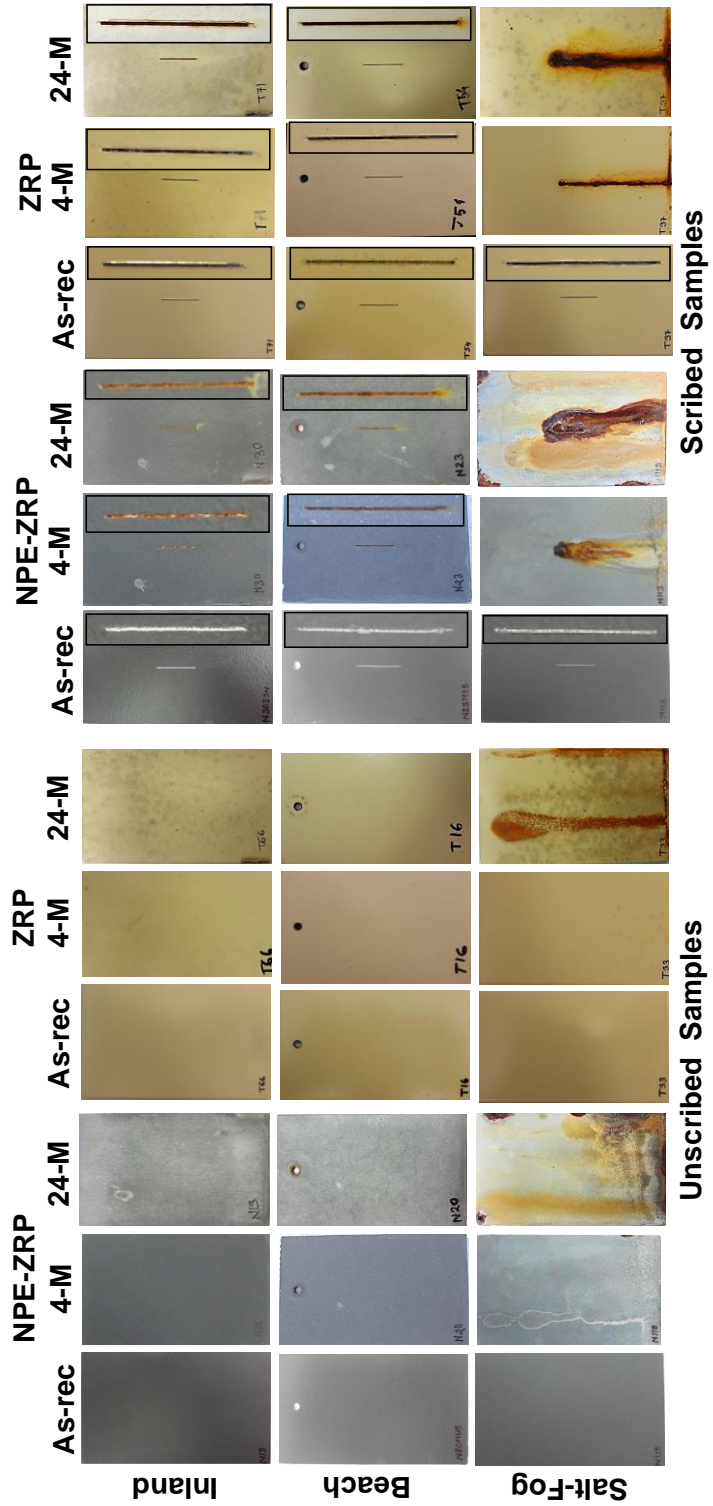
Photographic appearances of the coated samples for both NPE-ZRP and ZRP coatings after extended 24 months of atmospheric exposure are shown in Figure 4.4 (periodic pictures with exposure time are presented in Appendix A). A similar performance was observed between the samples of the inland and beach test sites for both coatings. There was no significant visual coating deterioration observed after 24 months of exposure, but the surface color change observed was likely due to polymer degradation for both coatings. Surface discoloration started within 1 month of exposure and progressively deteriorated over the exposure period. White staining (white rust) was observed over the NPE-ZRP coupon surface due to the oxidation of exposed zinc pigments, as there was no topcoat. For both coatings, tarnishing of the exposed steel at the scribe region started initially within 15 days of exposure and by the time of sample extraction after 24 months of exposure, the defect sites contained accumulated corrosion product. Similar coating degradation and rust bleeding at the defect sites were observed for both NPE-ZRP and ZRP exposed samples for up to 24 months is salt-fog exposure.

Figure 4.4. Visual Appearance of the Outdoors and Salt-fog Exposed Samples.

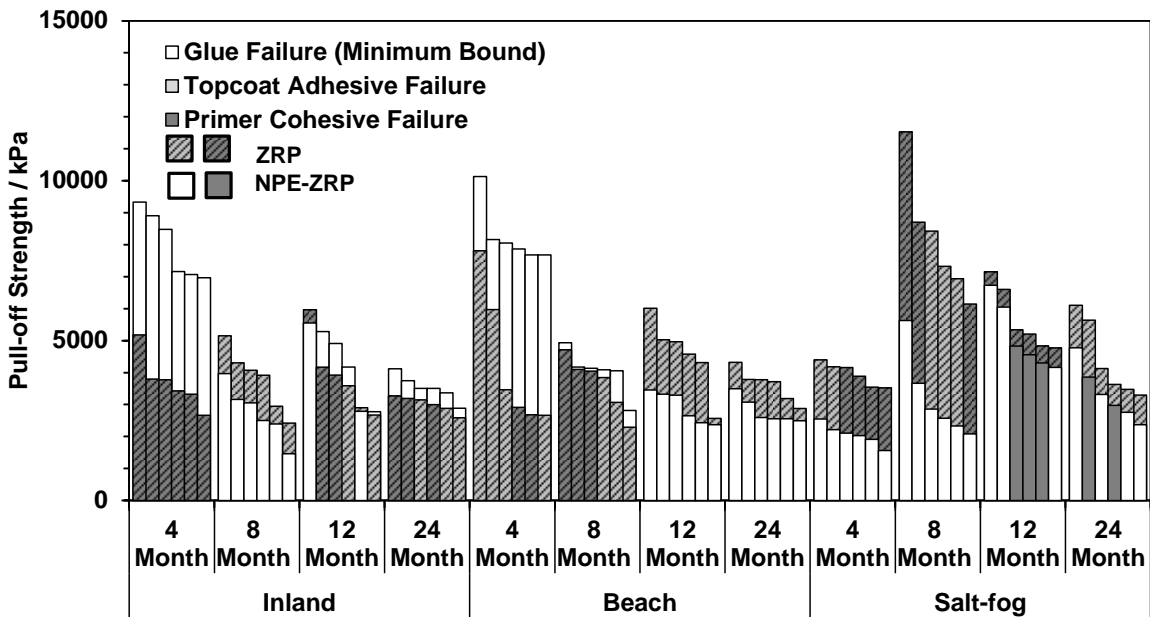
gave some indication of minor coating degradation. The mechanical dolly after testing typically showed evidence of residual particles that appeared to be removed from the primer substrate. The residual particles were thought to be the surface zinc oxidation product deposited on the primer surface described earlier. The result of salt-fog samples indicated possible degradation of NPE-ZRP in extended exposures in moist salt environments. However, the surface appearances of NPE-ZRP with salt-fog exposure up to 24 months were similar to comparable ZRP samples and did not show a propensity for worse coating degradation.

Figure 4.6. Pull-Off Strength of Outdoor & Salt-fog Exposed Samples.

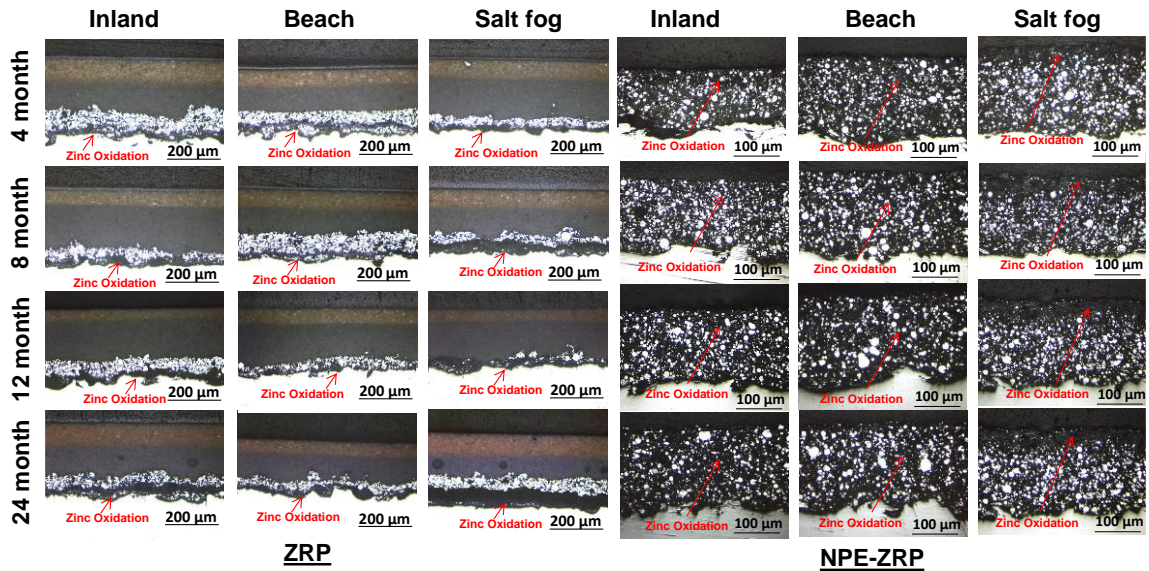
Coating degradation of samples from outdoor and salt-fog exposures was assessed by optical microscopy and photographic analysis. Image processing software was used to quantify the amount and modality of zinc consumption in consideration to the as-received zinc content by calculating the reduction of actual zinc area.

Figure 4.7. Degradation of the Outdoor and Salt-fog Exposed Unscribed Samples.

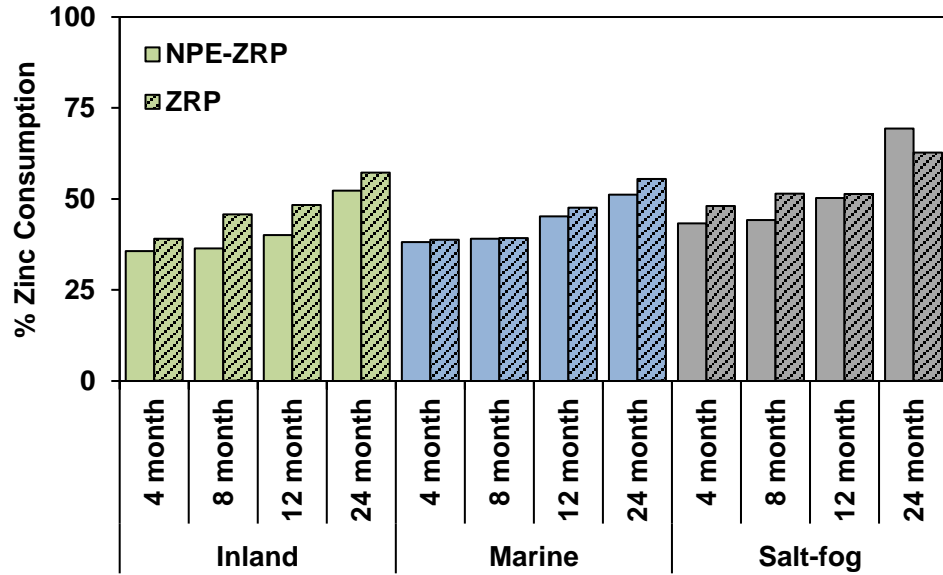
properties of NPE-ZRP due to the presence of the nano-particles. Better continuity of the zinc pigments could also prevent concentrated zinc consumption as observed for ZRP. Predominant zinc consumption at the steel/primer interface of ZRP coating in contrast at the top surface of NPE-ZRP coating indicates a better barrier of the later apparently due to the improved barrier performance due to the pore filling by the nano-particles.

Figure 4.8. Zinc Consumption of Outdoor & Salt-fog Exposed Unscribed Samples.

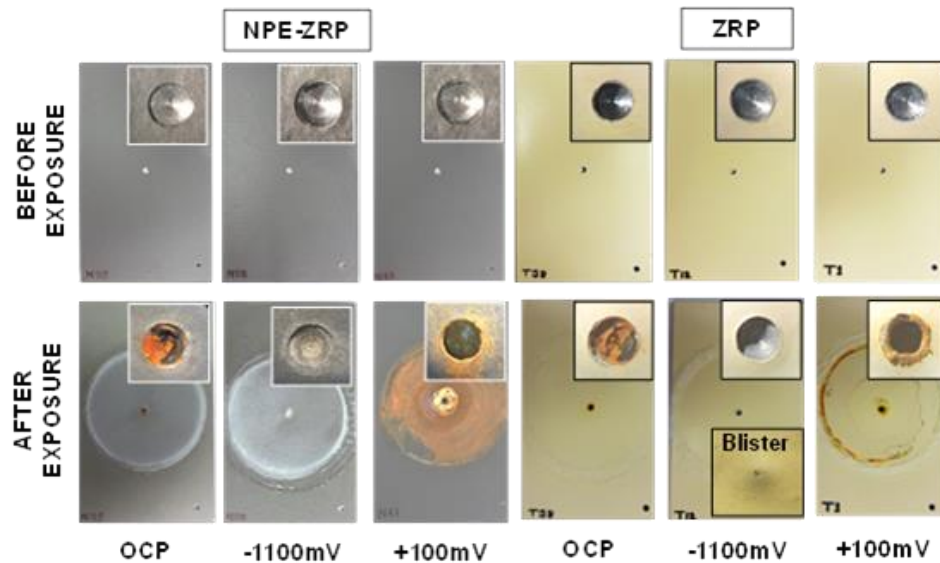
ZRP coating samples except for $-300 \text{ mV}_{\text{SCE}}$ and $+100 \text{ mV}_{\text{SCE}}$ polarization level where steel corrosion was predominant. Only ZRP samples showed coating blistering near the defect site for the $-1500 \text{ mV}_{\text{SCE}}$ and the $-1100 \text{ mV}_{\text{SCE}}$ cathodic polarization cases due to the large impressed cathodic currents as well as imperfection within the coating.

Figure 4.24. Condition of the Representative Samples before and after Exposure.

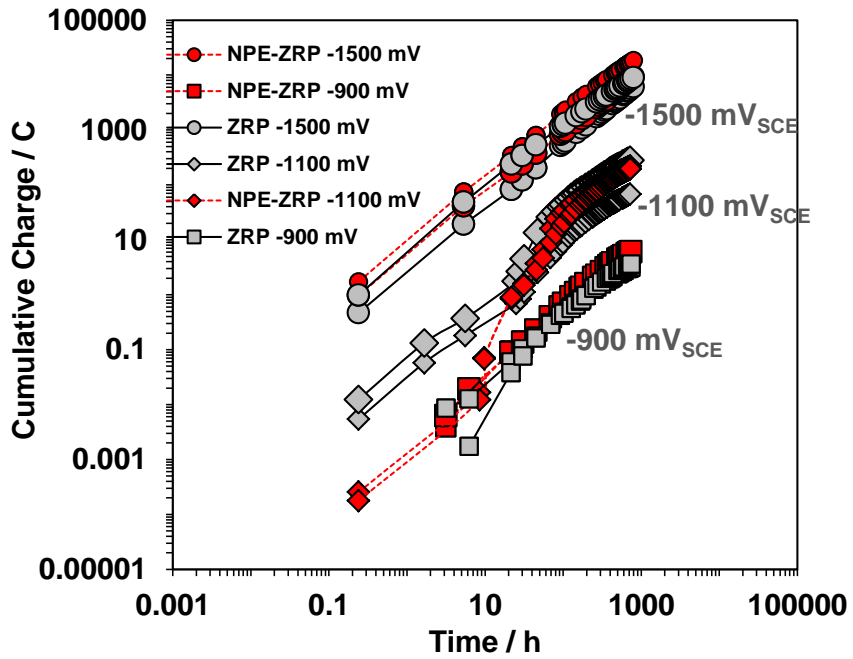
thought to be related to the relatively poor mechanical adhesion of the primer in comparison to the NPE-ZRP as reported elsewhere (Saiada, et. al., 2017). It was thought that some level of coating separation in the ZRP would allow moisture access within the occluded space thus resulting in greater surface area to support reduction reactions. After a couple of days, NPE-ZRP and ZRP exhibited a similar increase in cathodic current.

Figure 4.29. Cumulative Cathodic Charge for NPE-ZRP and ZRP Coating.

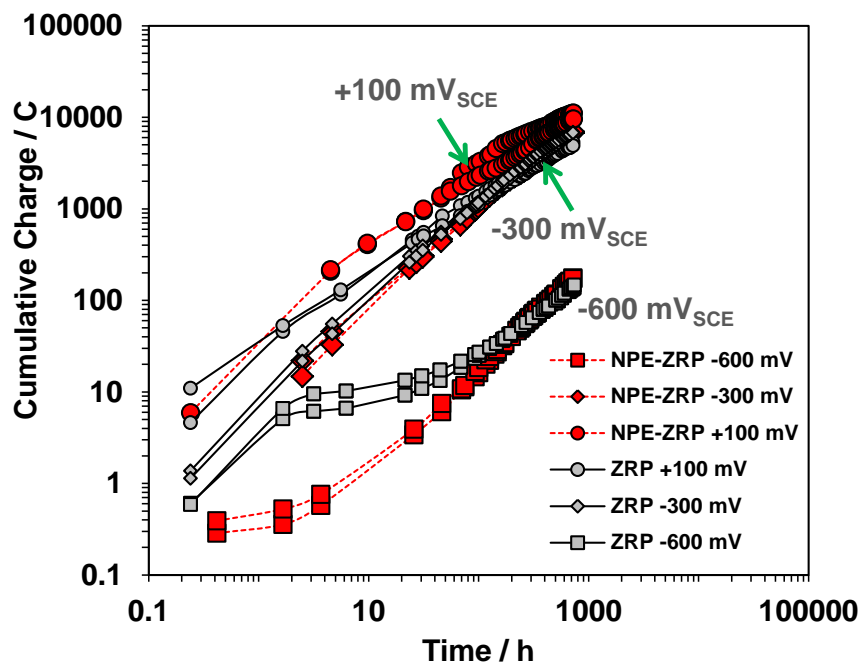
Figure 4.30. Cumulative Anodic Charge for NPE-ZRP and ZRP Coating.

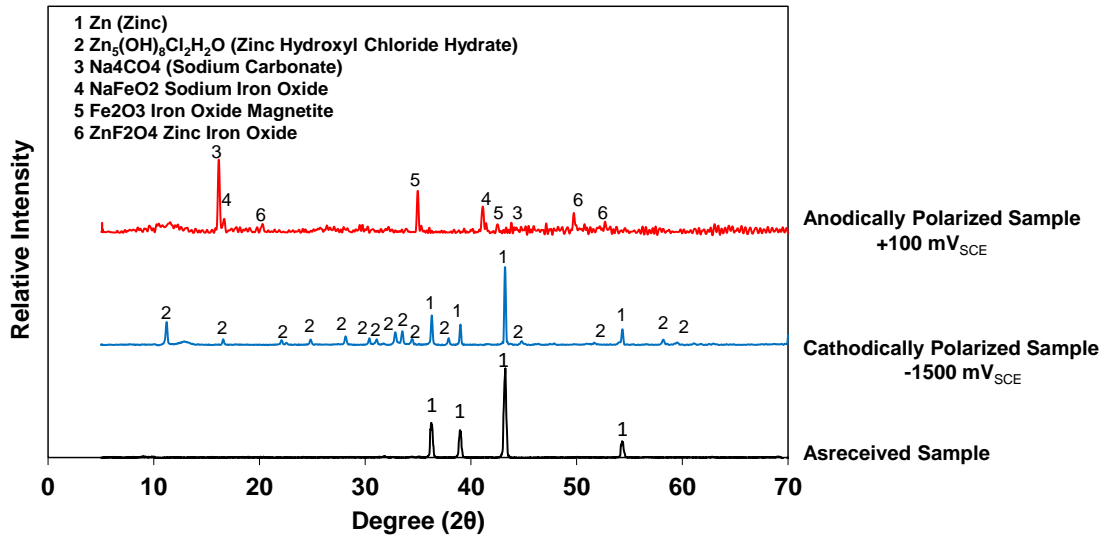
cathodically polarized samples was the reaction product of the zinc oxidation product with the NaCl solution. The blackish deposition visually observed over the anodically polarized samples was mainly the iron oxide and some form of zinc oxide resulting from severe steel corrosion in NaCl solution.

Figure 4.36. X-Ray Diffractogram for the sample after exposure.

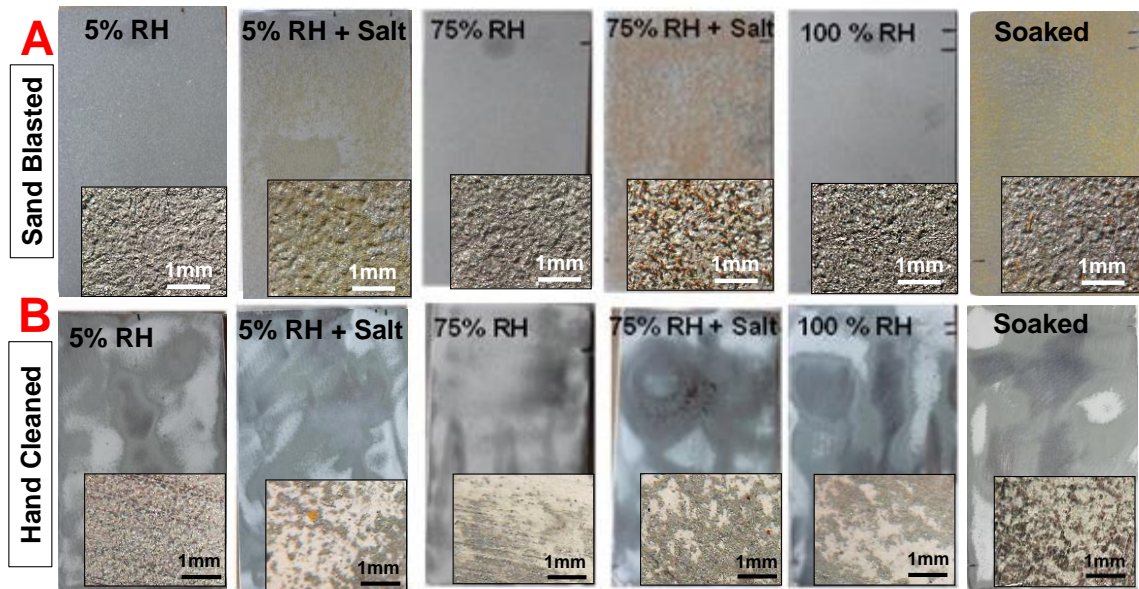
Figure 5.1. Condition of Uncoated Steel Test Panels after Exposure.
(A) Sandblasted Steel and (B) Hand Cleaned, Previously-Coated (Three-Coat) Steel.

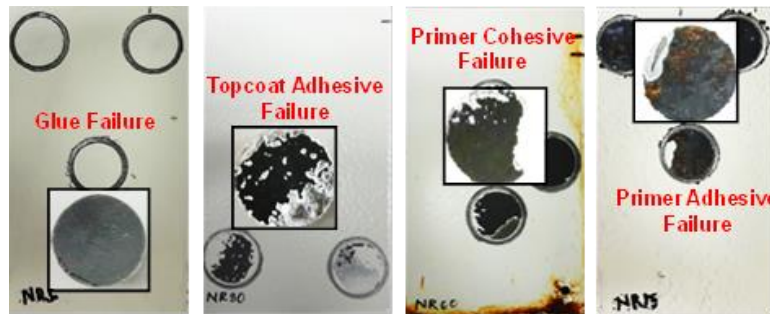
Tests that resulted in the failure of the glue to attach the dolly are shown as minimum pull-off strength. Representative pictures of different failure modalities are shown in Figure 5.8.

Figure 5.8. Different Failure Modality of Pull-Off Strength for NPE-ZRP Coupons.

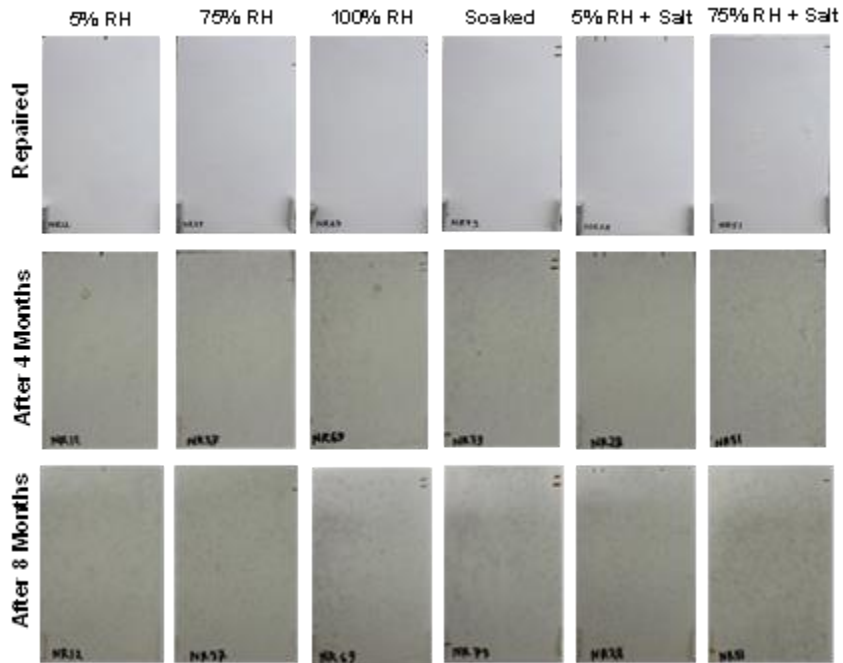
Figure 5.10. Hand Cleaned NPE-ZRP Samples after Outdoor Exposure.
 (Pre-exposure conditions are noted for each coupon shown)

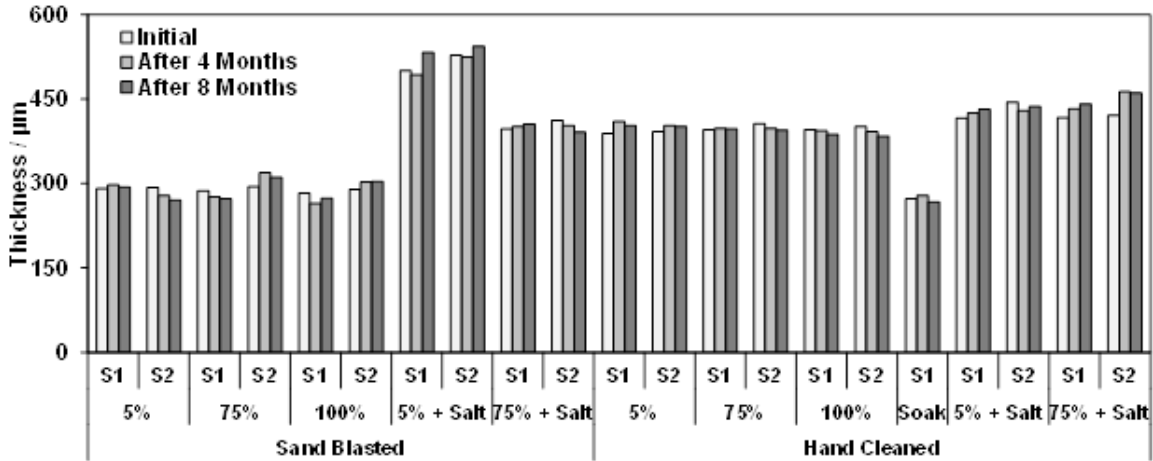
As shown in Figure 5.11, in outdoor testing, no significant changes in coating thickness were measured during the 8 months of exposure. Similar trends and discussion for the sample by sample preconditioning presented earlier are relevant although some variation in the initial coating thickness was apparent. Notably, the coating thickness (repair overcoating on remnant coating layer) on the surface-abraded samples was higher than the sandblast samples and the coating thickness was higher for samples with salt contamination prior to coating application (due to osmotic blistering) than non-salt-contaminated samples. Apparent increment in the thickness for the samples with surface pre-rusting observed due to the further oxidation in those samples as oxide products occupy a greater volume than the native zinc pigment.

Figure 5.11. Coating Thickness of Outdoor Exposed NPE-ZRP Repaired Samples.

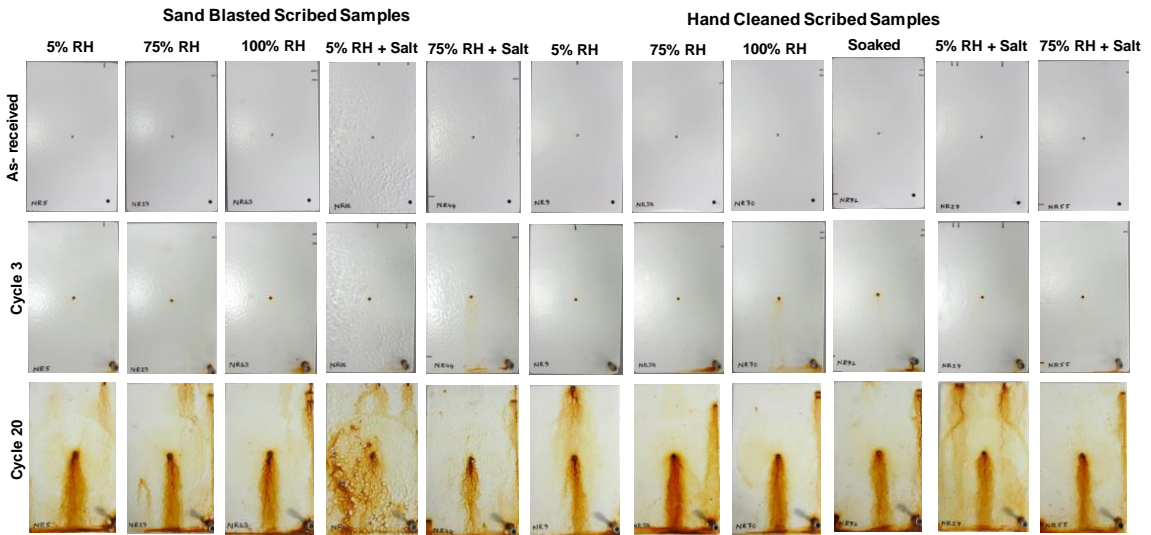
of the salt contaminated samples apparently due to the increment in water uptake at the coating/substrate interface because of osmotic driving forces which lead to the formation of corrosion products at the interface as chloride leads to the corrosion of the steel substrate. With the time of exposure, the blister is filled with corrosion products and develops a micro-hole at the blister surface which further leads to the breaking of the blister as well as corrosion of the steel substrate as seen for the salt contaminated samples. For the non-salt-contaminated samples, no major indication of coating deterioration (other than the noted rust at defects and holidays) was observed throughout the cyclic exposure other than minor surface roughening and discoloration. The coatings appeared intact throughout the test exposure.

Figure 5.13. Condition of NPE-ZRP Scribed Samples after Cyclic Exposure.

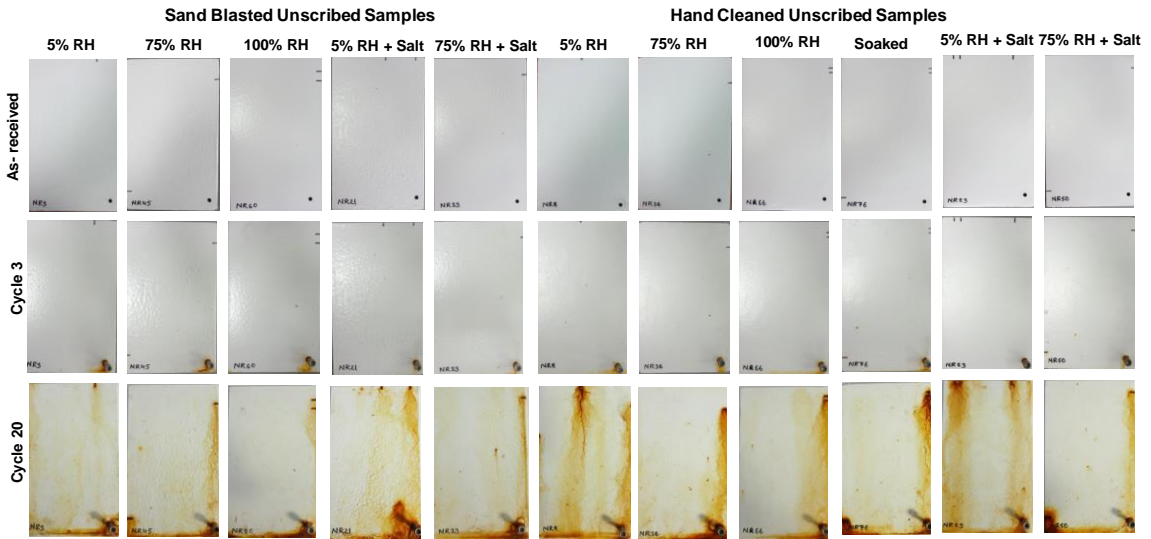
corrosion of the steel substrate with exposure and ingress of electrolyte. However, in the absence of local coating defects, the extent of coating degradation (although still significant) may be somewhat reduced without the easy access of moisture and salts. As mentioned earlier, a layer of zinc pigments from the original coating was retained on each of the steel substrates on the surface-abraded samples. This residual zinc layer is apparently providing some enhanced mitigation as it works as an additional barrier for the corrosive agents and also more source for cathodic protection. For example, samples with salt contamination after surface-abrasion cleaning showed less steel surface corrosion at the blister locations than samples that were sandblasted. However, the initial intact layers contained zinc pigment that was not pre-exposed. In actual service, the zinc particles in the remnant layers may not necessarily afford a similar effect if oxidized before.

Figure 5.14. Condition of NPE-ZRP Unscribed Samples after Cyclic Exposure.

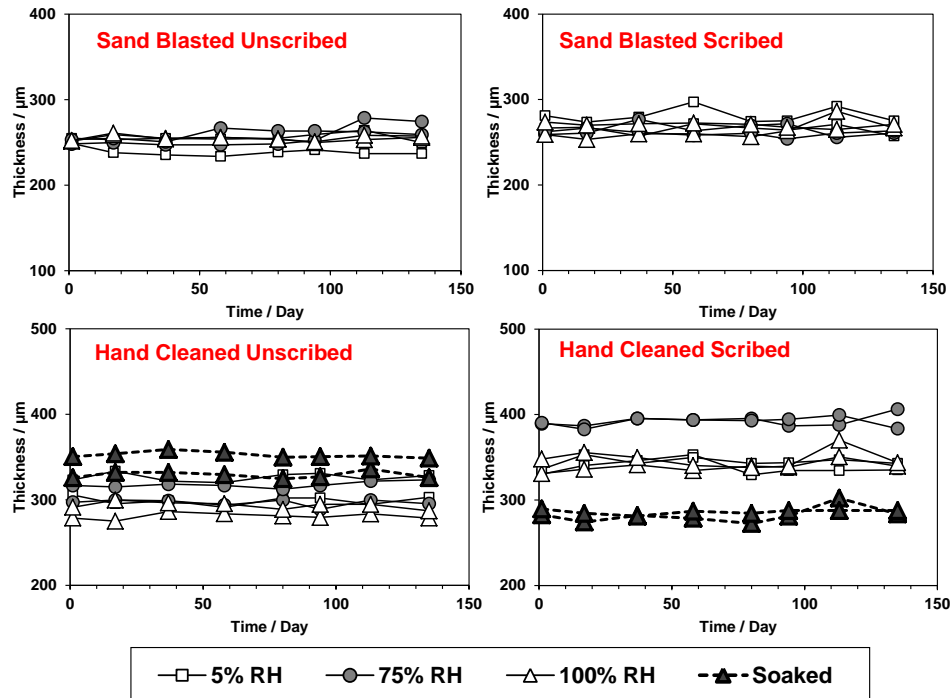
third cycle of exposure after the dry phase. Figure 5.15 represents the measured coating thickness with exposure time with different levels of humidity pre-conditioning. Coating thickness was measured for both unscribed and scribed samples to identify the effect of scribed defect. Figure 5.16 represents the measured coating thickness for samples with salt contamination.

Figure 5.15. Coating Thickness of NPE-ZRP Samples after Cyclic Exposure.
(Moisture Exposure during Coating Application)

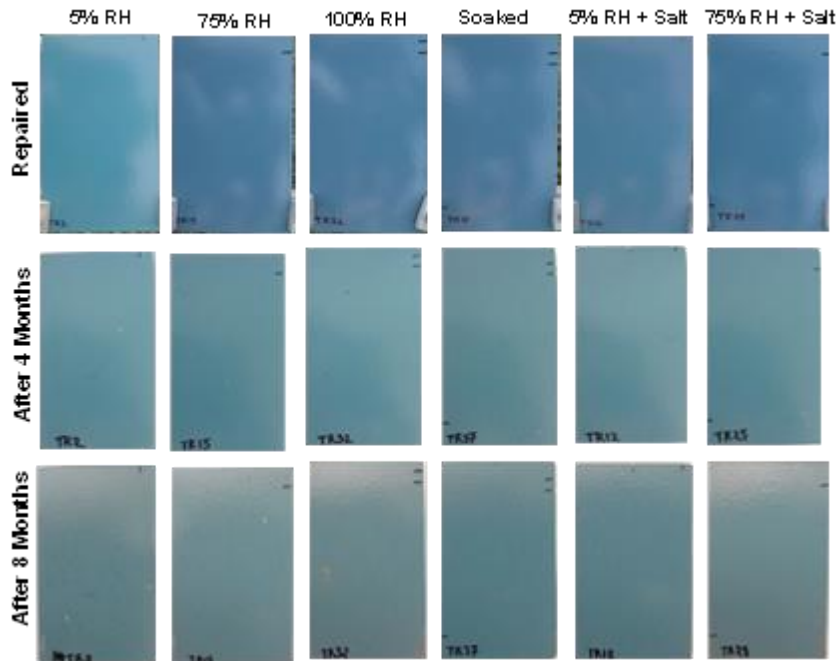
Figure 5.32. Condition of the Sandblasted ZRP Samples after Outdoor Exposure.

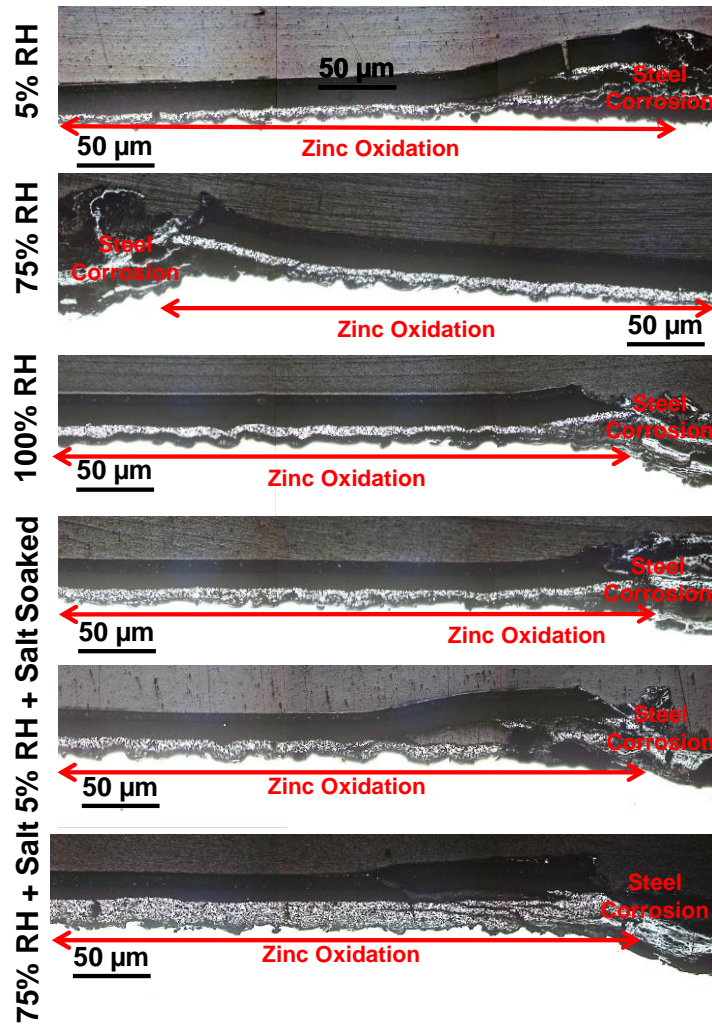
Figure 5.44. Micrograph of Sandblasted Scribed ZRP Samples.
(Pre-exposure conditions are noted for each coupon shown)

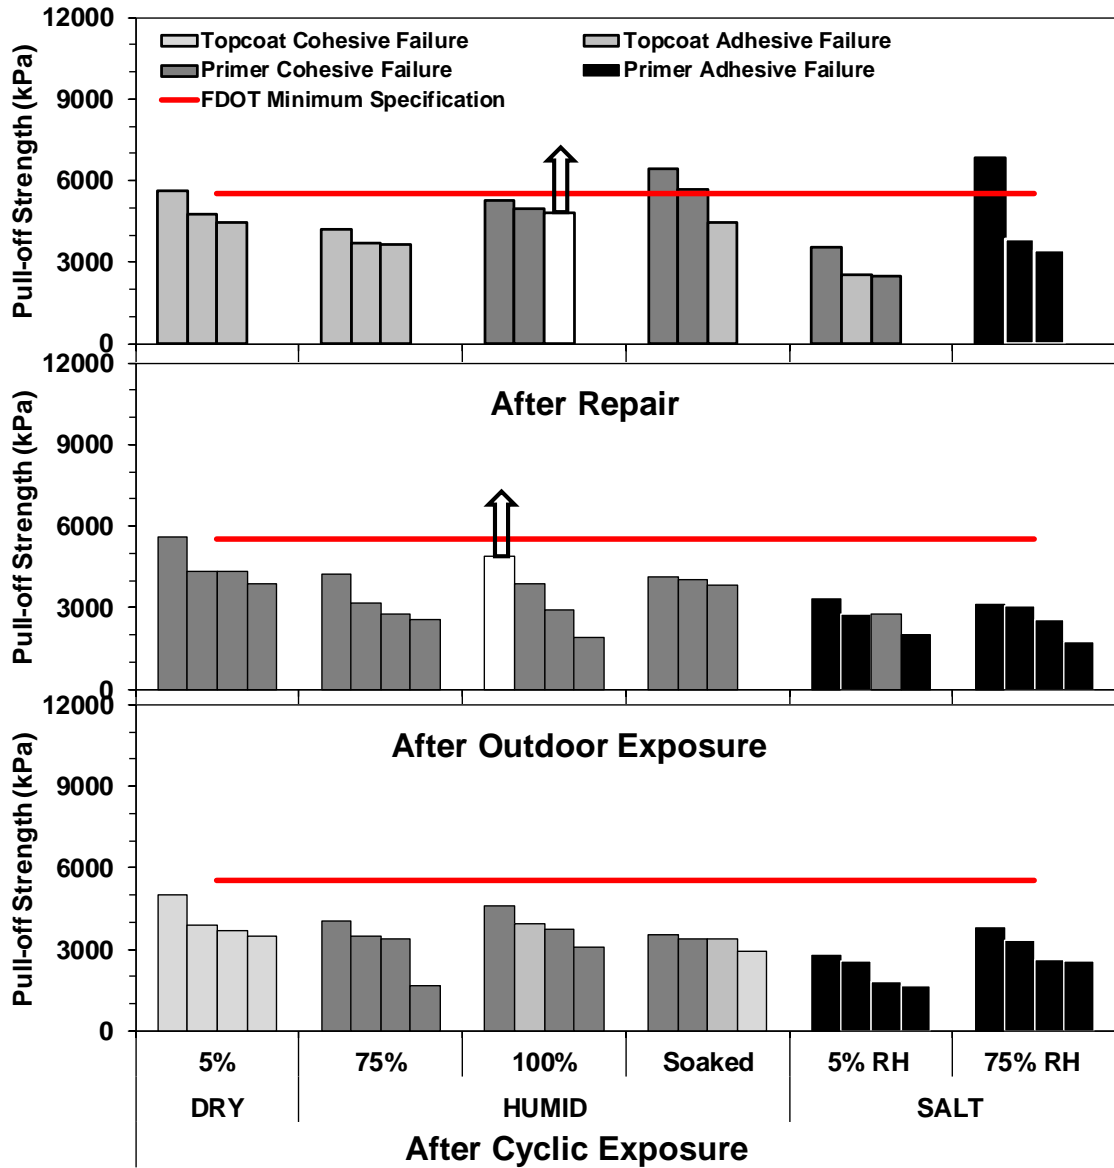
Figure 6.5. Coating Pull-off Strength of ZRP (Test Group A).
 (Arrow indicates apparent higher value)

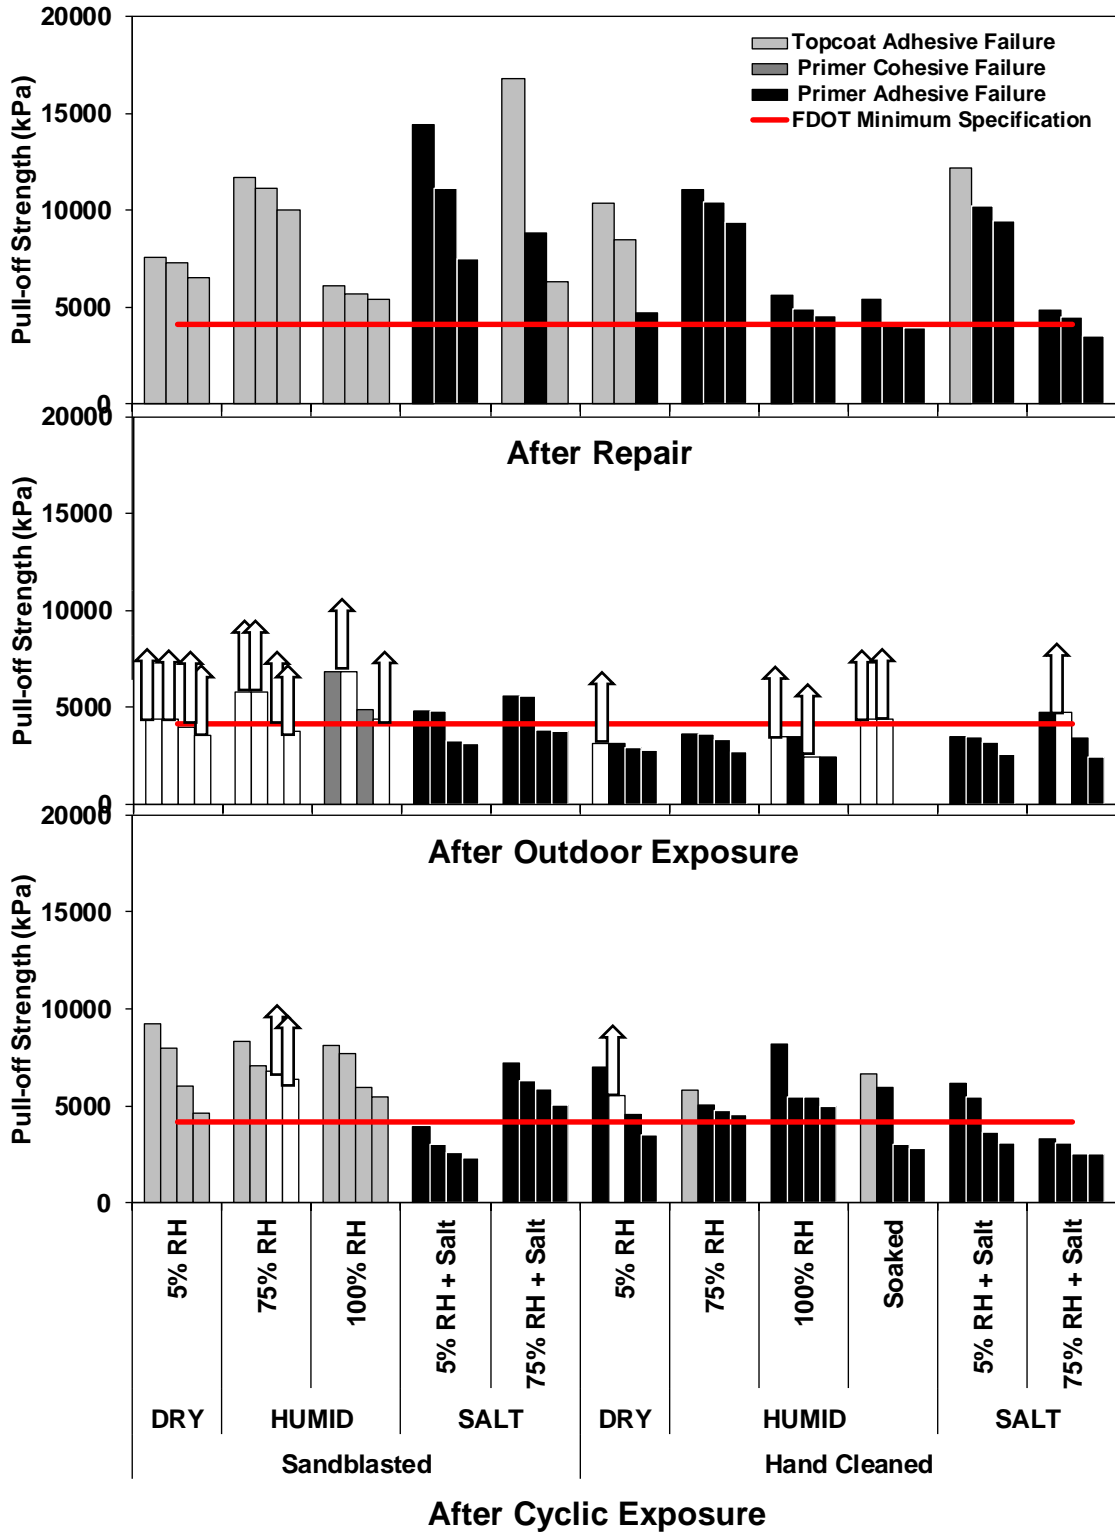
Figure 6.6. Coating Pull-off Strength of NPE-ZRP (Test Group A).
 (Arrow indicates apparent higher value)

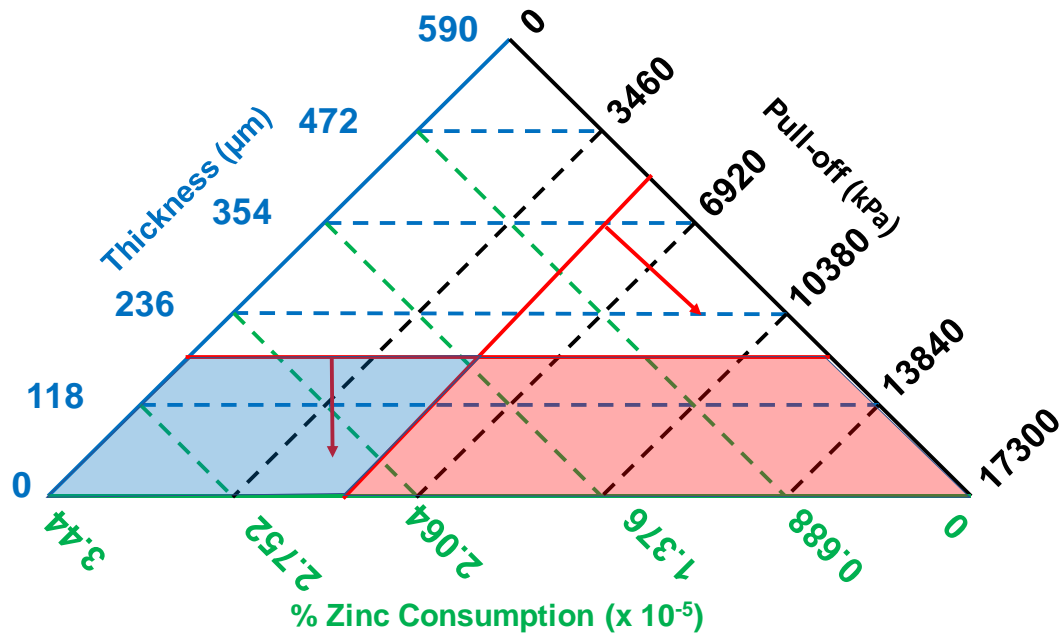
Figure 6.16. Proposed Range for Durability of ZRP Coating.
