Corrosion Durability of a Nano-Particle Enriched Zinc-Rich Coating System For Highway Steel Bridges

A dissertation submitted in partial fulfillment of

DOCTOR OF PHILOSOPHY

CIVIL ENGINEERING

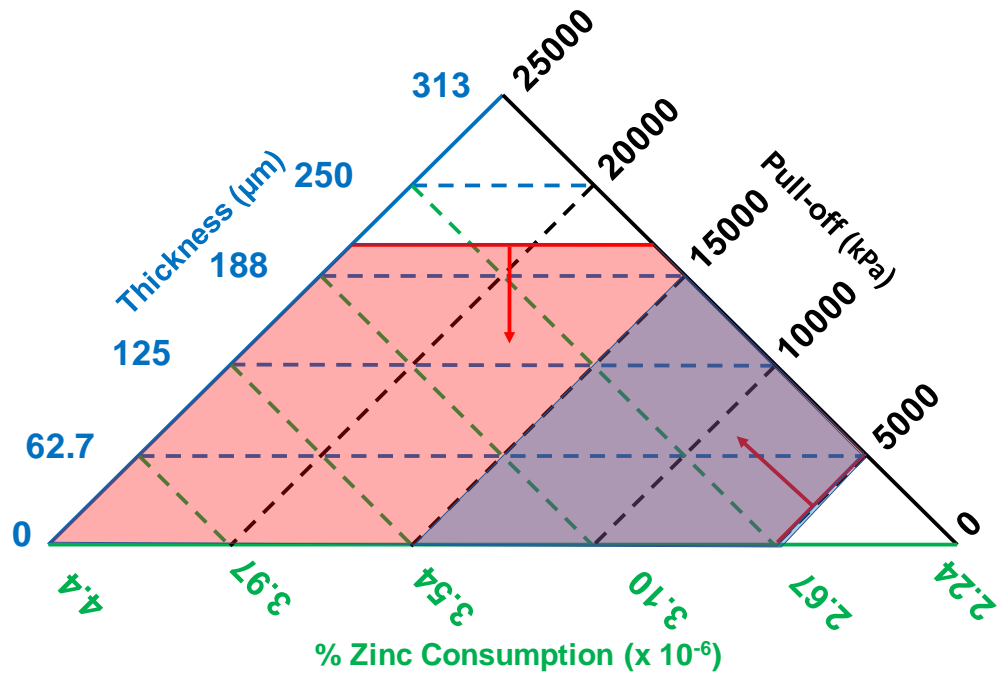
Figure 6.17. Proposed Range for Durability of NPE-ZRP Coating.

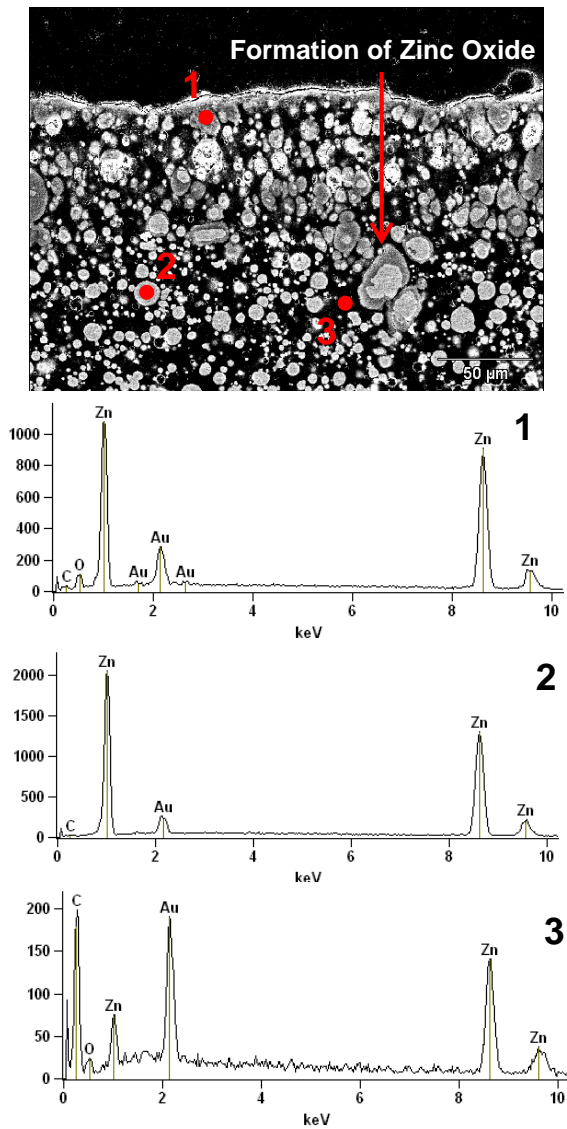
Figure 7.2. EDS Point Mapping on NPE-ZRP Sample.

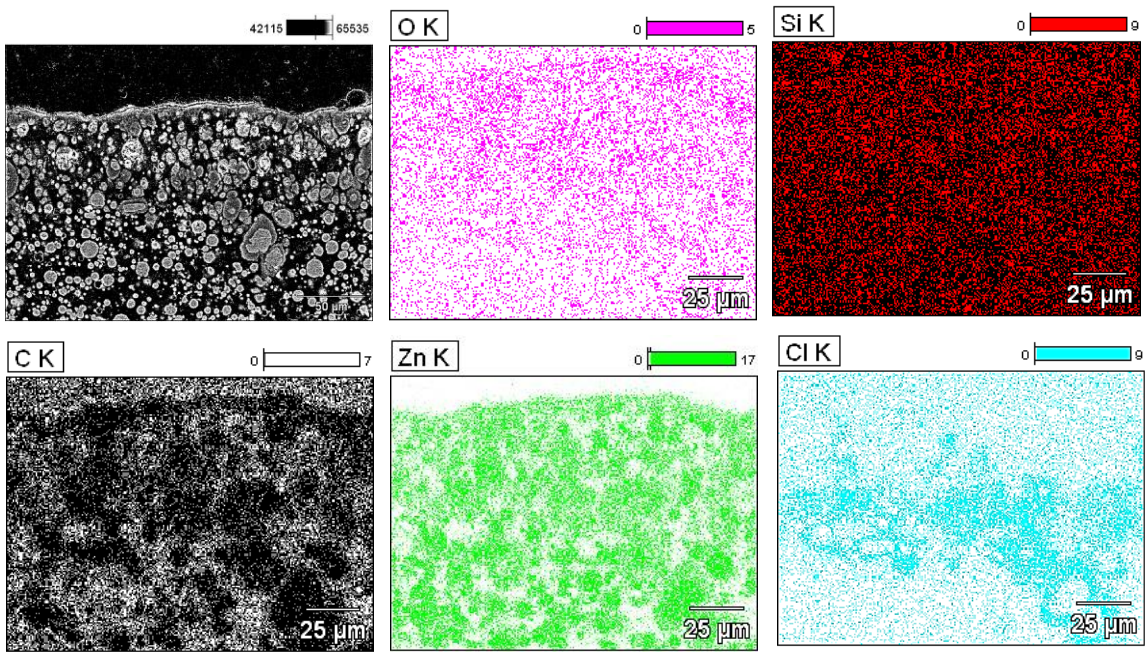
Figure 7.3. EDS Mapping of Salt-fog Exposed NPE-ZRP Unscribed sample (Top).

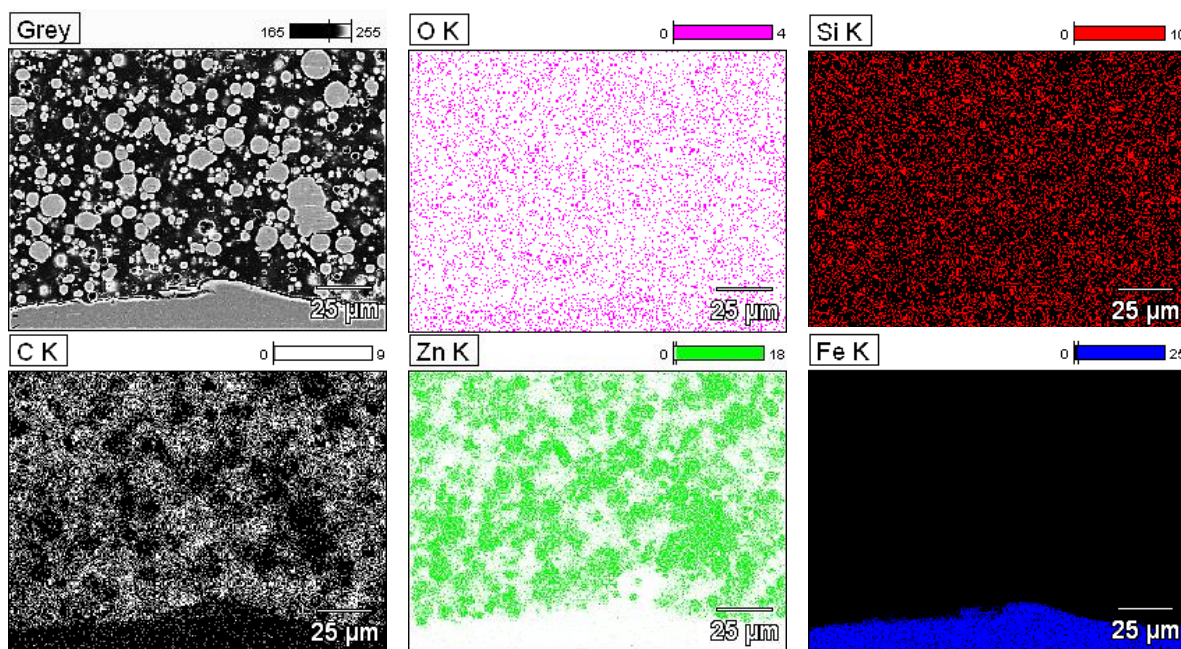
Figure 7.4. EDS Mapping of Salt-fog Exposed NPE-ZRP Unscribed sample (Botm).

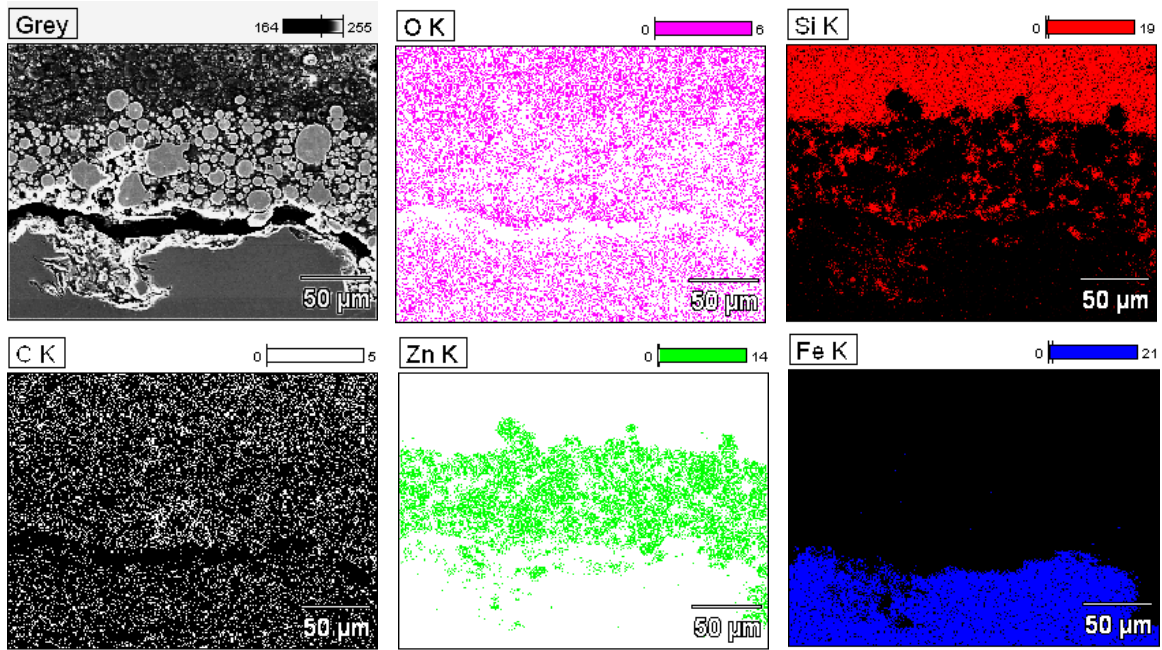
Figure 7.5. EDS Mapping of a Salt-fog Exposed ZRP Unscribed sample.

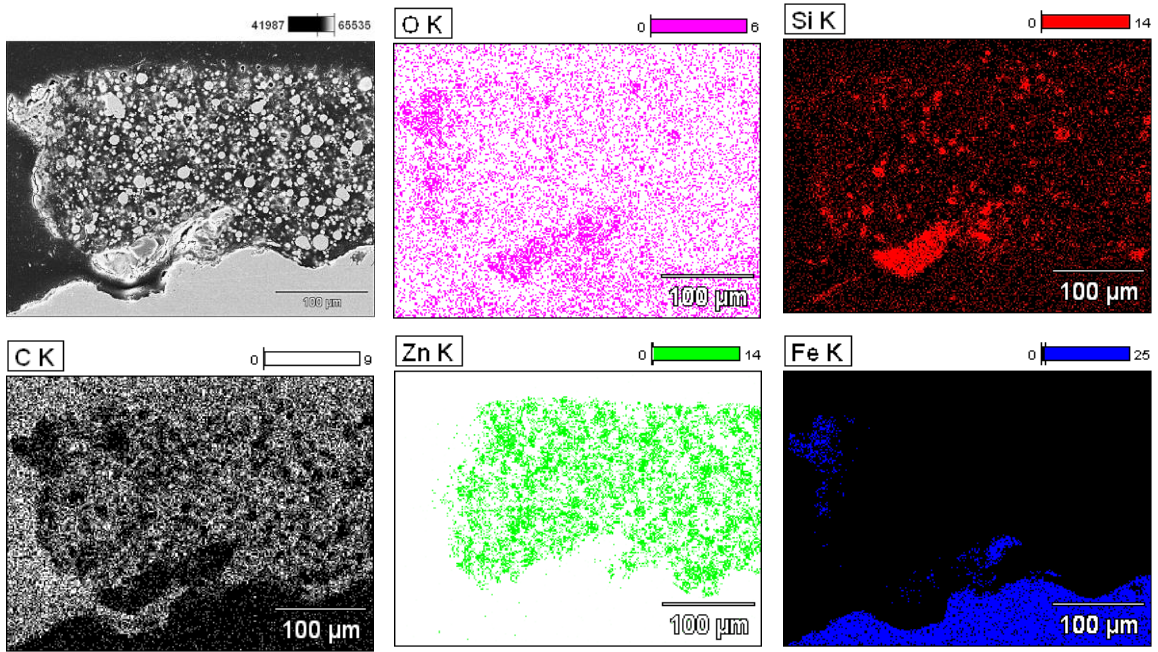
Figure 7.6. EDS Mapping of a Solution Immersed NPE-ZRP Scribed sample.
