# NEA PAPHOS

## SEASON 2006

Wiktor Andrzej Daszewski, Henryk Meyza

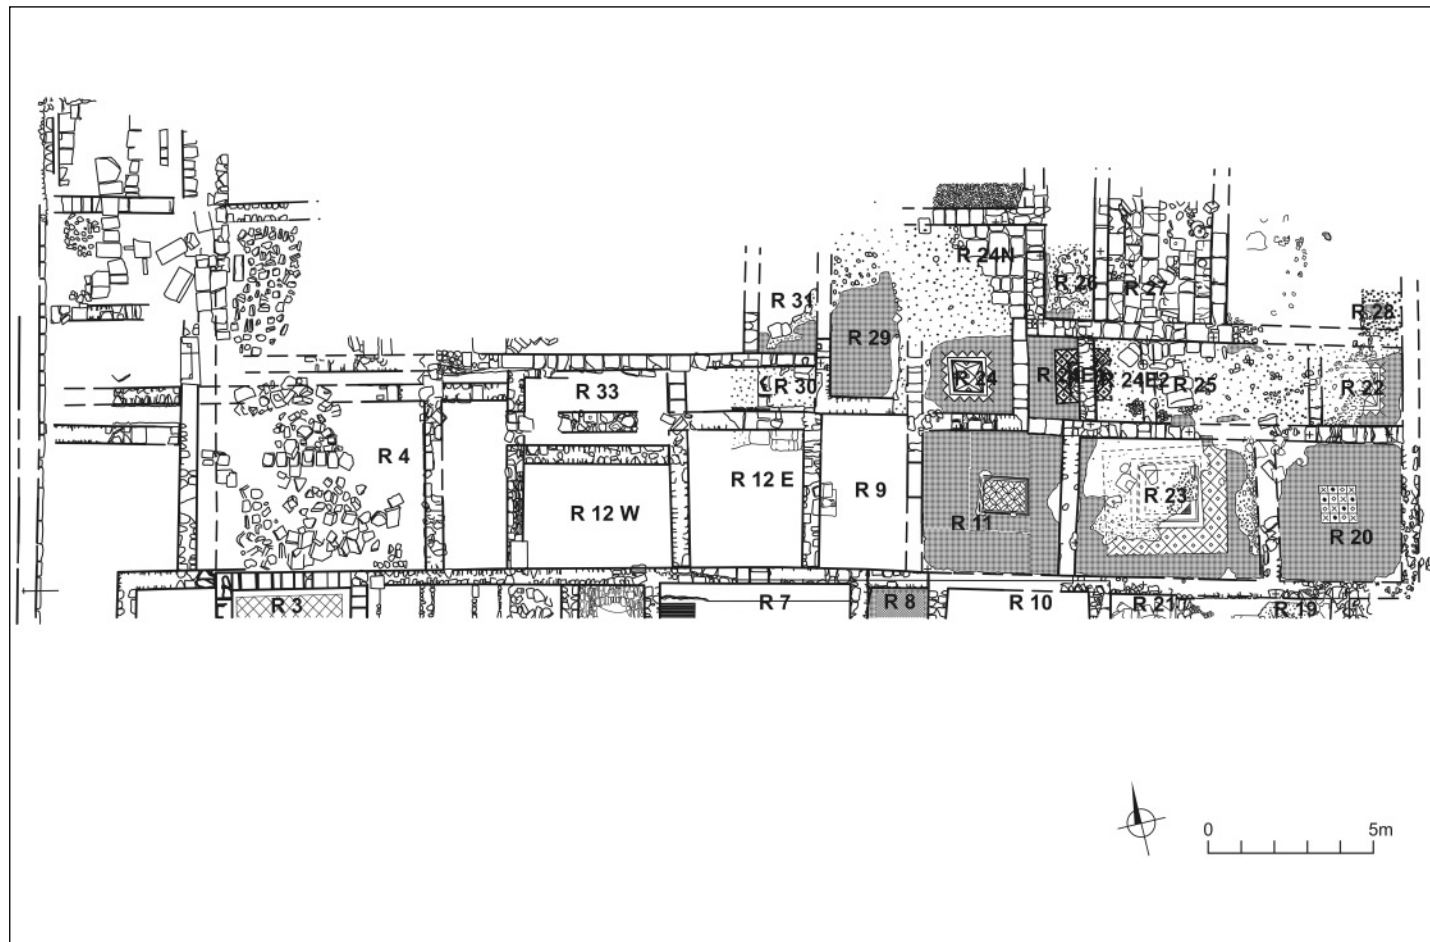
Fig. 1. Plan of the excavations in the northern part of the House of Aion  
(Updated by A. Brzozowska, based on original plan by S. Medeksza)

28, where a large disturbance was encountered. It continued west of Room 34, into the northern parts of Rooms 29 and 31. Down to below the level of the floors in these rooms, mixed fill with remains of plastic bags and other modern objects gave evidence of the scope of destruction caused by the activities of the British Army [Fig. 1].

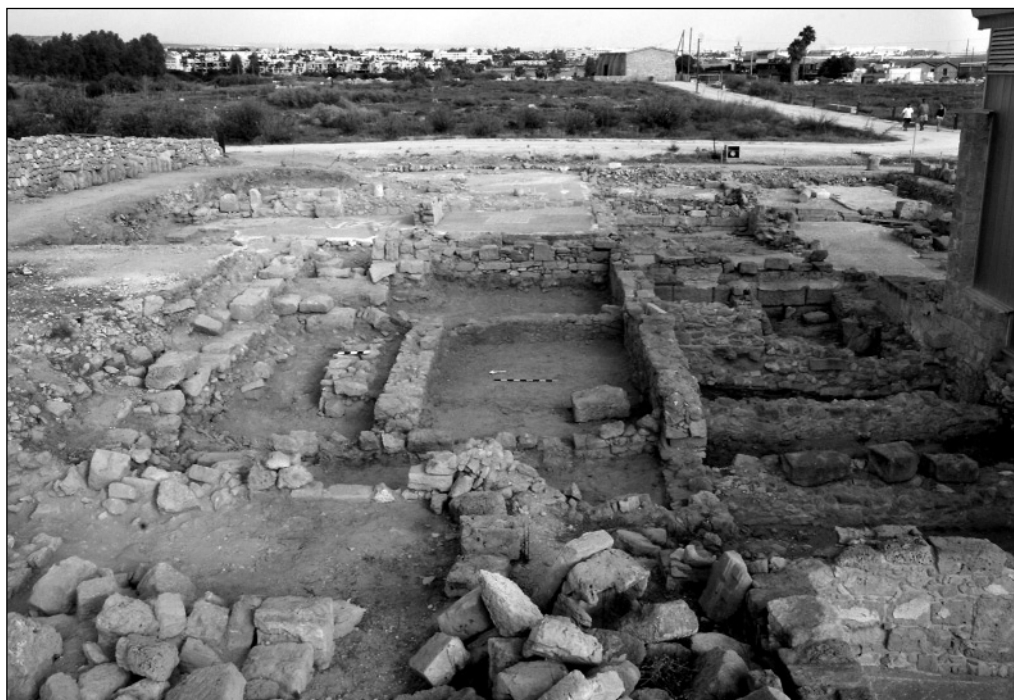
*Fig. 5. View of excavations in the House of Aion, seen from the west  
(Photo W. Jerke)*

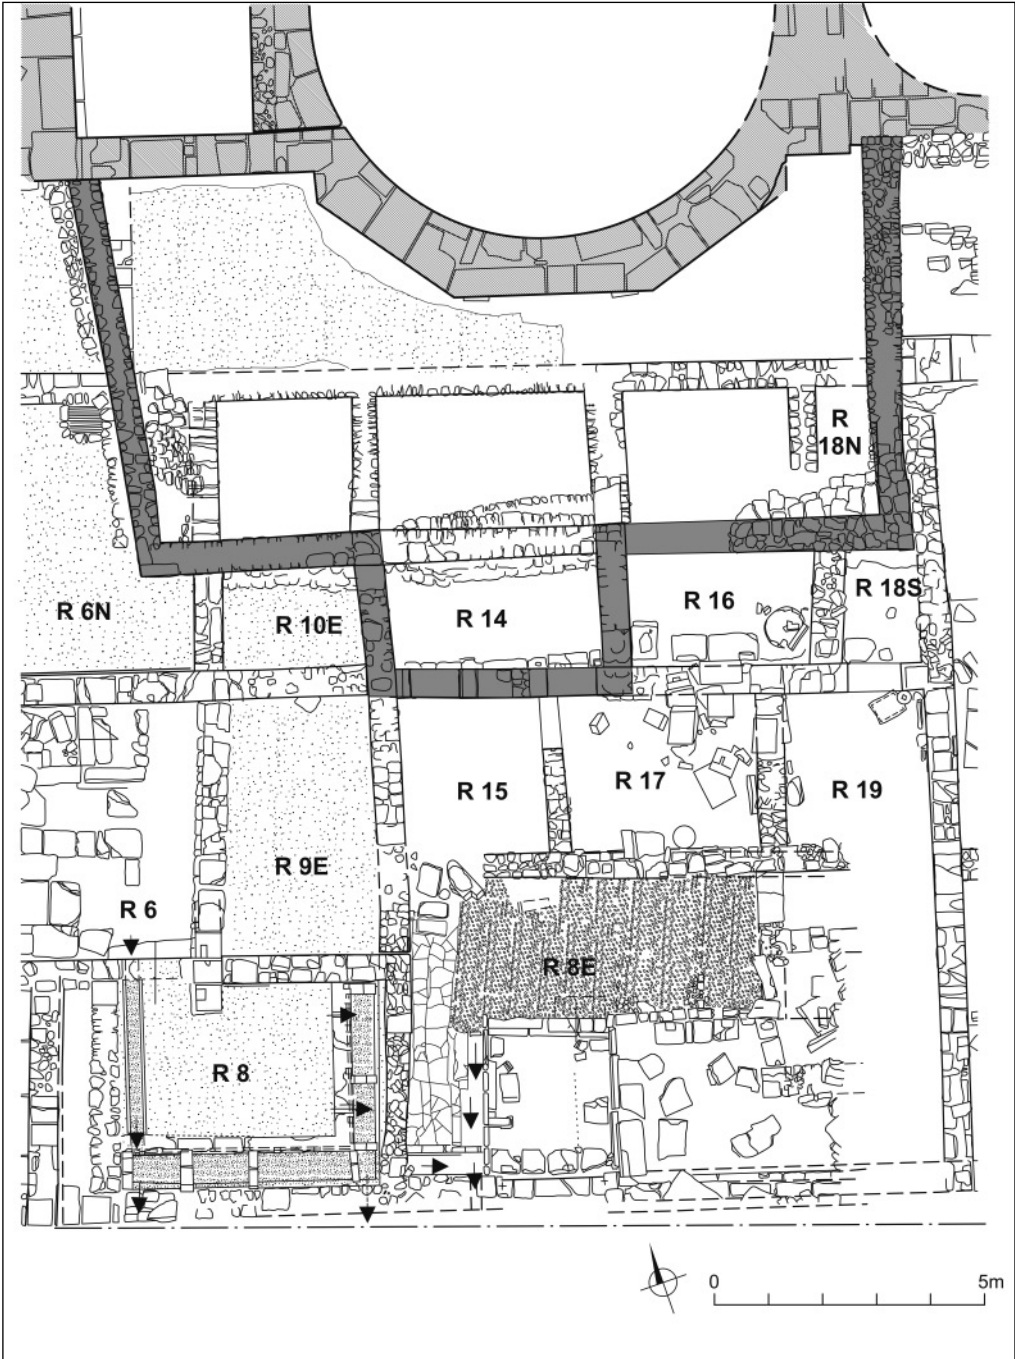
Fig. 6. Plan of excavations in the Hellenistic House  
(Updated by A. Brzozowska, based on S. Medeksza)

39, during a late stage in the occupation of the Villa. In 2006, excavations in HH Rooms 14, 15, 16, 17, 18 and 19, situated south of the damaged area [*Fig. 6*] led to the distinguishing of three phases of use of these structures. The latest phase was of Late Roman date: a dust floor recorded c. 1 m below the modern surface, stretching to the south of the VT, accessible from VT through an additional door opened in the south wall of Room 38. The curtain wall, allegedly “Byzantine”, built over Rooms 5, 6N, 10E, 14, 16 and 18, had a narrow passage 0.52 m wide, running above Room 14 and leading out from the enclosure (possibly for the sheep and goat herd); a daub floor ran across it. The southern part of the earlier Room 14 was reused, perhaps as a shed, with a threshold in the south wall at the same level, made of a large masonry block 1.02 m wide [*Fig. 7*].

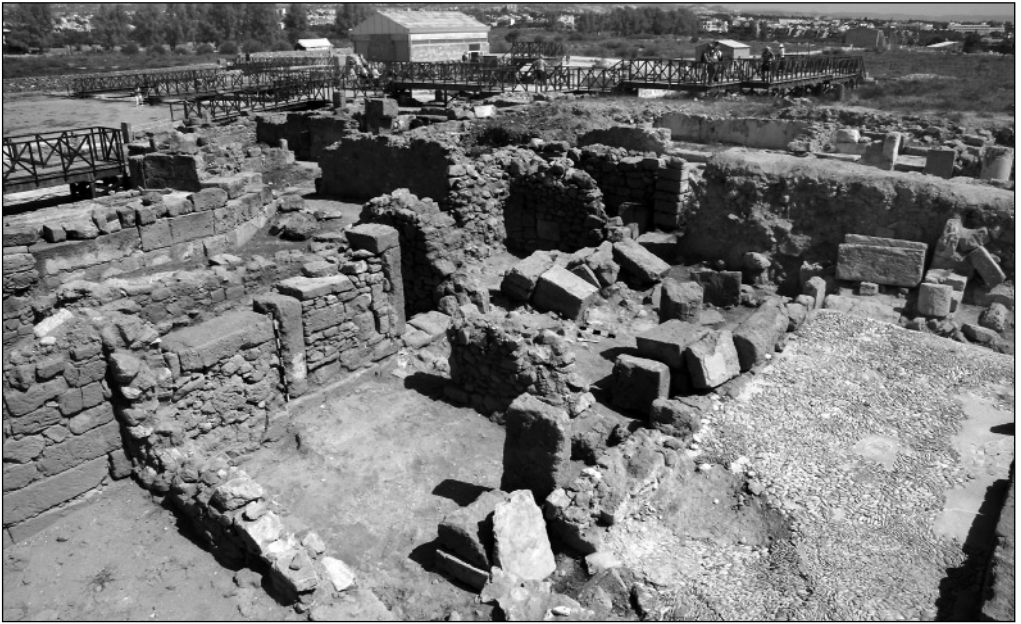
*Fig. 7. View of the excavations in the Hellenistic House, seen from the southwest  
(Photo W. Jerke)*

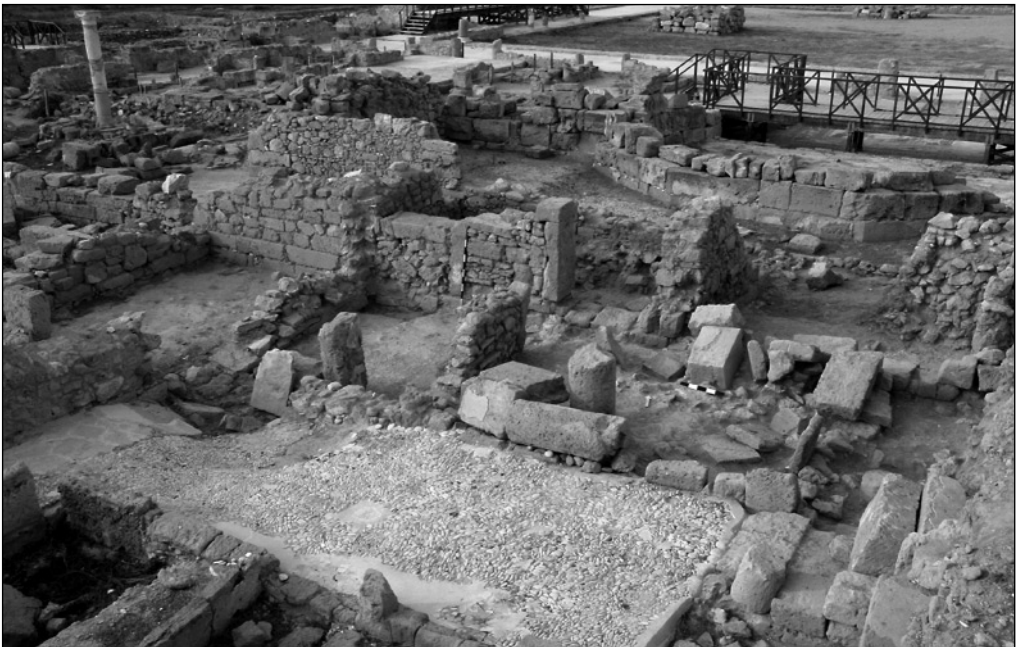
*Fig. 8. View of the excavations in the Hellenistic House, seen from the southeast  
(Photo W. Jerke)*

This “Byzantine” wall was damaged in the area of the Early Roman Room 16, leaving only a small part at the eastern part end. Further east, above the earlier Room 18, this late wall turned north to hit the south wall of VT at the back of Room 48B [Fig. 8].

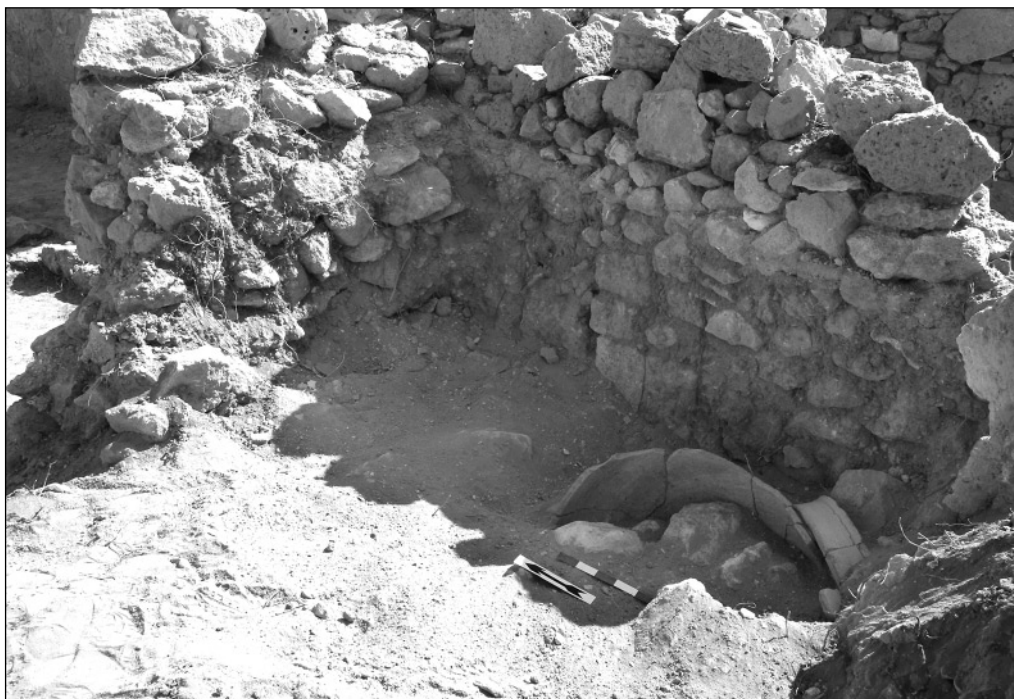
Fig. 12. *Pitbos* in Room 16 of the Hellenistic House, seen from the west  
(Photo W. Jerke)

of Room 17, there was a bronze candelabrum (FR 40/06), 35 cm high, dated to the 1st century AD [Fig. 13]. Close to it, a massive basalt quern or mortar (?) was unearthed. Witness to the cataclysm which destroyed the building was a heavily damaged and fragmentary male skeleton, found crushed under a large irregular stone in Room 14. By its side, an amphora from Kos was found also smashed by the collapsing walls. In Room 16, a large pithos was situated in the southeastern corner [Fig. 12].
