Youth in Conservation of Cultural Heritage, YOCOCU 2012

Effects of conservation interventions on the archaeological Roman site of Merida (Spain). Advance of research.

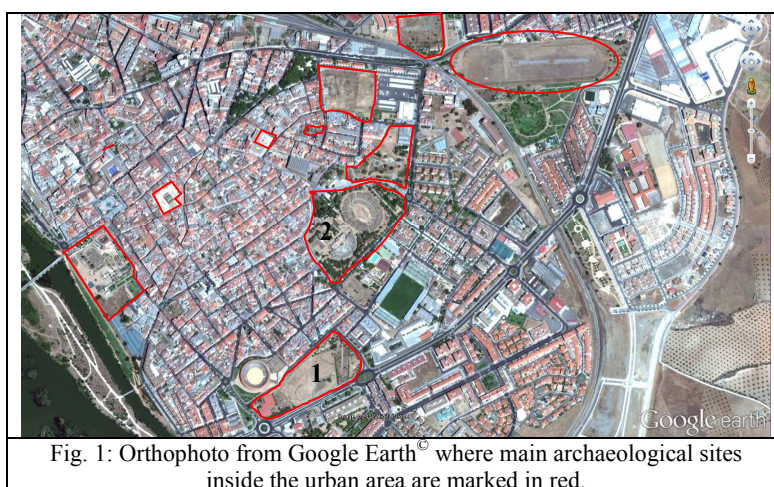
Fig. 1: Orthophoto from Google Earth[®] where main archaeological sites inside the urban area are marked in red.

Merida is an ancient Roman city that was listed World Heritage Site by UNESCO in 1993 (Figure 1). Excavation began in 1911 and the first restorations were performed in the early 20's with the anastylosis project on the theater (Figure 2). For this case study we count with an evolution of criteria, techniques and products, since the early 20's until the present day, thus showing a wide range of analysis cases.

This research is initially focused in two archaeological areas, House of Mitreo (1) and Roman Theater (2) (Fig.1).

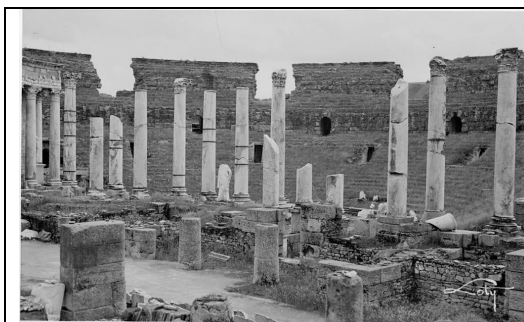
Fig. 2: Resetting of the front stage in the Roman theater during the 20's (Source: LOTY archive, IPCE)

In the case of Mérida we have found detailed architectural projects from the sixties to the eighties for the reconstruction of most representative monuments of Roman Augusta Emerita, (Figure 2) and some modern reports regarding interventions from the nineties and early years of this century (Figure 3), which allow for a review of the evolution of criteria and methodology of interventions on archaeological remains.

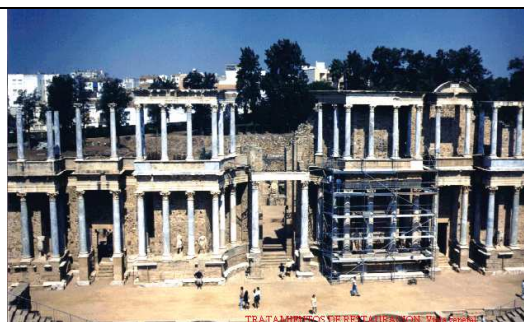
Fig. 3: Restoration works carried out in 1996 (Source: Agora S.L)

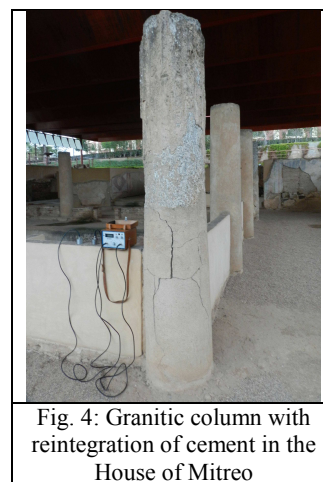
Fig. 4: Granitic column with reintegration of cement in the House of Mitreo

- Decay arising from the use of cement or concrete due to different properties between the cement applied and traditional mortars. The major problem arising from the use of cement as a restorative material is the difference in its physico-chemical properties and those of traditional mortars present in the original fabric [16]. The greater resistance of cement makes it markedly more rigid than the material upon which it stands. This difference in elasticity creates an area of big tension between both materials. The thermal expansion between stone or brick and cement can be twice higher, which results in strong internal tensions that lead to fissures and cracks (Figure 4), allowing the access of moisture and thus biodegradation.

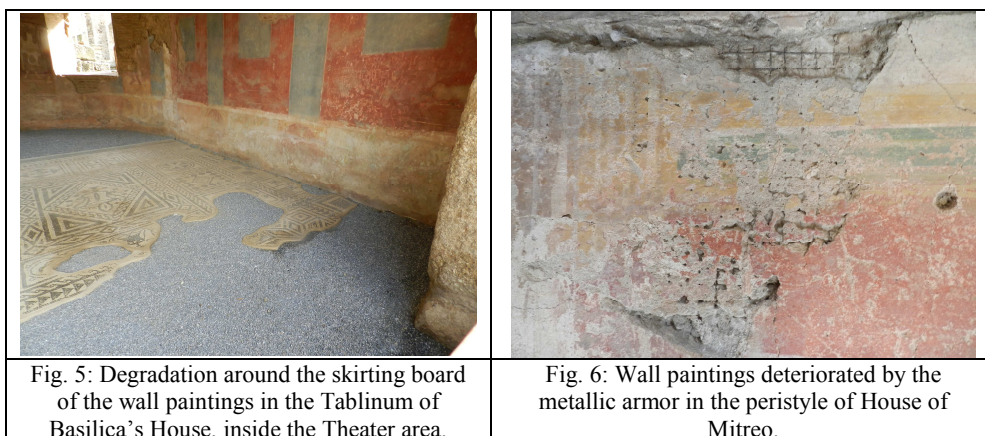
water to lateral walls. Water absorption by capillarity has seriously damaged wall paintings and has motivated a new intervention in order to “restore former restoration”, by removing cement reintegration of the mosaic and temporally filling the voids with gravel (Figure 5).

- Mechanical damages from the use of metal elements: bursting due to corrosion and expansion of a metal fixing and rust stains (Figure 6).

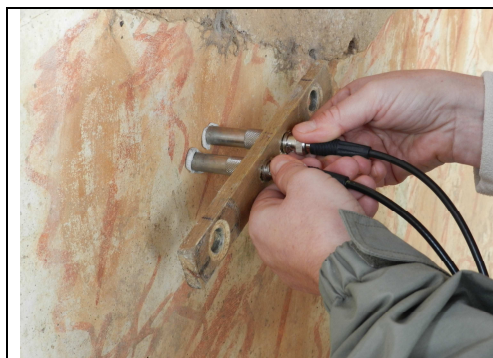
Fig. 7: US measurements on treated area of wall painting in Room 13, House of Mitreo.

Results from first measurements, carried out recently on the site of House of Mitreo (Figures 7 and 8), show interesting figures. We are still working on the interpretation and analysis of these results, however, it can be mentioned some interesting data from direct measurements of the propagation velocity of ultrasound (V_p , Pundit equipment), the most remarkable one is shown by the different values in US velocity between treated (with acrylic resin) and untreated areas. The values recorded by indirect method shows that propagation velocity is higher in the treated area (between 2000 and 2500 m/s) compared to the untreated area (ranging from 1580 to 1765 m/s); this means that the cohesive consolidation appears to have been effective, given that voids have been filled (fostering the propagation of US). Structural disintegration of the stone causes the reduction of velocity of propagation of US. This provides information on the state of the conservation of material, allowing for the recognition of altered or weak areas or elements with different quality of preservation. The pulse propagation time is directly related to the materials density, and the presence of voids, any hole, crack or fracture, slows down the velocity of the waves. It is especially useful to evaluate consolidating treatments, making comparative tests

between the material before and after treatment, checking if its application provides greater cohesion or produces changes in the pore system.

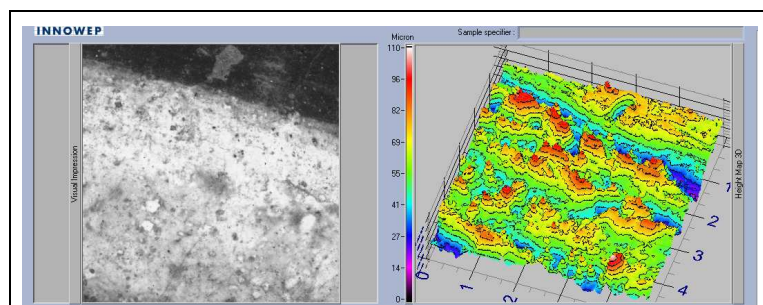
Fig. 9: White and blue pigments are clearly distinguishable by the bond line and a different roughness

Some changes in the superficial texture of some wall paintings can be observed by using optical surface roughnessmeter (TRACEiT, Innwep GmbH). It allows 3D roughness topographic maps and obtains values for Ra, Rq and Rz roughness parameters according to DIN EN ISO4287 standard. This factor influences the degree of degradation in relation to the specific surface of the material; a rougher surface could help soiling and water retention, and accelerate material decay due to a specific surface increase (more reactive) [17]. At first sight it seems that superficial texture is more homogeneous in untreated areas (Rq factor has a value of 2,50 along the x axis, and 2,62 along the y axis) and more rough in treated ones, with acrylic resin (Rq factor has a value of 2,74 along the x axis, and 3,01 along the y axis). Rq factor shows the increase of rough in the second case. Nevertheless, it is necessary a deeper knowledge about all variables present to determine the influence of the treatment in the roughness increase, the fragments of wall painting analysed from the cistern (Room 17) of House of Mitreo are part of the collection of the National Museum of Roman Art of Merida. It can also be observed changes in the roughness of the different pigments (Figure 9), taking into account that comparable studies must be analysed by colours (the Rq values mentioned are from light red pigment).
