Detection and Measurement of Matrix Discontinuities in UHPFRC by Means of Distributed Fiber Optics Sensing

Bartlomiej Sawicki, Antoine Bassil, Eugen Bruhwiler, Xavier Chapeleau,
Dominique Leduc

Article

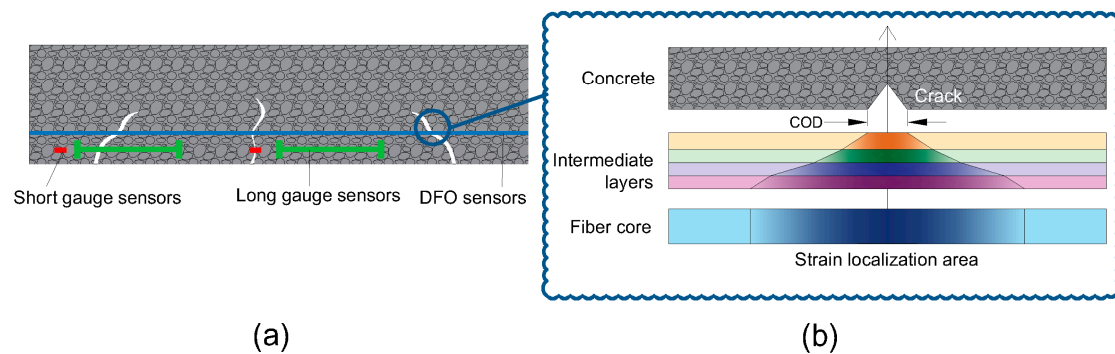
Figure 1. Crack detection in concrete using Distributed Fiber Optics sensing techniques; (a) comparison to traditional sensors, (b) strain transferring between layers.

The DFOs techniques can be used not only to measure strains but also to detect, localize and measure cracks of small openings. DFO sensors allow achieving of an accurate, reliable and quasi real-time crack detection and characterization in concrete structures. They contributed to the detection and localization of cracks in the massive structures, showing supremacy over the short and long gauge sensors (Figure 1a). Actually, any type of discontinuity in the host material, like a crack, can cause a strain localization propagating through the optical fiber layers up to the core of the optical fiber (Figure 1b).

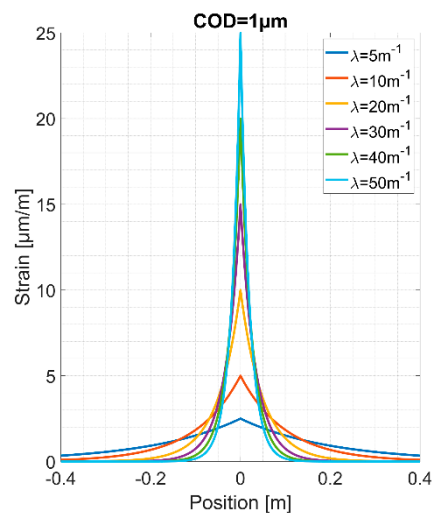
Figure 2. The spatial distribution form of the crack-induced strains $\varepsilon_{crack}(z)$ for different strain lag parameter λ values.

The strain lag parameter λ is crucial for the sensing of cracks. As this value increases, the crack-induced strains $\varepsilon_{crack}(z)$ figure higher peaks at the crack location, and thus, the exponential part covers a narrower zone over the optical fiber length, as shown in Figure 2. Thanks to this, the capacity of detecting and localizing discontinuities increases.

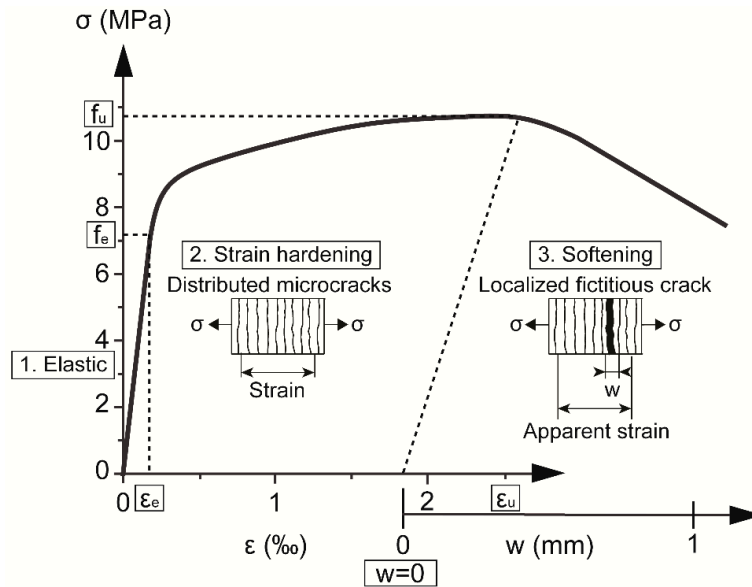
Figure 3. UHPFRC behavior under tension.

After the elasticity limit (f_e, ε_e) is reached, discontinuities in the matrix start to appear and the material enters the strain-hardening phase. The openings of these fine, distributed microcracks (hairline cracks) are smaller than 50 μm and their spacing can vary from 2 to 30 mm [43–45]. They are not detrimental from a durability point of view [46,47] and are impossible to see with the naked eye. These microcracks can be, however, measured using appropriate instrumentation. From the macroscopic point of view, the material can be considered as continuous, with strain-hardening quasi-linear behavior and reduced stiffness [48]. However, after unloading, the residual strain remains in the material.

When the maximum tensile resistance f_u is reached, the material enters the softening phase. One or more neighboring microcracks start rapidly growing, eventually reaching openings above 50 μm . This localized discontinuity is bridged by multiple fibers carrying the tensile stress. It is called a fictitious crack, contrary to the real crack which cannot transfer the stress [49]. Since the stress transfer capability in this critical zone is reduced, the overall stress in the area decreases. The localized fictitious crack is growing, while the strain and stress around it decrease. The location of the fictitious crack depends on the distribution of fibers [44,45,50,51]. Since this fictitious crack leads eventually to the

failure of structural elements, it is called the critical crack as well. With the gradual opening of the fictitious crack, the measured deformation increases, leading to fast growth of the apparent strain. Importantly, it is not the real strain of the material anymore due to the fictitious crack localized between the reference measurement points.

The fictitious crack grows until opening of half of the steel fiber length, in the present case $l_f/2 = 6.5 \text{ mm}$ [44] and the resistance of the material decreases. After the fibers are pulled out, no more stress transfer is possible and the real crack is formed.

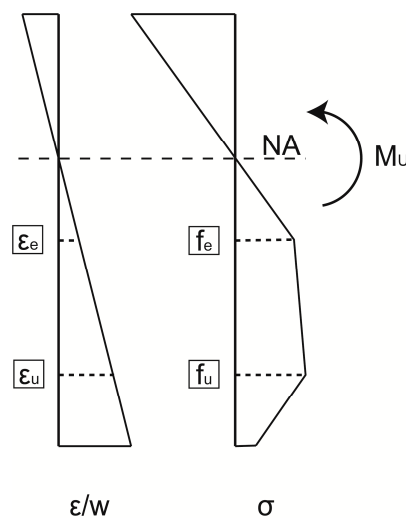
Figure 4. Schematic distribution of stresses and strains in UHPFRC at the critical section of R-UHPFRC beam under the ultimate bending moment.

In the case of a structural R-UHPFRC (Reinforced UHPFRC) element under bending action, the tensile behavior of UHPFRC has important influence on the overall response. Each of the three stages are present under the maximum bending moment in the critical section, where the fictitious crack forms. Under the assumption that the cross-sections remain plain, the distribution of stress along the height of the beam is nonlinear due to nonlinearity of the constitutive law of UHPFRC, as presented schematically in Figure 4. The proportion between parts in elastic, strain-hardening and softening regimes depends on geometry of the element [44].

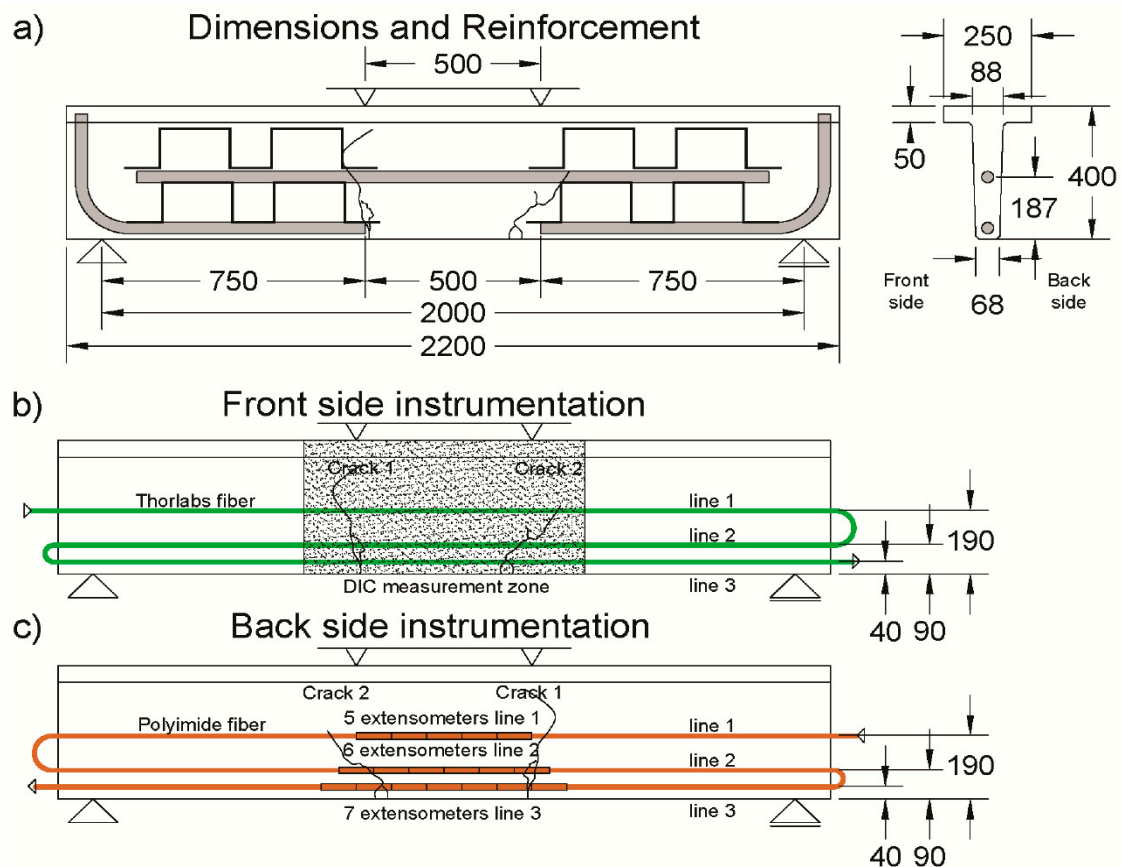
Figure 5. Scheme of test setup and instrumentation: (a) beam dimensions and reinforcement, (b) instrumentation on the front side and (c) instrumentation on the back side; dimensions in mm; the critical fictitious cracks 1 and 2 are marked.

The tested beam has a T-shaped cross-section and dimensions according to Figure 5. This kind of design refers to the use of UHPFRC for waffle deck or unidirectional ribbed slab designs. An example of such a structure is the railway bridge in Switzerland described in reference [52].

The beam was instrumented with extensometers; photogrammetry DIC by means of two 20 MP cameras; DFO sensors (Figure 5). The fiber optics sensors for distributed strain sensing were installed in three lines at each face of the beam—40, 90 and 190 mm from the bottom of the beam. As shown in Figure 6, the DFO sensors were glued in a 2×2 mm groove on the UHPFRC surface using a bicomponent epoxy adhesive (Araldite 2014-2). On the front side of the beam, the SMF-28 Thorlabs[®] fiber was glued, with an external diameter of $\varnothing 900 \mu\text{m}$ and elastomer tubing. On the back side of the beam, the Luna[®] High-Definition Polyimide fiber was used, with an external diameter of $\varnothing 155 \mu\text{m}$. The DIC measurement zone spanned 35 cm from the midspan symmetrically, and over the whole height of the beam on the front side. The extensometers of 100 mm measurement base were glued on the back side of the beam, at the level of each DFO measurement line. Additionally, three LVDTs with the common measurement base were vertically installed on the back side of the beam, at midspan and over the supports. The mean vertical displacement over the supports is subtracted from the vertical displacement at midspan to obtain the deflection of the beam. The resistance force was measured by the load cell of the actuator.

The measurements taken along each measurement Line 1, 2 and 3 are presented below from the top to the bottom, respectively, in coherence with their position over the height of the beam (Figure 5).

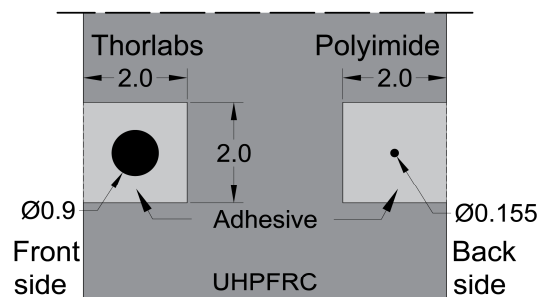
Figure 6. Scheme of installation method of DFO sensors in UHPFRC; dimensions in mm.

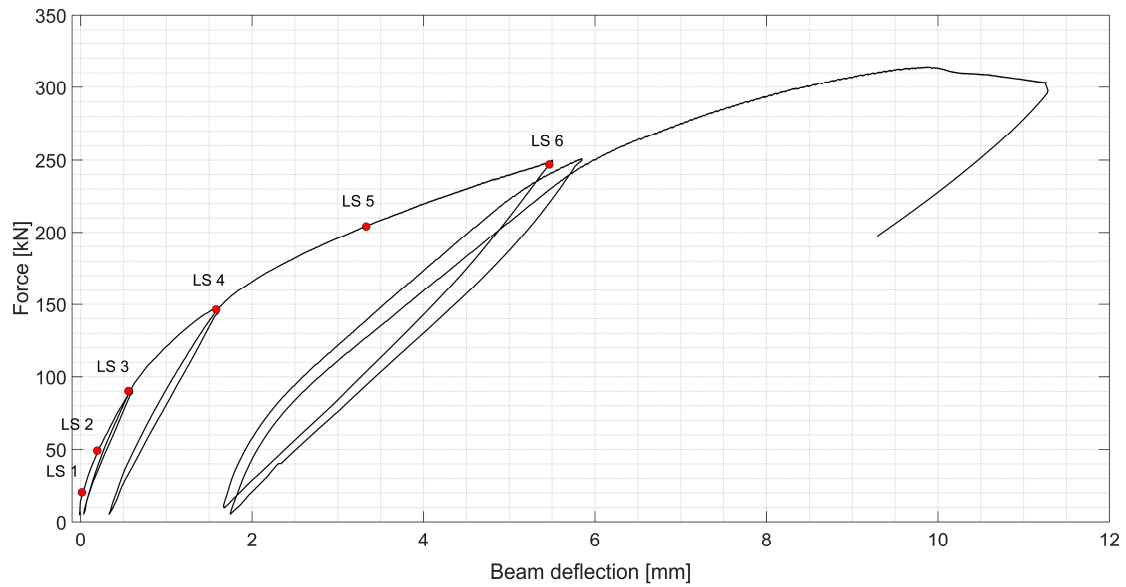
Figure 7. Load–deflection curve of the R-UHPFRC beam during quasi-static test, total jack force presented with consecutive load steps (LS) marked.

The force–midspan deflection curve is presented in Figure 7. Several loading–unloading cycles were executed at different stages of the test. The goal was to visualize the influence of residual strain of the UHPFRC in the strain-hardening domain after unloading on the global response of the beam. Thanks to this, a gradual degradation of material can easily be observed. The load steps (LS) were chosen arbitrarily to discuss the state of material in detail.

The first linear part of the curve is very short. This is due to the material at the bottom of the beam entering the strain-hardening regime relatively soon. As the zone where UHPFRC is in the strain-hardening regime is growing, gradual reduction in material stiffness, and thus, beam rigidity occurs, effecting nonlinearity of the force–deflection curve. The residual deflection in the unloading cycle comes from the fact that this part of cross-section contains discontinuities (microcracks $< 50 \mu\text{m}$) or, in the further stages, the fictitious crack ($> 50 \mu\text{m}$) is present. Both types of discontinuities transmit the tensile stresses thanks to fibers, but do not close completely while unloaded. Finally, when the beam resistance is maximum with the force of 313 kN, gradual degradation with a rise in deflection continues as the localized fictitious cracks propagate and the longitudinal rebar is yielding.

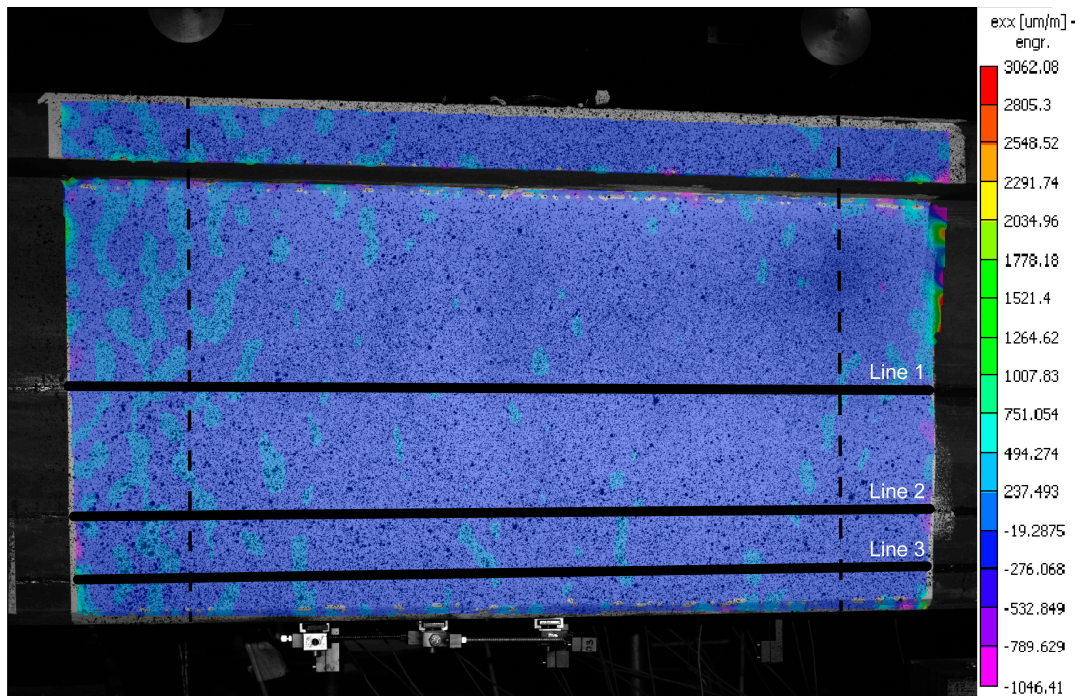
Figure 8. DIC measurement at unloaded state with virtual measurement lines noted; the constant bending moment zone is marked with dashed lines.

The unloaded state of the beam is presented in Figure 8. The measurement noise for DIC is mostly at the level of $\pm 100 \mu\epsilon$, with local peaks of $-300 \mu\epsilon$. The strain noise is not only due to the quality of the cameras and nonuniformity of light, but mostly from the variation of size and distribution of speckles.

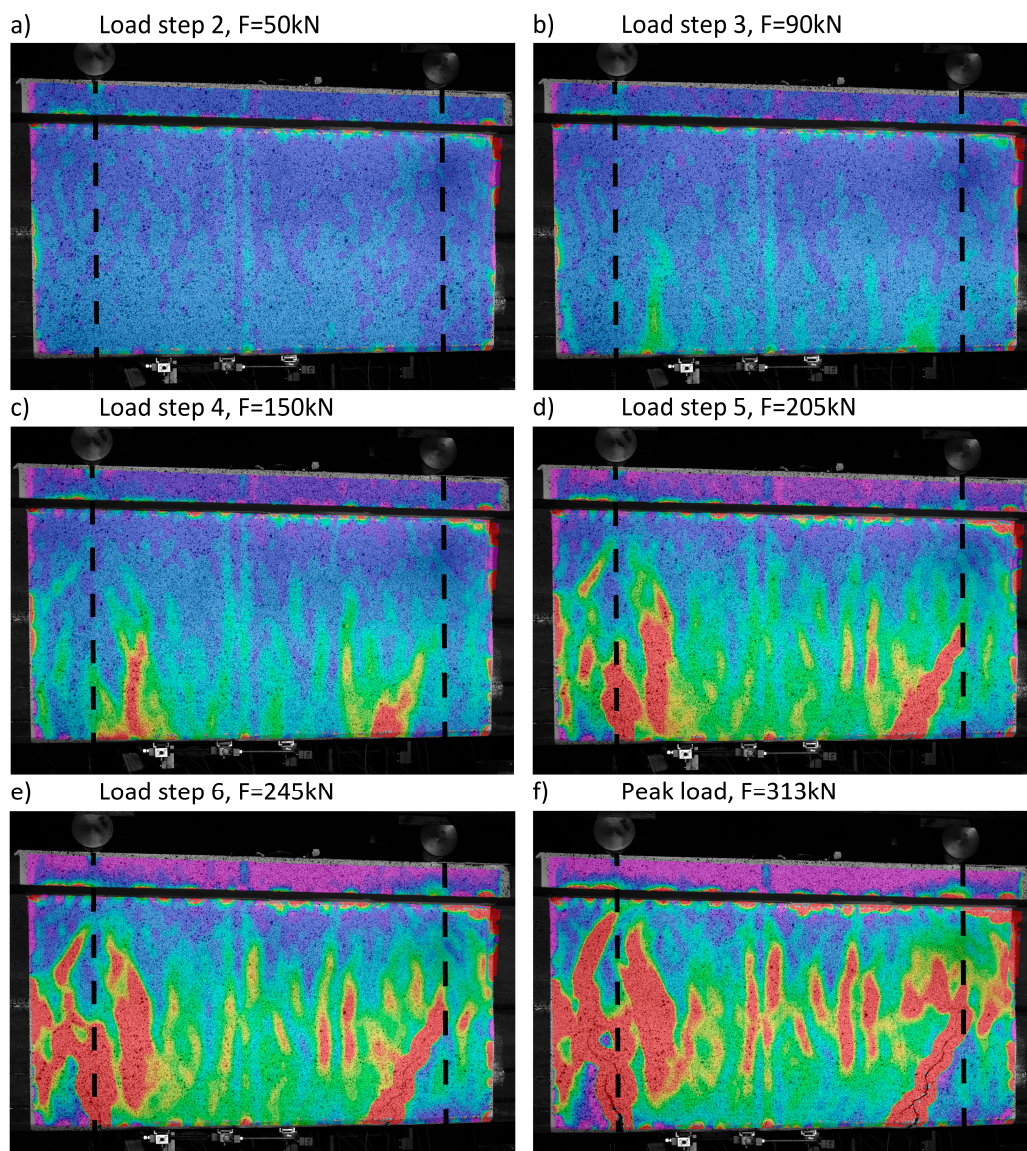
Figure 9. Strain distribution obtained with DIC for different load steps: (a) LS2, (b) LS3, (c) LS4, (d) LS5, (e) LS6, (f) Peak load; ϵ_{xx} with scale as in Figure 8; the constant bending moment zone is marked with dashed lines.

Figure 9 presents the horizontal (ϵ_{xx}) strain distribution measured with DIC at different load steps (LS), marked in Figure 7. The color scale is the same as presented in Figure 8. LS 1 is not shown since mostly the noise is registered. At load step 2, the uniform elastic strains are registered. At LS 3, strain

peaks are observed due to the distributed microcracking of UHPFRC in strain-hardening. They are more pronounced in two weak spots at around -0.25 m and $+0.25$ m (Figure 9b). While the microcracks keep growing and propagating, two of them grow faster than others, leading to localization of fictitious cracks (Figure 9c). At LS 5, fictitious Crack 1 develops a second, left branch. This could be due to the first branch reaching a stronger area with higher concentration of steel fibers (Figure 9d). Simultaneously, fictitious Crack No. 2 keeps propagating on the right side. At LS 6, the fictitious cracks are clearly visible to the naked eye (Figure 9e). As the fibers bridge these macrocracks, the overall response of the beam remains in the hardening domain. When the beam reaches the peak resistance with a force load of 313 kN, the fictitious cracks reach the level of the reinforcement bar (see Figure 9f). In their bottom part, they transmit hardly any stress due to the large opening and advanced fiber pullout. This is why the bottom part of the beam between the fictitious cracks is almost unloaded. The highest strains are present at the level of the reinforcement bar. After this stage, due to transformation of the fictitious cracks into real cracks with no stress transfer and reinforcement yielding, the resistance of the beam started to decrease and the test was stopped.

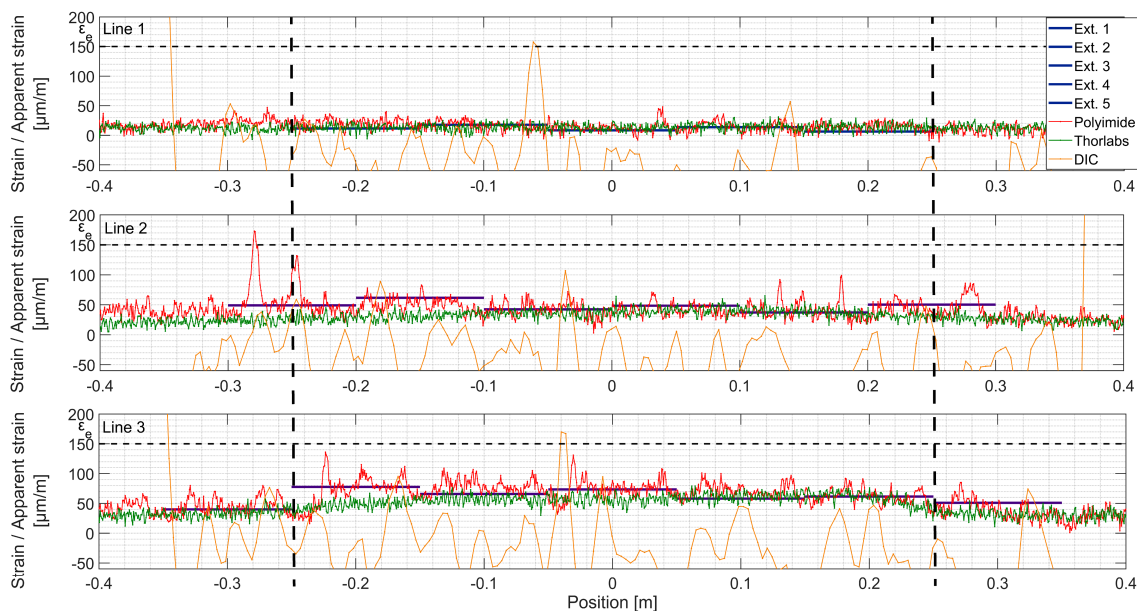
Figure 10. Strains measured with different techniques, load step 1, $F = 20$ kN; the constant bending moment zone is marked with dashed lines.

At load step 1 (LS 1), all systems, except DIC, show good agreement (Figure 10). The strain spatial distribution can be considered as uniform in the constant bending moment zone, between ± 0.25 m from the midspan. The material remains elastic and the structural response is linear. In the bottom line (Line 3), local variations of modulus of elasticity can be visible with extensometers and Polyimide, but not with Thorlabs fiber. Possibly, initial microcracks appear. Two strain peaks are visible at Line 2 position -0.25 m. Apparently, there is a local defect of the UHPFRC material there, possibly due to the fabrication of the beam. It can be considered as a disturbance on the surface, since other measurement techniques do not record it.

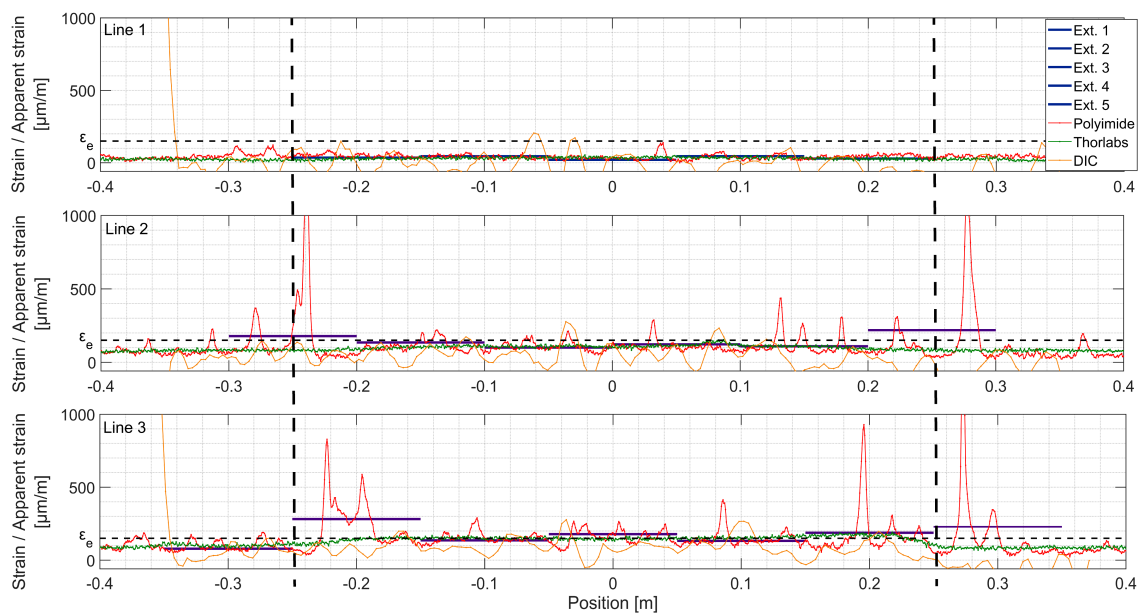
Figure 11. Strains measured with different techniques, load step 2, $F = 50$ kN; the constant bending moment zone is marked with dashed lines.

At LS 2 (Figure 11), as UHPFRC enters into the hardening stage at Lines 2 and 3, clear peaks from microcracks are visible over the Polyimide lines, while Thorlabs do not present any local strain variations. The microcracked zones can be identified with extensometers as well, which show higher strains than in the neighboring zones. It is important to mention that at this stage, propagating microcracks are identifiable by the naked eye when the surface is wetted with alcohol. The difference between the measurements of systems deployed on the back (Polyimide, extensometers) and the front (Thorlabs, DIC) sides of the beam may come from non-horizontal loading of the beam, despite the hinge between the actuator and redistribution beam, or to locally weaker material close to the surface. In perfect conditions, the total elongation obtained with extensometers and DFOs, thus, ‘smeared’ strain, are equal [39]. These incoherencies are not observed for Line 1, which remains in the elastic stage.

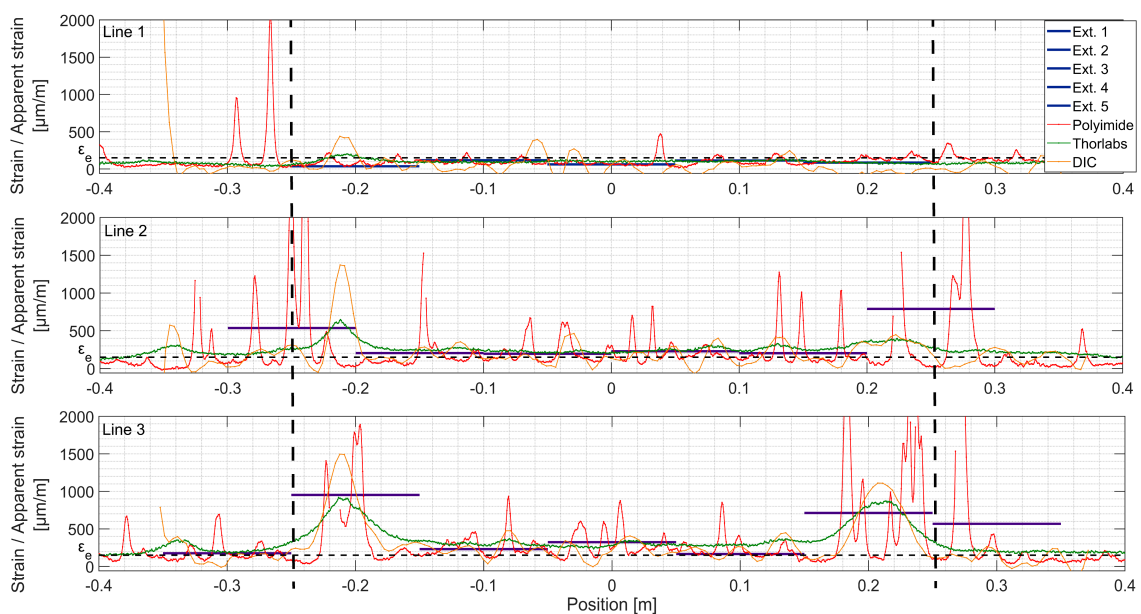
Figure 12. Strains measured with different techniques, load step 3, $F = 90$ kN; the constant bending moment zone is marked with dashed lines.

Under the force of 90 kN (LS 3, Figure 12), more microcracks are visible over Line 3. Most of these cracks are localized around positions -0.2 m and $+0.25$ m. Line 2 presents more uniform microcracking behavior. The origin of this nonuniformity in the bottom of the beam is discontinuity of the L-shaped rebars (see Figure 5) causing disturbance of fiber orientation and concentration of stresses. Zones where the fictitious crack will further develop are now clearly visible with DIC and Thorlabs fiber (Crack 1 and 2 line 3, Crack 1 line 2), as well as extensometers (both fictitious cracks, Lines 2 and 3). For zones where the fictitious cracks are developed, the apparent strain measured with extensometers cannot be considered as material strain anymore (see Figure 3). Clear microcracks start to appear at Line 1.

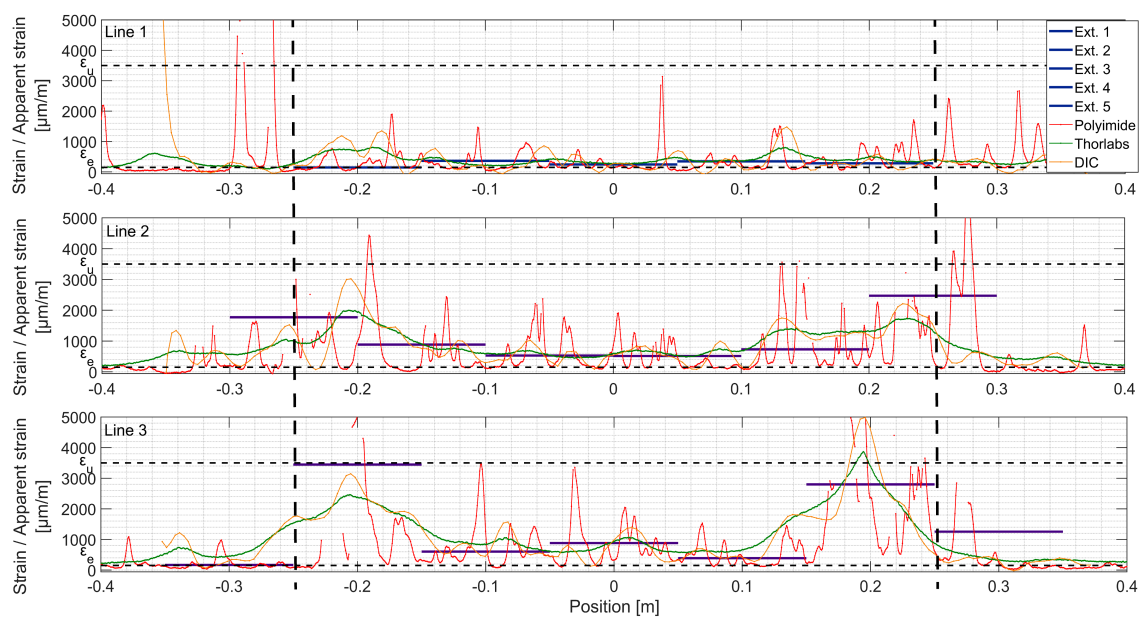
Figure 13. Strains measured with different techniques, load step 4, $F = 150$ kN; the constant bending moment zone is marked with dashed lines.

At LS4 (Figure 13), dropout points start to appear at crack locations in Lines 2 and 3 in the DFOs results. These points are dropped out by the spectral shift calculation algorithm due to low

correlation with the reference spectrum. This phenomenon of miscalculated points increases due to rapid variation of strain over the spatial resolution length. For fictitious Crack 1, Line 3, DIC shows three fictitious crack fronts forming at positions: -0.25 , -0.2 and -0.17 m. They all lay within the same extensometer measurement base, and thus, cannot be distinguished with this technique. Additionally, the Thorlabs fiber is arguably not sensitive enough to clearly separate these fronts due to low shear lag parameter λ (Equation (1)). For fictitious Crack 2, Line 3, the apparent strain reaches ϵ_{iu} , exponential shape is being formed in Thorlabs, and UHPFRC enters softening stage. Two other fictitious crack fronts can be noticed with DIC but hardly with Thorlabs. Extensometer of location $[0.05; 0.15$ m] does not show fictitious crack formation, while it is visible in the same position with DIC and Thorlabs fiber. This comes from the nonorthogonality of the crack regarding the beam axis and is confirmed by Polyimide fiber recording only microcracks in the discussed location. On Line 2, localization of fictitious Crack 2 starts being detectable by Thorlabs fiber and DIC.

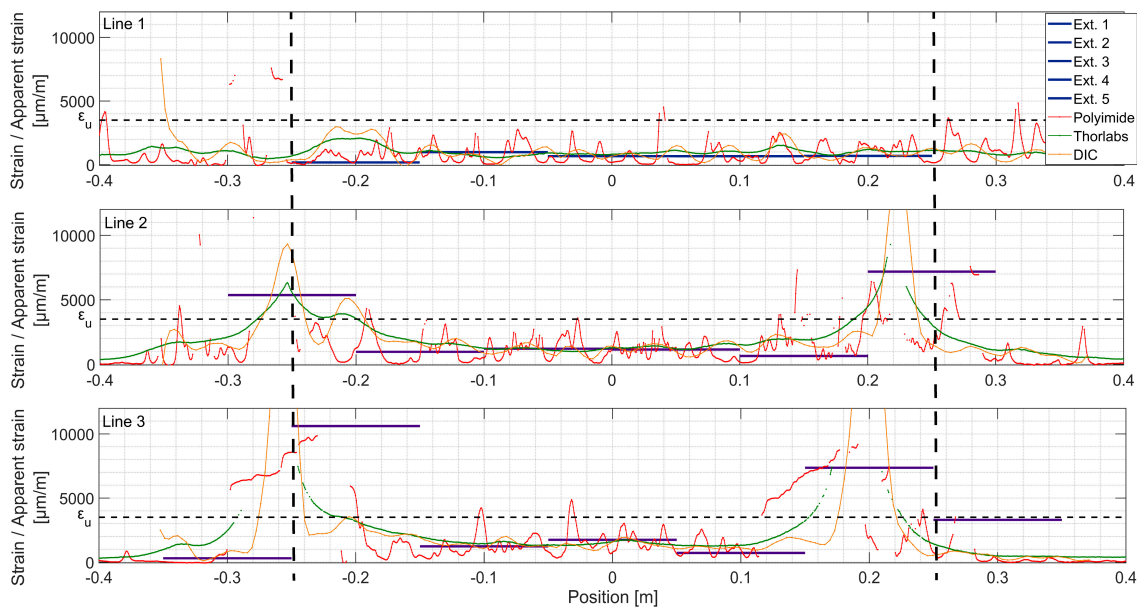
Figure 14. Strains measured with different techniques, load step 5, $F = 205$ kN; the constant bending moment zone is marked with dashed lines.

At LS 5 (Figure 14), both fictitious cracks are clearly formed in Line 3, and UHPFRC is in the softening stage. The DFOs do not work properly in their vicinity anymore. The transversal skewness of fictitious Crack No. 1 can be seen, since the peak of DIC is shifted with respect to the extensometers. Interestingly, it is positioned some 7 cm towards the left regarding the previously observed strain concentration. For both Lines 2 and 3, the clear exponential shapes can be noticed in Thorlabs fiber measurements, but with multiple dropouts. While comparing the measurement Line 1 at the current load step with Line 2 and Line 3 at LS 3, it can be concluded that microcracking is more uniformly spaced for the lines positioned higher on the beam. The reasons might be the nonuniformity of fiber dispersion and discontinuity of strains, both due to the rebar alignment. At this load step, the fictitious cracks are clearly visible to the naked eye, and UHPFRC is in the softening stage (see Figure 9d). The stress transferred by bridging fibers is lower than f_u (see Figure 4), and stress in the neighboring material decreases. Thus, the strain measured at midspan is similar for all the measurement lines.

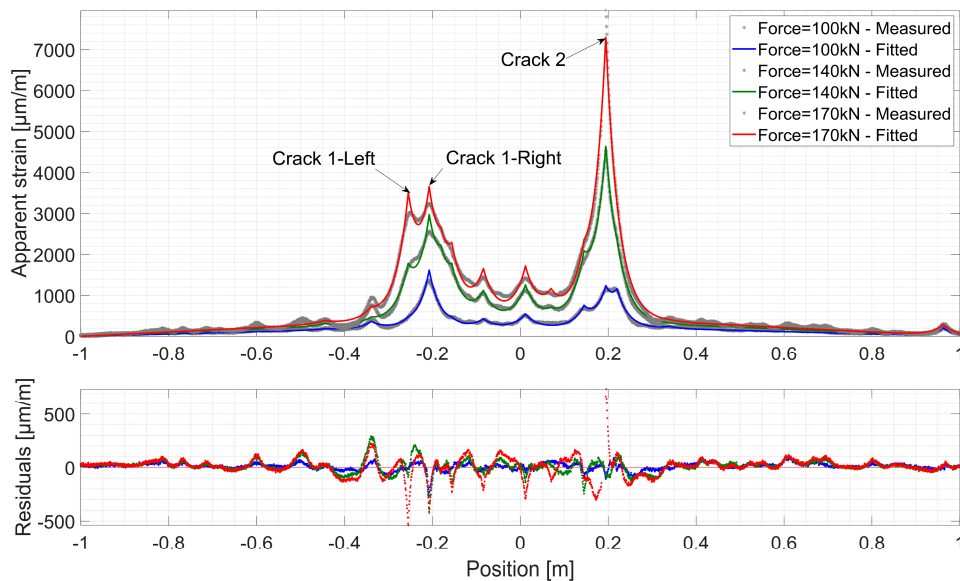
Figure 15. Comparison between the measured and fitted strain profiles and the corresponding residuals over Line 3 of Thorlabs cable.

Figures 15 and 16 present fitted strain profiles to those measured over Line 2 and Line 3 respectively, together with the corresponding residuals for different load levels. A discontinuity propagates in the UHPFRC material through searching the lowest energy path depending on the local fiber content and orientation [51]. Despite the host material's complex microcracking nature, the proposed mechanical

model fits clearly the distributed strain profiles measured by the DFOs system at different levels. Low residual levels are randomly scattered around zero all over the length of FO Line 2 and 3.

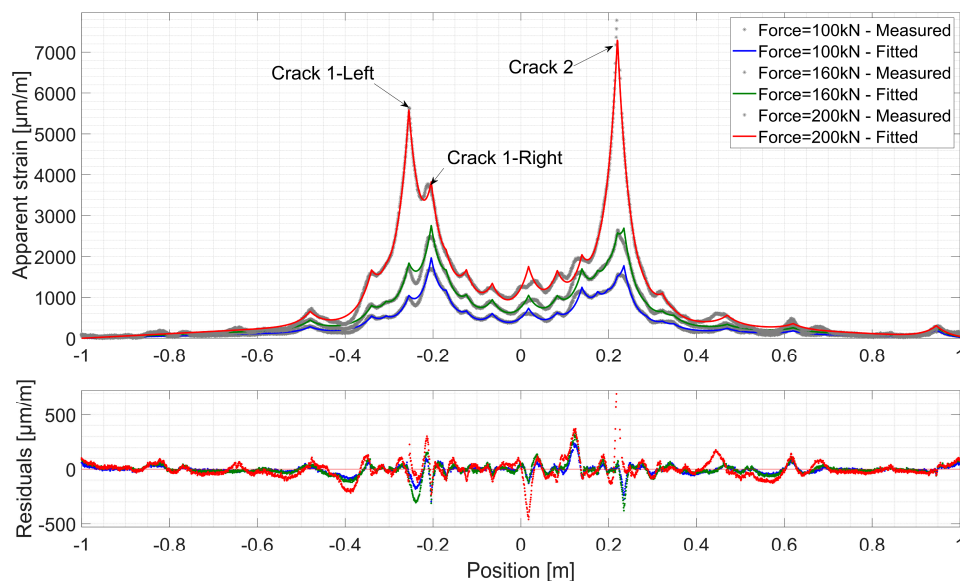
Figure 16. Comparison between the measured and fitted strain profiles and the corresponding residuals over Line 2 of Thorlabs cable.

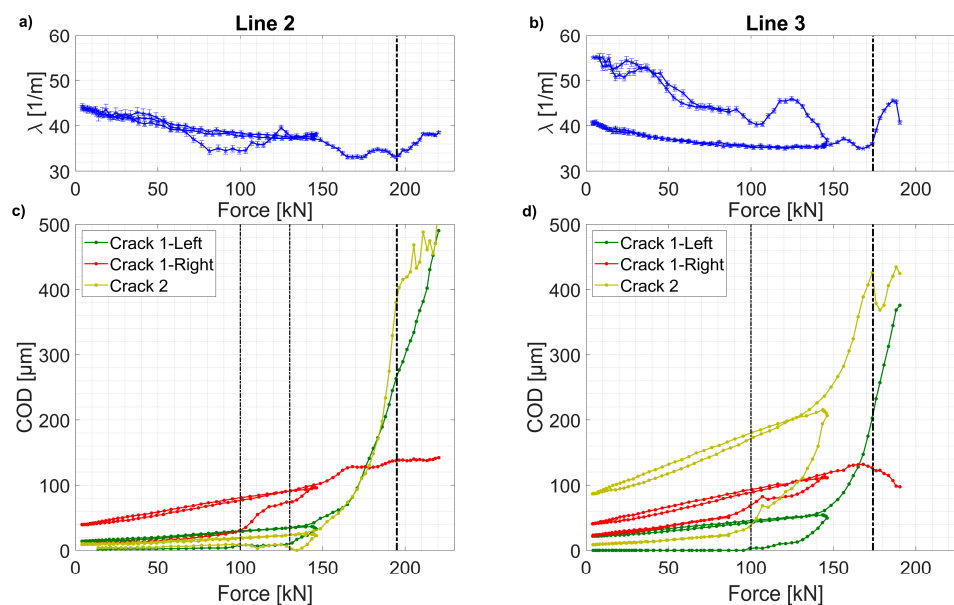
Figure 17. Variation of the estimated COD ((a,b)) and λ ((c,d)) during the test; fictitious crack initiation marked with thin dashed lines; loss of precision marked with thick dashed lines.

Figure 17 shows the estimated strain lag parameter λ as well as the discontinuity openings COD_i of fictitious Cracks 1 and 2, under loading and unloading cycles. For both Line 2 and 3, the estimated strain lag parameter λ varies around 35 m^{-1} in a $\pm 10\%$ interval (Figure 17a,c). Higher λ values can be observed at early stages of the tests. Similar to previous findings on concrete structures [42,53], this variation can be associated with the first stages of UHPFRC cracking behavior, where discontinuities in the cementitious matrix are starting to develop in the so-called fracture process zone, and end up leading to the creation of a microcrack. When most of the matrix discontinuities exceed an estimated opening COD_{min} of $50 \mu\text{m}$, the strain lag estimations become stable and consistent around $\lambda \approx 35 \text{ m}^{-1}$. This confirms the assumption of one global strain lag parameter characterizing the Thorlabs fiber/epoxy glue/UHPFRC mechanical response in the presence of a fictitious crack. Lower λ (compared to concrete's surface-mounted fibers (50 m^{-1})) can be attributed to a lower stiffness level at the Epoxy/UHPFRC interface, possibly due to much smaller porosity.

The estimated CODs for discontinuities Cracks 1 and 2 are shown in Figure 17 c and d. At the level of Line 3, the discontinuities Crack 1-right and Crack 2 are formed as microcracks ($<50 \mu\text{m}$) and propagate steadily until a force of around 80 kN , where they grow rapidly to form fictitious cracks. At $F = 120 \text{ kN}$, another microcrack grows rapidly to form the fictitious Crack 1-left. This growth leads to a decrease in the growth rate of fictitious Crack 1-right.

Similar development of COD for the three discontinuities can be observed for Line 2, with a delay regarding Line 3 due to its closer position to the neutral beam axis. Akin two-phased growth of COD is observed: stable during microcracking and fast once the fictitious crack is formed in the softening phase.

The growth of COD of fictitious Crack 2 is faster than Crack 1, where the damage development is shared by the two branches. Once it reaches a COD_{max} of $400 \mu\text{m}$, unstable growth in estimated COD is observed in both measurement lines. This threshold marks the validity limit of the strain transfer model, where all the layers behave in an elastic manner with no progressive debonding occurring at successive layer interfaces. This phenomenon, equally observed in concrete [41], is pronounced by a change in the exponential form of the strain profiles initiated near the strain peak, and thus, leading to an increase in strain residuals (Figures 15 and 16). Consequently, this leads to a change in the tendency of λ and COD variations due to increased estimation errors.
