Experimental behaviour of stainless steel cellular beam in fire

ABSTRACT

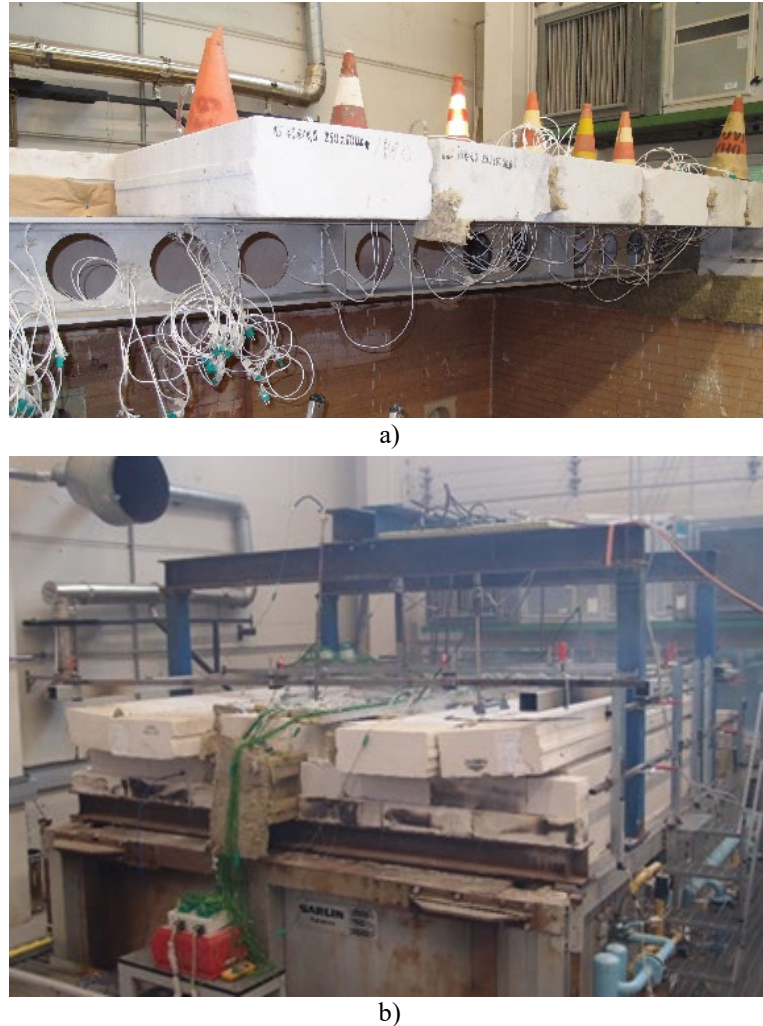
Fig. 2. a) Beam and slab construction during installation; b) Test set-up during the test.

The beam was tested under two point-loading. Constant loads of 58 kN were applied through hydraulic loading jacks fixed to a load application frame above the test furnace, as shown in *Fig. 2b)*. The test load was considered to be approximately 30 % of the ultimate load found from pre-design calculations made at ambient conditions. In addition, the self-weight of the concrete blocks bearing on the beam was approximately 1.5 kN/m. The beam was continuously loaded to the test load for over an hour before the elevated temperature loading was applied through ignition of the furnace. The fire load was applied in accordance with the standard ISO 834 fire curve, described in EN 1363-1 (7).

The fire test was performed in accordance with SFS-EN 1365-3 (6). *Fig. 2b)* shows the test set-up during the fire test.

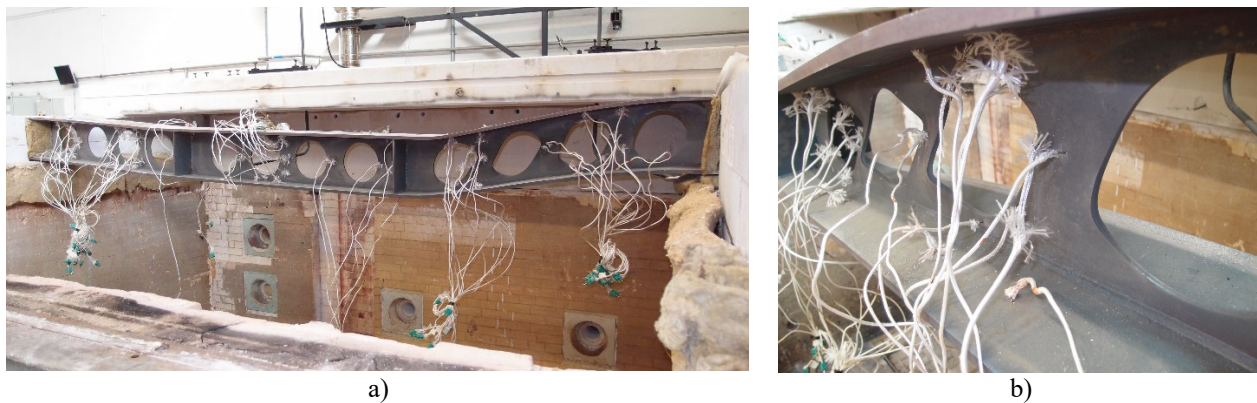
Fig. 4. a) Steel beam after testing; b) Web post buckling failure mechanism

The failure mechanism of the beam was buckling of the web posts between the load application point and the beam support. *Fig. 4* shows the deflected shape of the beam after testing and the failure mode forming an S-shape on the web between openings. As described above, the beam responded linearly until about 24 min at which point the maximum and average beam web temperatures were 703 °C and 672 °C, respectively. Failure occurred around 5 minutes later when the maximum web temperature had increased to 785 °C and the average web temperature was 759 °C. At this average temperature, Young's modulus and the material strength ($f_{2,\theta}$) are reduced to 66% and 43%, respectively, of their value at 20 °C (9). For carbon steel at 759 °C temperature the corresponding reduction factors are significantly lower being 16% and 11% for the effective yield strength and the slope of the linear elastic range, respectively (10).
