CONNECTING THE DOTS: CHOOSING AN APPROPRIATE TERRESTRIAL
LASER SCANNING HARDWARE AND SOFTWARE SYSTEM TO DOCUMENT
THREE EARLY 20TH CENTURY BUILDINGS ON THE CAMPUS OF TEXAS
A&M UNIVERSITY

A Thesis

ANDREW JACOB BILLINGSLEY

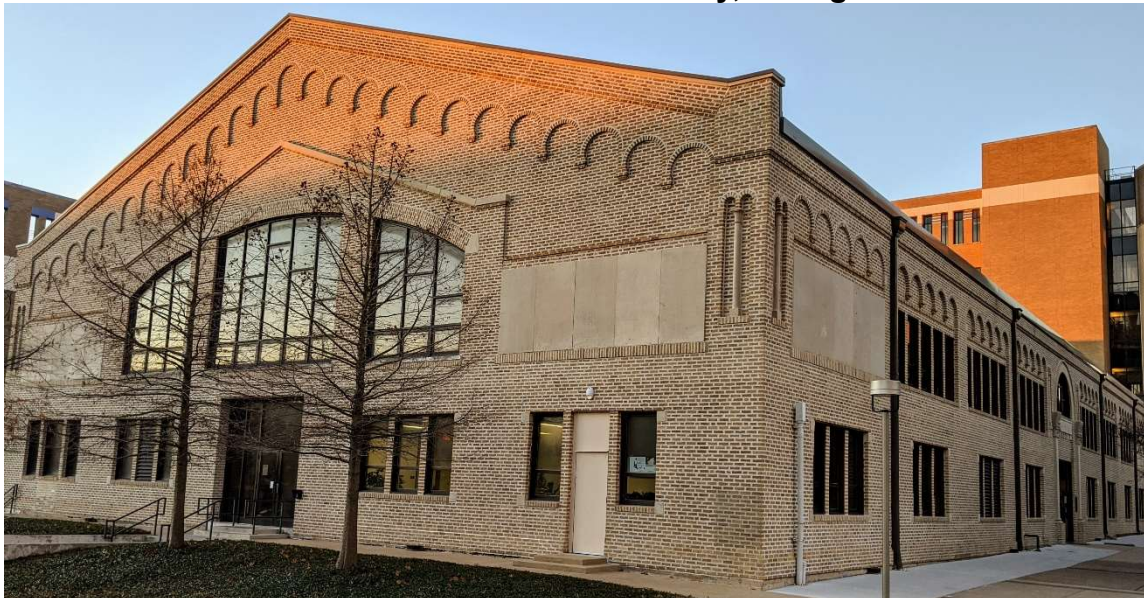
Figure 3.2 – Billingsley, Andrew. North corner of the Animal Husbandry Pavilion. December 2019. Texas A&M University, College Station.

The Animal Husbandry Pavilion was designed by Rolland Adelsperger and built in 1917. Throughout its lifespan the building has endured multiple uses including use by the U.S. military during WWI as an aircraft hangar. Its original Beaux-Arts style Romanesque-inspired features, shown below in Figure 3.2, can still be seen on the façade today, despite its renovation in 1988 to provide office space for registration, student financial aid, and student activities, among others.²

In regards to the Animal Husbandry Pavilion there are two obstructions causing missing data in all three point cloud data sets. First is a set of four (4) trees that are located on the northeast side of the building, which can be seen in Figure 3.2 on page 23 of this study. The second obstruction was the shading caused by the retaining wall of an elevated walkway on the southeast side of the building. During the data gathering processes the researcher made the decision to place the scan locations outside of this area due to time constraints and in an effort to better capture the façade of the building from a farther distance, despite the loss of data it caused. This retaining wall can be seen in Figure 4.3 below.

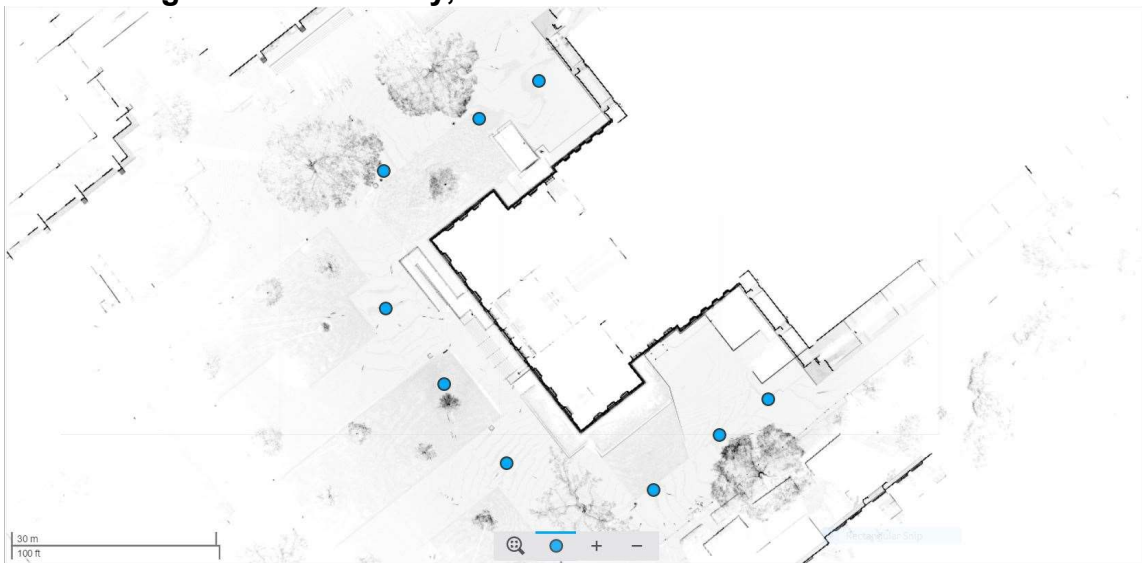
As Cushing Memorial Library was the most unobstructed building and most open site of the three it required the least number of scan locations to provide the desired coverage. However, as the building is physically attached on the northeast side to the Sterling C. Evans Library main building, built in 1968, it was only possible to scan Cushing Memorial Library on the three remaining sides.⁵ These nine scan positions can be seen in Figure 3.4 on the next page.

Figure 3.4 – FARO Scene Overview Map showing the scan locations used on Cushing Memorial Library, the FARO Focus 3D data set is shown.

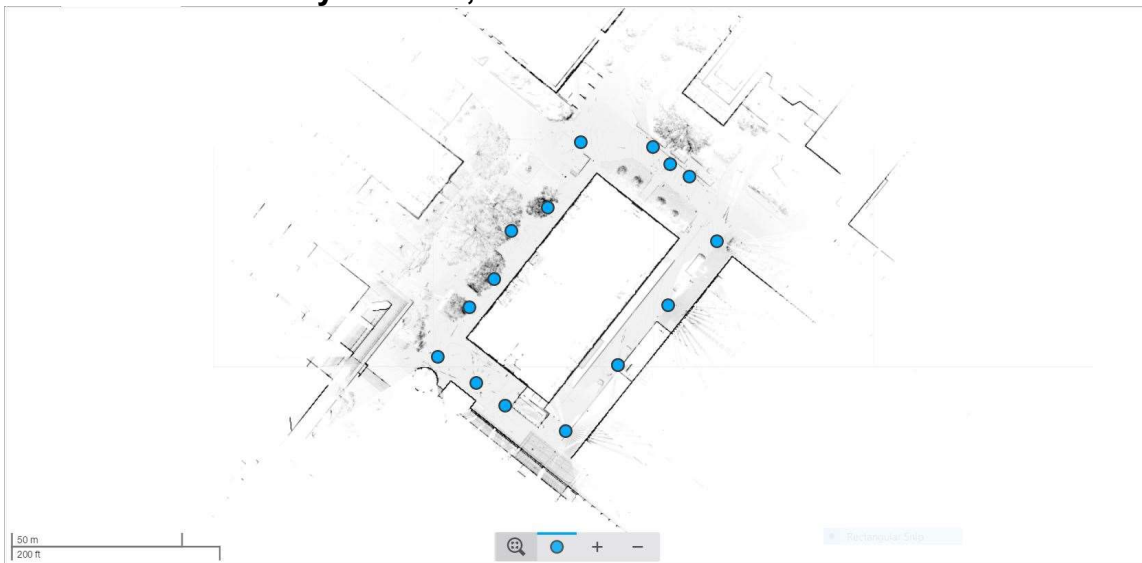
In contrast, the Animal Husbandry Pavilion was scanned on all four sides as there were fewer obstructions. These scan locations can be seen in Figure 3.6 on the next page. It required the largest number of scan positions due to this additional side, in combination with the need for the majority of scans to be in close proximity of the building due to adjacent structures on the south and west sides, and landscaping on the north side. The east side of the building also contained landscaping elements, but due to their sparsity scan positions were able to be located farther away from the building.

Figure 3.6 – FARO Scene Overview Map showing the scan locations used on Animal Husbandry Pavilion, the FARO Focus 3D data set is shown.

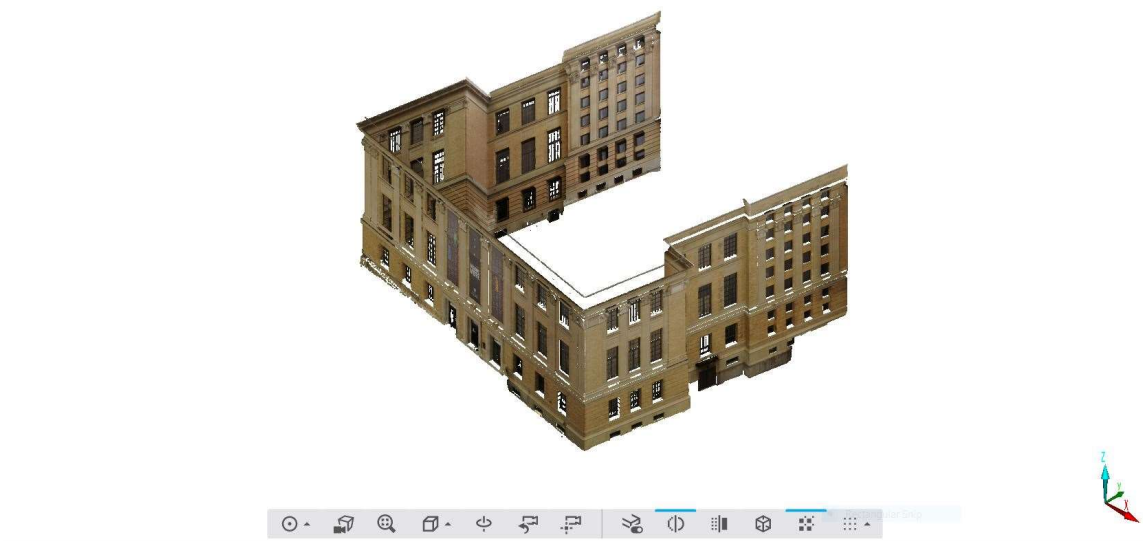
Figure 3.8 – Isometric view of Cushing Memorial Library trimmed point cloud looking north, created using the FARO3D Focus x330 HDR.

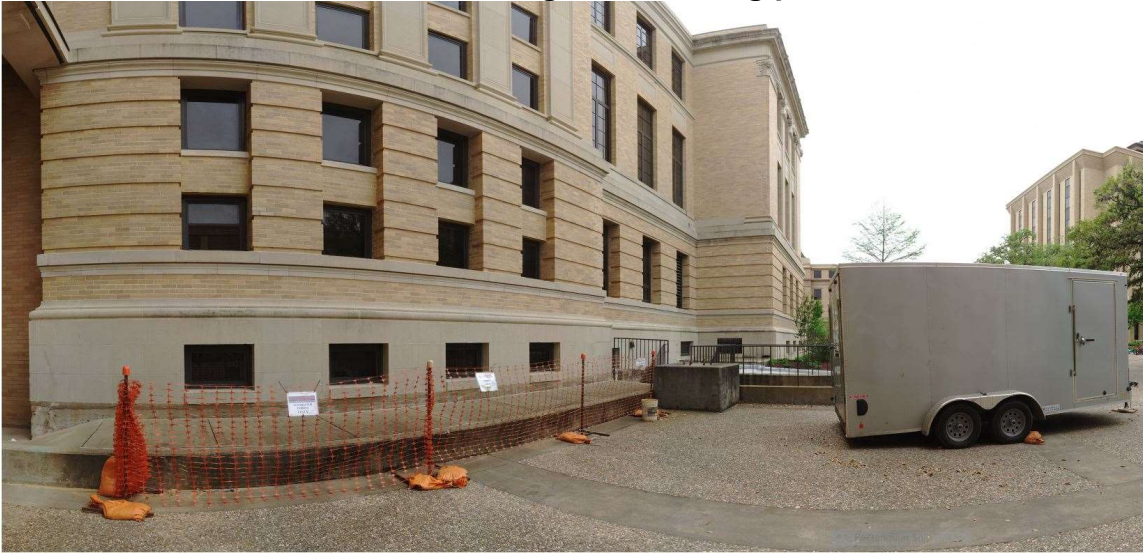
Figure 4.1 – Temporary fencing and trailer on the northwest side of Cushing Memorial Library during the data gathering process, captured by the FARO Focus3D x330 HDR during the scanning process.

When assessing the registration reports for this building a few differences stood out immediately. The most notable differences were in regards to the Maximum Point Error and Mean Point Error of each data set. As shown above in Table 4.1 the Focus S 350 displayed higher numerical values than its two predecessors, despite showing a higher level of overlap between scan locations. Based on the factors mentioned in the visual assessment of the point clouds, section 4.2 of this study, it is the opinion of the researcher that the difference was most likely caused by the obstructions present during the gathering of that data set, more specifically the orange temporary fencing on the northwest side of the building and the parked vehicle on the southeast side of the building.

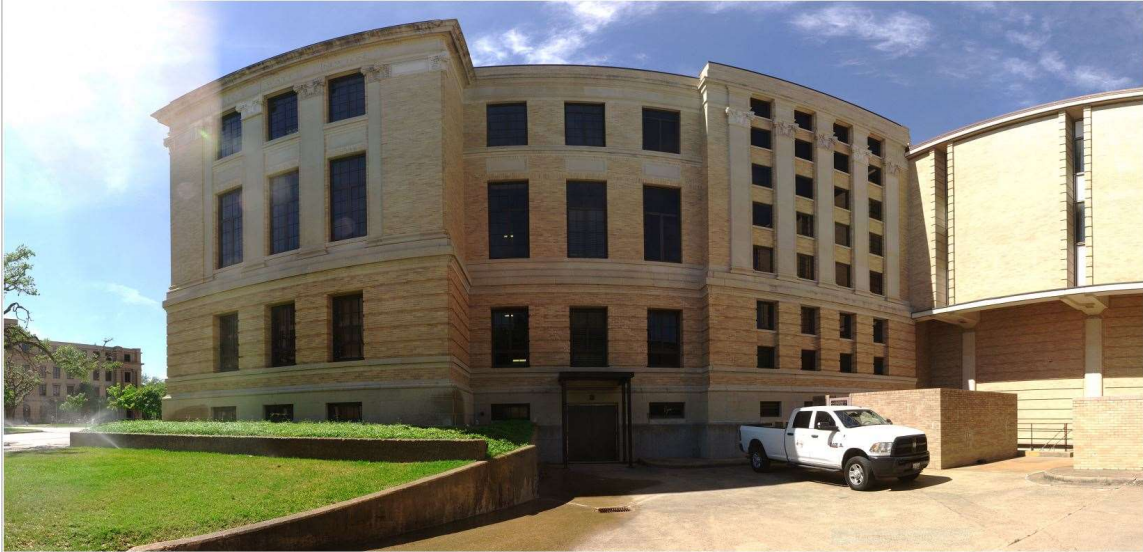
Figure 4.2 – Parked vehicle and active sprinklers on the southeast facade of Cushing Memorial Library during the data gathering process, captured by the FARO Focus S 350 during the scanning process.

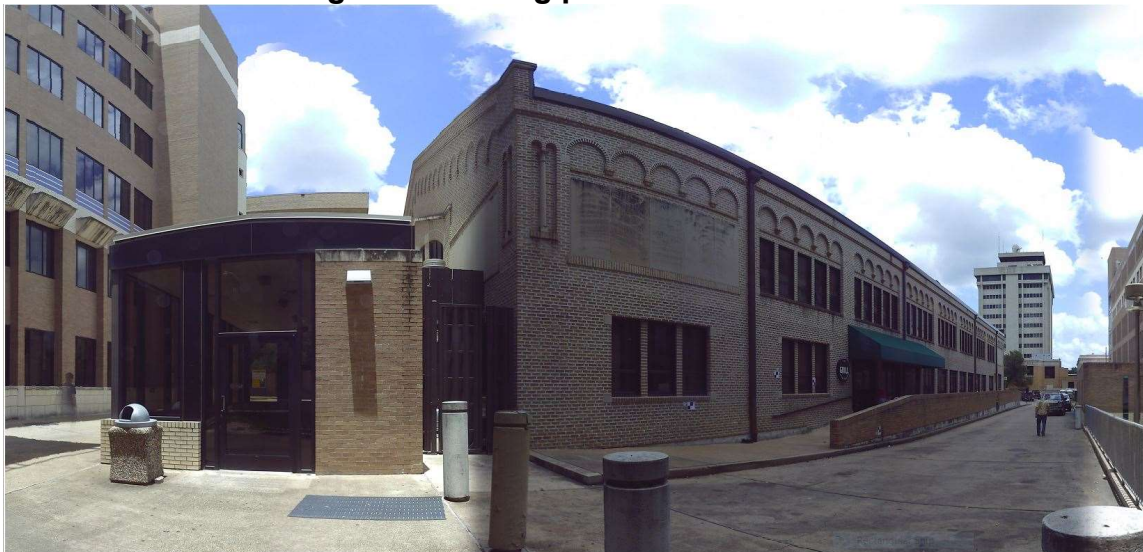
Figure 4.3 – Retaining wall for elevated walkway blocking the lower portion of the southeast facade of the Animal Husbandry Building, captured by the FARO Focus3D during the scanning process.

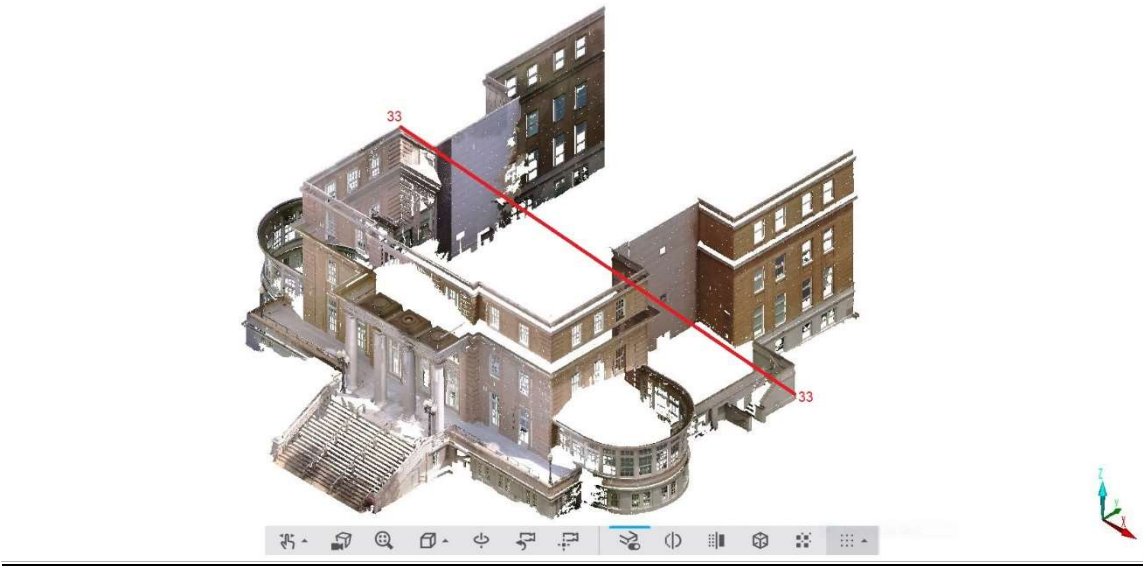
Figure C.13 - Isometric view of the volumetric measurement location between the northwest and southeast façade features of Y.M.C.A. Building. Data shown was collected by the Focus S 350 laser scanning system.
