## Nuclear Engineering and Design

## Infrared observation of ballooning and burst of nuclear fuel cladding tubes

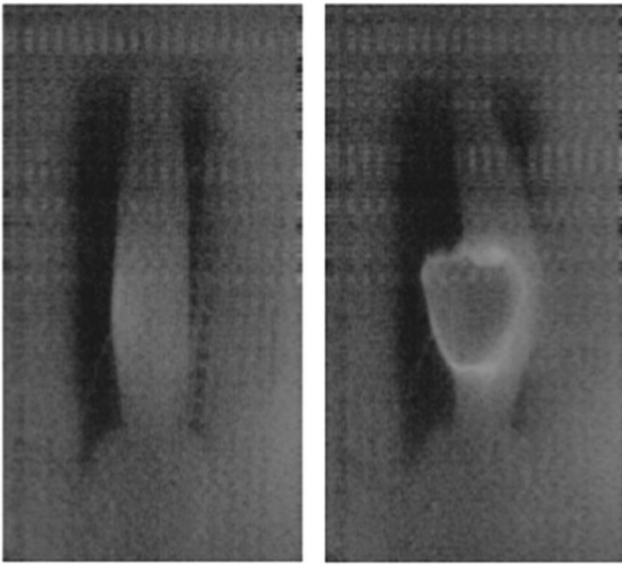
Fig. 1. A cladding sample right before the burst (left) and one frame later, just after the burst. The edge of the rupture is lighter/hotter than its environment (recorded at 2000 frames/s).

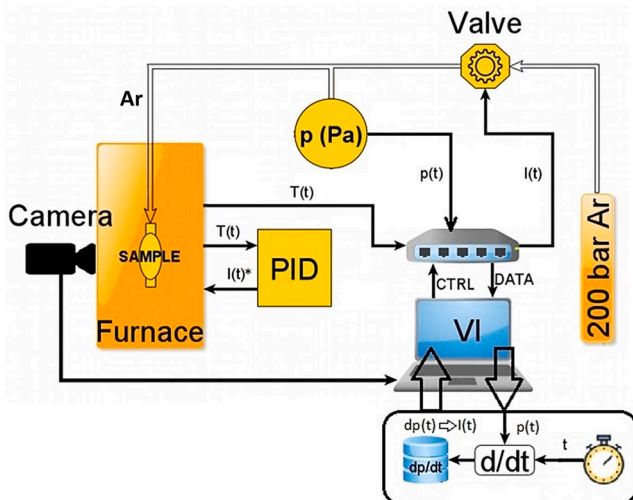
Fig. 2. Flow chart of pressure control and data acquisition.

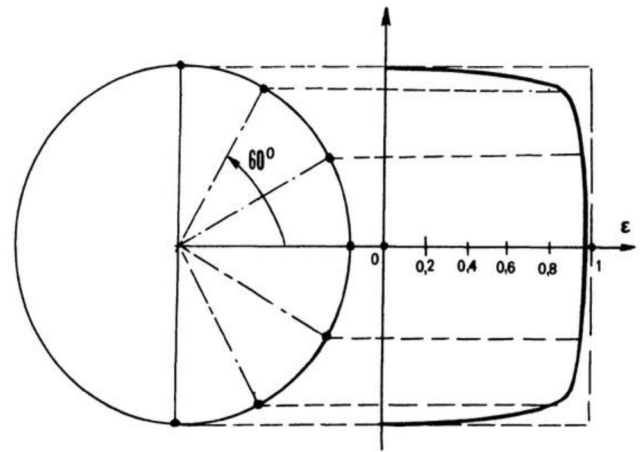
**Fig. 4.** Emission effectiveness of a cylindrical sample with the directional dependency of the emission coefficient.

As it can be seen on Fig. 4, the effective emission from the cylindrical sample in the direction of the camera decreases rapidly at the edges of the sample. This effect was detected on the recorded frames as cooler stripes at the very edges of the sample (as seen on Fig. 3). Therefore, the edges were also excluded from the temperature measurement, and only those points were used where the shape effect caused minimal distortion. The emission parameter is considered to be the same in the experiment in the interval of  $-30^\circ < \alpha < 30^\circ$  and the error is small up to  $\pm 60^\circ$ . This was confirmed at the beginning on the tests as the surface temperature of the samples (excluding the edges and the central band) was found to be relatively uniform (left side of Fig. 3).

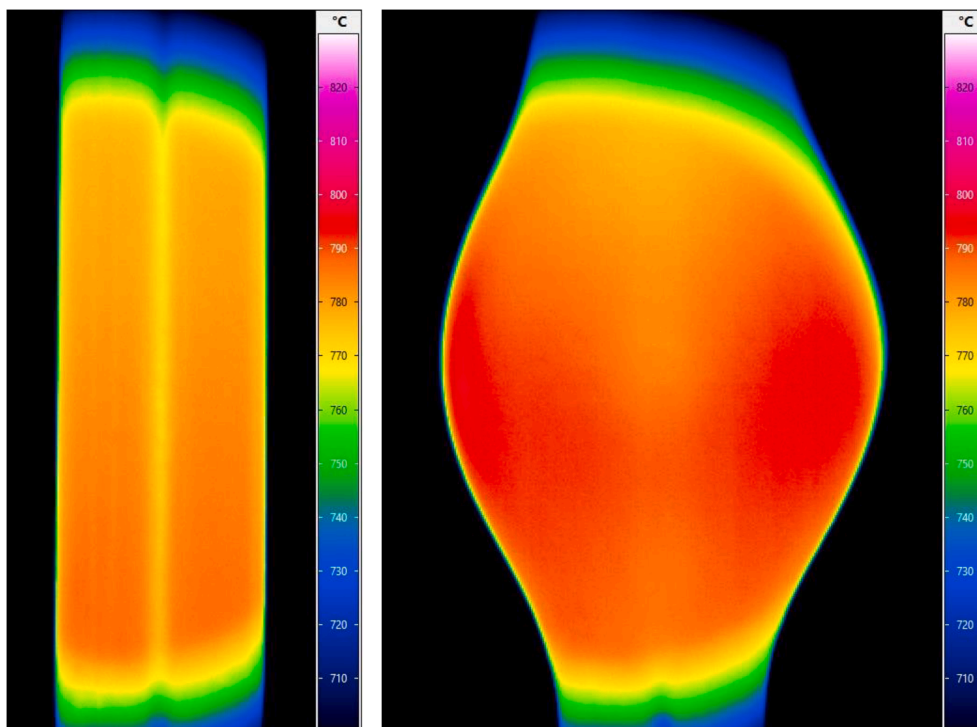
**Fig. 3.** Converted infrared image of Sample 1 at the beginning of the test (left) and right before the burst (right).

Furthermore, the captured infrared images showed a clearly visible brighter band through the middle of the samples (see Fig. 3). This band had the same temperature as the rest of the sample, but it reflected the largest intensity of the 22 °C laboratory background radiation that entered into the furnace via the camera hole. This scattered laboratory background reflection caused a seemingly cooler central region on the tube, but this was negligible at the sides. In order to avoid this reflection, we only took measurements to the sides of this central band. The camera gave a sharp image of about 32 mm of the sample. The sides of the image show much colder temperatures as these were not directly visible through the camera hole.

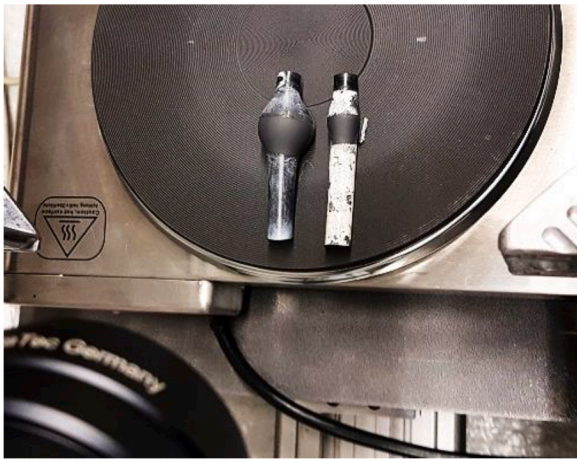
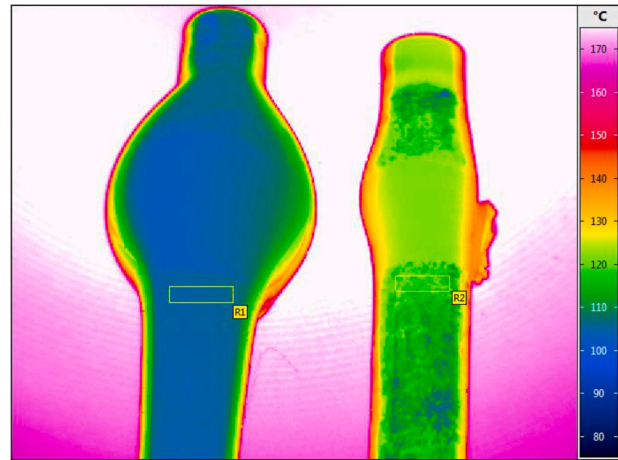
Fig. 5. Determination of the emission coefficient of the two burst samples. The direct measurement arrangement (left) and the result of the measurement can be seen in the image conversion software (right).

The measured emission coefficients of the two samples seen on Fig. 5.

The results showed that the emissivity doesn't depend on the sample temperature, and that the emissivity of the slightly-oxidized and the heavily-oxidized samples are close. It shows that the emissivity doesn't change too much during the tests, so we could use the same emissivity coefficient for the whole test. On the converted IR image (right hand-side of Fig. 5) it can be seen that the oxidized sample is hotter than

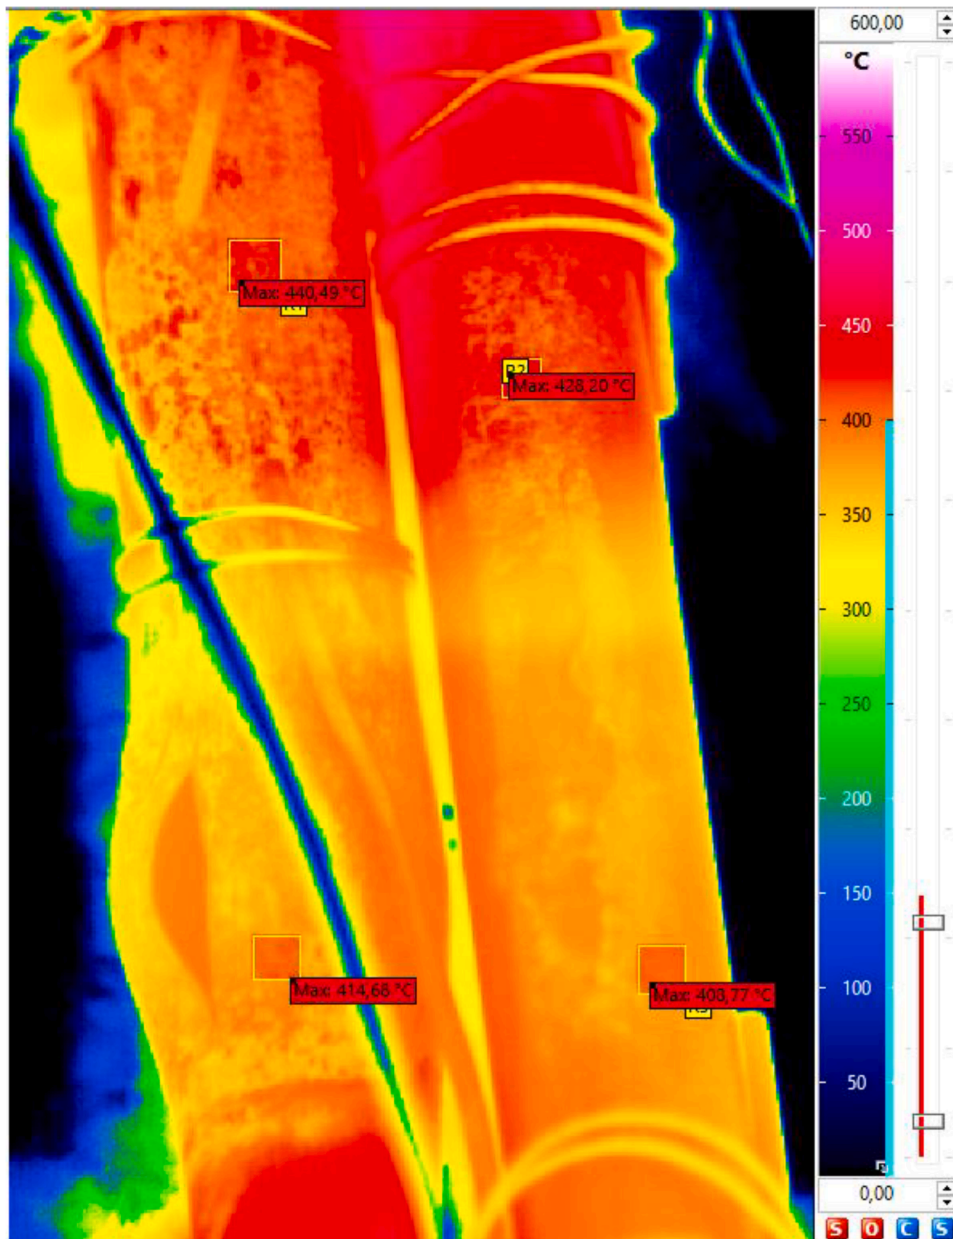
Fig. 6. Calibration measurement using Sample 5 (left) and an as-received tube (right). The colour scale was set to 0–600 °C temperature range. The bottom half of the image shows the effect of the protective film.

sample (Sample 5) that had a thin oxide layer (Fig. 6). These were heated to 800 °C in the furnace simultaneously. The measurement was performed by removing the samples from the furnace and placing them outside into the camera field of view. The field of view was divided into two parts, the lower half was covered by the thin polyethylene film, the other half was measured directly. The samples were equipped with thermocouples. The thermocouple data acquisition was synchronized to the infrared camera and the measured temperature series were compared. Even distribution of temperature and even cooling rate was considered on the surfaces of both samples in the area of interest. The transmissivity of the protective film was determined to be around 80%. The infrared video measurements were then corrected by the transmission of the protective film using the conversion software.

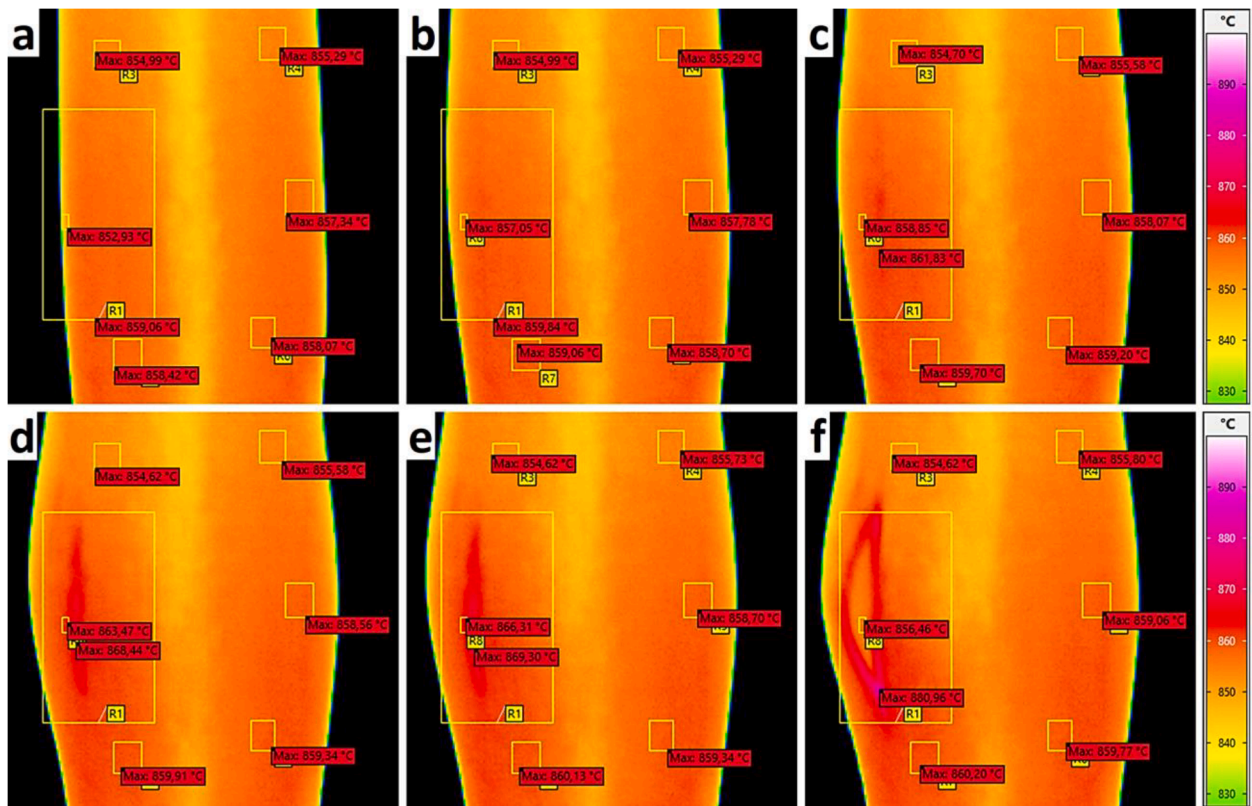
Fig. 7. Crack propagation on Sample 6 in the last two seconds before the burst. The frame numbers for frames a; to f; are 1, 525, 640, 699, 700, 701 respectively.

In Fig. 7 the burst of Sample 6 can be seen, broken down into individual frames. The room temperature as background noise was at 22 °C, reflection background was set to 950 °C and the emission coefficient of the sample was set to  $\epsilon = 0.89$  in the software to fit the value given by the thermocouples. The thermocouples attached to the sample indicated  $853 \pm 5$  °C, the average temperature of the sample in this frame was 855.5 °C using this emissivity. This emissivity is halfway between the previous metallic and oxidized samples, therefore this sample could be considered as slightly oxidized.

It can be seen in Fig. 7 that the average outside temperature of the sample was between 854 and 859 °C, while the temperature inside the tube was measured as 856 °C one frame after the cracking, while the adiabatic cooling effect of the escaping gas could not be felt. The local heat-up before the crack opening was around 869 °C, which is at least 10 °C higher than the average surface temperature measured on the other side of the bulge. It can also be seen that the tip of the crack right after the burst is 25 °C warmer than the average (maximum temperature on region R1 was 881 °C), significantly higher than the rest of the sample. Fig. 8 shows the temperature variation of the hottest point in region R1 (hot spot) and a ‘control’ region on the other side of the sample before the burst. It shows that the temperature increase is significant, higher than the range of accuracy and uncertainty of the measurement. The highest temperature in the burst region is the crack tip at the point of burst, the sudden decrease in temperature afterwards was caused by the adiabatic cooling effect of the escaping argon gas. In Fig. 9 the estimated outer diameter of Sample 6 is shown based on the video captured by the infrared camera. The calibration reference for the pixel scale to mm was based on the unloaded sample (diameter 9.1 mm) at the beginning of the test. The time scale on Figs. 8 and 9 are similar, which means 2 mm diameter increase in the last 0.3 s before the burst (about 100 video frames) corresponds to the local heat-up of approximately 8 °C.

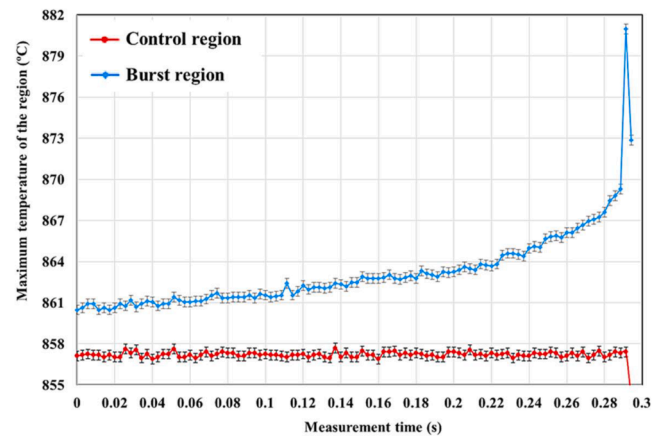
Fig. 8. The maximum temperature of Sample 6 in an area around the burst (R1) and on the other side of the sample in a control region (R6) with the corresponding error bars.

To examine the temperature change, small measurement regions were placed on the sequence of images in the software. The location of pixel with the highest temperature was marked in each region. The largest region (R1) covers the whole crack formation area and gives the maximal temperature of the sample. There is a slight rise in temperature during the inflation/ballooning stage. The hottest point was always near the position where the crack later occurred. After the rupture, the sudden outflow of argon gas adiabatically cooled the tube, and small torn-off pieces of the cladding could be identified (as seen in previous

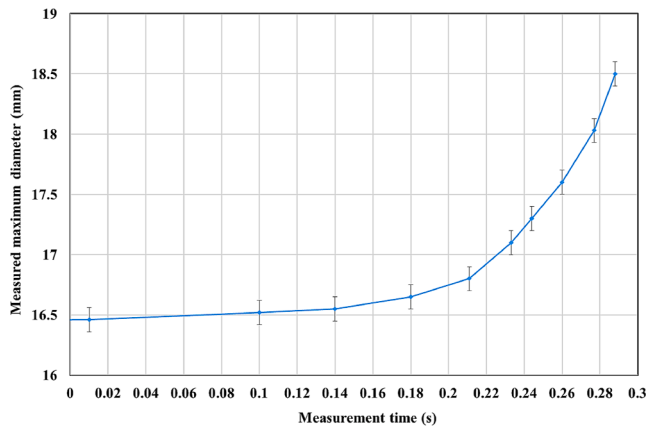
Fig. 9. The maximum diameter of Sample 6 before the burst, based on the frames captured by the infrared camera, with the corresponding error bars.

In order to find out if the local temperature increase is due to a change in the shape of the sample or a real increase in temperature, we examined the infrared images of Sample 6 where the crack had formed in view of the camera and we could see inside the tube (Fig. 7, frame f). When Sample 6 split open, the inner surface certainly could not be oxidized in such a short time. We also assumed that due to the good thermal conductivity of metal, the surface of the tube wall had the same average temperature inside and outside. The local heating of the samples before and during the burst was not caused by an optical phenomenon resulting from a change in the curvature of the tube, nor by an altered emission coefficient of the slightly oxidized outer surface. The evolution of the temperature change correlated with the local increase in tube

radius, which also supports the fact that the heating can be attributed to the change in stress and the mechanical work in the metal, caused by the high-pressure gas.

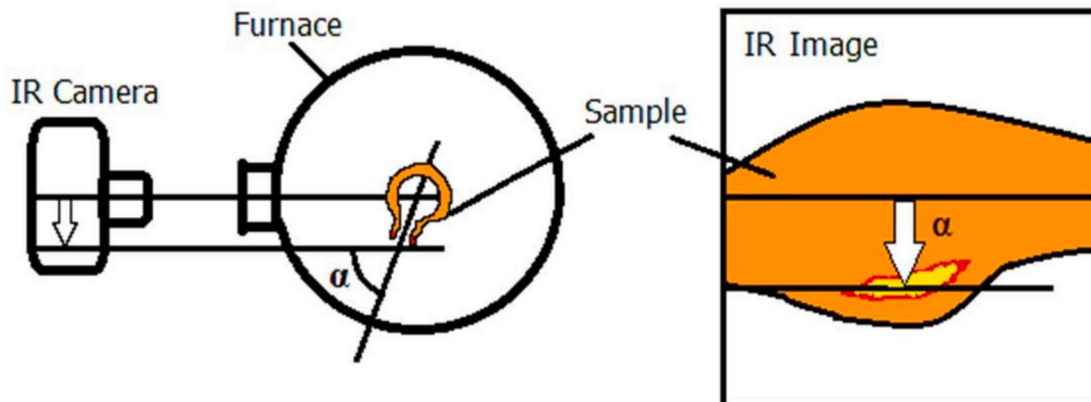
Fig. 10. The approximation of the azimuthal position of the crack and the burst opening relative to the position of the IR camera.

Every measured sample behaved similarly, but the crack opening was different in each test. The approximate azimuthal position of the crack and the burst opening relative to the position of the IR camera was determined based on the captured images, as seen in Fig. 10. The results of the temperature measurements (without the additional uncertainty of  $\pm 3$  °C) are shown in Table 3. Sample 5 ruptured in the opposite direction to the infrared camera, therefore the measured heat-up of this sample was not significant. For those samples that ruptured away from the camera, the exact temperature of the local heat-up of the bulge or the maximal temperature of the crack tip could not be determined, only Samples 2 and 6 provided good measurements in this regard. However, the burst of the other samples revealed other interesting phenomena, like the evolution of the diameter of the sample in the last seconds before the burst and the maximal pressure before the burst at different temperatures and pressure increments.
