Experimental study of prefabricated RC column-foundation assemblies with two different connection methods and using large-diameter reinforcing bars

Fan, J, Feng, D, Wu, G, Hou, S & Lu, Y 2020, 'Experimental study of prefabricated RC column-foundation assemblies with two different connection methods and using large-diameter reinforcing bars', *Engineering Structures*, vol. 205, 110075, pp. 1-16. <https://doi.org/10.1016/j.engstruct.2019.110075>

Jiajun Fan¹, De-Cheng Feng¹, Gang Wu^{1*}, Shitong Hou¹, Yong Lu²

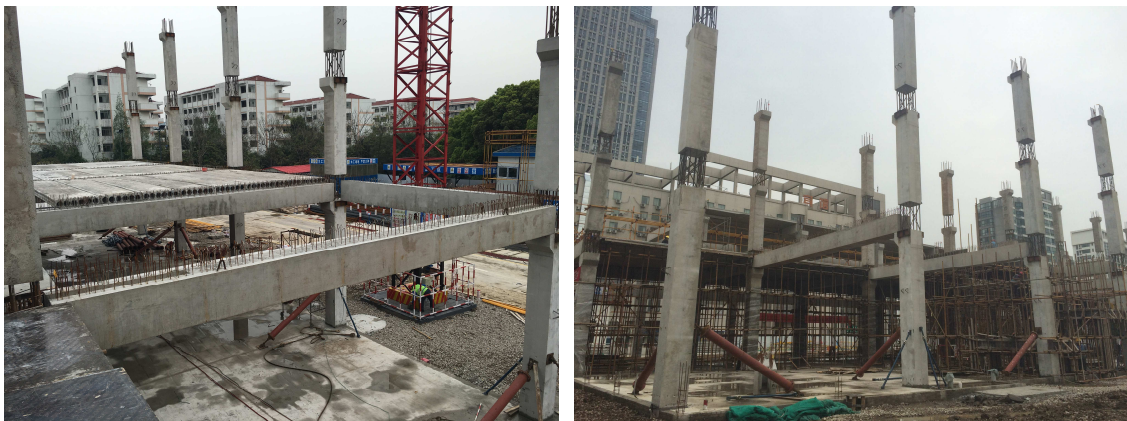
Figure 1 Multi-storey precast reinforced concrete columns

In a multi-storey precast reinforced concrete (RC) frame structure, as shown in Figure 1, the column-to-foundation connections play a critical role in determining the performance of the entire structure. Hence, the design of these connections becomes a crucial task [6-7]. Equally important is the understanding of the actual seismic behaviour of a particular type of connections in terms of the strength, stiffness, ductility, energy dissipation and failure mode [8-10]. The failure patterns of PC column-to-foundation connections after earthquake were presented in Fig. 26 in the reference 8, and Fig. 6 and 7 in the reference 9.

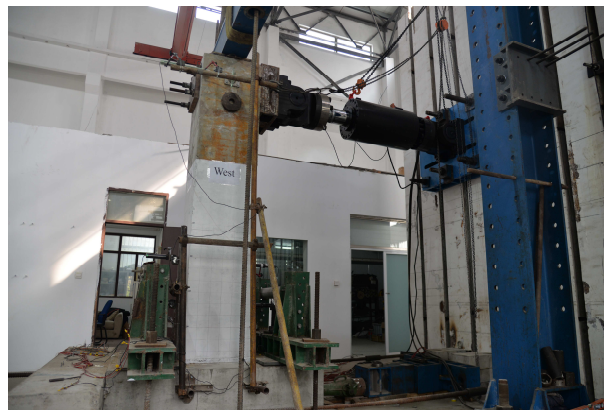
Figure 9 Photograph of the test setup

The test setup is illustrated in Figure 8 and Figure 9. The end condition at the top of the test specimen was basically a lateral sliding pin support, while axial load is applied vertically. This was intended to simulate the response of the ground storey column of the prototype frame under earthquake lateral loading, where contra-flexure usually develops around the mid-height of the column. The net length of the column, which means the displacement between the loading point to the top of the foundation, was 2500 mm. The foundation was anchored upon the strong floor in the laboratory. Lateral load was applied by using one hydraulic actuator with 500 mm maximum stroke and ± 1000 kN loading capacity. The applied lateral load and displacement at the top of the column were measured by a load cell of 1000 kN and a LVDT (linear variable differential transformer) of 500mm, respectively. One LVDT of 50 mm was installed at the bottom of the foundation to check whether the lateral displacement remained zero during the whole process of testing. A few more LVDTs were used to measure the rotation of the connection region and lateral displacements at selected locations, as shown in Figure 8. Six D15.2 steel strands and two D40 screw-thread steel bars were used to apply a vertical load of 1540 kN at the top of the column. The jack and load cell of two D40 screw-thread steel bars remained in place to continually monitor and adjust the vertical load during the test, since the force level was prone to change as the specimen deformed. Although the vertical load applied on the column could be generally considered to maintain constant. The magnitude of the vertical load was selected to obtain an axial load ratio (defined as $N/f_c A_c$) of 0.22. This level of axial compressive stress in concrete is common for columns of multi-storey office buildings.

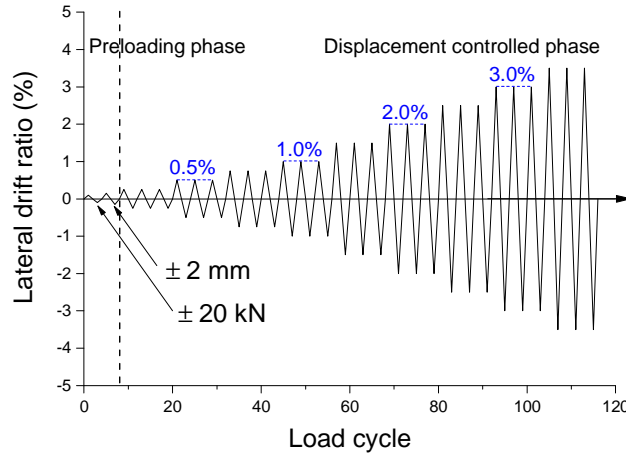
Figure 10 Loading protocol

reverse cyclic loading was applied. Figure 10 shows the loading protocol, which was controlled by incremental stages of displacement at lateral drift ratios of 0.25%, 0.5%, 0.75%, 1%, 1.5%, 2%, and so forth. Before 1% lateral drift ratio, the applied lateral drift ratio was increased by 0.25%. After that, the increment was raised to 0.5% until the failure of the specimens. Each displacement level was performed with three cycles to ensure the stable crack propagation of the specimens. This testing protocol was consistent with the recommendations of ACI374.2-R13 [43] and FEMA-461 [44]. The loading was paused at the end of the last cycle of each level to mark the cracks on the specimens, measure the width and length of cracks and record the observations. The tests were terminated when the applied load was reduced to 80% of the maximum lateral load, at which point the specimen was considered to have reached the ultimate state and failed. All data, including loads, displacement and strains, were collected by a static-data acquisition system at a sampling frequency of 0.5 Hz.

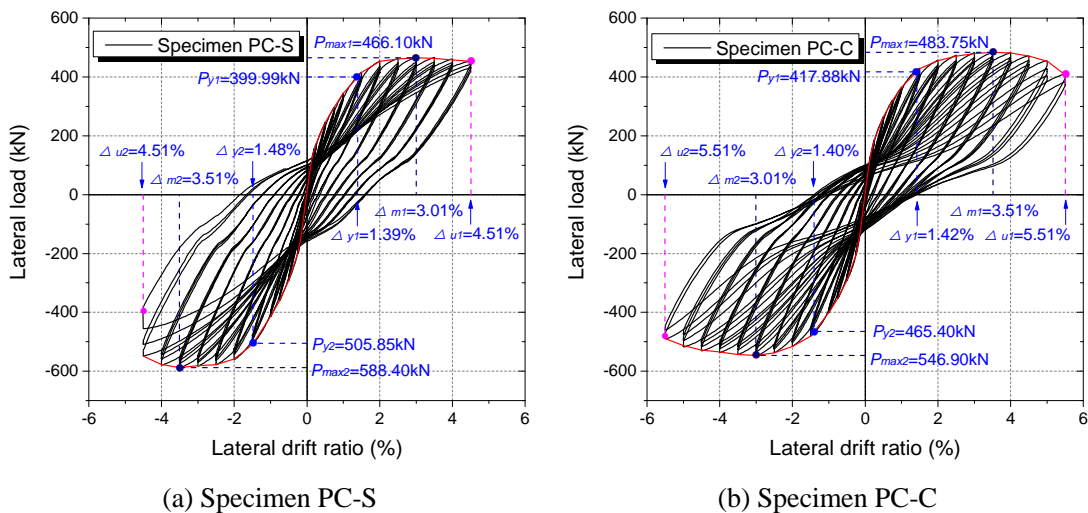
Figure 11 Lateral load - displacement (drift ratio) relationships of test specimens

The lateral load-displacement (drift ratio) relationships of the three specimens are shown in Figure 11(a) to (c). The drift ratio was calculated by dividing the lateral displacement at the loading point by the net height of the column, which is 2500 mm. The yield lateral ratio Δ_y , yield strength P_y , maximum strength P_{max} , the corresponding drift ratio Δ_m , the ultimate drift ratio (at 80% reduction of the load) Δ_u , and the ductility μ of the specimens in both positive and negative directions are summarized in Table 3. The yield displacement Δ_y was defined by using the equal energy principle based on the envelopes of hysteresis loops. The ductility μ ($=\Delta_u/\Delta_y$) was defined as the ratio of maximum displacement Δ_u to yield displacement Δ_y .

The hysteresis loops were asymmetrical in positive and negative directions due to the previous damage during the positive loading process, as well as usual fabrication inaccuracies. The usual fabrication inaccuracies refer to such inaccuracies as the thickness of the concrete cover, location of the longitudinal reinforcing bars, and so on. These inaccuracies are deemed to be unavoidable during the fabrication and assembly construction of PC components, as well as in the cast-in-place specimen. According to the test results of others [12, 16, 18], the asymmetrical hysteresis loops were mainly caused by the previous damage in the opposite loading directions. The influence of the “usual fabrication inaccuracies” on the asymmetrical hysteresis loops was relatively small.

Specimen PC-C with grouted corrugated duct achieved a similar ultimate lateral drift ratios as specimen CIP at 5.5%, in both the positive and negative directions. However, the ultimate lateral drift ratio of the specimen PC-S was lower at 4.5%. From the monitoring of the damage process, the reduction in the ultimate drift capacity in PC-S was attributed to the buckling of the longitudinal bars above the grouted sleeves and rupture of the stirrups there. The hysteresis loops of specimen PC-C showed more pronounced pinching than the specimens PC-S and CIP, indicating a more significant bond-slip effect of reinforcing bars and less energy dissipation at the column base. However, the specimen PC-S exhibited very similar hysteresis loops as specimen CIP until a the 4% lateral drift ratio was reached.

The hysteresis loops in Figure 11 show that the strength decreased during repeated cycles at the same displacement level, and this was attributed to a combination of concrete crush, reinforced bar bond-slip and reinforcement yielding. The strength degradation can be defined by the ratio of the cyclic load-carrying capacity at the i^{th} ($i=2, 3$) load cycle to that at the first load cycle at a certain displacement level, i.e.,

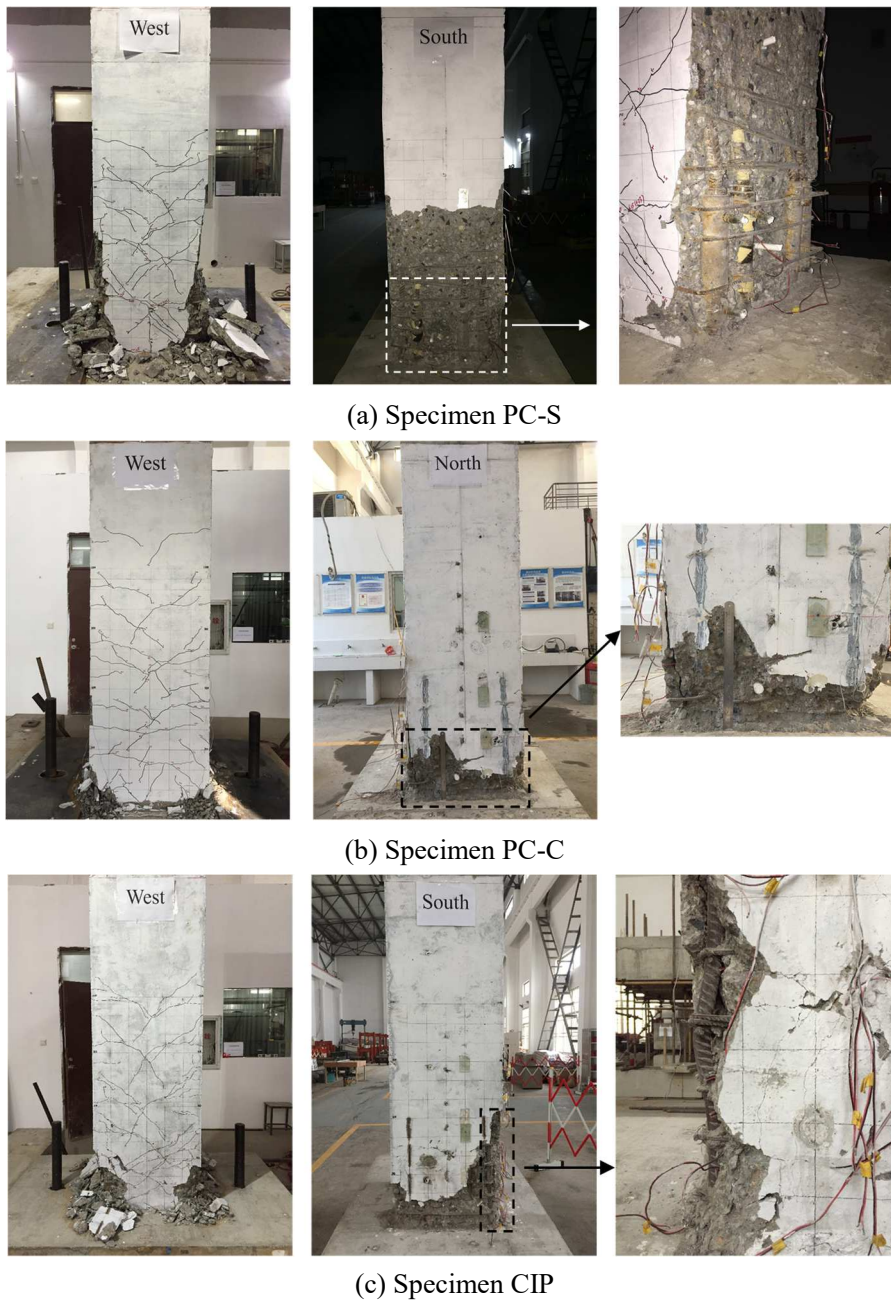
Figure 12 Crack patterns and failure modes

The three specimens show distinctly different crack patterns and failure modes, as shown in Figure 12. The damage was concentrated at the bottom part of the columns with different lengths, indicating different plastic hinge mechanisms in the three specimens.

As shown in Figure 12(a), the damages were located at the bottom of the column within a height of approximately 900 mm in specimen PC-S. The first transverse crack with the length of 250 mm was noticed at a height of 300 mm on the column, just at the top of the grouted sleeves. The transverse crack developed across the whole section height at a 0.75% drift ratio, and the width increased with the increase of the lateral drift ratio. At the same time, several transverse cracks were found within a height of 410 mm to 950 mm on the column. After a lateral drift ratio of 1.5%, several local vertical cracks formed at the two corners at the column base under compression, then extended upward and widened quickly. At a lateral drift ratio of 3.5%, large pieces of concrete spalled at and above the position of the grouted sleeves, resulting in the exposure of the grouted sleeves and stirrups. At the first

cycle of 4% lateral drift ratio, severe buckling of the longitudinal bars at the top of the grouted sleeves resulted in the rupture of stirrups and crushing of concrete at this location. Subsequently, the load-carrying capacity dropped quickly during the three cycles at the 4.5% lateral drift ratio, indicating severe damage accumulation during this period, leading to the failure of the specimen. This failure mode was attributed to the abrupt change of lateral stiffness at a height of 300 mm from the column base, apparently due to the stiffness and strength contribution of the grouted sleeves. This failure mode also indicated that more large-diameter stirrups above the sleeves could prevent the buckling of reinforcing bars there, which was benefit in achieving a larger ultimate lateral drift ratio and improving the seismic behaviour of the connections. Within the height of the grouted sleeves at the bottom of the column, the concrete crush was not serious.

Unlike the specimens PC-S and CIP, spalling of the concrete cover in specimen PC-C was limited and concentrated within the height of approximately 250 mm at the column base. Meanwhile, the longitudinal reinforcement was not exposed, and buckling did not occur. At a lateral drift ratio of 0.5%, two horizontal cracks were observed at the top of the grouted corrugated ducts with a length of 320 mm and 250 mm in the positive and negative direction, respectively. At a lateral drift ratio of 1%, diagonal shear cracks formed and then developed. However, the width of the diagonal shear cracks in specimen PC-C was smaller than the width of the diagonal shear cracks in specimens PC-S and CIP. The gap-opening between column and foundation was larger and it reached a width of approximately 20 mm at 3% lateral drift ratio. During the next level of loading, local concrete crush occurred at both corners, and the spiral stirrups were exposed over a height of approximately 120 mm at the column base. Distributed transverse cracks occurred along the column over a height of approximately 950 mm starting from a lateral drift ratio of 0.25%. However, these cracks developed slowly and closed after unloading, and this could be explained by the increased amount of the longitudinal reinforcement due to overlapping. Combined with the contribution of spiral stirrups and the mortar inside the grouted corrugated ducts, the cross-section stiffness at the bottom region was much larger than the cross-section stiffness above the grouted corrugated ducts. Moreover, the pinching of the hysteretic loops indicated a severe bond slip between the longitudinal bars and the concrete around the grouted corrugated ducts.

The specimen CIP showed a different failure mode as compared with specimens PC-S and PC-C. The spalling of the concrete cover occurred over a height of 600 mm at the bottom of the column at a lateral drift ratio of 2.5%. The height of the spalling region is essentially the same as the width of the column. Buckling of the longitudinal

bars was observed at a lateral drift ratio of just 2%, as shown in Figure 12(c).

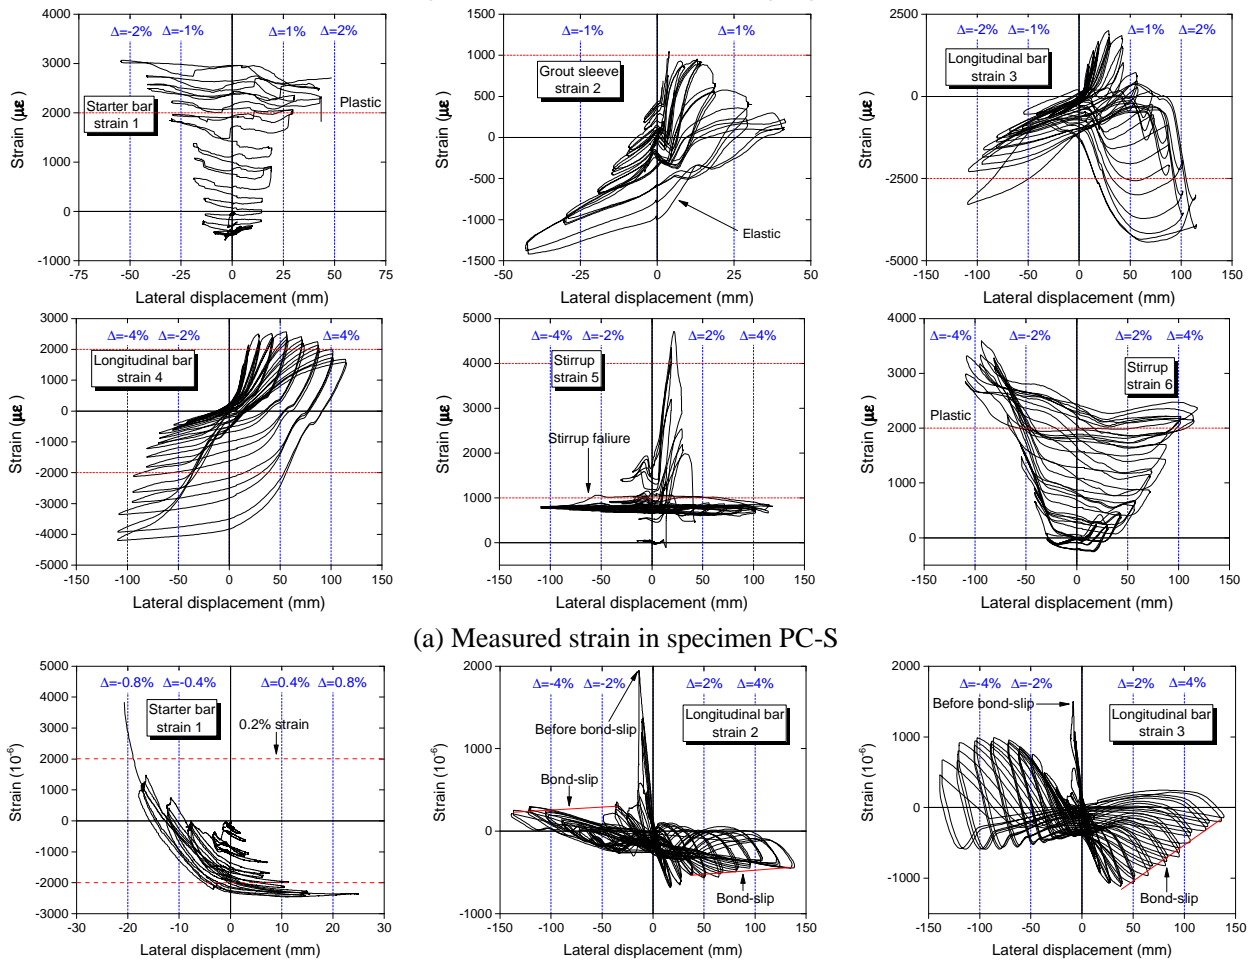
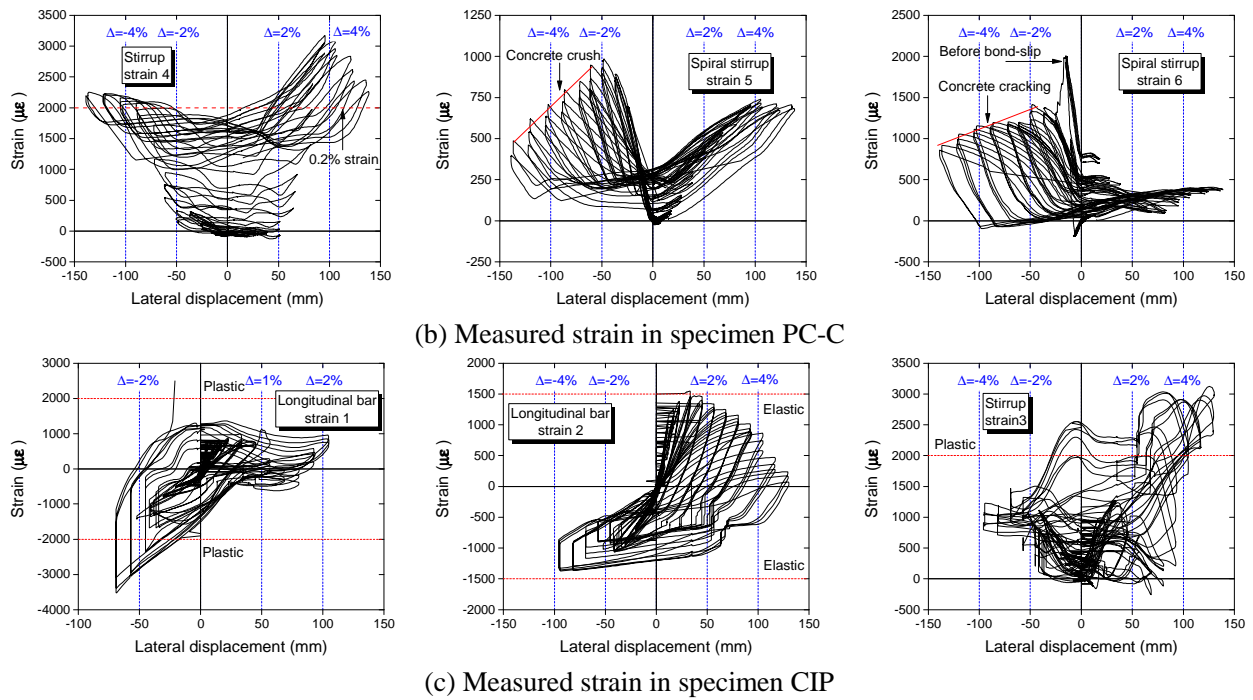
(a) Measured strain in specimen PC-S

Figure 14 Measured strain distribution

In specimen PC-S, the grouted sleeves remained elastic throughout the whole loading process. However, the longitudinal bars yielded with over a length of approximately 500 mm above the grouted sleeves at a lateral drift ratio of 2%. The longitudinal bars at the height of 650 mm from the column base developed both larger compression plastic strain and tensile plastic strains at a lateral drift ratio of 4%. The peak strain of the stirrup at a height of 250 mm was beyond 4500 $\mu\epsilon$ at a lateral drift ratio of 1%, and then the strain dropped abruptly, indicating the rupture of the stirrups due to the large deformation there. The stirrup above the grouted sleeves yielded at a 2% lateral drift ratio and subsequently developed large tensile strain. This indicated that the failure of the test specimen was partly caused by the rupture of stirrups and more stirrups were required there. The strain distribution of the longitudinal bars and stirrups was consistent with the failure mode shown in Figure 14(a). The starter bar embedded in the foundation developed large tensile plasticity due to the strain penetrations from the column and gap-opening between the column and foundation.

In specimen PC-C, the yielding of the longitudinal bars did not occur, while bond-slip deformation between the overlapping longitudinal bars within the grouted duct took place at an early stage, as shown in Figure 14(b). The peak strain of the longitudinal reinforcement was less than 2000 $\mu\epsilon$, and then a rapid decrease was observed. The variation of the strain in the spiral stirrups with the lateral displacement also reflected the bond-slip between the longitudinal reinforcement and the concrete. The stress in the starter bars protruding from the foundation was not completely transferred to the longitudinal bars by overlapping, resulting in the pinching behaviour in the specimen PC-C. Due to the overlapping of the reinforcing bars at the column bottom region above the bedding mortar, the strain of the longitudinal reinforcement in this region was reduced. The stirrups at the column base yielded at a 2% lateral drift ratio. The plasticity of the starter bars was concentrated near the bedding mortar. Moreover, the concrete crush was observed over a height of approximately 300 mm at the column base, and transverse cracks across the section height formed at a spacing of approximately 120 mm above.

For the specimen CIP, the plastic compression strain of longitudinal bars reached $2000 \mu\epsilon$ at a 1% lateral drift ratio at a height of 250 mm of the column, as shown in Figure 14(c). Subsequently, the plastic strain increased with the lateral displacement, and buckling of the bars was observed accompanied by the spalling of the concrete cover. The peak strain of the longitudinal bars at the height of 550 mm was approximately $1500 \mu\epsilon$, so the longitudinal bars there remained elastic during the test.

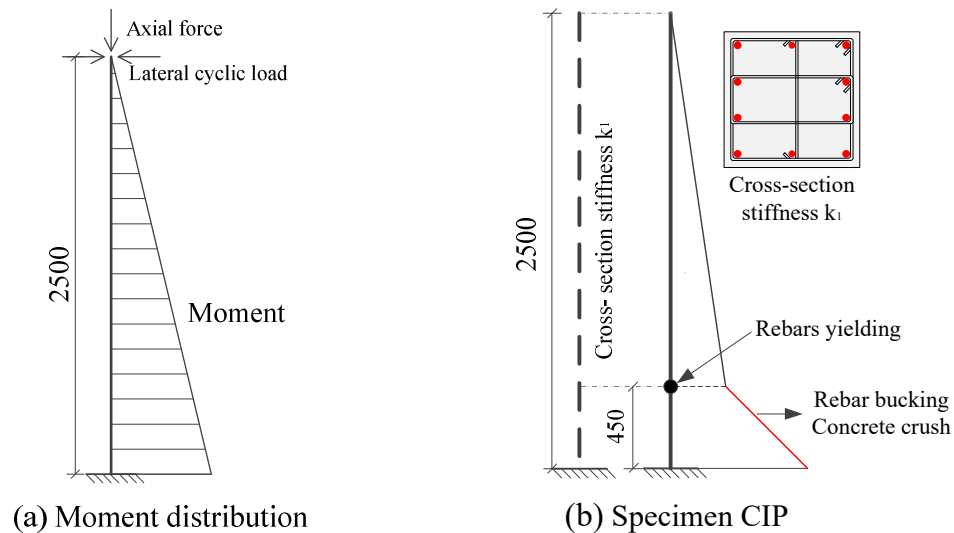
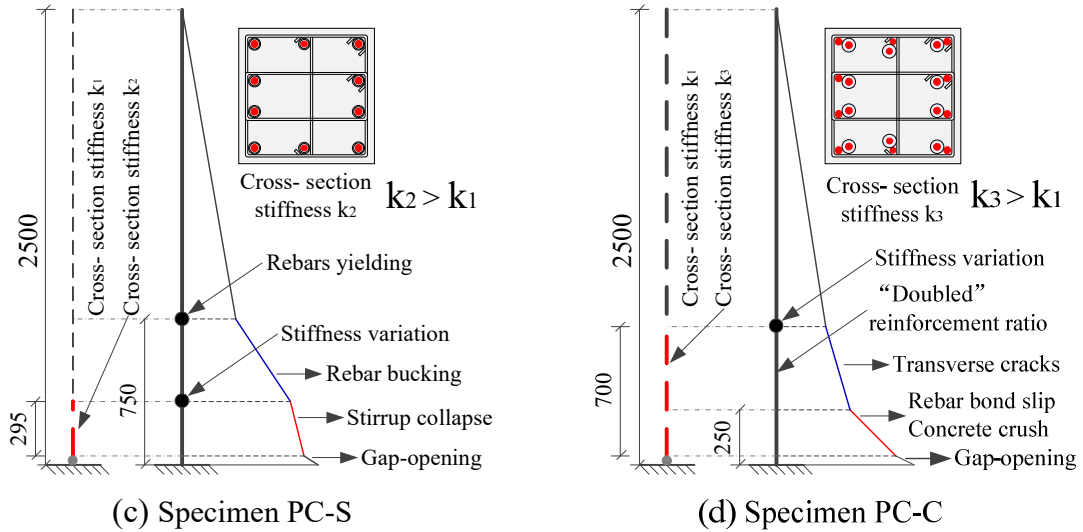
Figure 15 Schematic of moment and deformation distribution

In the reference specimen CIP, the cross-section stiffness k_1 (for simplicity, the sectional stiffness here refers to the cracked section stiffness) was a constant along the column, as shown in Figure 15(b). The plasticity and energy dissipation of the column caused by yielding of reinforcement and local concrete crush were concentrated within the length of 450 mm at the column base.

15(c). As a result, the local deformation tended to be smaller in the grouted sleeve region before yielding occurred. This, compounded by the increased moment capacity in the grouted sleeve region, resulted in the upward shift of the concentration plastic deformation to a height of approximately 300 mm above the column base after yielding. With further increased lateral drift, buckling of the longitudinal bars eventually occurred over the length of approximately 500 mm above the grouted sleeves, as well as the rupture of stirrups above the sleeves. In all, the presence of the grouted sleeves led to the development of the actual plastic hinge at this region above the grouted sleeves. Therefore, the indicative curvature distribution in specimen PC-S may be represented as shown in Figure 15(c).

In specimen PC-C, a shorter plastic hinge was caused by the “doubled” (considering the rebar bond-slip) longitudinal reinforcement ratio by overlapping of the reinforcing bars in the grouted corrugated duct with the length of 700 mm at the column base, which also meant a larger stiffness k_3 there. Inevitably, varying degree of slip of the longitudinal bars overlapped in the grouted duct would occur, and this, combined with the gap-opening at the column-foundation interface, resulted in a reduced energy dissipation capacity of specimen PC-C. The plastic deformation was observed to concentrate at the column base with a height of approximately 250 mm, which could be attributed to the compounded effect of the concrete crush, reinforced bar bond slip in the grouted duct, and large gap-opening at the column base, as shown in Figure 15(d). The length of plastic hinges, the key influence factors on the plastic hinges and the failure modes are summarized in Table 4.

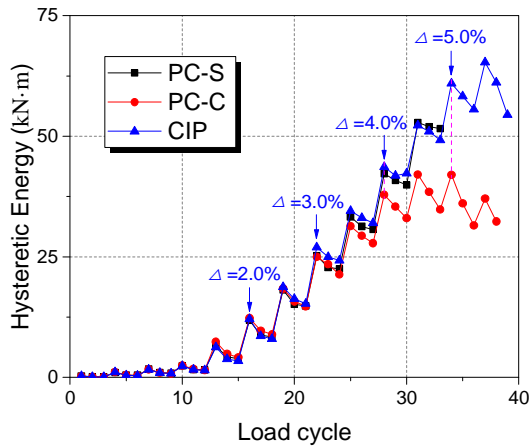
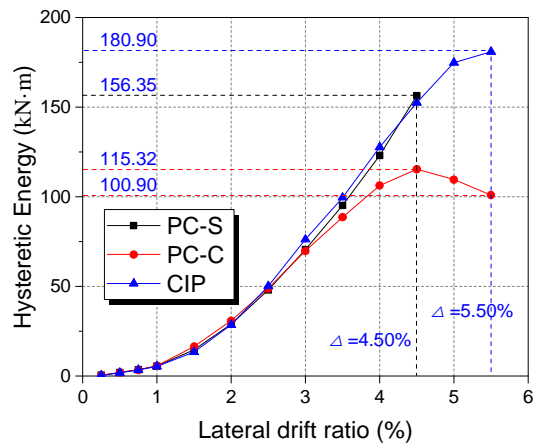
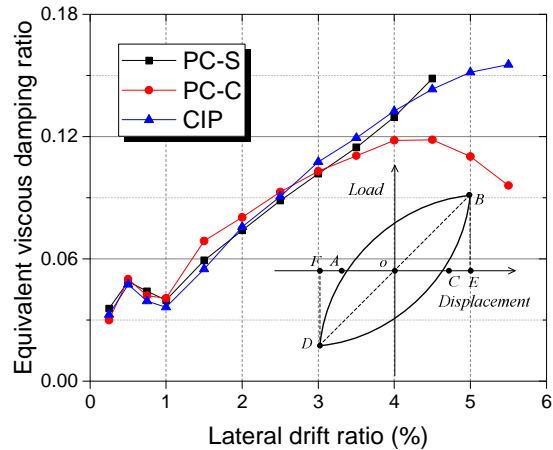
(a) Energy dissipation per load cycle

(b) Energy dissipation per load level

(c) Cumulative energy dissipation

(d) Equivalent viscous damping ratio

Figure 16 Energy dissipation of the test specimens

The results of the above energy dissipation measures for the three specimens are compared in Figure 16. In general, the energy dissipated in the first loading cycle was the largest among the three cycles at a given displacement, as shown in Figure 16(a)., This can be attributed to the strength degradation and damage accumulation during the cyclic loading at a given load level.

The energy dissipation per load cycle, per load level and cumulative energy dissipation of specimens PC-S and PC-C were almost the same as specimen CIP before the lateral drift ratio of 3.5%. This was acceptable for both connections for the PC structures. However, the cumulative energy dissipation of specimen PC-S was only 60% of specimen CIP, caused by its early failure. The specimen PC-C showed a markedly lower energy dissipation capacity after the lateral drift ratio of 3.5%, which echoes the increased pinching in the hysteretic loops. In the last three load levels, i.e., 4.5%, 5%, and 5.5%, the energy dissipation of specimen PC-C no longer increased and this was attributed to the severe bond-slip between the reinforced bars and concrete. At 5.5% drift ratio, the energy dissipation per load level of specimen PC-C was only 55.5% of specimen CIP, despite a similar load-carrying capacity between the two specimens. Finally, the cumulative energy dissipated by specimen PC-C was 76.2% that of specimen CIP and 27.2% larger than the cumulative energy dissipated by specimen PC-S, as shown in Figure 16(c).

The same conclusion can be drawn from the equivalent viscous damping ratio shown in Figure 16(d).
