## **Half-cell potential mapping for corrosion risk evaluation of prestressed concrete ribbed panels from agricultural building after 20 years of service**

**Abstract.** Corrosion of steel is a significant problem in prestressed concrete structures as it decreases structural capacity and performance. In this research the 20-year-old prestressed concrete ribbed ceiling panels (of type PNS-12) with dimensions of 6 m (length) by 1.5 m (width) from an existing Estonian agricultural building (pigsty) are studied. The objective is to evaluate the corrosion risk of steel reinforcement of ribbed panels by means of an indirect (non-destructive) method and compare the results with a direct method.

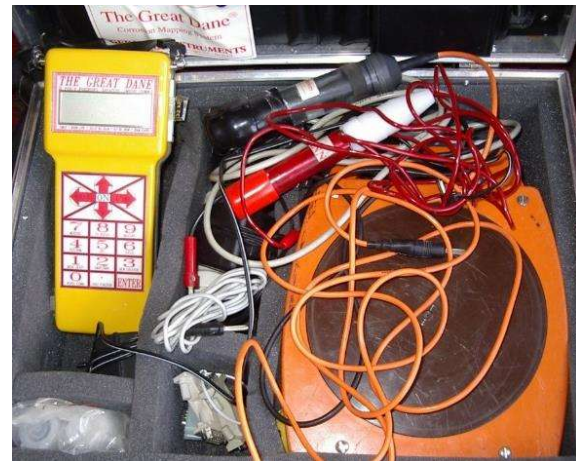
**Figure 5.** The Great Dane corrosion mapping system.

The mapping of the corrosion potential of steel was performed with a German Instruments GD-2000 Mini Great Dane system (Fig. 5) The Mini Great Dane measures the surface potentials relative to an Ag/AgCl/1M KCl reference electrode and the electrical resistance of the cover concrete between the electrode and the reinforcement. The indicated potential,  $E_{\text{corr}}$ , is in terms of a Cu/CuSO<sub>4</sub> electrode (CSE), which are -110 mV lower in value than for the Ag/AgCl/1M KCl electrode.

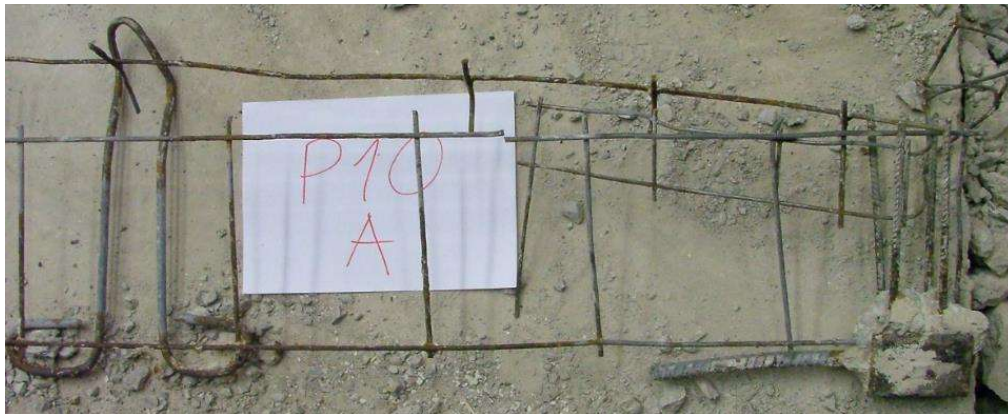
**Figure 7.** Photograph of the steel prestressing bar, reinforcements and eye bolt details of the longitudinal rib A-B of ribbed panel P10 (P10/A-B) after demolition.

The half-cell potential map of P10/A-B shows the most negative potentials in the lower right corner of the Fig. 6. The position and condition of steel details of P10/A-B was also photographed (direct method, in Fig. 7), which enabled the comparison with half-cell potential map (indirect, non-destructive method). Fig. 7 shows that that the steel prestressing bar (initial  $\varnothing$ 16 mm in Fig. 3), reinforcements ( $\varnothing$ 3 and 4 mm), eye bolt ( $\varnothing$ 12 mm) and other details of P10/A-B had relatively large visually distinguishable corrosion deterioration. It should be mentioned that large negative potential readings of half-cell have also other causes such as water saturation and pressure of galvanised components.

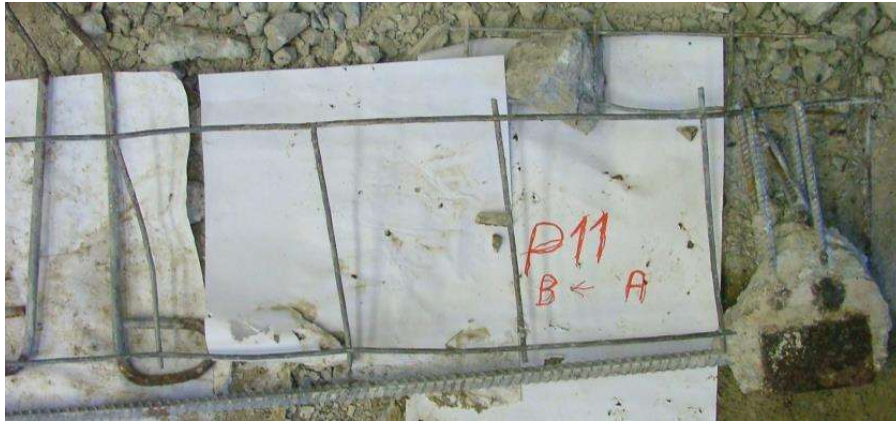
**Figure 9.** Photograph of the steel prestressing bar, reinforcements and eye bolt details of the longitudinal rib A-B of ribbed panel P11 (P11/A-B) after demolition.

Fig. 9 shows that the steel prestressing bar (initial  $\varnothing 16$  mm in Fig. 3), reinforcements ( $\varnothing 3$  and 4 mm) and eye bolt ( $\varnothing 12$  mm) of P11/A-B details are relatively intact in visual observation. This corresponds rather well with the half-cell potential map (Fig. 8) of the same member (P11/A-b). Therefore, good correlation between half-cell measurements and visual observation was found in the current study.
