Hygrothermal analysis of masonry wall with wool glass interior insulation

K. Leiten, P. Kirotar and M. Kiviste

Estonian University of Life and Science, Institute of Forestry and Rural Engineering, Kreutzwaldi 5, EE51014 Tartu Estonia

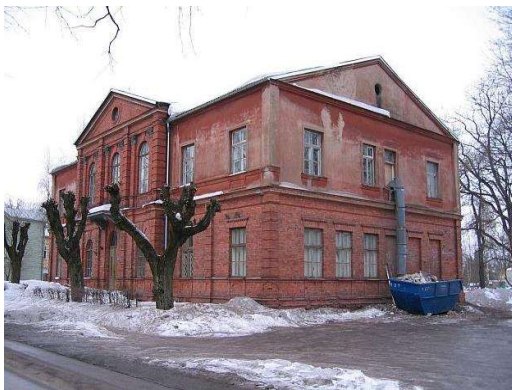
Figure 1. Veski 13 before renovation.

The case study building is situated in Estonia Tartu Veski Street 13. It was designed by architect Reinhold Guleke. In 1893 the construction was completed and taken into use by student corporation Livonia. Originally the building was one-storied and rectangular shaped. In 1958 the second story was built (National Registry of Cultural Monuments). In 1997 the building (Fig. 1) was listed as ‘Cultural monument building’ and therefore became under strict preservation regime (Regulation of Cultural Ministry no 12 published 20.03.1997). In 2010 the building was privatised and renovation works began. The renovated house is presented in Fig. 2.

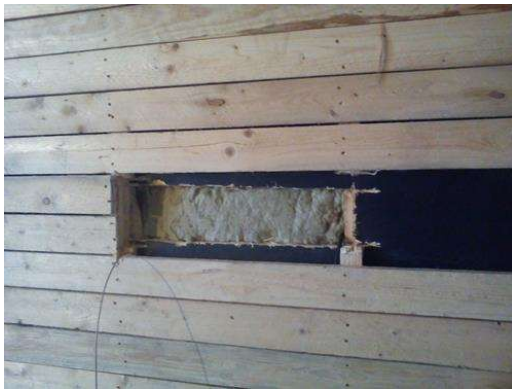
To install the devices into the wall we had to open it from inside as shown in Fig. 3. Afterwards the perimeter of excluded piece of OSB-board was sealed with silicone as seen in Fig. 4.

Figure 3. Applying sensors between layers.

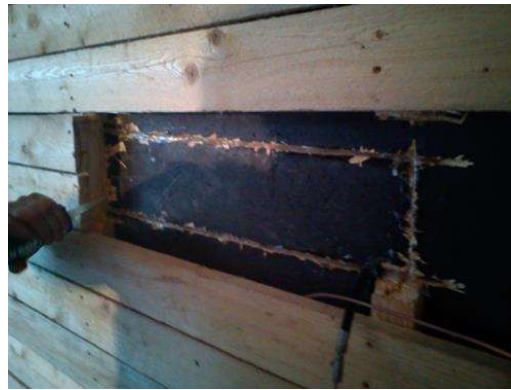
Figure 4. Sealing the opening with silicone.

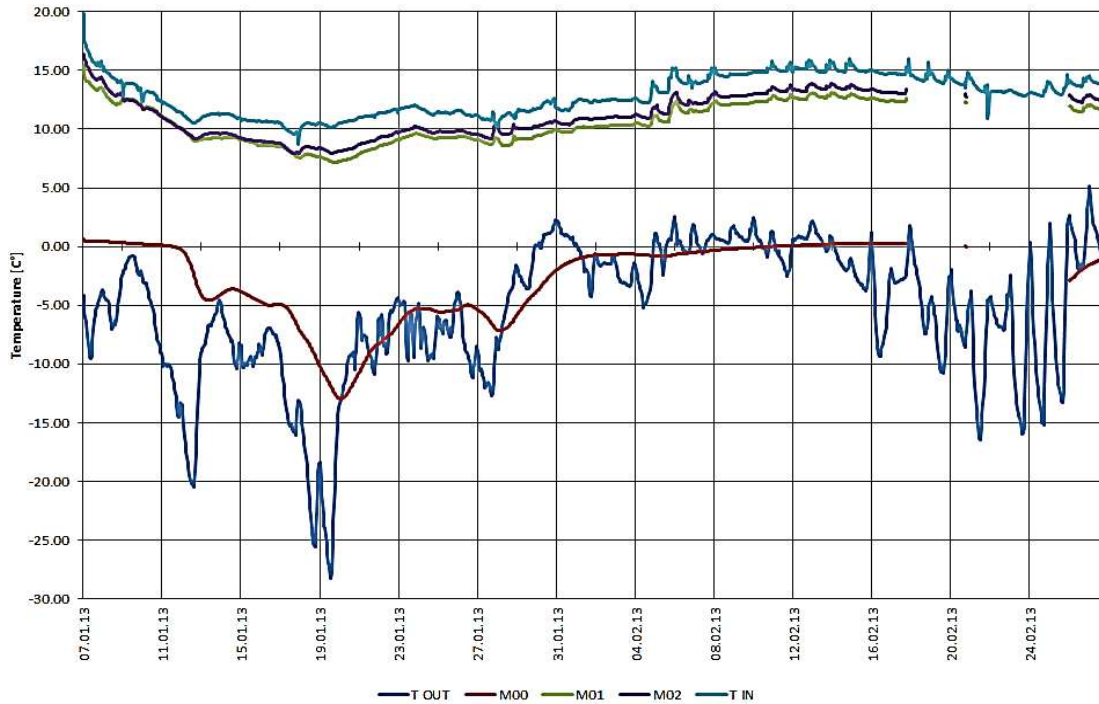
Values measured during the period of time 31.01.2013 – 16.02.2013 were calculated as arithmetic averages. Measured values of temperature and relative humidity inside/outside in points M00/M10; M01/M11; M02/M12 are presented in Fig. 6 and Fig. 7. Until 18.02.2013 all the devices were working properly. Afterwards were some periods when some of the devices were out of order.

The temperature line in Fig 6 show us that whole masonry wall was frozen throughout measuring period. The sensor, M00, between insulation layer and masonry wall show also mainly zero degrees in the measuring period and the relative humidity sensor M10 at the same place indicated that during the measuring period the RH was above 80% as seen in Fig. 7. These numbers refer to a great risk of decay and destruction of the wall caused by moisture and freezing. As the temperature remains more constant

Figure 6. Measured temperature values: inside, in points M00, M01, M02 and outside.

Based on the measurements the average value of the relative humidity in point M10 was higher than 90%. The temperature in point M00 was constantly below zero. Calculations show high risk of condensation and mould growth and condensed water amount was 0.06 kg m⁻² but according to DIN it dries out during the summer time.

The most extreme differences between measurements and calculation results were in point M00/M10 that was between masonry and insulation layers. It might be that the sensor was covered with ice and therefore did not give the proper temperature and relative humidity values. Even though when calculations done by DIN give condensed
