NPS-MAE-10-003

**DAMAGE DETECTION IN COMPOSITE INTERFACES
THROUGH CARBON NANOTUBE REINFORCEMENT**

Mollie A. Bily, Young W. Kwon, and Randall D. Pollak

12 February 2010

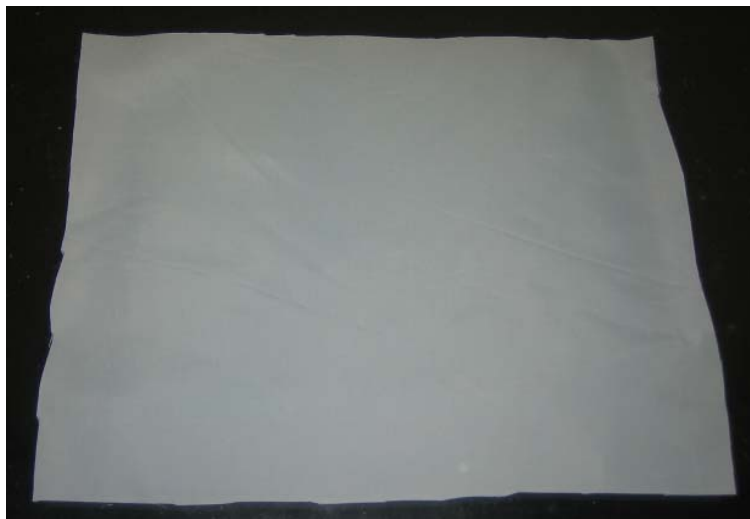
Figure 5. Peel ply laid on top of distribution media for co-cured samples.

To begin making the two-step cured samples, a layer of peel ply was placed on a piece of glass to allow for easy removal of the sample upon completion of the VARTM process. The glass used must be at least 1.27 cm (0.5 in) thick, in order to be able to withstand the extreme heat generated during the resin curing process. When making a co-cured sample, a layer of distribution media is laid down first, covered by a layer of peel ply, as shown in Figures 4 and 5.

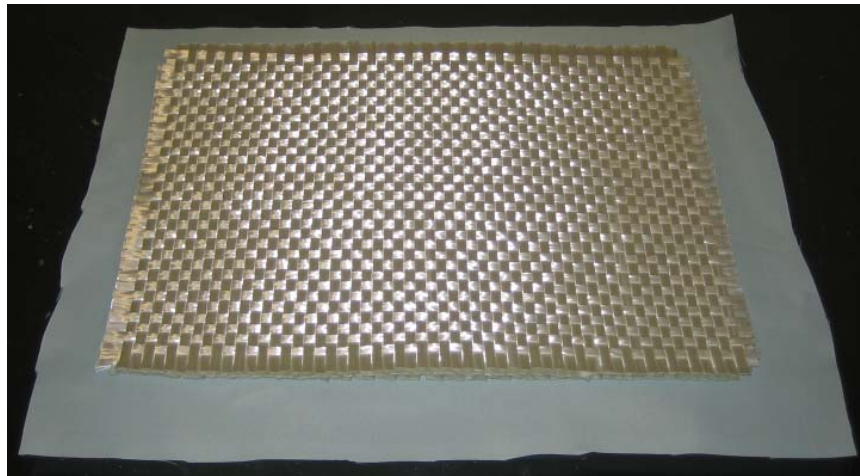
Figure 6. Bottom five layers of a sample.

Next, the sample size was chosen and the fiber materials were cut to the appropriate size. For all samples, 10 layers of fabric were cut, five for the bottom layer, and five for the top layer. The bottom five layers were then placed on top of the peel ply, as shown in Figure 6. For the co-cure process, a Teflon® film of thickness 0.0051 cm (0.002 in) was placed partially on top of the bottom five layers in order to build a crack into the sample. The last five layers of fiber material were evenly stacked on top of the fiber material and Teflon® already in place. Then another layer of peel ply, followed by a piece of distribution media, was stacked on top of the complete co-cure sample. For the double-cure sample, the bottom five layers were covered with the peel ply and distribution media, as shown in Figure 7.

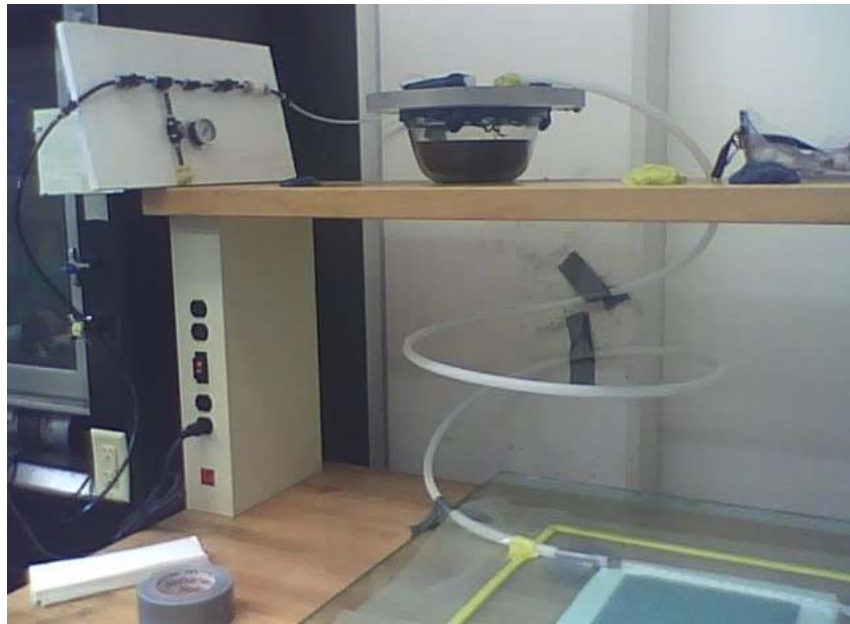
Figure 8. Gage board and resin trap.

In order for the resin to be pulled through the fiber material, a Rietschel Thomas Vacuum Pump model 2688CE44 was used. Tubing was hooked up to this pump and run through a gauge board to a resin trap, as shown in Figure 8. The resin trap was used to protect both the pump and gauge board from excess resin. From the resin trap, solid ½-inch diameter plastic tubing was measured and cut to be used inside the vacuum bag as the outlet for the resin. This same tubing was used to suck resin from the bottom of the sample to the top. Attached to both the inlet and outlet tubes, and spread across the top and bottom of the sample, was spiral tubing, as shown in Figure 9. This tubing allowed for an even distribution of the resin throughout the sample.

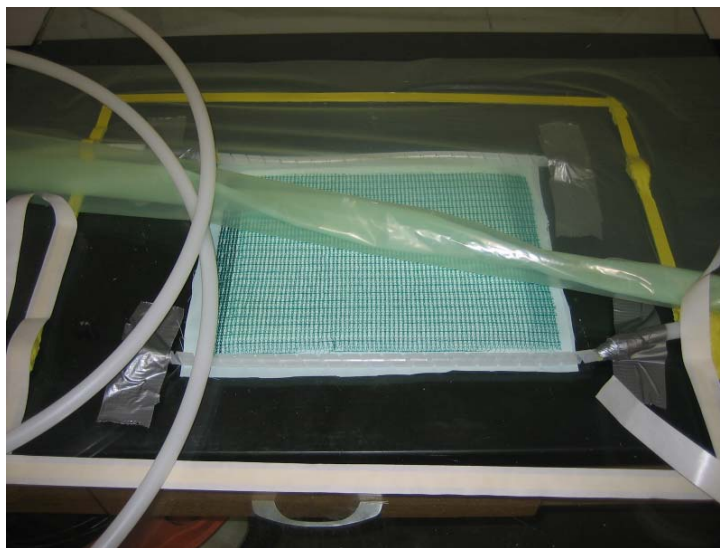
Figure 11. Rolling out the plastic sheet used to form the vacuum bag.

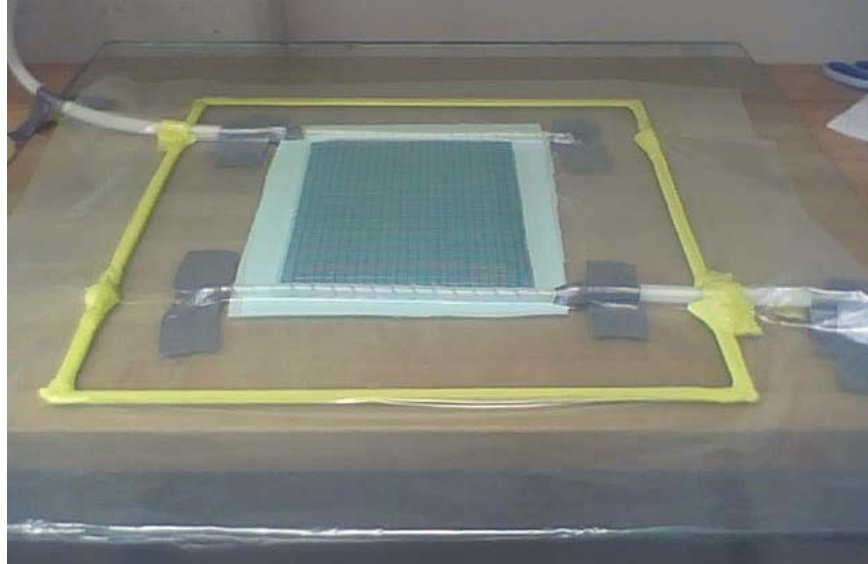
Figure 12. Sample setup under vacuum.

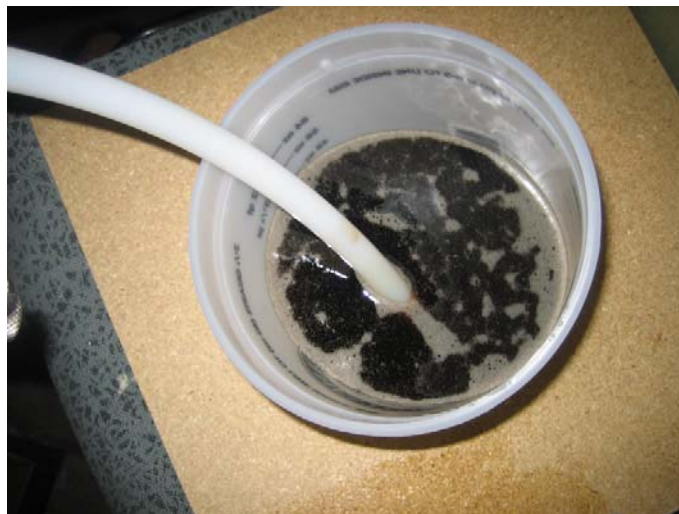
Figure 13. Resin at inlet with bubbles after mixing.

While the vacuum was still running, the temperature was noted and the appropriate amounts of resin and hardeners were mixed to ensure a 60-minute cure time. Once mixed, the resin was transferred to the inlet of the vacuum bag and the inlet tube was clamped to prevent the resin from flowing through the sample. As a result of mixing and transferring the resin to a new bucket, small bubbles are formed throughout the resin, seen in Figure 13. Enough time (about 10-15 minutes), was allowed for these bubbles to dissipate before running the resin through the sample. If allowed to run through the sample, these bubbles would have gotten caught and ruined the sample.

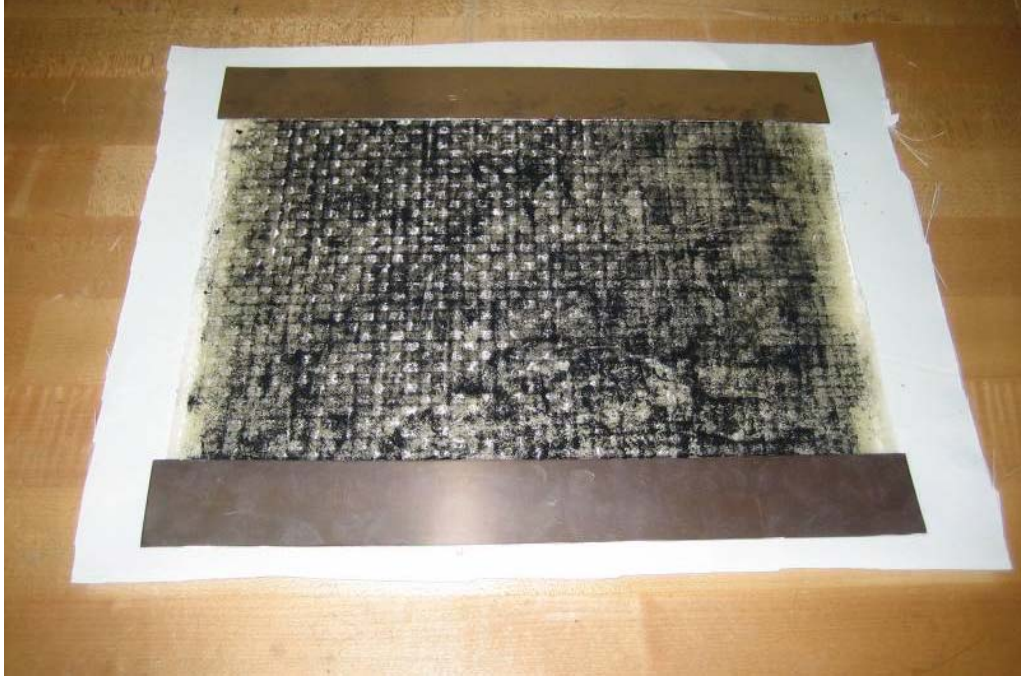
Figure 16. Bottom layer of two-step cured sample covered with CNTs.

CNTs, they were dispersed over the top of the entire sanded composite plate using acetone, again ensuring enough time was allowed for the acetone to dry, as shown in Figure 16.

For sample sets two and three, thin pieces of stainless steel plates were fastened to the top and bottom of the sample, as shown above in Figure 16. The stainless steel was needed to allow for a point to secure conductive test equipment to the sample and not interfere with any other testing. For all other samples, this step was skipped.

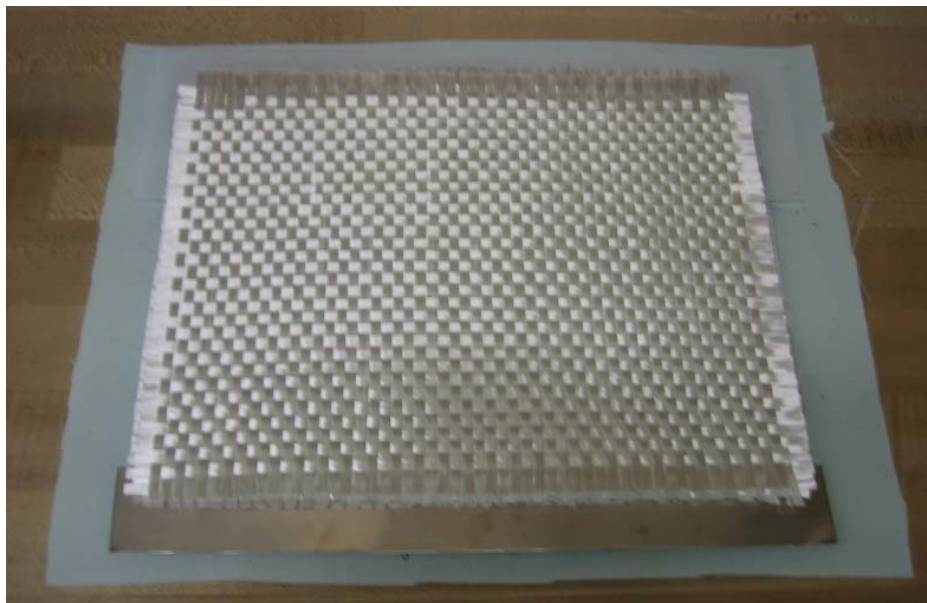
Figure 18. Remaining fiber material stacked on top of bottom plate.

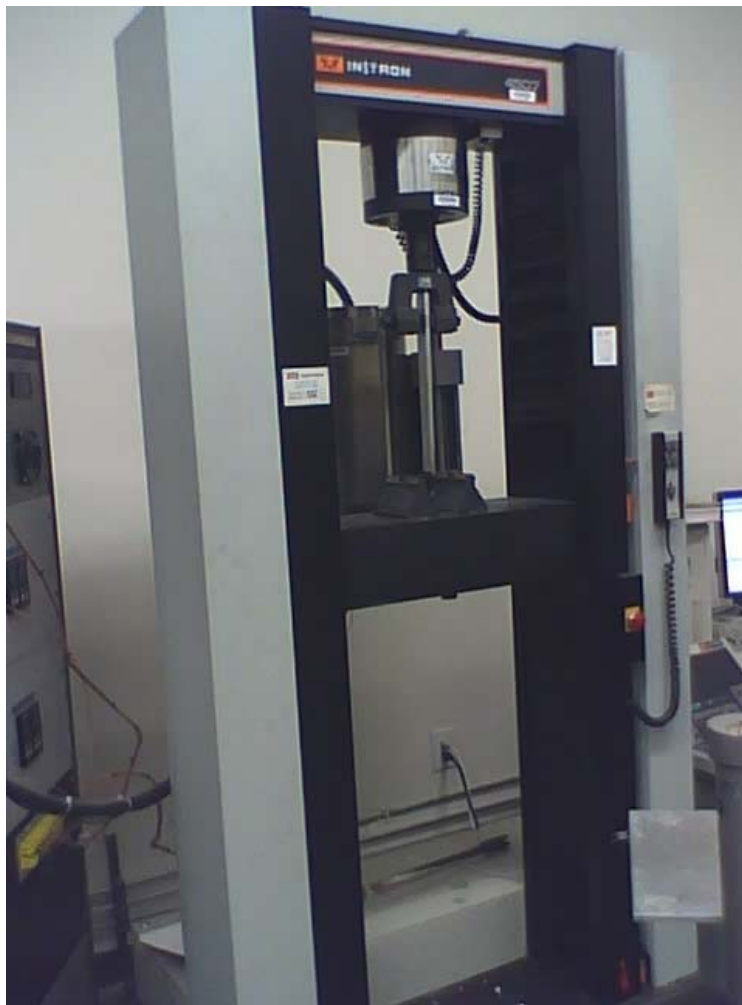
Figure 19. Mode II test setup in Instron test machine.

All tests were conducted using an Instron Tension/Compression Machine (Model Number: 4507/4500), shown in Figure 19. All testing phases were conducted using a 10-kN load cell. Collection of data generated by the Instron was done by a Series IX computer software which was also used to control the Instron to achieve desired test requirements. Additionally, for Phase III, IV, and V, the coupons were hooked up to a Fluke 8840A multi-meter as displayed in Figure 20. This device was used to measure the resistance within the coupons throughout the entire test period. Data produced from this machine was collected by hand at 30-second intervals.

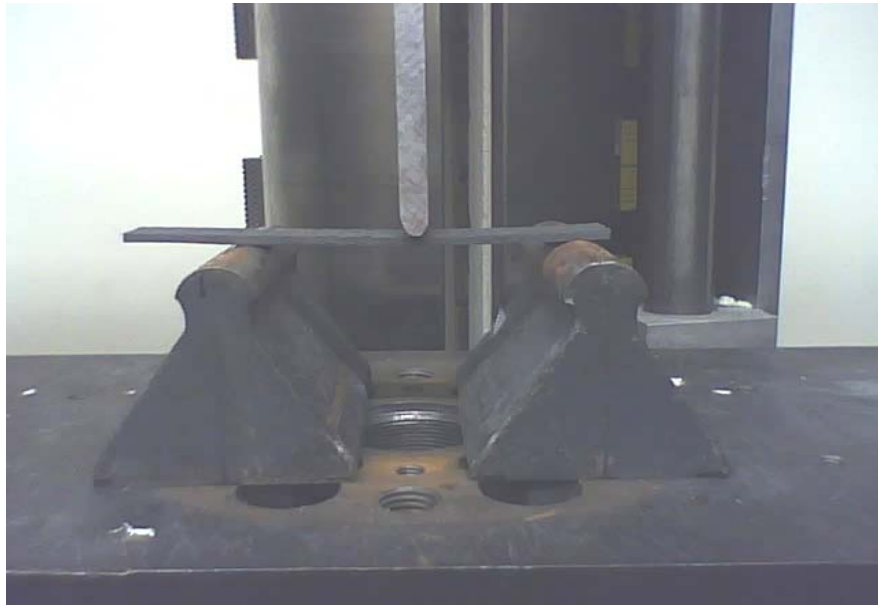
Figure 22. Picture of three-point bending test for Mode II.

The setup used is shown in Figures 21 and 22. For all tests, the Instron held the center support stationary, attached to the load cell, while the base supports were incrementally moved up into the stationary support. The higher the base moved the greater the load felt on the coupon became, resulting in higher shear stresses felt at the crack tip. A plot of force versus displacement was provided from the Series IX computer software and used to help calculate the Mode II critical strain energy release rate, G_{II} .

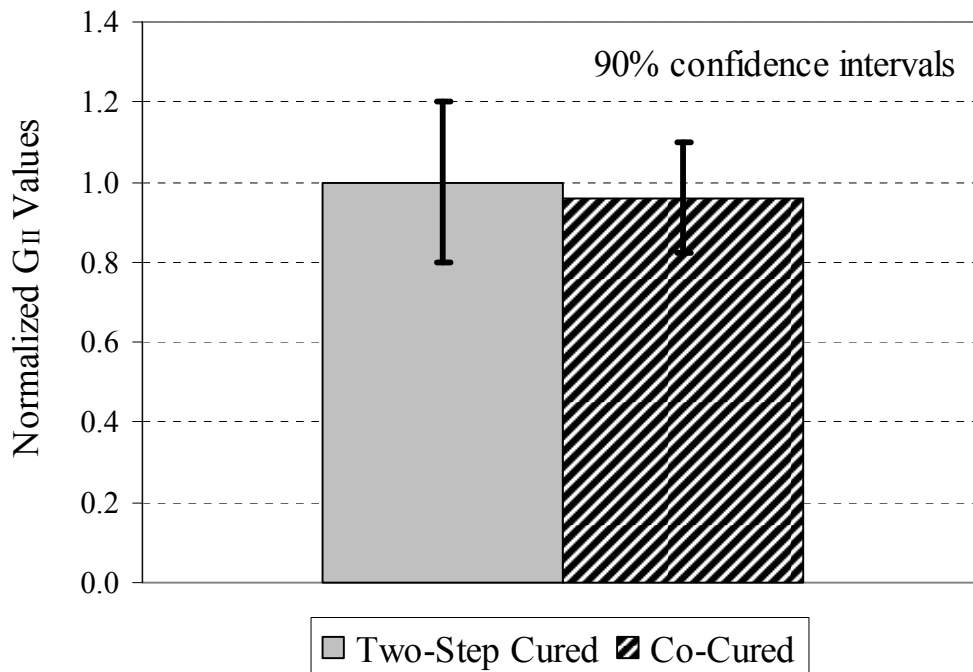
Figure 23. Normalized mean values of G_{II} for carbon fiber composite samples with two-step and one-step curing.

Once a set span length was acquired, test results showed a slight increase in G_{II} for two-step cured coupons over that of co-cured coupons, although this increase was not statistically significant at the $\alpha = 0.05$ level (i.e., a two-sided 90% confidence interval). Figure 23 shows the normalized average values of G_{II} , showing the five two-step cured coupons with G_{II} values 3.8% higher on average than the six co-cured coupons. The G_{II} calculations for each coupon are tabulated in Appendix A, Section A.

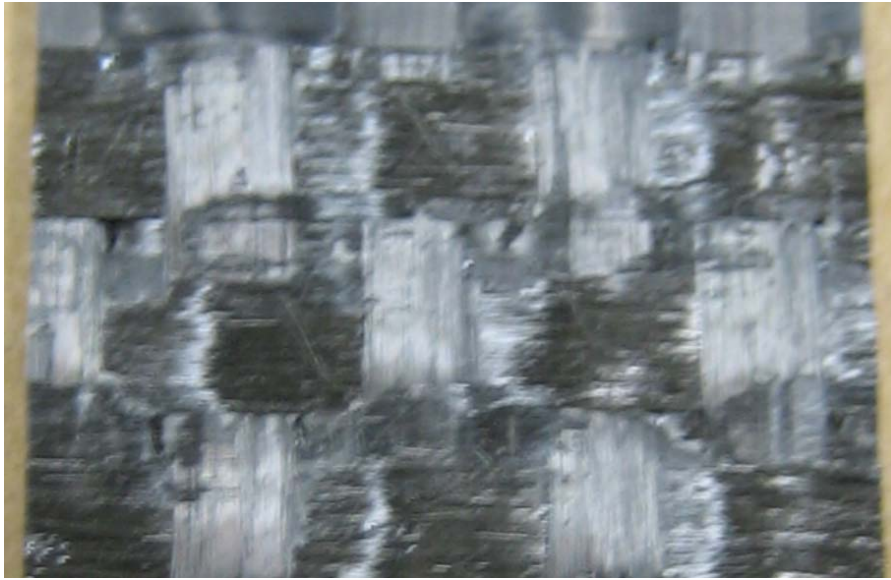
Figure 26. Surface crack propagation path for a co-cured coupon.

After testing was complete, coupons in which crack propagation occurred were pulled apart to inspect the cracked surface. Both the co-cured and two-step cured coupons experienced the same type of failure. In some areas, the joint interface bond was

broken through the resin, while in others the resin was pulled away from the fibers, as shown in Figures 26 and 27.

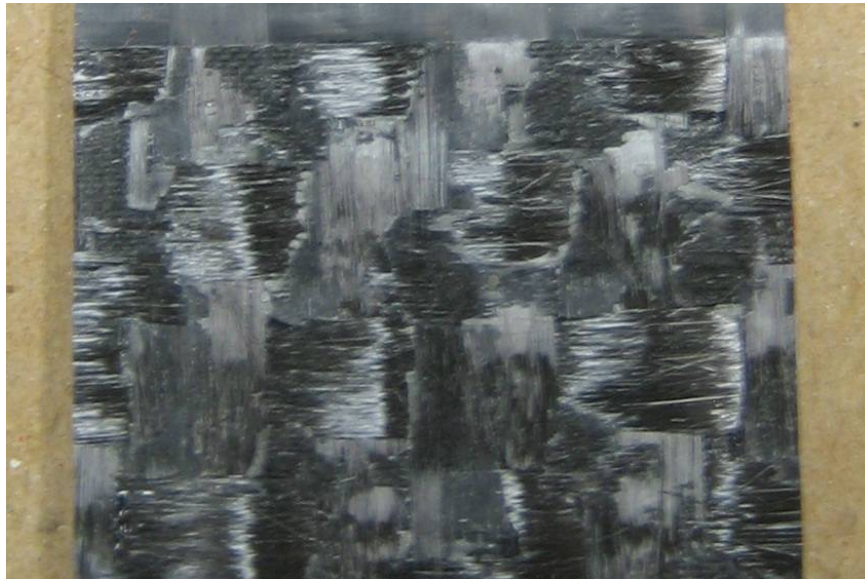
Figure 27. Surface crack propagation path for a two-step cured coupon.

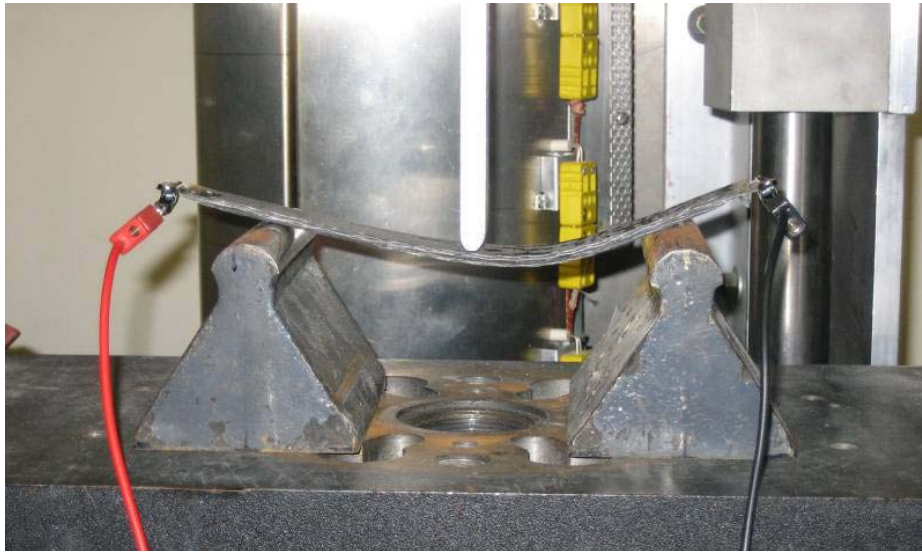
Figure 28. Carbon fiber Mode II resistance testing in bent position.

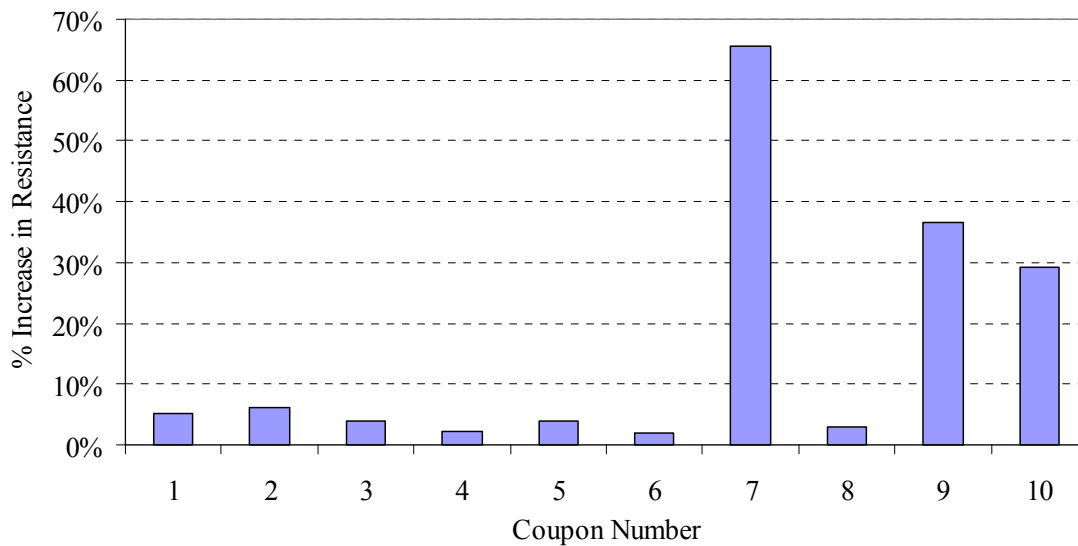
Figure 29. Electrical resistance increases for carbon fiber composite coupons after crack propagation upon unloading.

attributed to the CNT dispersion method used during the VARTM process. On average, the increase in resistance readings for carbon composite coupons with a layer of CNTs was 15.7%, although the majority of coupons had increases less than 10% as shown in Figure 29. It is important to reiterate that these increases were seen after the coupons were unloaded. Thus, even after the crack had propagated, the electrical resistance was not significantly altered while still under load. Only after returning to the unbent position was the damage evident through higher resistance readings.

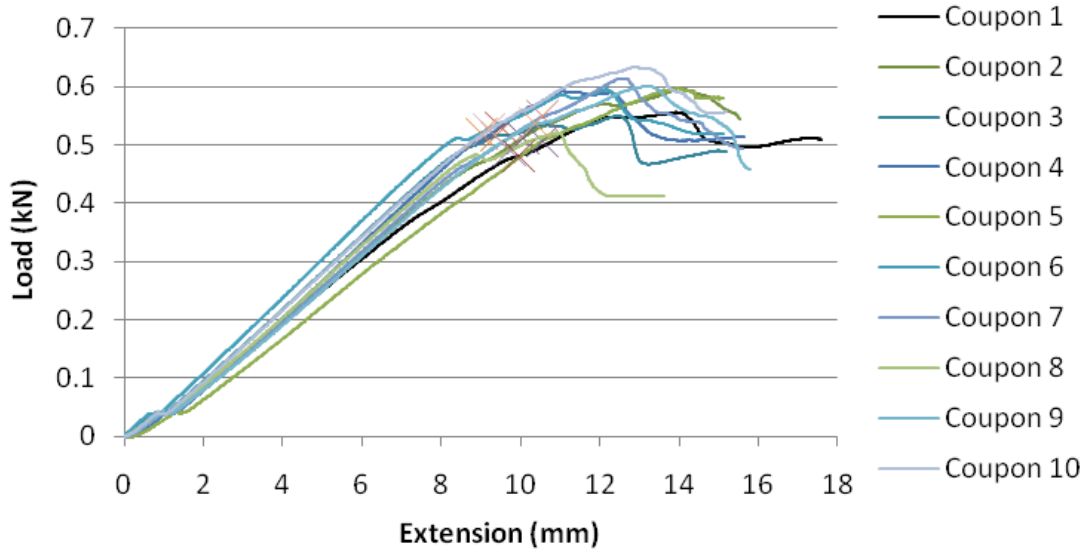
Figure 30. Load-extension data for carbon fiber composites with CNTs.

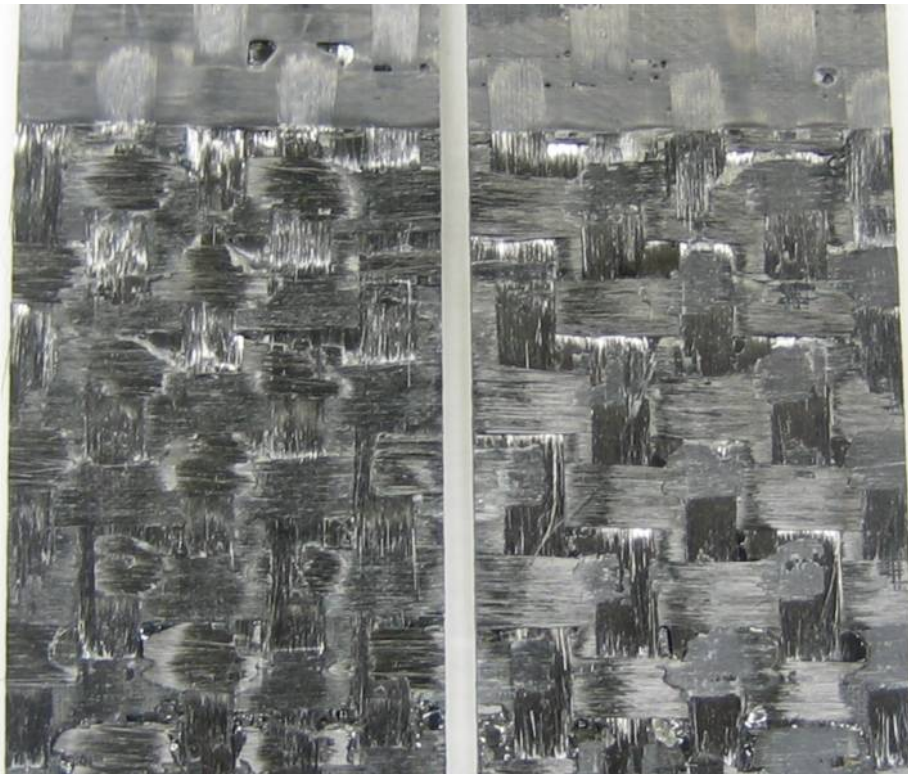
Figure 33. Crack propagation path of carbon fiber composite without CNTs.

Based on previous Naval Postgraduate School research²⁶, the layer of CNTs within the carbon fiber composite acted as expected. The coupons without CNTs experienced crack propagation at the initial crack tip, followed by propagation through the joint interface. Coupons with CNTs first experienced cracking at areas away from the crack tip, giving evidence of the strengthening effect of the CNTs along the interface. These cracks then propagated back towards the initial crack tip. These different crack propagations can be verified by observing the surface of the joint interfaces where cracking occurred. Figure 33 shows the relatively smooth joint interface of a coupon without CNTs, with few fibers broken. This is a result of the crack propagating through the joint interface. Figure 34, on the other hand, shows the rougher joint interface of a composite coupon containing CNTs. The rough surface has CNTs on both sides, as well as several areas where the crack propagated back to the initial tip through fibers. The crack was forced to propagate through the fibers due to the CNTs at the joint interface strengthening it and making it resistance to crack propagations.

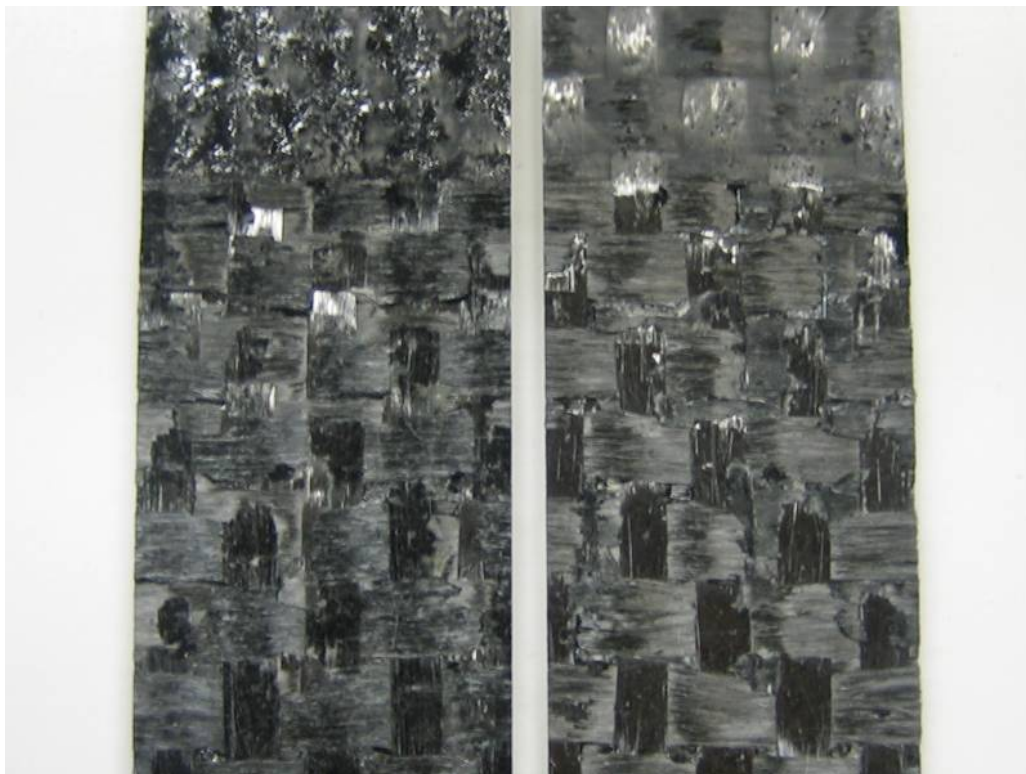
Figure 34. Crack propagation path of carbon fiber composite with CNTs.

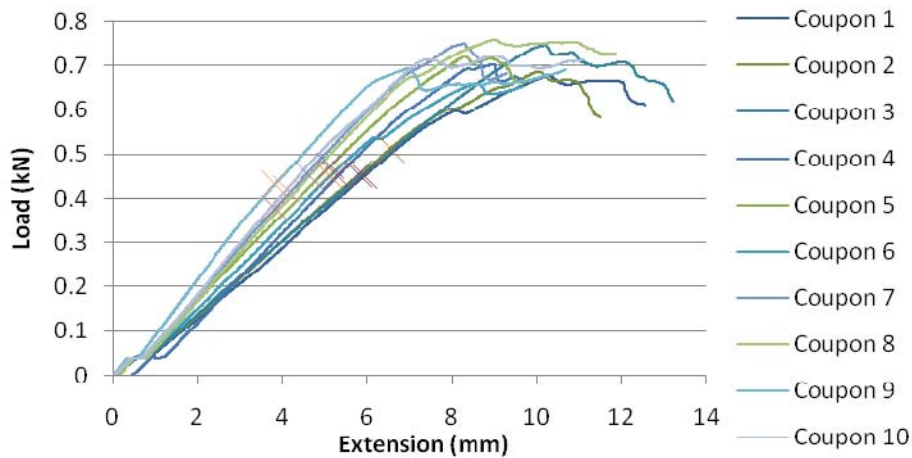
Figure 39. Load-extension data for fiberglass coupons without CNTs.

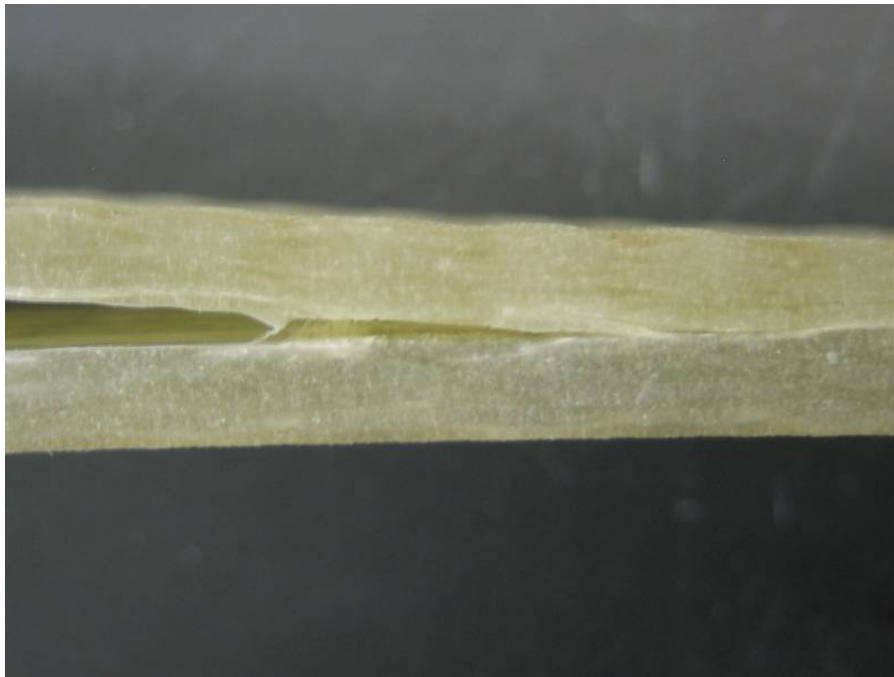
Figure 41. Crack propagation image for fiberglass coupon without CNTs.

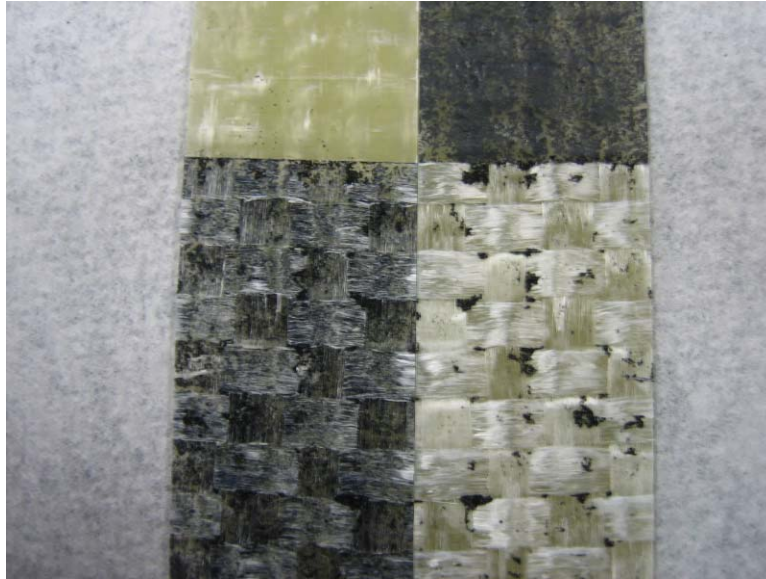
Figure 44. Surface view of crack propagation path in fiberglass coupon with CNTs.

After all testing was completed, coupons in which crack propagation occurred were pulled apart to inspect the cracked joint interface surface, and verify crack propagation paths. When the fiberglass coupons with CNTs were pulled apart, one side contained more CNTs than the other. Looking closer, it could be seen that initially the crack did propagate through the layer of CNTs, but then quickly took the path of least resistance under the layer of CNTs through the fiberglass. The fiberglass coupon without CNTs showed a slightly different crack propagation path. The joint interface bond was broken through the resin by the crack propagation, resulting in the resin being pulled away from the fibers. Both surface interfaces are shown in Figures 44 and 45.

The differences in crack surfaces can also explain the differences in the physical observations, as well as the differences in the loads each sample set was able to carry. The pure fiberglass composite acted as the two-step cured samples tested during Phase II. The crack propagated through the joint interface, an area which was inherently stronger due to the VARTM process. This allowed for higher loads to be carried and slower crack growth. The fiberglass without CNTs acted more like the co-cured samples from Phase

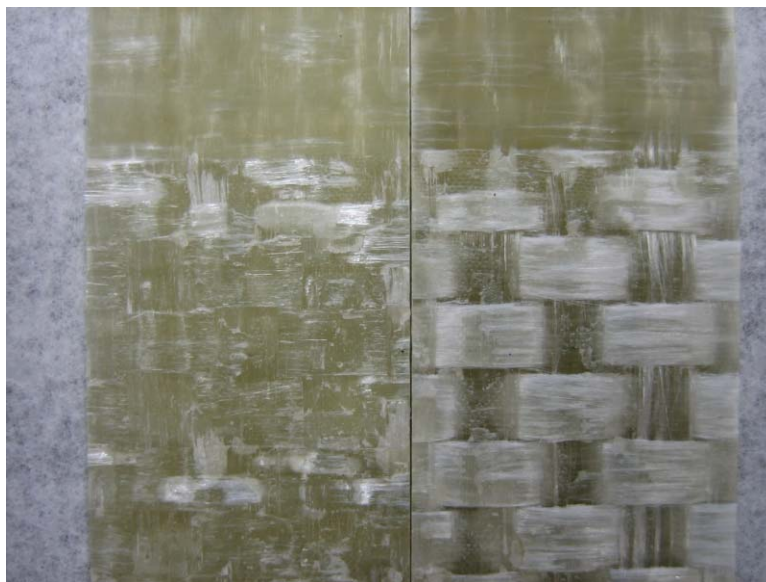
Figure 45. Surface view of crack propagation path in fiberglass coupon without CNTs.

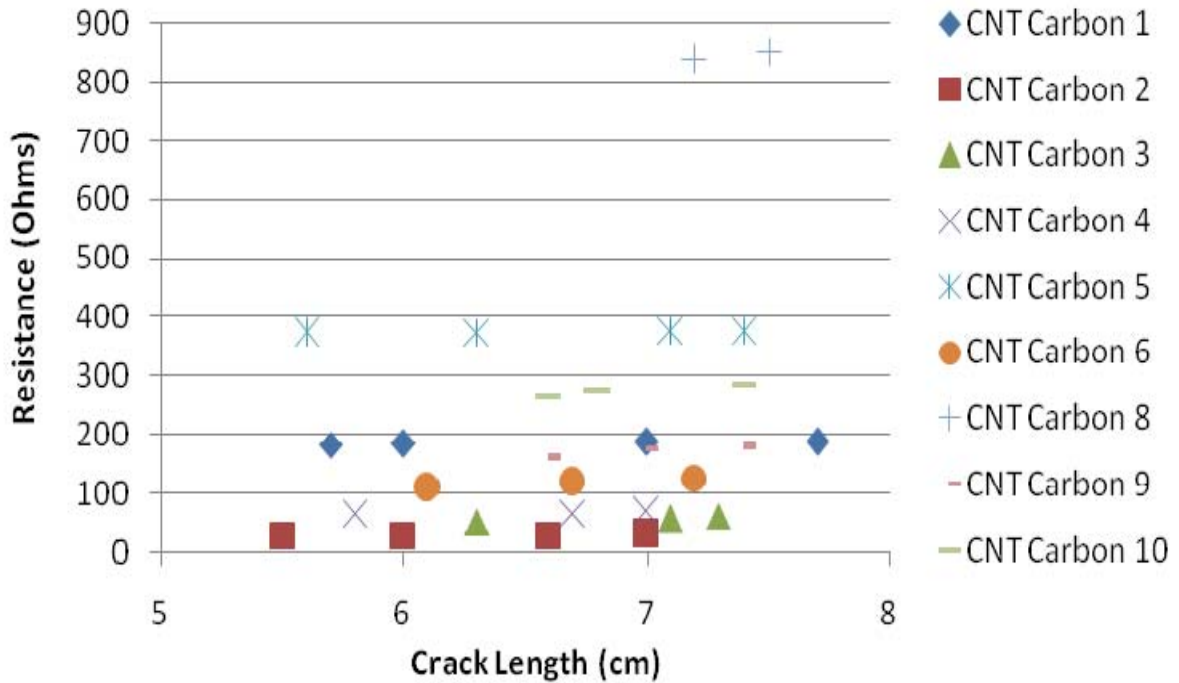
Figure 46. Resistance vs. crack length for all carbon fiber coupons with CNTs.

After taking the consistency readings, the carbon fiber coupons were then manually cracked using the Instron machine. Once the crack propagated, which was determined by both sight and sound, the new crack length was measured, and the corresponding resistance reading was taken. This was done repeatedly until the crack tip had reached the point of load application, and it was no longer possible to further crack the coupons with the Instron machine. The resulting data was then plotted to determine the relationship between change of crack length and change in resistance. Figure 46 shows all the data collected for coupons with CNTs on the same graph.

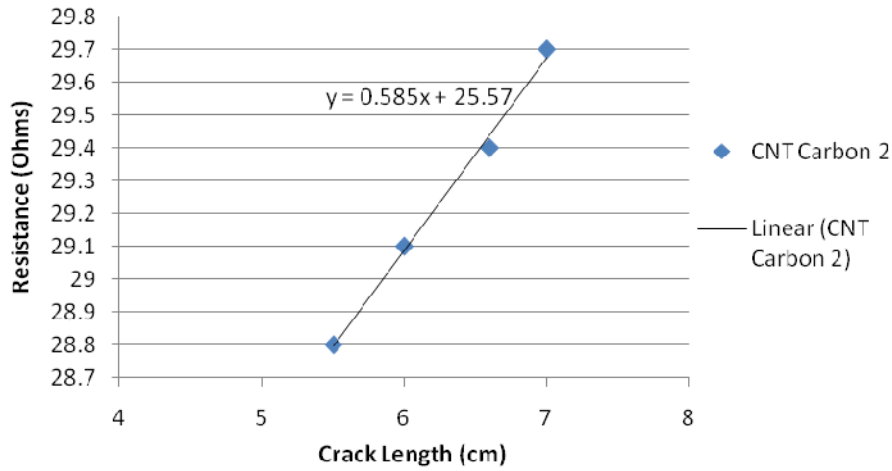
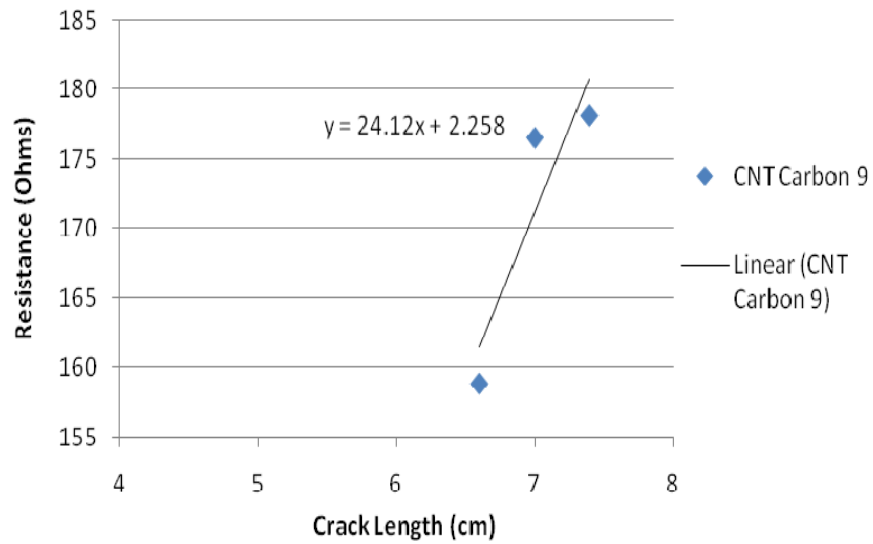
Figure 47. Electrical resistance vs. crack length, carbon fiber coupon #1.

Figure 48. Electrical resistance vs. crack length, carbon fiber coupon #2.

Figure 49. Electrical resistance vs. crack length, carbon fiber coupon #3.

Figure 50. Electrical resistance vs. crack length, carbon fiber coupon #4.

Figure 51. Electrical resistance vs. crack length, carbon fiber coupon #5.

Figure 52. Electrical resistance vs. crack length, carbon fiber coupon #6.

Figure 53. Electrical resistance vs. crack length, carbon fiber coupon #8.

Figure 54. Electrical resistance vs. crack length, carbon fiber coupon #9.

Figure 55. Electrical resistance vs. crack length, carbon fiber coupon #10.

Because the resistance readings from coupon to coupon vary due to unique CNT dispersions, it's useful to see the trends in resistance versus crack length for individual coupons, and determine if these trends follow similar relationships. The nine figures which follow (Figures 47 through 55) show the same data as in Figure 46, but data for each coupon are plotted separately. The electrical resistance varied approximately linearly with crack length for those samples with four data points, as these figures show. A least-squares linear regression line is shown for each, even if there were less than four data points. These figures show that no standard slope fits each plot, although an average value was taken to be 13.68 ohms/mm with a standard deviation of 14.52 ohms/mm. The fact that each plot of resistance versus crack length has a different slope presents a challenge to the use of dispersed CNTs as a means for damage progression. It appears that it is very important to make the CNT networks as uniform as possible. In addition, calibration for each specimen may be required.
