A first report on electromigration studies at a model
copper-aluminum railgun contact

THESIS

**A FIRST REPORT ON ELECTROMIGRATION STUDIES AT A
MODEL COPPER-ALUMINUM RAILGUN CONTACT**

Luc D. Delaney

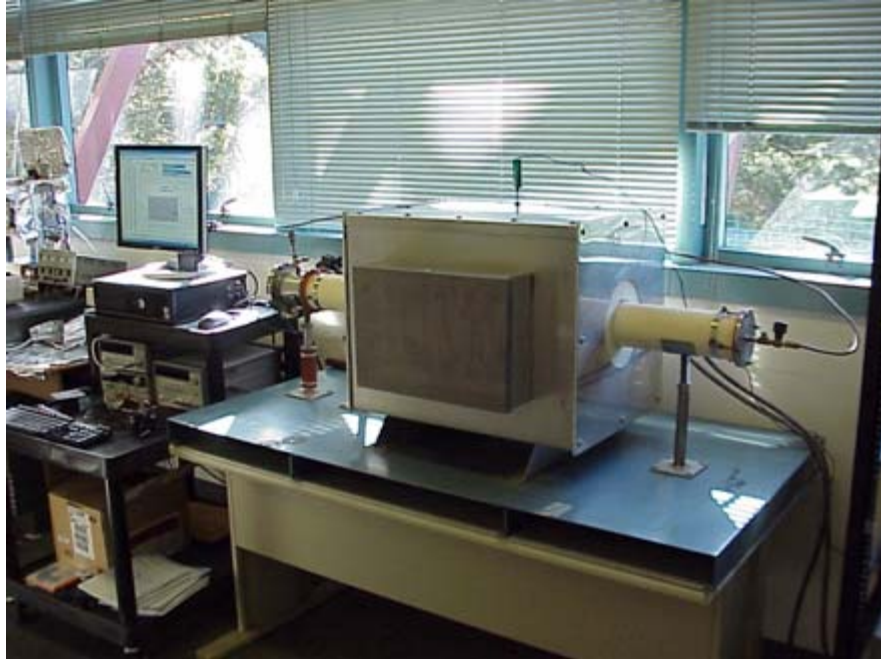
Figure 3. Picture of tube furnace and associated data logging computer.

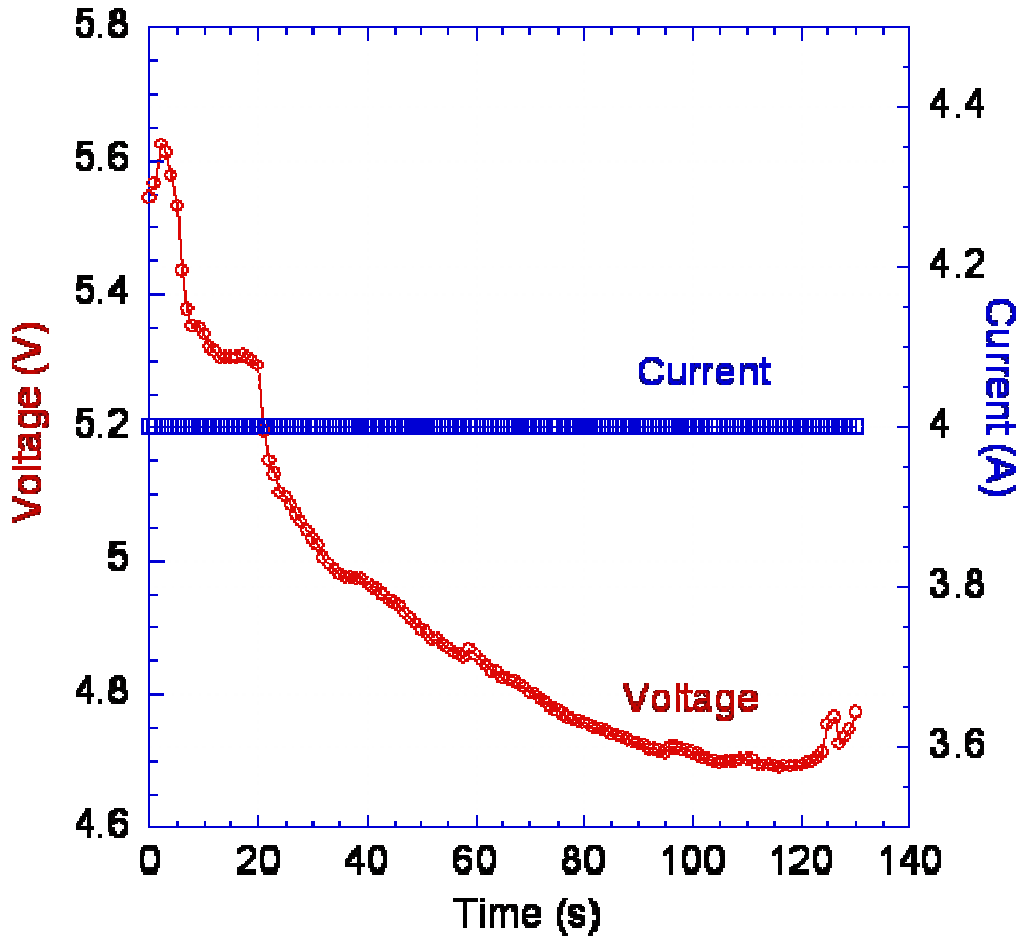
Figure 35. Voltage and Current versus time for two minute test.

The final test was conducted for a period of 130 seconds. The duration of this test was not predetermined; instead it was determined by watching the value of the voltage during the test. The voltage peak was observed and the test was allowed to continue until the low point of voltage was reached. Once the voltage began to increase the test was terminated, see Figure 35.
