THE EFFECTS OF MULTIPLE WELD
REPAIRS ON THE
ALUMINUM-MAGNESIUM ALLOY 5083-0

NAVAL POSTGRADUATE SCHOOL

THESIS

The effects of multiple weld repairs on the aluminum-magnesium alloy 5083-0 as used in the primary self-supporting containment systems for Liquefied Natural Gas Tankships were studied. The changes experienced by the material in microstructure, mechanical properties and stress-corrosion susceptibility as a function of number of weld repairs were carefully characterized and recorded. The results of these findings are discussed from both the metallurgical and the practical engineering standpoint.

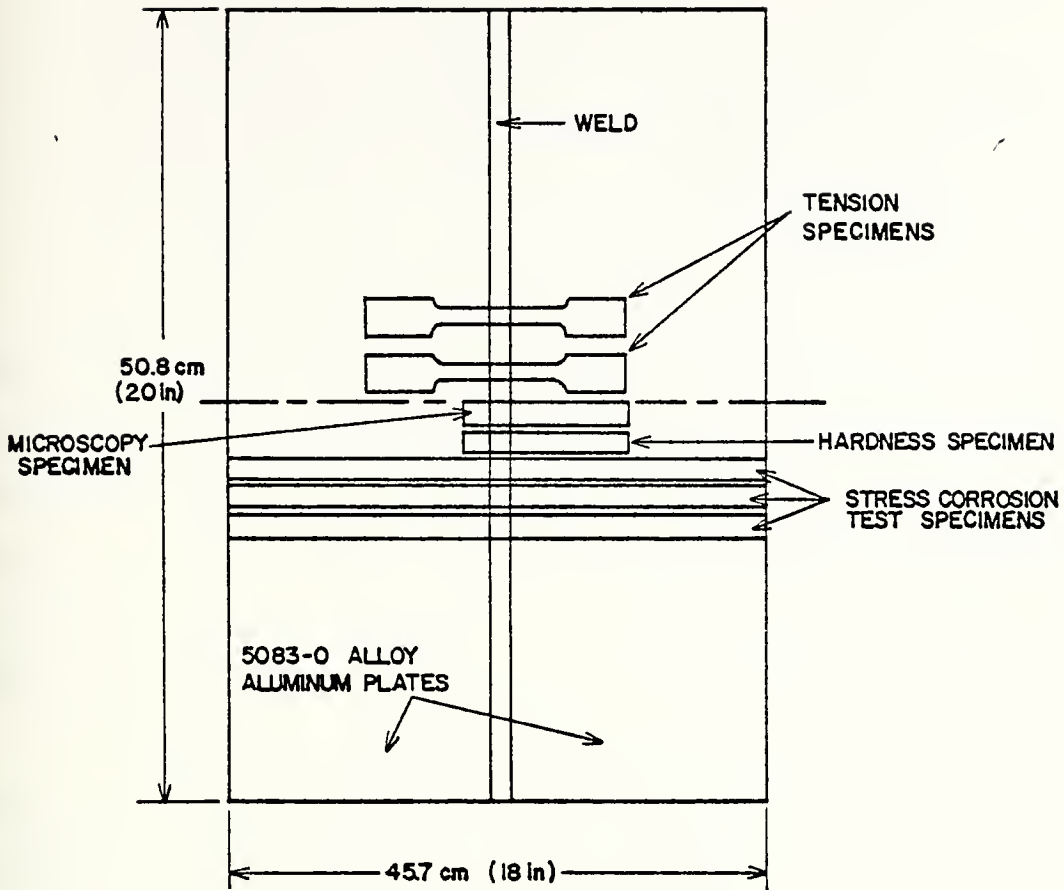
Figure 8. Schematic representing the areas of the welded test plates used for metallographic, mechanical, and stress corrosion testing. The specimens were taken as near the center of the test plates and as close together as possible to avoid significant differences in cooling rates between specimens.

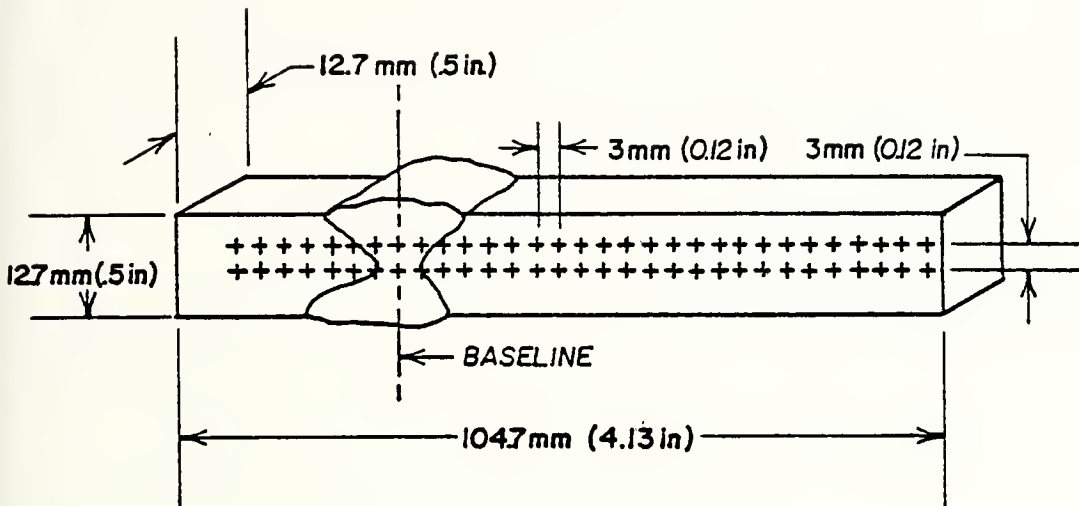
Figure 12. This figure represents the specimens used in determining the hardness profiles. The +'s indicate the locations where hardness data was compiled for each specimen. A series of hardness data was taken at 3 mm (0.118 inch) intervals along a line defining the midplane of the welded plate and at 3 mm from the midplane.

Hardness tests were performed on specimens taken from each of the nine test plates. Figure 12 shows the locations where hardness data was taken relative to the individual specimens. The specimens were prepared by machine surfacing to a surface finish of $\sqrt{65}$ followed by a final sanding on 600-grit wet/dry paper using kerosene lubricant.

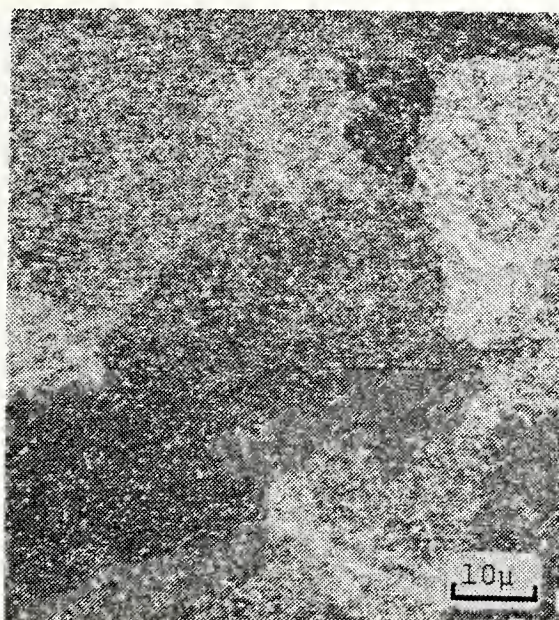
Figure 21. Photomicrographs in the etched condition of the specimens subjected to the original two-pass weld only (a), 8 (b) and 16 (c) repair simulations. The area represented in each of these micrographs is the "as-cast" weld metal. (100X, etchant: modified #12)

Figure 21 shows micrographs in the etched condition of the "as-cast" weld metal of specimens subjected to the original

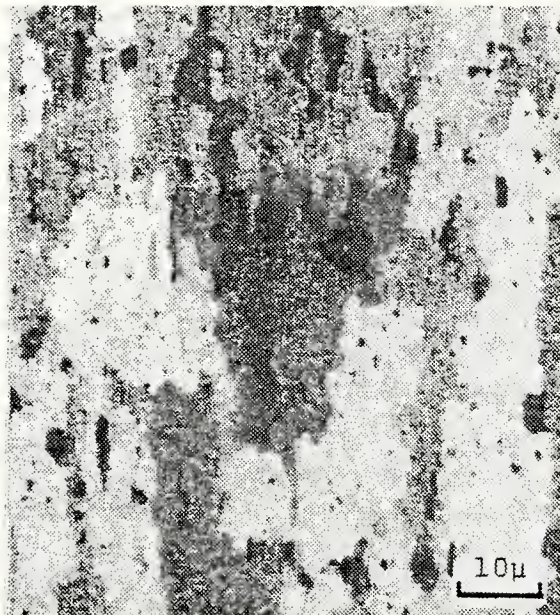
Figure 22. Photomicrographs taken of the etched specimen subjected to the original two-pass weld only. The locations represented are the interface (a), and approximately 6 mm (b), 18 mm (c) and 27 mm (d) from the interface. (100X, etchant: modified #12)

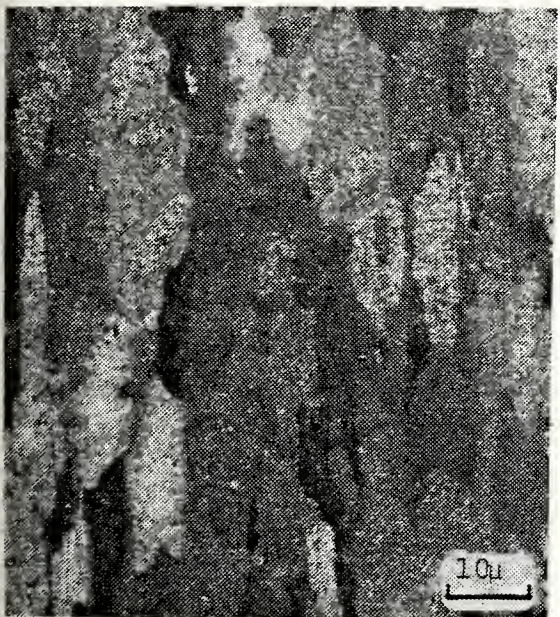
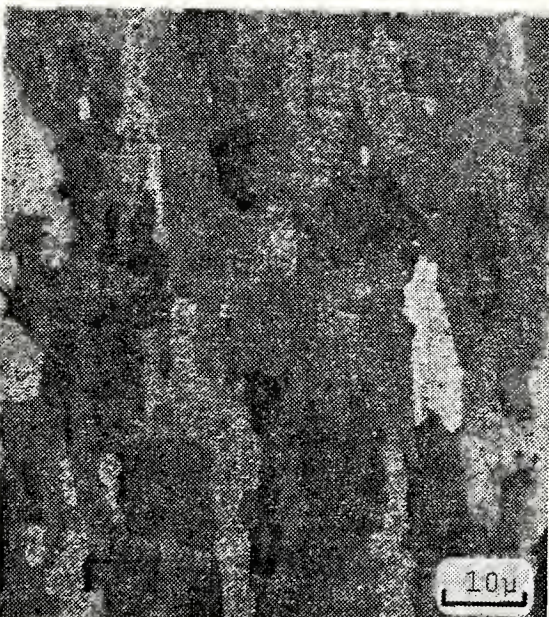
Figure 23. Photomicrographs taken of the etched specimen subjected to 4 repair simulations. The locations represented are the interface (a), and approximately 6 mm (b), 18 mm (c) and 27 mm (d) from the interface. (100X, etchant: modified #12)

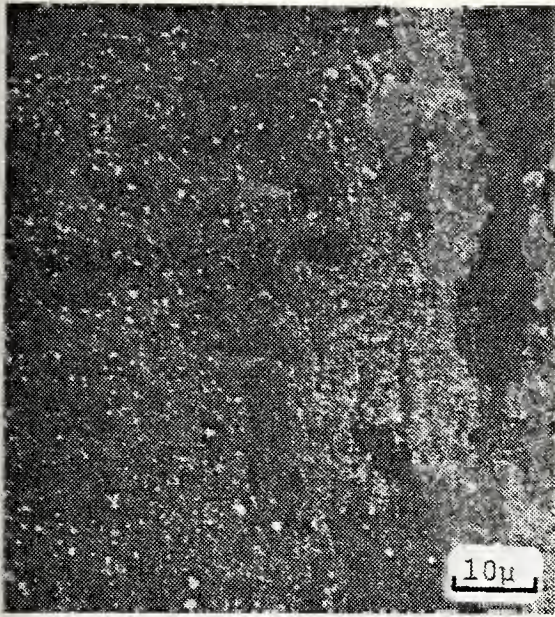
Figure 24. Photomicrographs taken of the etched specimen subjected to 8 repair simulations. The locations represented are the interface (a) and approximately 6 mm (b), 18 mm (c) and 27 mm (d) from the interface. (100X, etchant: modified #12)

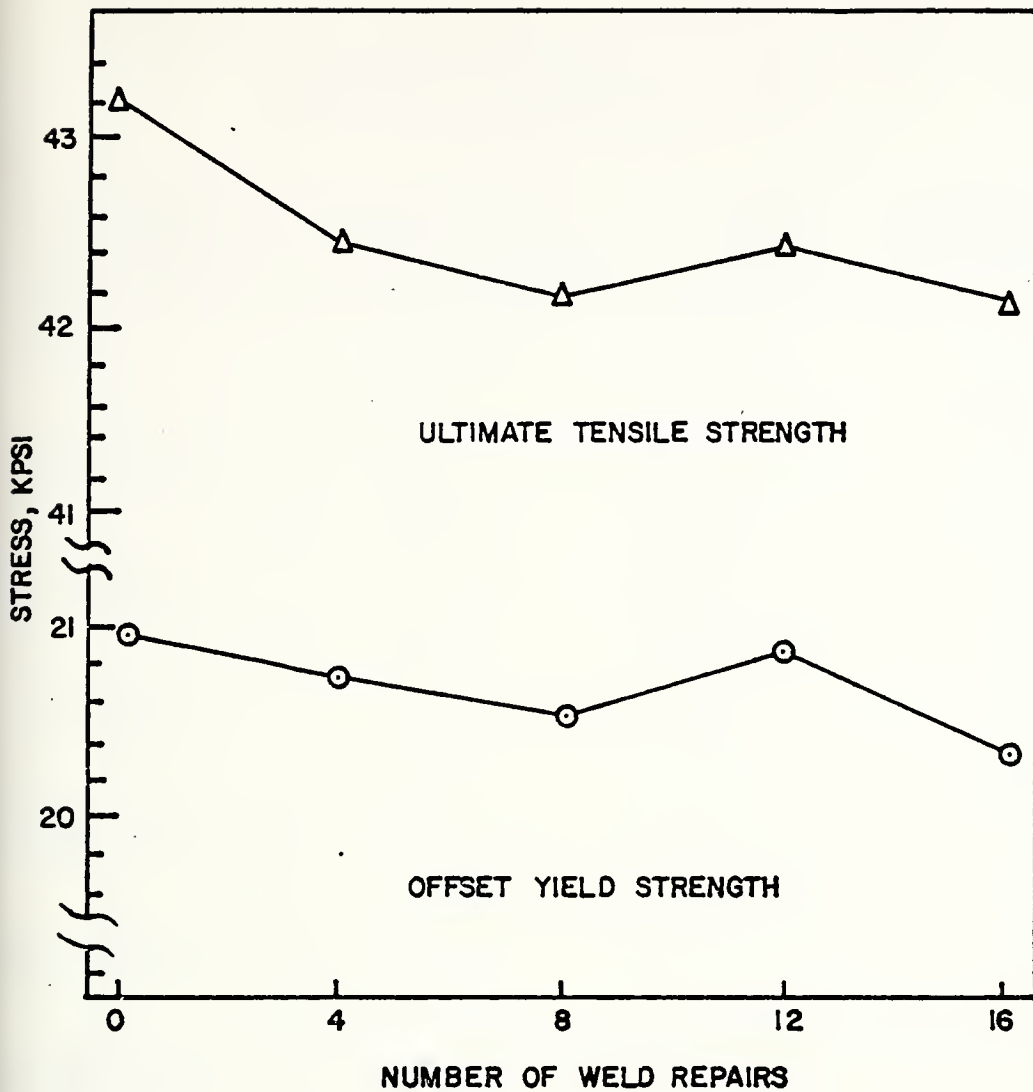
Figure 33. This figure is a plot of the average tensile strengths recorded for specimens subjected to the original two-pass weld only, 4, 8, 12 and 16 repair simulations as a function of number of weld repairs.
