NPS-56-80-012

COMBAT DAMAGE ASSESSMENT TEAM
A-10/GAU-8 LOW ANGLE FIRINGS
VERSUS
SIMULATED SOVIET TANK COMPANY (ARRAY 25)
(LAVP LOT NUMBER AJD79A181-001)
(4 DECEMBER 1979)

OCTOBER 1980

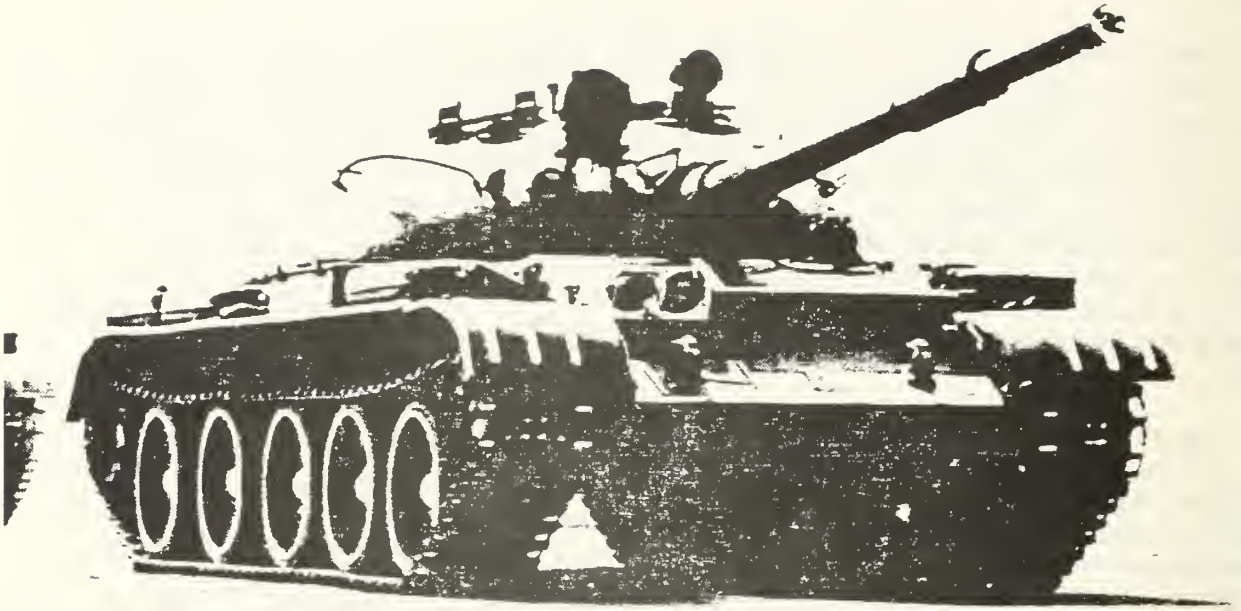
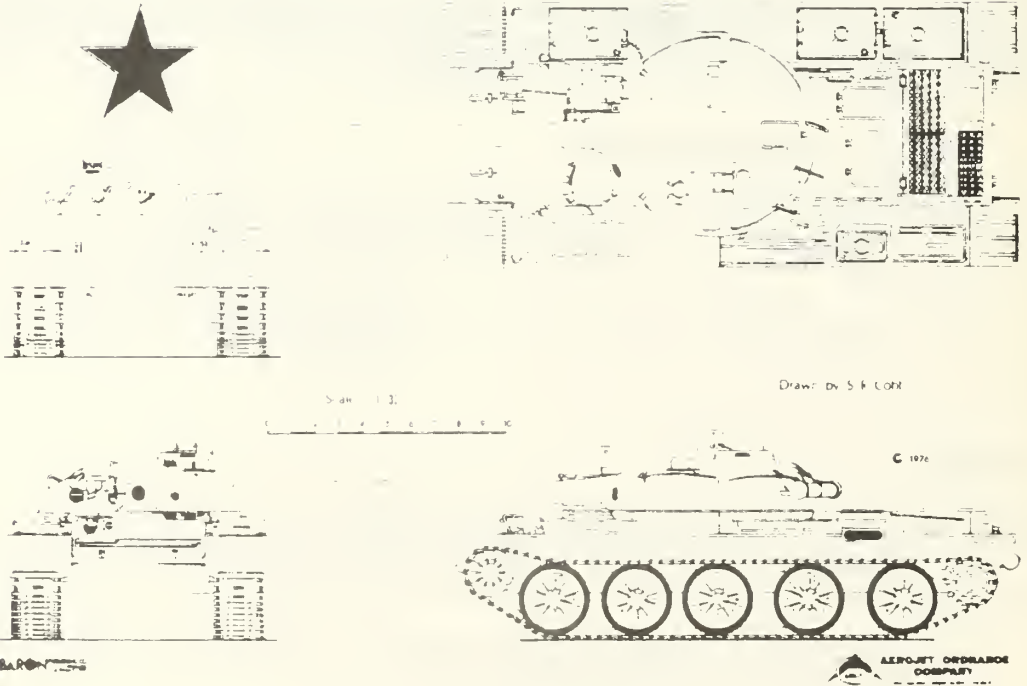
FIGURE 1. Russian T62 Medium Tank.

The most effective targets, available in sufficient numbers to simulate Soviet T-55 and T-62 tanks (Figure 1), were the US M-47 tanks. Both of the Soviet tank models are similar in armor protection to the M-47. With appropriate purging of the gasoline fuel system of the US tanks, the CDAT managed to field targets similar in survivability to the T-55 and T-62 tanks in terms of their ignitable internal material. Few data are available on armor protection and the arrangement of internal components in the Soviet T-64 and later model tanks. The decision was made, accordingly, to simulate the earlier model Soviet tanks with the readily available US tank equivalents.

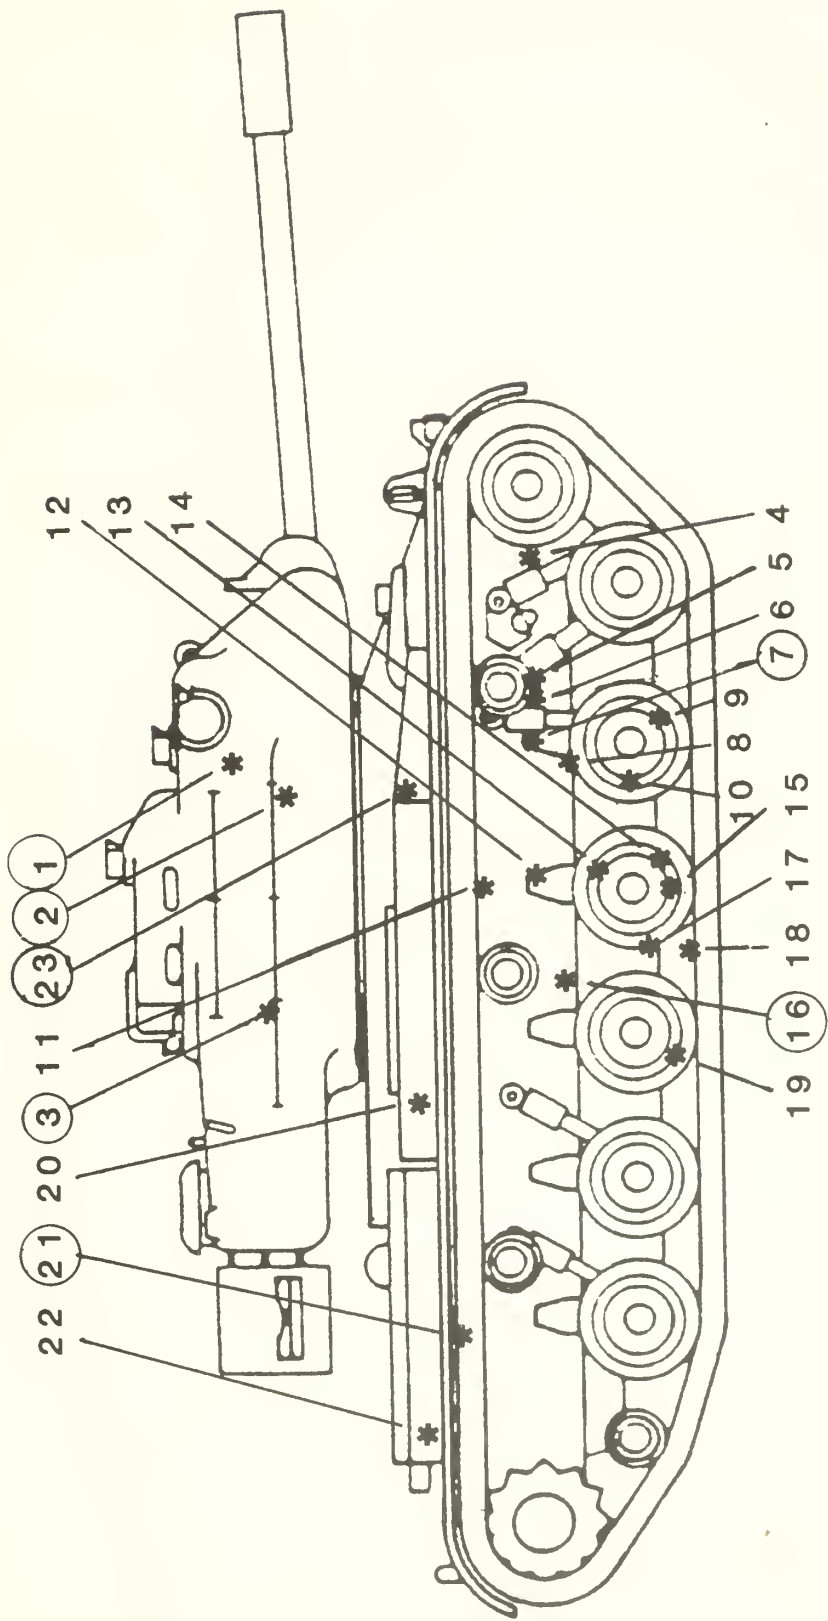
100% M-Kill and 95% F-Kill, resulting from the following observed effects (Figure 7):

a. Perforations	:	7
b. Significant Impacts	:	4
c. Insignificant Impacts:		<u>12</u>

- a. M-Kill: A 100% M-Kill was assessed, based on Impacts 16 and 21 which perforated the right hull armor and penetrated the fuel tank and oil cooler, and on cumulative damage to the track and suspension system caused by Impacts 4, 5, 6, and 8.
- b. F-Kill: A 95% F-Kill was assessed, based on Impacts 1, 2, and 3 which perforated the right turret, penetrated the fighting compartment, caused damage to the gunner control panel, destroyed gunner's power control handle, and caused casualties to the commander, gunner, and loader.

Circled numbers indicate perforating impacts.

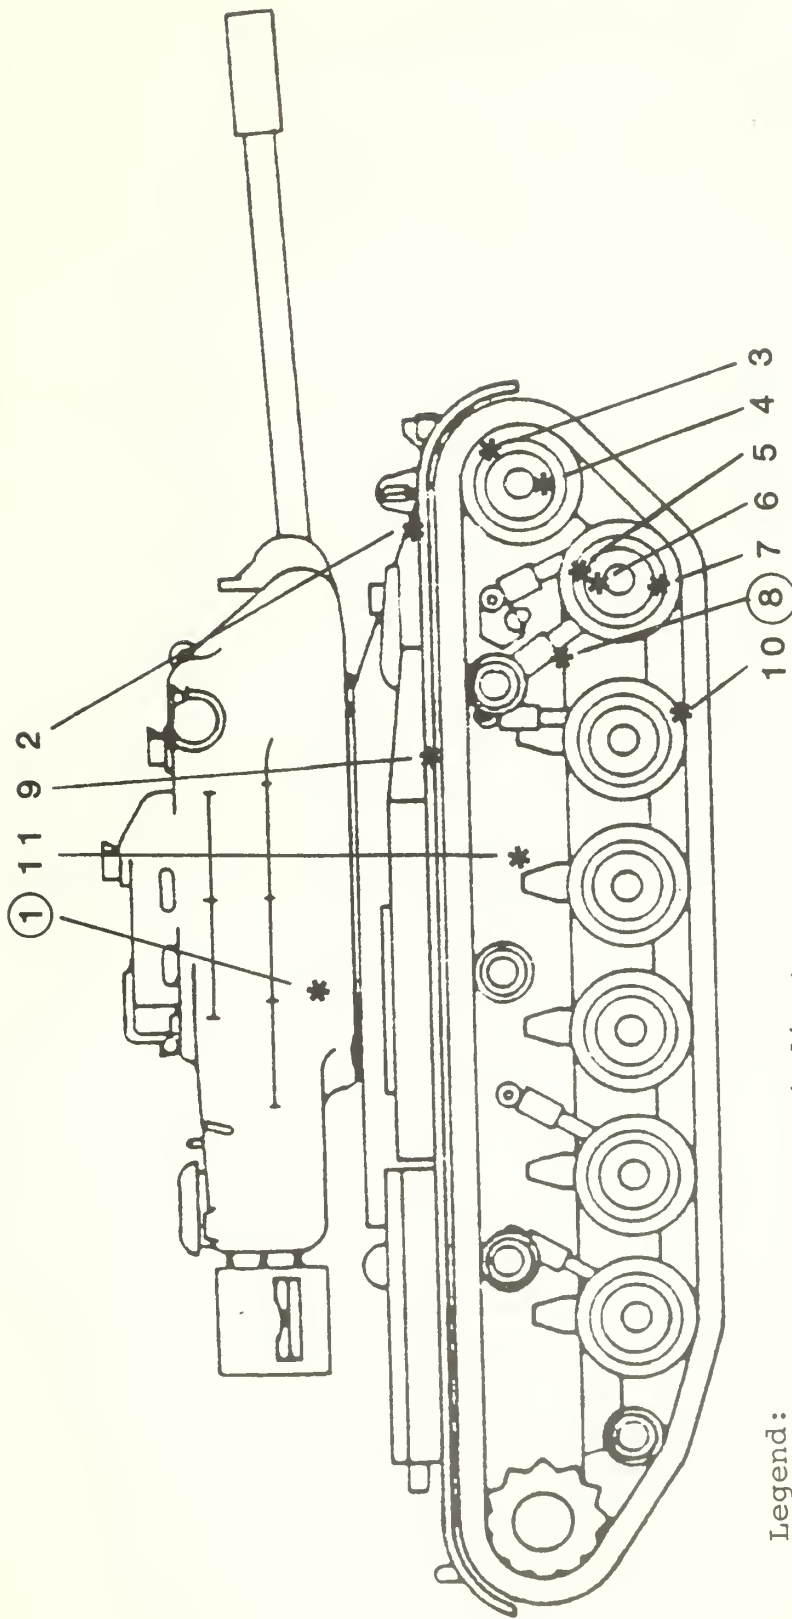
65% M-Kill and 70% F-Kill, resulting from the following observed effects (Figure 8):

- a. M-Kill: A 65% M-Kill was assessed, based solely on the contribution to a mobility kill caused by commander and loader casualties. Mechanical damage to mobility components was insignificant.
- b. F-Kill: A 70% F-Kill was assessed, based on Impact 1 which perforated the right turret and penetrated into the fighting compartment, severing the power control wiring harness and causing casualties to the commander and loader.

Legend: Circled numbers indicate perforating impacts.

NOTE: Impacts 12 and 13 are not shown in this view.

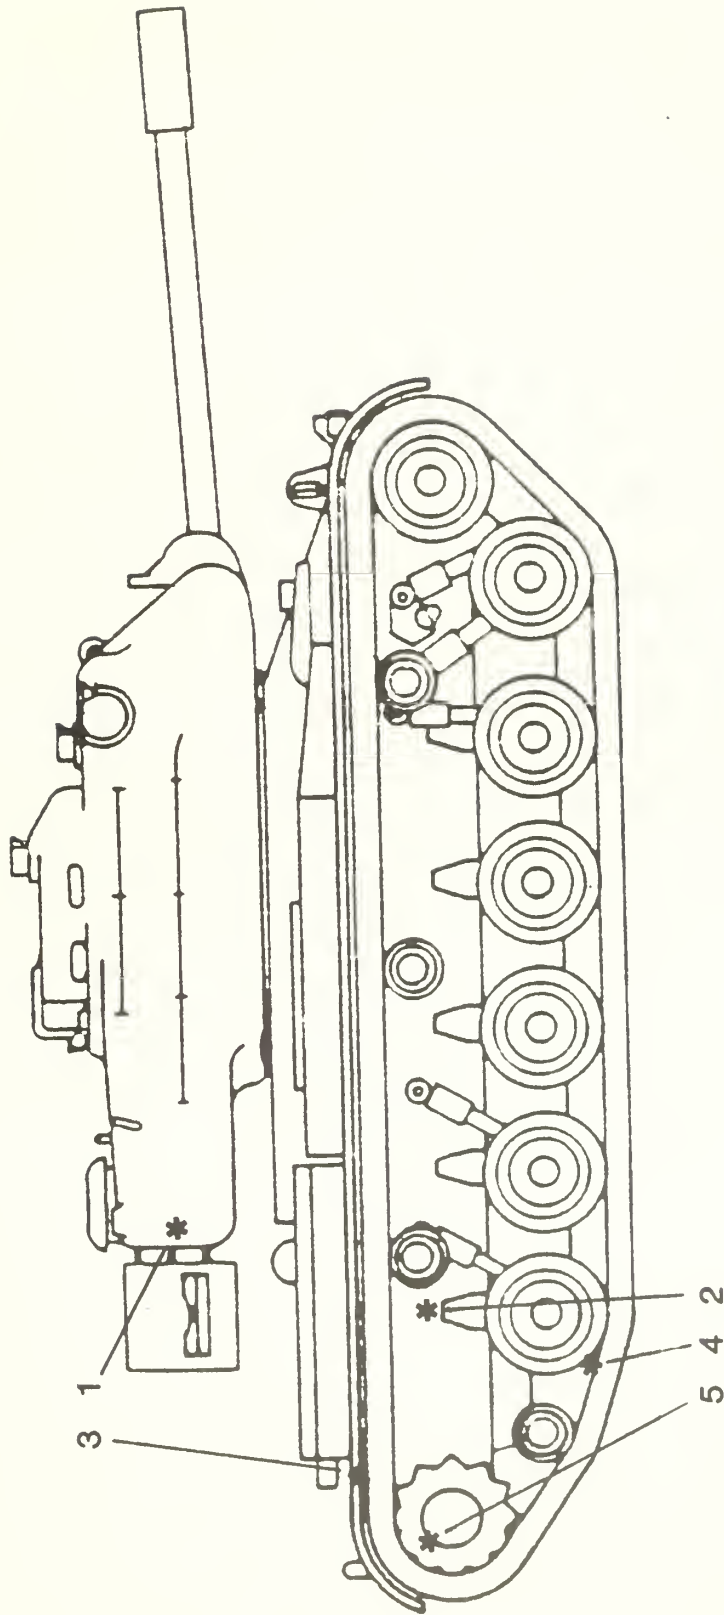
FIGURE 9. Impact Diagram, Target 71.

100% M-Kill, resulting from the following observed effects:

The assessment of 100% M-Kill is based on damage caused by Impact 4 which severed one wedge nut, destroyed one center guide and one end connector (Figure 9), all on one pair of track shoes. This would have caused track failure after 300-500 meters of movement.

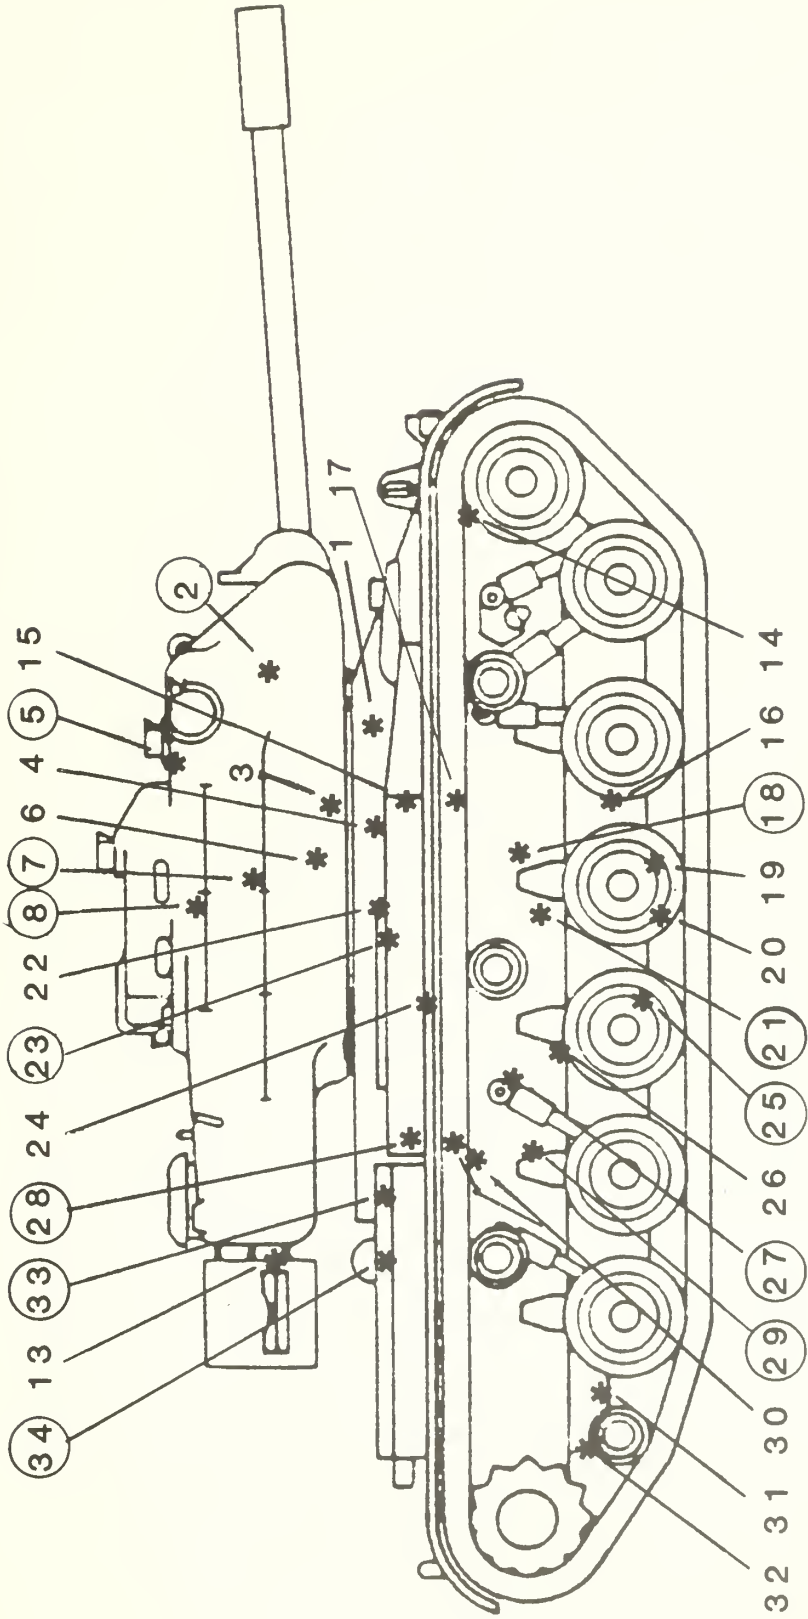
FIGURE 10. Impact Diagram, Target 50, Right Side.

100% M-Kill and 95% F-Kill, resulting from the following observed effects (Figures 10 and 11):

- a. M-Kill: The assessment of 100% M-Kill is based on Impacts 21, 27, 28, and 33 which perforated the right hull armor and penetrated the right fuel turret and two valve covers, and on cumulative damage to the track and suspension system caused by Impacts 14, 16, and 30. Crew casualties caused by Impacts 2, 5, 7, and 8 contributed to the kill.
- b. F-Kill: The assessment of a 95% F-Kill was attributed to Impacts 2, 5, 7, and 8 which perforated the right turret armor and caused casualties to the commander, gunner and loader.

Legend: Circled numbers indicate perforating impacts.

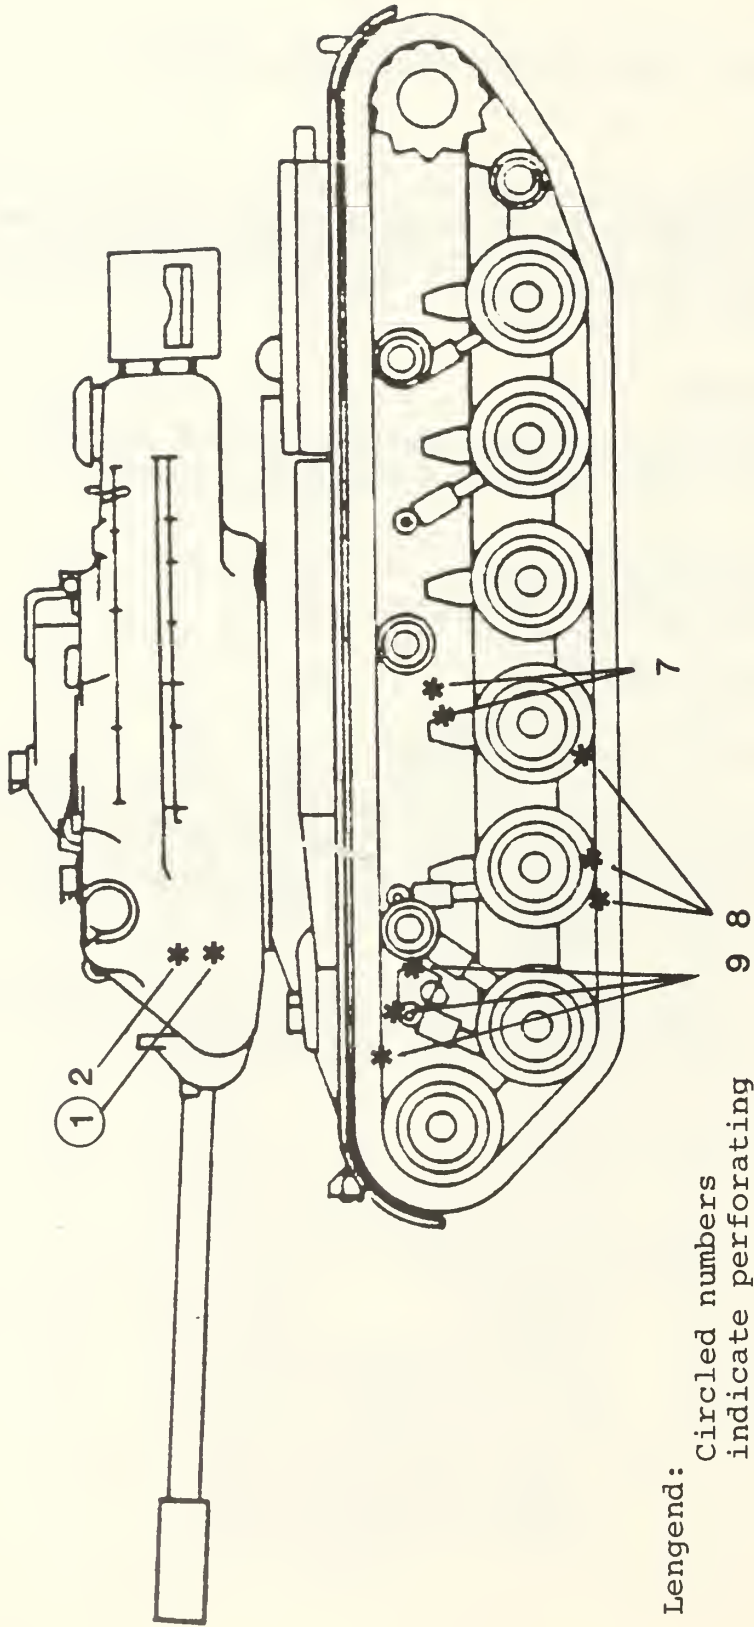
FIGURE 12. Impact Diagram, Target 53, Left Side.

- a. M-Kill: A 100% interdiction type M-Kill, based on cumulative damage to the track and suspension system caused by Impacts 9, 11, 17, and 18 (Figures 12, 13, and 14), which would have caused total track failure after 5 to 8 kilometers of travel.
- b. F-Kill: The assessment of 30% F-Kill is based on slight wounds to the loader caused by Impact 1, which perforated the left turret armor.

Lengend: Circled numbers
 indicate perforating
 impacts.

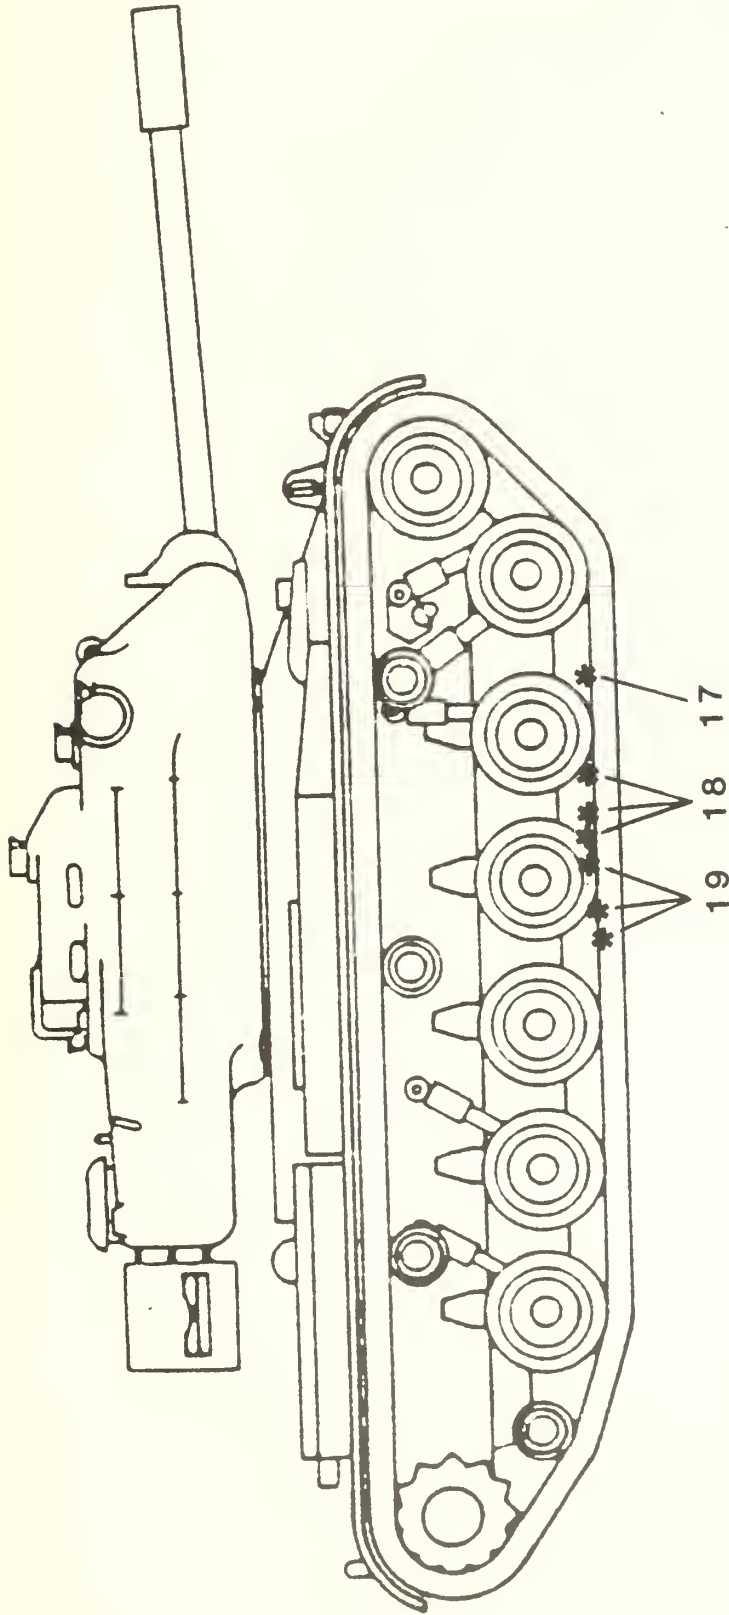
FIGURE 13. Impact Diagram, Target 53, Right Side.

NOTE: Impacts 17, 18, and 19 are from inside to outside of wheels and track.

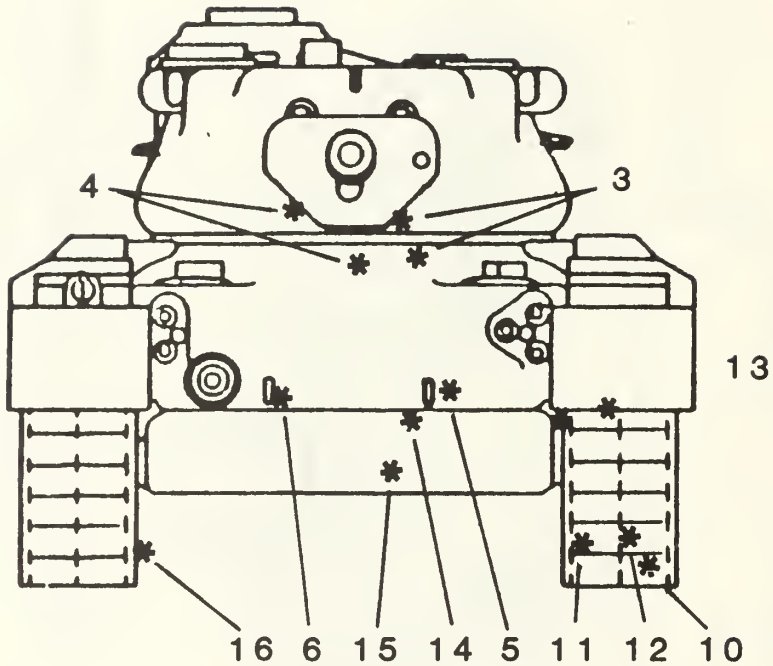
FIGURE 14. Impact Diagram, Target 53, Front.

NOTE: Impact 16 is on inside of number 1 road wheel.

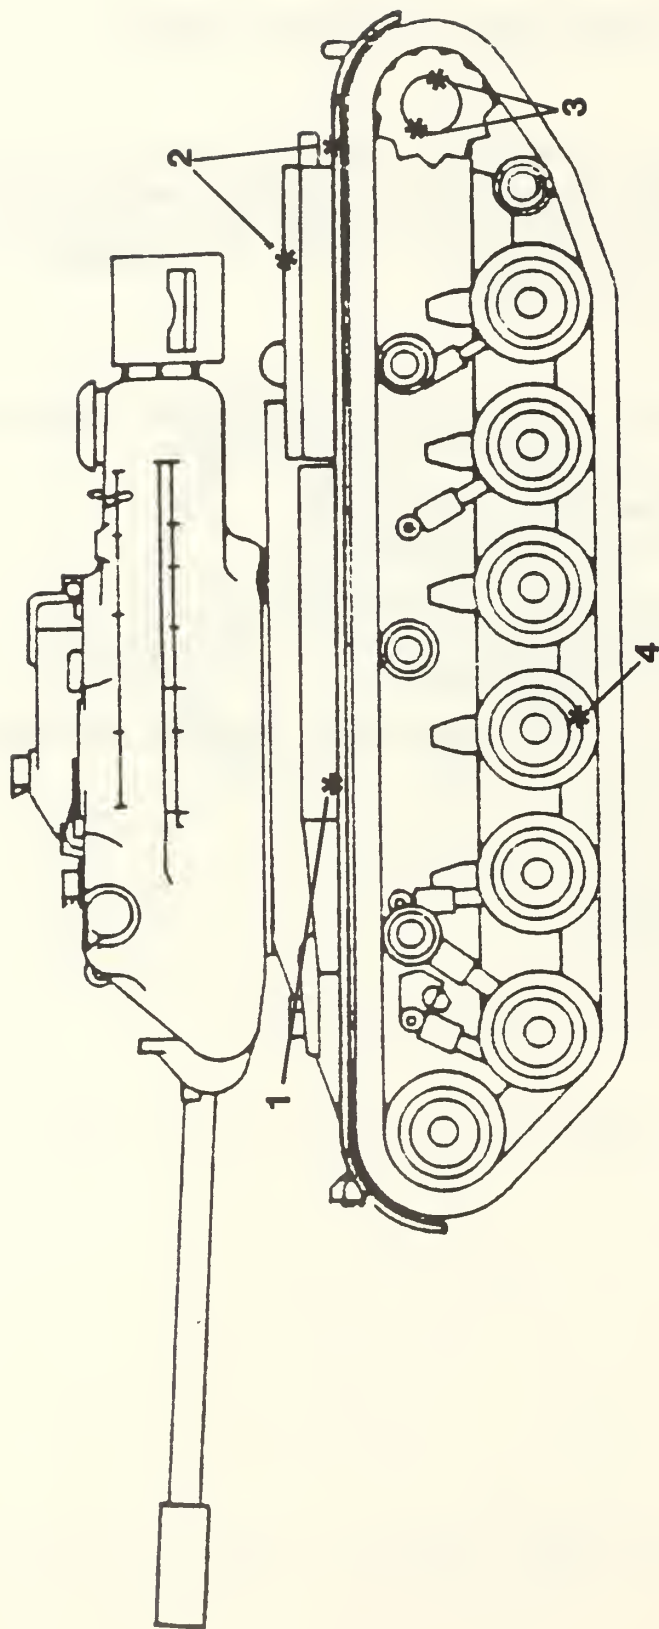
FIGURE 15. Impact Diagram, Target 33.

No degradation in mobility or firepower (Figure 15):

No perforations or significant impacts were observed on target tank 33.

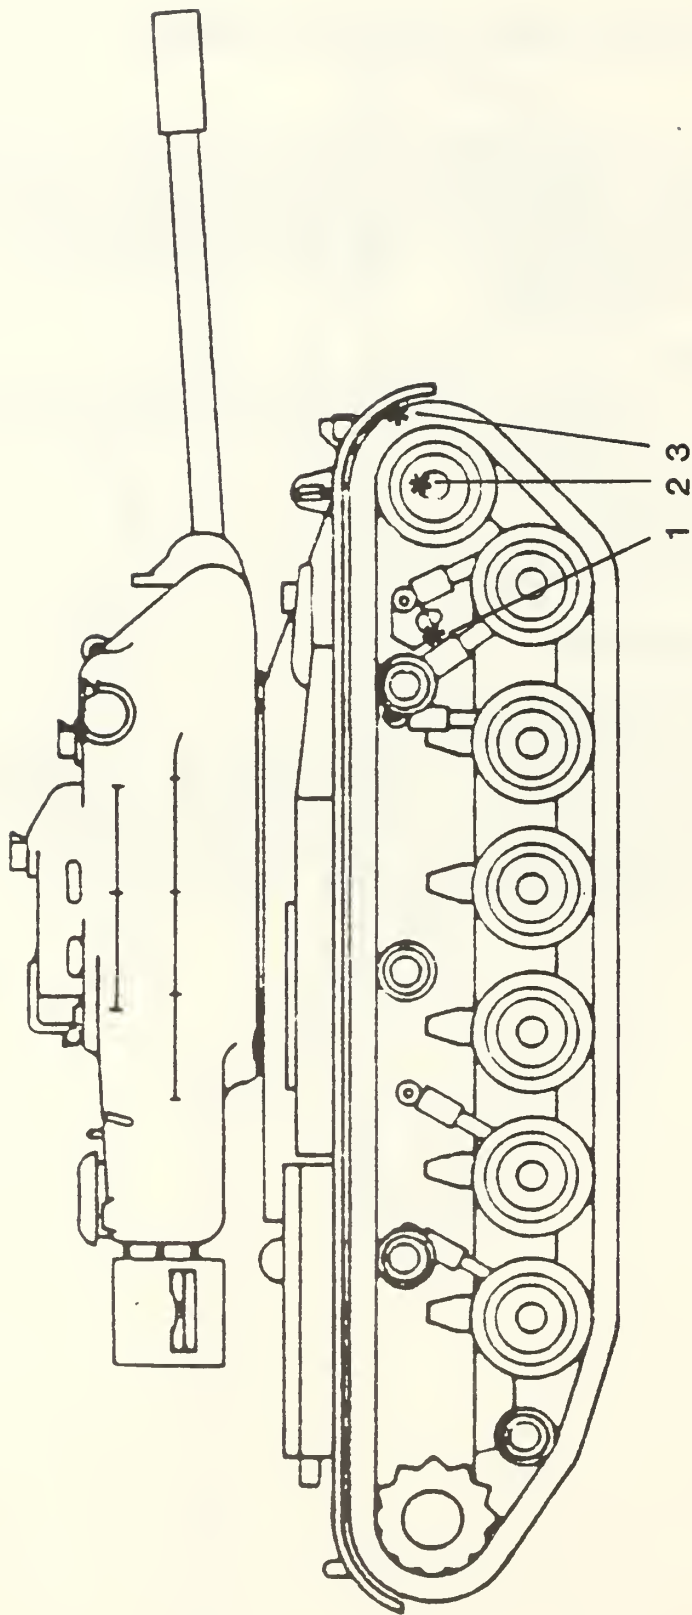
FIGURE 16. Impact Diagram, Target 51, Right Side.

100% M-Kill, resulting from the following observed effects (Figures 16 and 17):

The assessment of 100% M-Kill is based on damage to the right track adjusting idler, caused by Impact 2, and to Impact 3 which destroyed an end connector and track center guide on the same pair of track shoes. See Figure 16 for locations of Impacts 2 and 3.

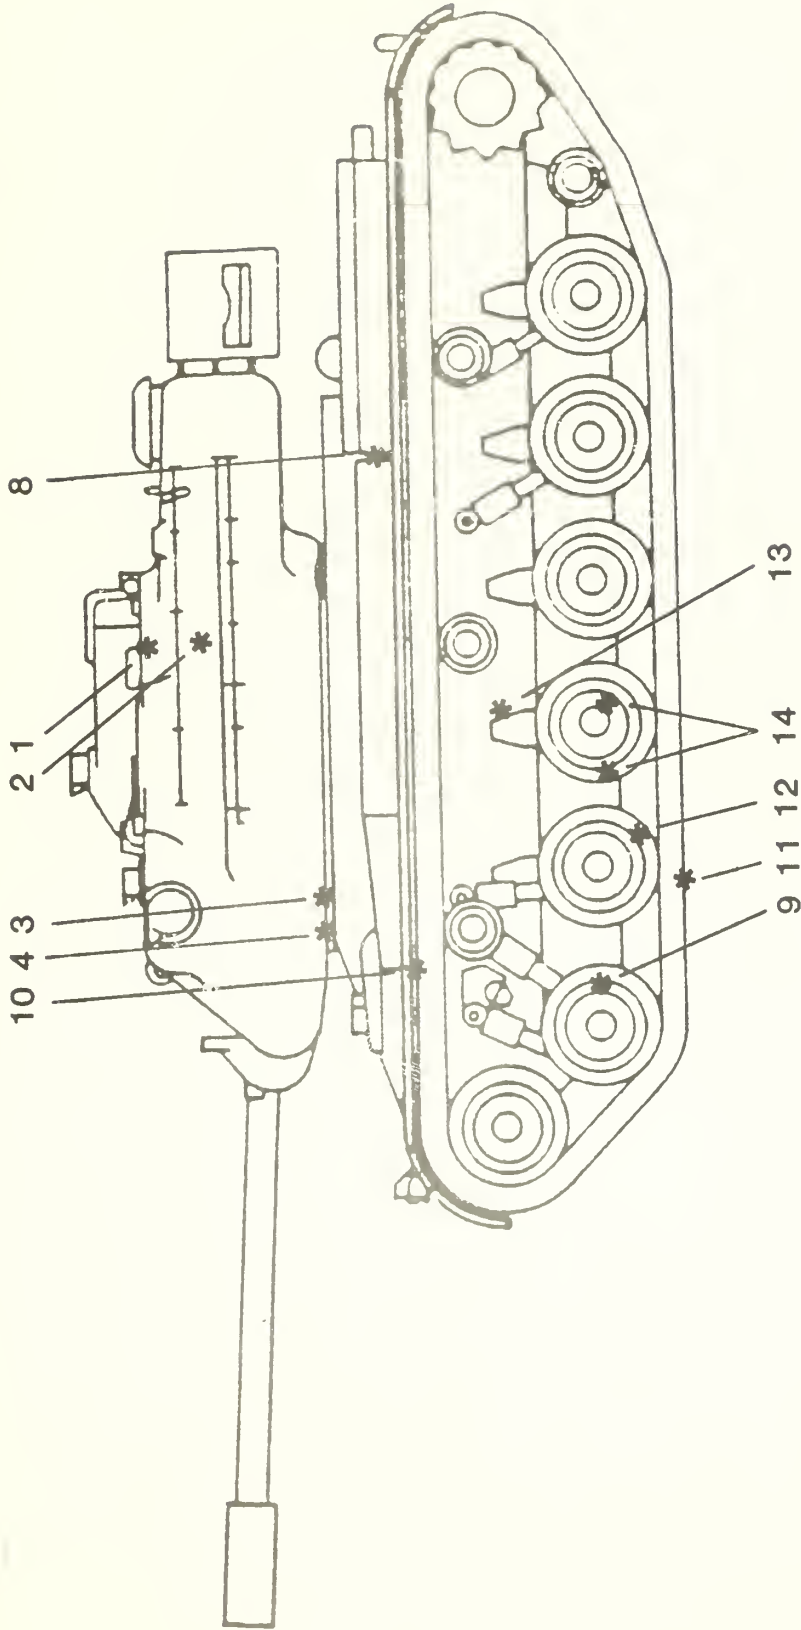
FIGURE 18. Impact Diagram, Target 57, Left Side.

100% F-Kill, resulting from the following observed effects (Figures 18, 19, and 20):

Impacts 3 and 4 jammed the turret, preventing traverse and, consequently, the use of main armament.

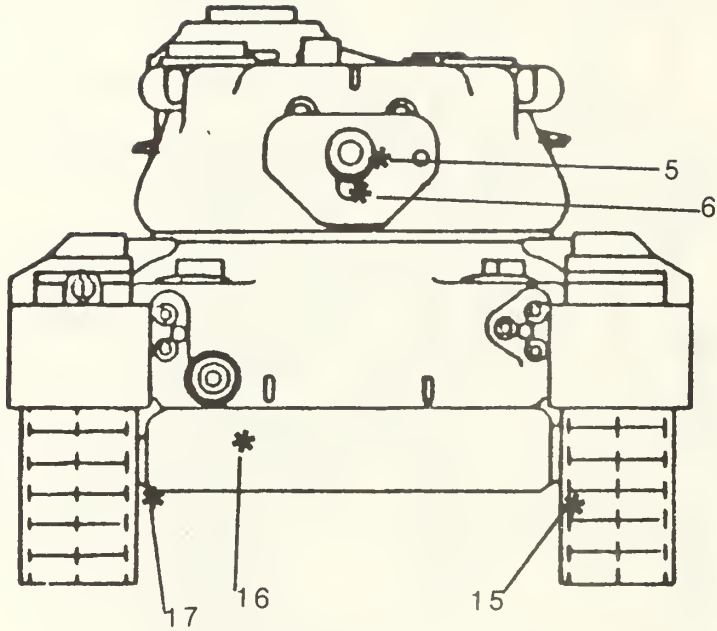
FIGURE 19. Impact Diagram, Target 57, Front.

NOTE: #17 impacted #4 roadwheel torsion bar housing.

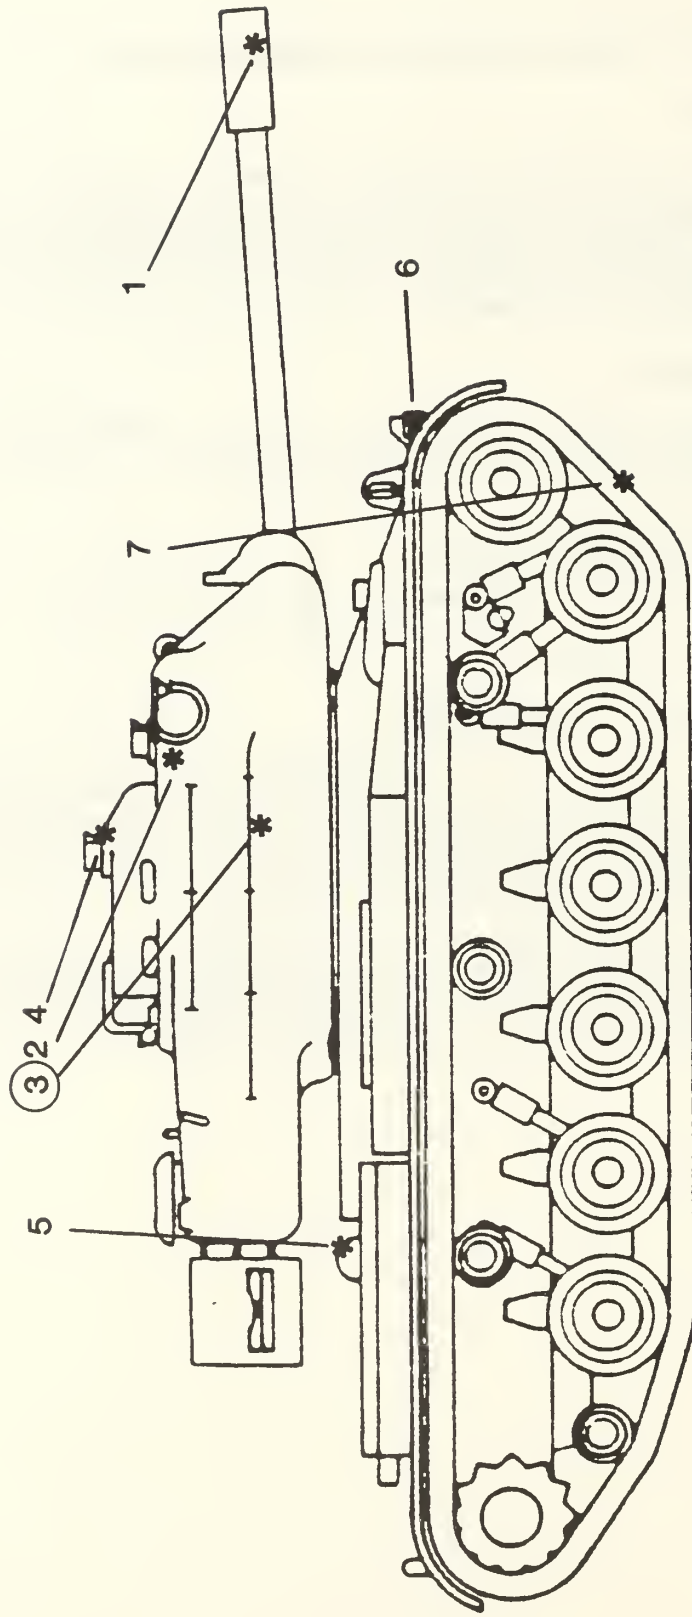
FIGURE 21. Impact Diagram, Target 55.

55% M-Kill and 85% F-Kill, resulting from the following observed effects (Figure 21):

- a. M-Kill: A 55% M-Kill was assessed, based solely on the contribution to a mobility kill caused by gunner and loader casualties. Mechanical damage to mobility components was insignificant.
- b. F-Kill: An 85% F-Kill was assessed, based on Impact 3 which perforated the right turret, causing casualties to the gunner and loader and on Impact 1, which penetrated both walls of the gun tube.

Legend: Circled numbers indicate perforating impacts.

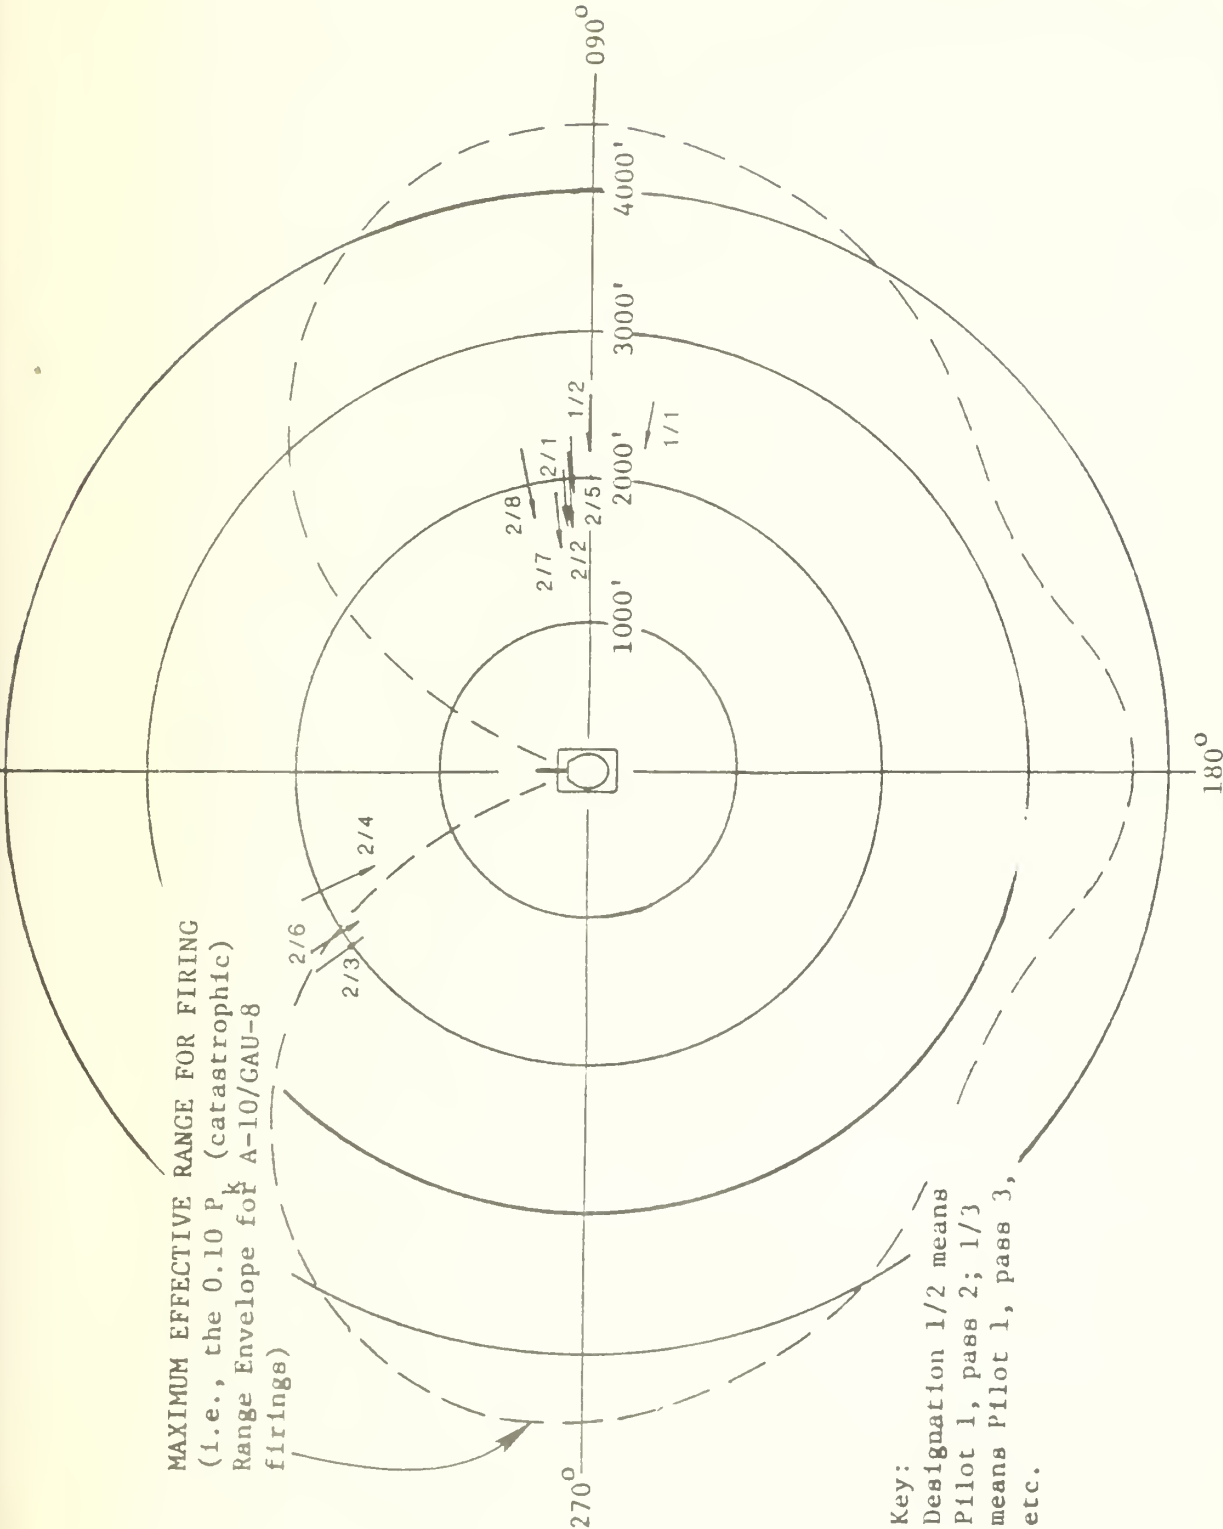
FIGURE A-1. Mission 25 Attack Aspect Summary.

Table A-1 contains a summary of the results of mission 25 on 4 December, 1979. Table A-II relates the assessment of damage in Table A-I to locations of perforations. Table A-III summarizes the aircraft attack parameters of altitude, attitude, air speed, firing slant range, and burst length for each pass on each target. Figure A-1 relates the aircraft attack aspect by firing pass to aircraft range from target at the beginning and at the end of each burst. The attack directions are shown as arrows on a plan view diagram of the simulated combat engagement. The arrows are located at the ranges from the targets at which firing took place.

MAXIMUM EFFECTIVE RANGE FOR FIRING
 (i.e., the 0.10 P_k (catastrophic)
 Range Envelope for A-10/GAU-8
 firings)

Key:
 Designation 1/2 means
 Pilot 1, pass 2; 1/3
 means Pilot 1, pass 3,
 etc.
